Memo to Mr. A. M. Toye, **Date** November 10, 1960.
Bridge Engineer, **Subject** FOUNDATION INVESTIGATION REPORT
From Materials & Research Section. **By:** Wm. A. Trow & Associates, Inc.

Re: C.N.R. Overhead and Hwy. 403 Underpass
Lemonville Rd., Aldershot, Ont., Dist. 4.
W.P. 197-58.

FOUNDATION INVESTIGATION
HWY. 403, C.N.R. CROSSINGS ON LEXINGTON RD.,
ALDERSHOT, ONTARIO
W.P. 197 - 58

FOUNDATION INVESTIGATION
HWY. 403, C.N.R. CROSSINGS ON LEMONVILLE RD.,
ALDERSHOT, ONTARIO
W.P. 197 - 58

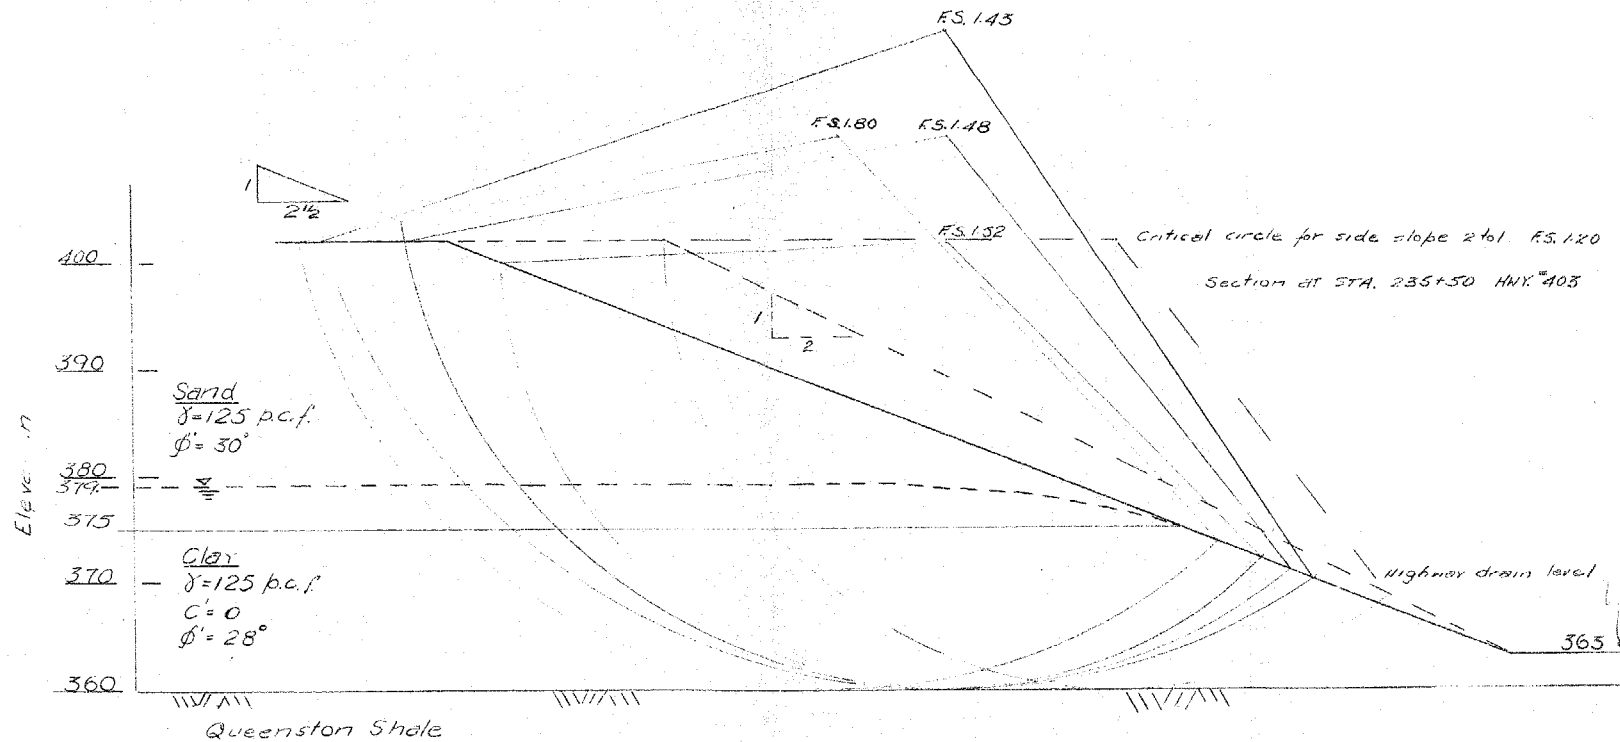
Drawing #13

A more critical condition was found for the long term stability. The minimum factor of safety in this circumstance, assuming slopes of 2:1, was $F = 1.20$. If the slopes are cut to $2\frac{1}{2}:1$, the minimum factor of safety increases to $F = 1.43$. According to the contours of the existing hillside, the present slopes have stabilized close to a value of $2\frac{1}{2}$ to 1.

In both analyses, a water table perched 4 feet above the surface of the clay was assumed. The level of this water can be expected to vary slightly depending upon the amount of rainfall over the area. This change in level will not affect the stability computations since the soil was assumed to be saturated up to Elev. 402 feet. Some minor sloughing of the sand may be experienced at its point of outcrop just above the clay layer, but this can be controlled by plant growth. As stated in an earlier section, there was no evidence of springs or unstable conditions on the existing slopes.

RESULTS OF LONG TERM SLIP CIRCLE STABILITY ANALYSIS
 PROPOSED CUTTING HIGHWAY N° 403

In order to ensure that the cutting is permanently stable with a factor of safety of 1.3 against failure this north cutting should be made at $2\frac{1}{4}$ to 1. The existing hillside falls approximately at this slope.

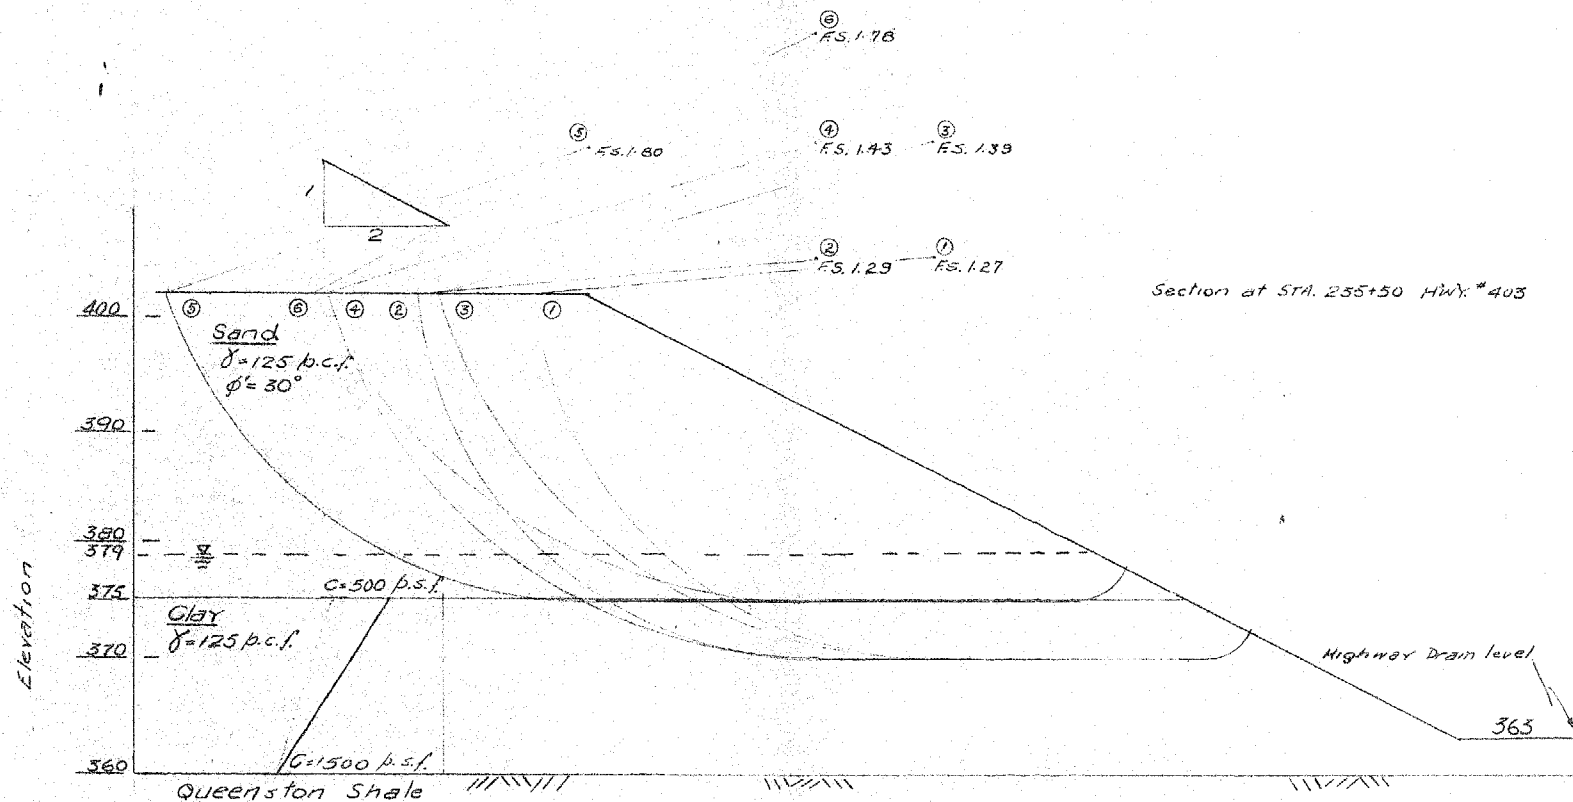
Drawing #14

An analysis of this highway cutting was made to examine both its short and long term stability. The results of this analysis are shown on Dwg. 13 and 14, and typical calculations and assumptions are presented in Appendix 2. The minimum factor of safety for the short term, after-construction case, was found to be $F = 1.27$. This value applies for a slope of 2 horizontal to 1 vertical.

RESULTS OF SHORT TERM SLIP CIRCLE STABILITY ANALYSIS
 PROPOSED CUTTING HIGHWAY N^o 403

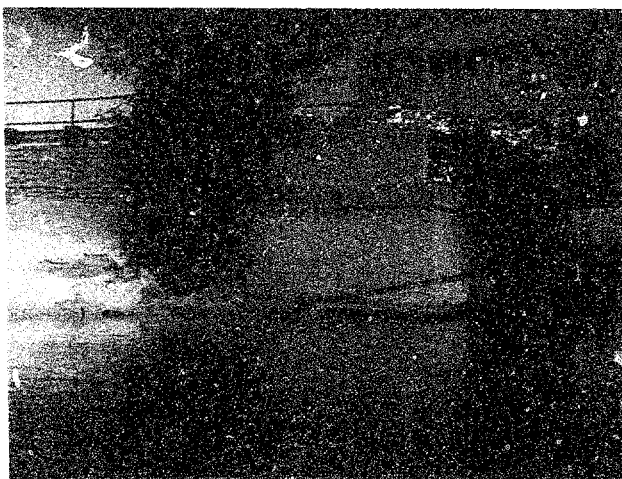
(1) Chainage 0+00 to 1+50

View of North
Abutment Looking
Downstream

The abutment is exposed here, in contrast to the south abutment which is protected by the river bank. Note the exposed tree roots and the poor condition of the unrelieved concrete apron.

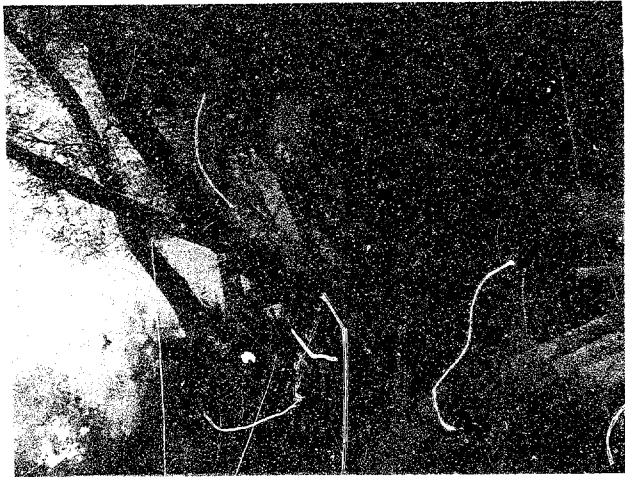
(11) Chainage 1+50 to 3+00

View of outflanked
clump of willows
on north bank,
looking unstream

Beyond this clump the water comes in about as far as it has in the foreground.

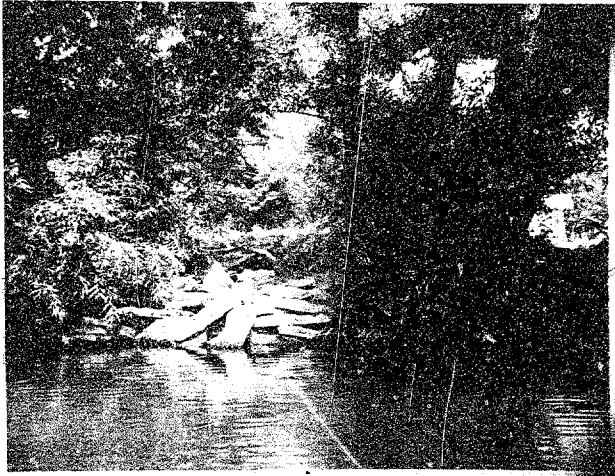
Typical view in this reach showing the dumped rubble between two outflanked clumps of willows.

Note also the rubble here, which has been dumped to protect the next clump.

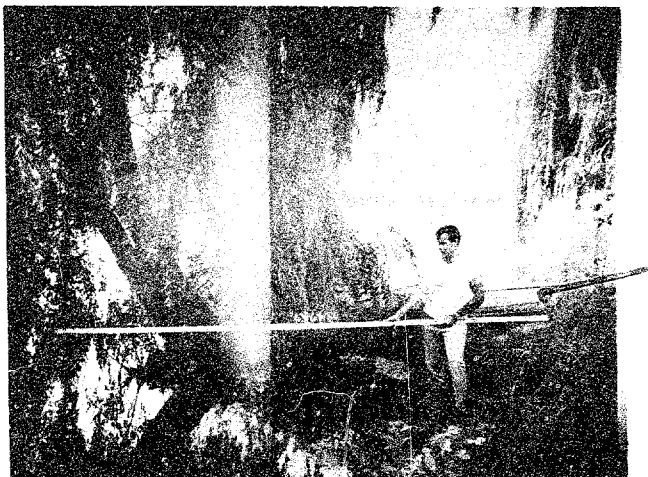
The first really
outflanked willow
looking upstream

Note the boat
which shows how far
the river is behind
the willow. The
surveyor is standing
on the water's edge
and his left hand
is on the 10 ft. mark
on the rod.

The chainage is approximately 4+00 and the depth at
the point jutting right into the river is about 5'-6".

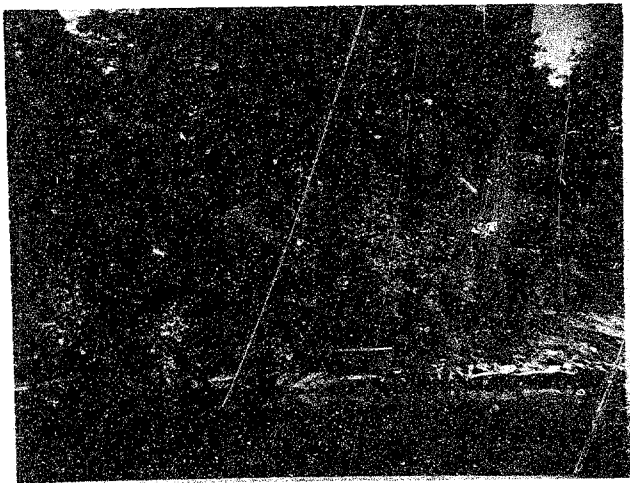
(v) Chainage 6+00 to 7+50

The picture is slightly upstream of station 6+00.

The low, almost vertical banks described in previous section start just downstream of picture. This picture shows the worst undercutting detected.
