MEMORANDUM

Embankment Settlement Problems
In the Vicinity of
Station 274+00 and Station 276+00
Westbound Lane of Highway 403
1000 Ft. East of Snake Road and
Highway 403 Crossing
District No. 4 (Hamilton)
-- W.J. 68-F-56 --

EMBANKMENT SETTLEMENT HWY. 403 STA 274+00 TO 276+00

RECOMMENDED DRAINAGE INSTALLATIONS

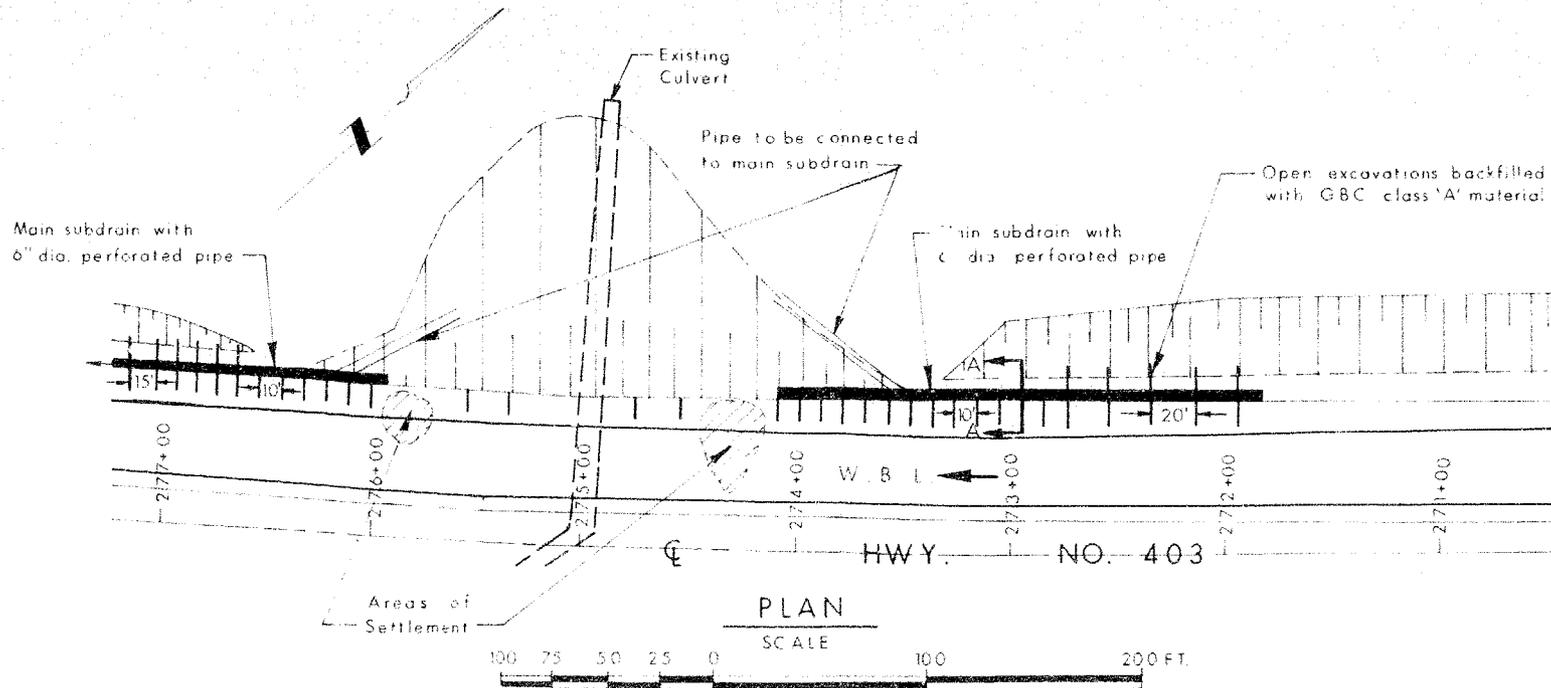
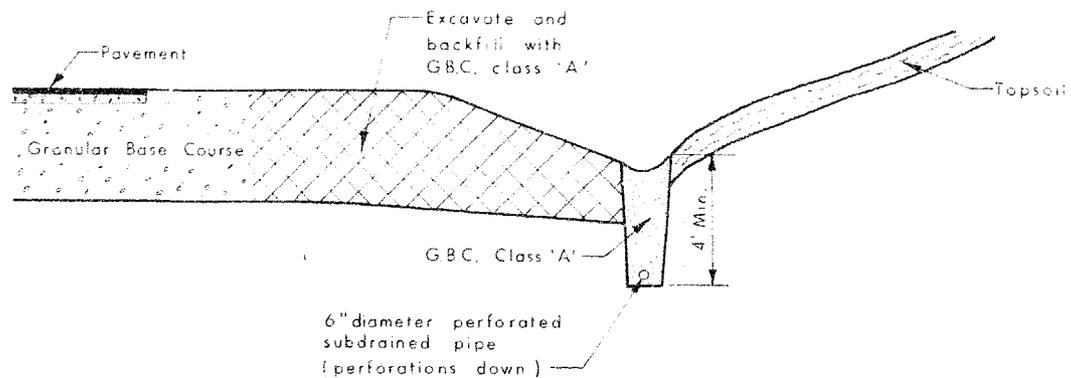
SKECH NO. 1

Based on the above values, it is concluded that the fill is poorly compacted in the upper 12 ft., being well compacted below a depth of about 12 ft. from the road surface. No groundwater was encountered within the fill. However, one piezometer in the failure area indicated a water level at elevation 339, i.e., some 10 ft. below shoulder level. At about the same elevation, water was noted seeping out through the embankment slope north of the settlement area around Sta. 274+00. By means of shallow boreholes and open trench excavations put down along the north shoulder of the westbound lane as well as in the slope of the roadside ditch, it was found that the base course beneath the shoulder in the vicinity of the grade points was saturated with water. Although the source of this water was not positively established during the investigation, it is believed that the water collected in the base course due to lack of effective drainage. Boreholes put down in the median adjacent to the problem area as well as along the south shoulder of the westbound lane, did not reveal any presence of water. It is concluded, therefore, that only a narrow portion of the north shoulder of the westbound lane is saturated with water which has percolated into the upper portions of the fill material which has subsequently been softened. Consolidation of this softened material has resulted in the observed settlement.

1. The existing roadside drainage ditch for the westbound lane between Stations 278+00 to 276+00 and 274+00 to 272+00 should be subexcavated to a depth of at least 4 ft. and backfilled with G.B.C. Class 'A' material. A 6" \emptyset perforated subdrain pipe should be provided at the base of this trench and should be suitably graded. The subdrain should be connected to suitable pipes in the vicinities of Stations 274+00 and 276+00 so that erosion at the grade points is kept to a minimum.

2. Open trench excavations perpendicular to the 6" \emptyset subdrain should be carried out in such a way as to drain all the water from the sub-base beneath the shoulder into the main subdrain. These excavations should be spaced at about 10-ft. intervals between Stations 277+00 and 276+00 and Stations 274+00 and 273+00; the spacing may be increased up to 20 ft. to the west and east, respectively, of Stations 277+00 and 273+00. The details, which have already been discussed on site with Mr. D. A. Waller, Maintenance Engineer, Hamilton District, are shown on the attached sketch.
