HWY. No. 25N

FOUNDATION INVESTIGATION REPORT
For
Proposed Realignment of Hwy. #25 (New)
Fill Stability
Station 120+00 to Station 124+00
Hwy. #5 Southerly to Q.E.W.
District No. 4 (Hamilton)
W.O. 70-11030 -- W.P. 131-65-01

To determine cause and propose counter measures for bin type retaining wall's movement on the west side of Highway 25 some 1500 feet north of Q.E.W. (Station 122+00+ to Station 123+50+ left of centre line Highway 25). Following at the site discussions, the meeting was moved to Bronte field office on South Service Road.

The results of an investigation carried out to determine the probable cause(s) of movement of an approximately 25 ft. high bin type retaining wall on Hwy 25 about 1/4 mile north of the Queen Elizabeth Way in Oakville, Ontario are reported and recommendations are provided for stabilizing the existing wall or replacing the wall with a new structure.

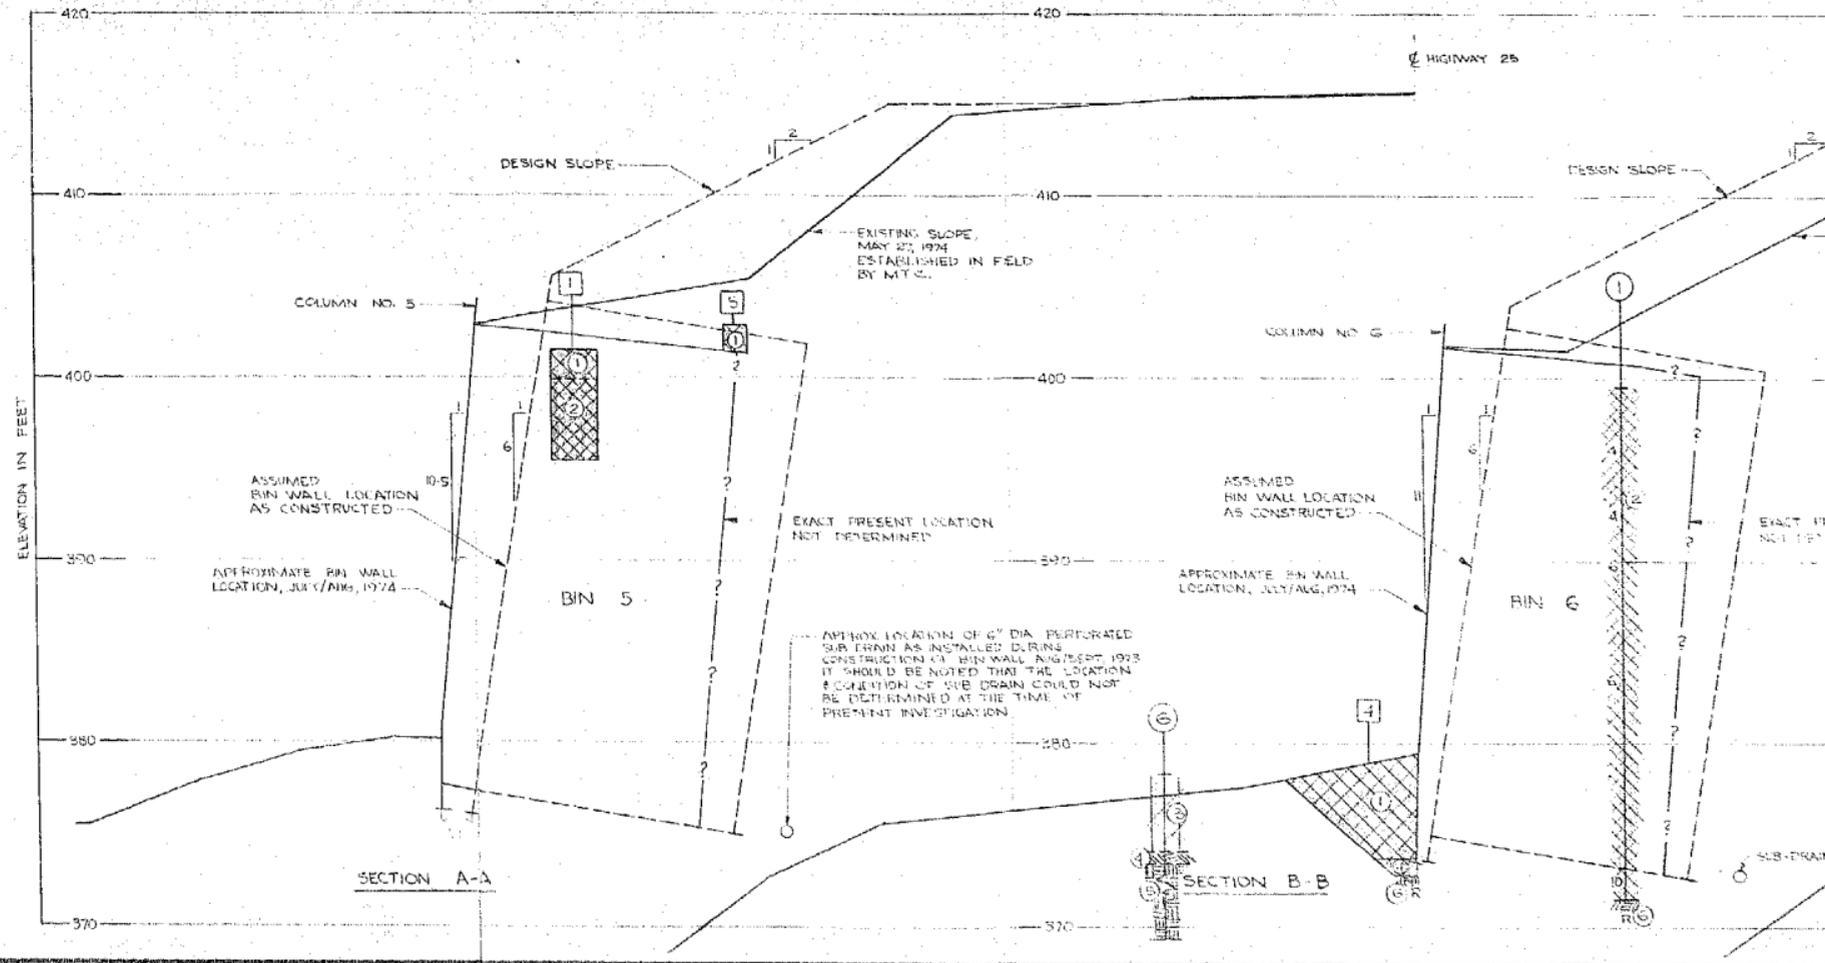
FIGURE 2

- 1) Bin type retaining wall at top has moved in the vicinity of bin panels #'s 4, 5 and 6 at maximum to 4'± westerly and 'nil' at bin panel #0 from designed alignment.
- 2) Although not as pronounced, movement of bin panels has taken place at existing ground level.
- 3) A cushioned pad was not designed under base plates which is normally included with this type of structure.
- 4) Earth fill on top is sliding and settling into bins.
- 5) Movement of bin type retaining wall was not noted in the month of May.
- 6) Present safety factor of bin type retaining wall is about 1 (K. Selby).

SECTIONS SHOWING SOIL STRATIGRAPHY & RELATIVE MOVEMENT OF BIN RETAINING WALL

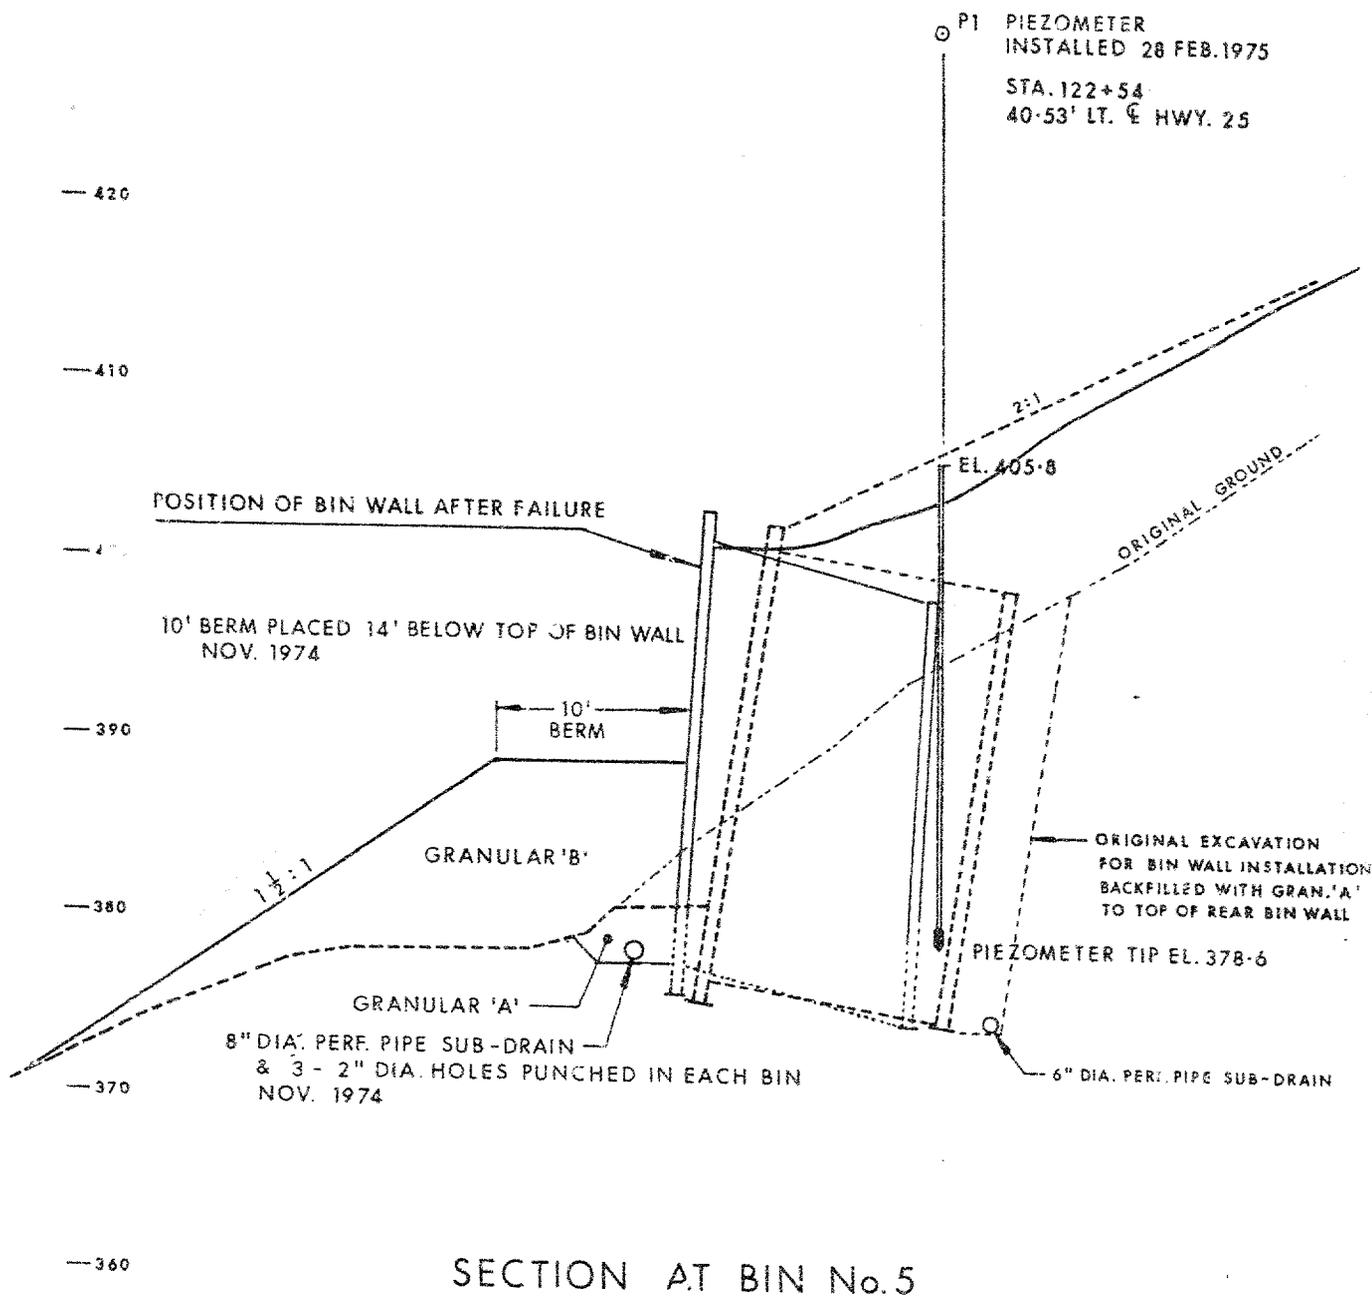
FIG. 1
 SHOWING POSITION OF BIN BEFORE (BROKEN LINES) AND AFTER FAILURE

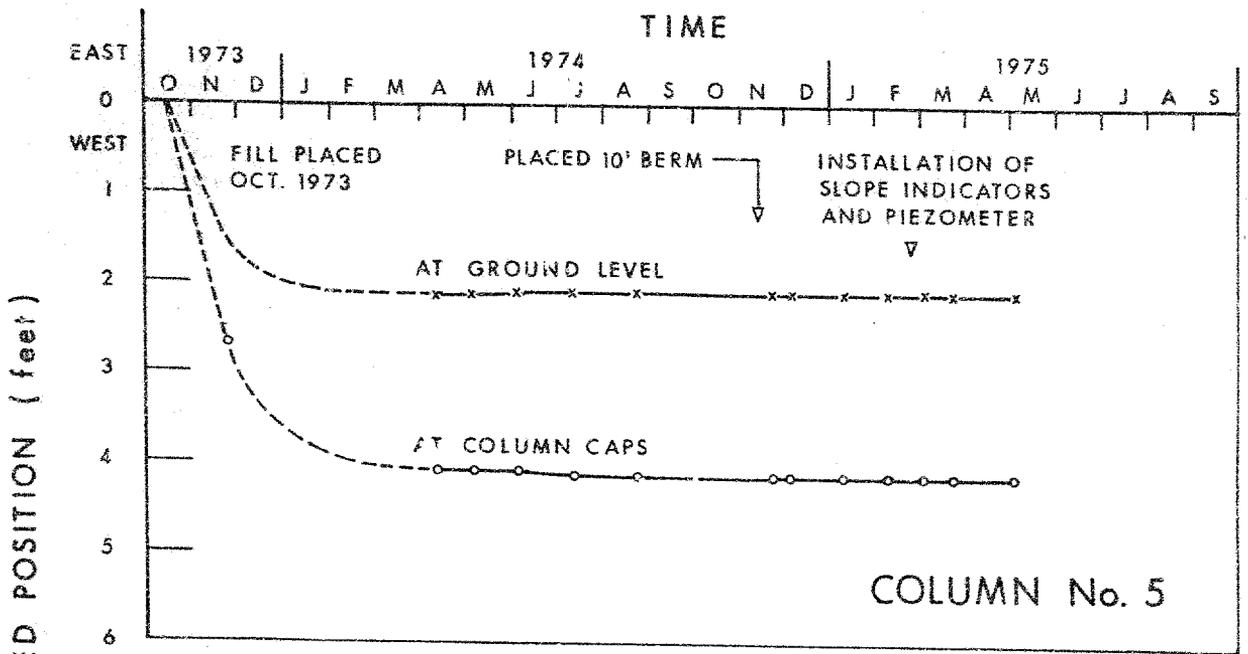
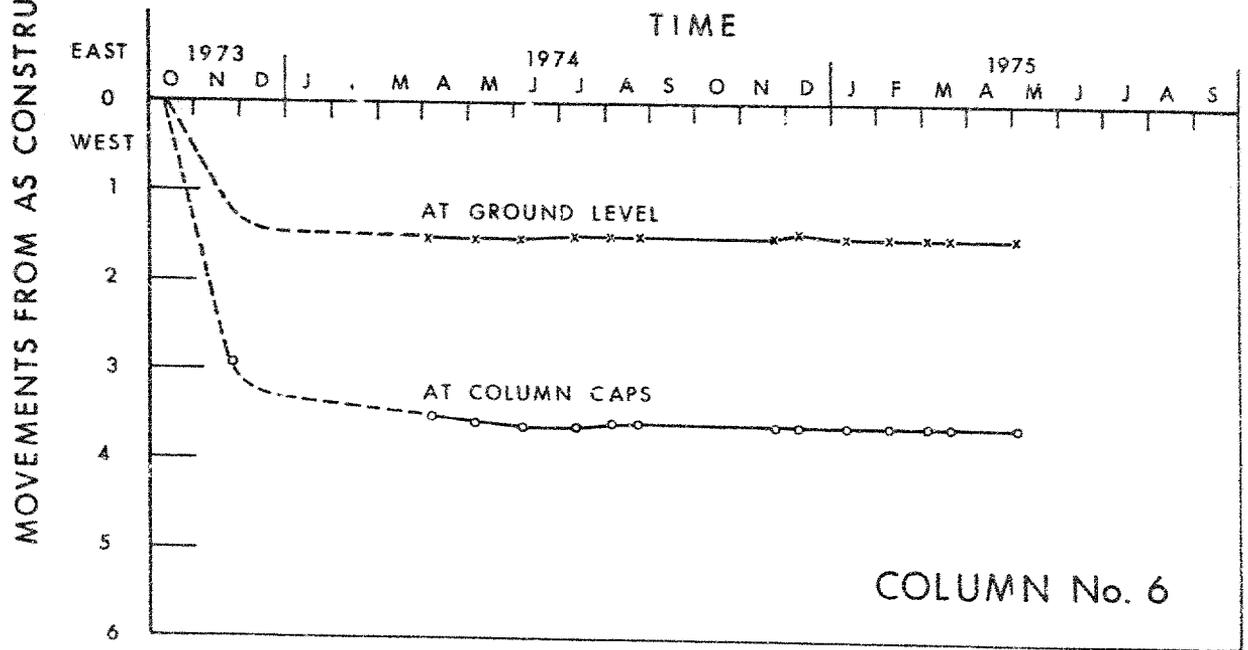
FIG. 3
SHOWING MOVEMENTS RECORDED BY THE DISTRICT

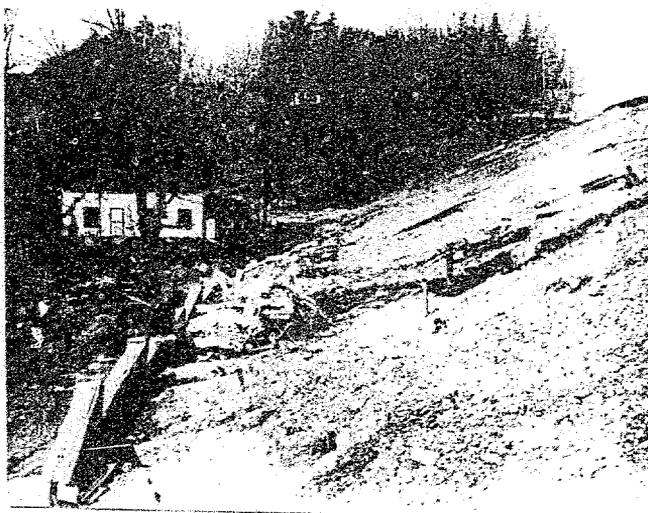
View to north, showing piezometer and slope indicator pipes, as well as wet areas on side slope

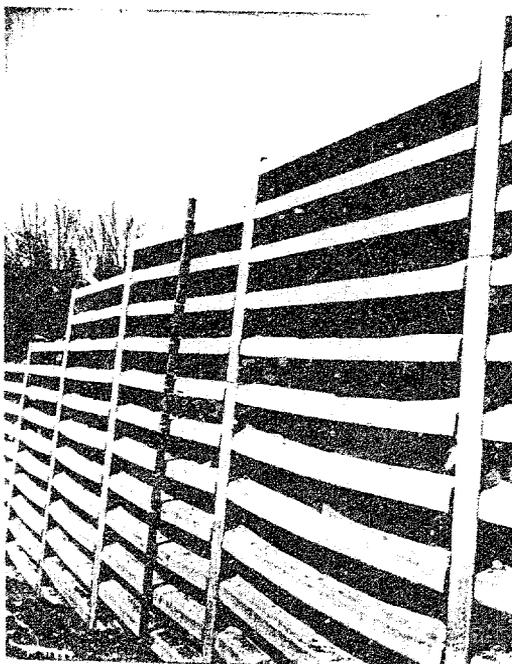
Slope indicator No 1 strapped to face of Bin No. 6

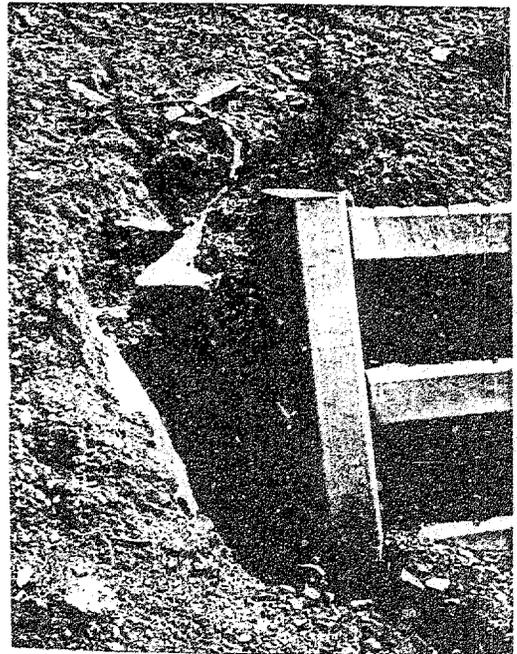
Wash out of soil
around column No. 17
of last Bin
