TROW, SODERMAN AND ASSOCIATES

Project: C108/J238

July 21, 1958.

Foundations - Bronte Creek Bridge,
Queen Elizabeth Highway

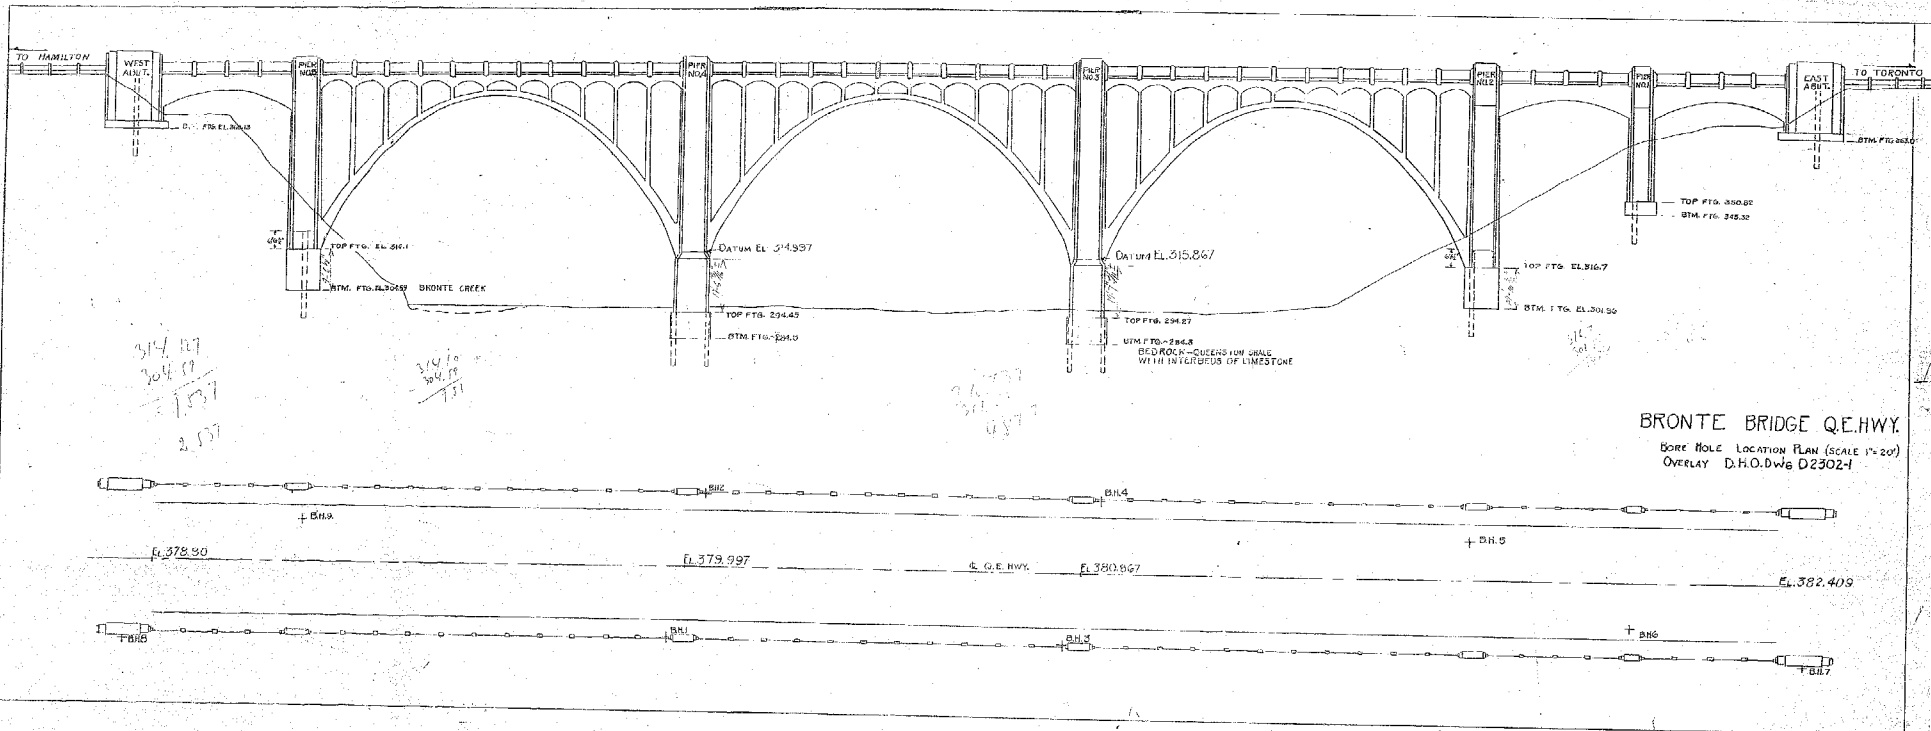
- 1) The elevations of the bottoms of the existing footings are recorded in Table No.1 and the drawing attached to this letter. With the exception of the west abutment, these measurements agree very closely with the footing depth record engraved in the concrete of most of these members. The engraved record for the west abutment indicated a footing depth approximately $2\frac{1}{2}$ feet lower than was measured in borehole No. 8. No check was obtainable for the east abutment and the second pier to the west because the records were buried in fill.
