VIDEO INSPECTION OF CAISSONS
AT HAMILTON ENTRANCE BRIDGES NOS. 1 & 3
HIGHWAY NO. 2 AND YORK BOULEVARD
HAMILTON, ONTARIO

Prepared for:
THE MINISTRY OF TRANSPORTATION AND COMMUNICATIONS

WILLIAM TROW ASSOCIATES (HAMILTON) LTD.
Project: H1569/H1533 1870 Barton Street East
February 12, 1973 Hamilton, Ontario
Telephone: 547-6385
Direct Toronto Line: 368-6293

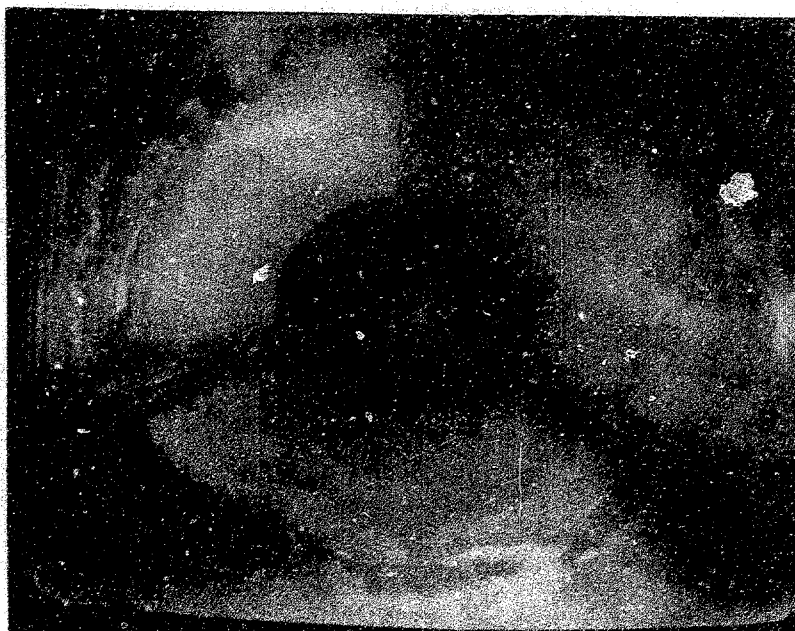
Photograph #1 Caisson 1, El. 225.5 feet
Axial view of exposed bedrock seam just
below liner.

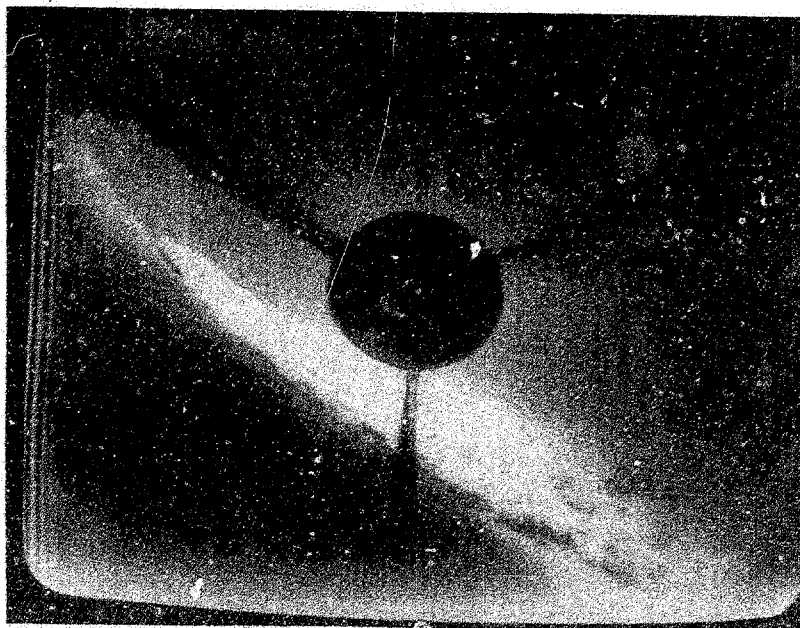
Photograph #2 Caisson 1, El. 225.5 feet
Axial view of rock at bottom of liner indicating
liner virtually flush with socket

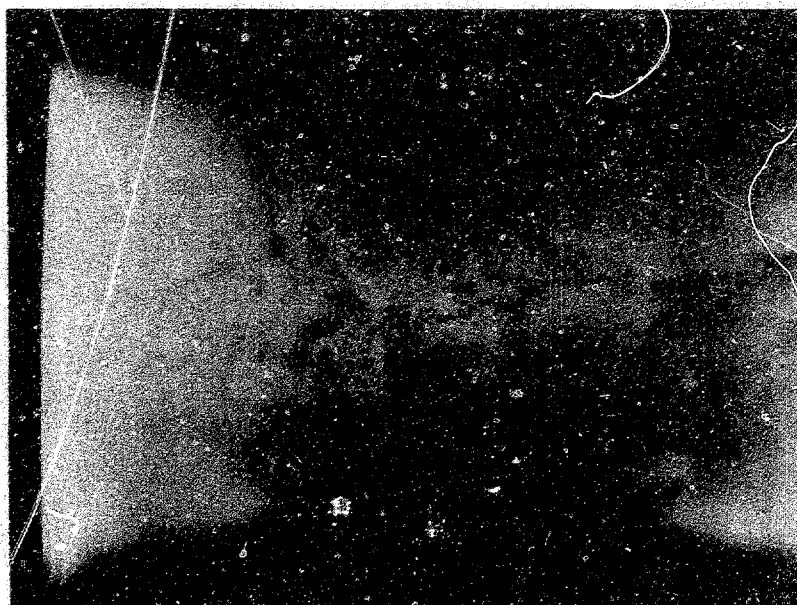
Photograph #3

Caisson 1, El. 225.5 feet
Radial view of seam in bedrock

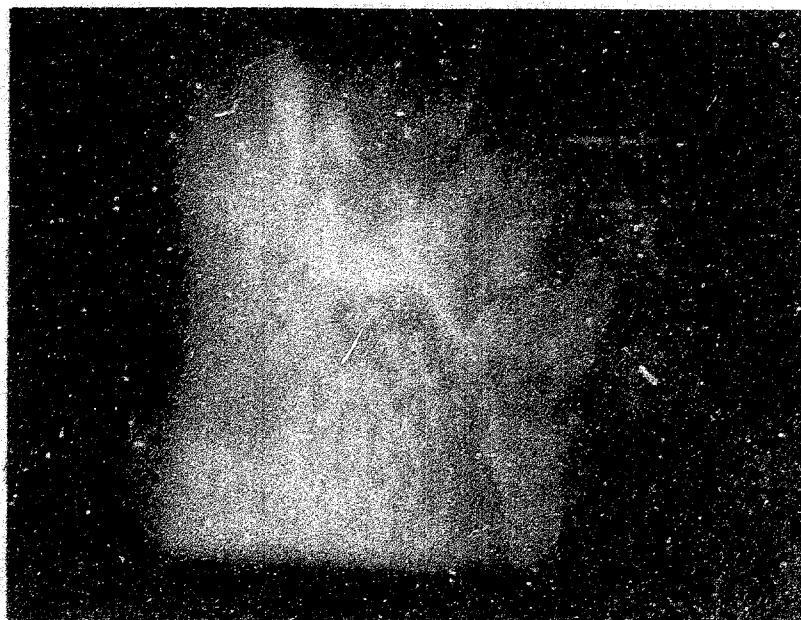
Photograph #4

Caisson 2, El. 208.46 feet
Radial view of shattered rock

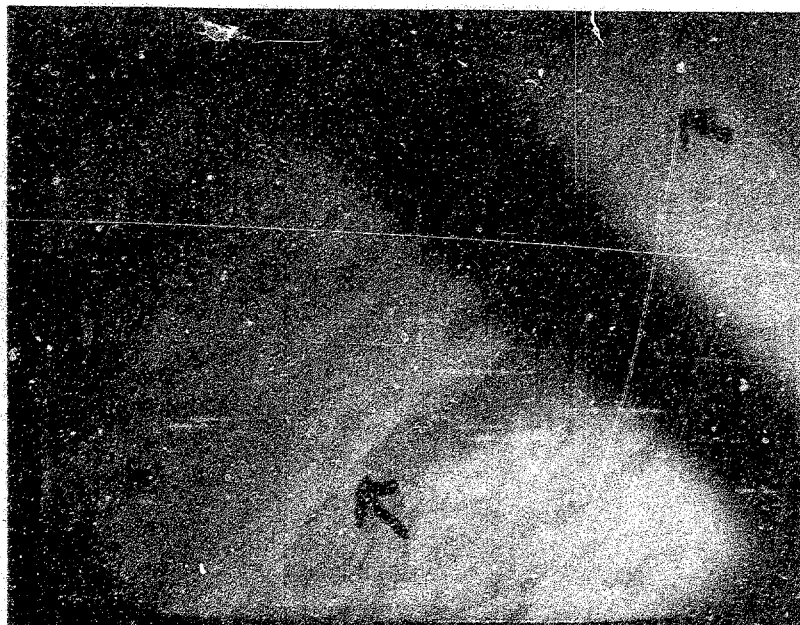
Photograph #5

Caisson 6, El. 209 feet
Radial view of horizontal
crack and seam in bedrock

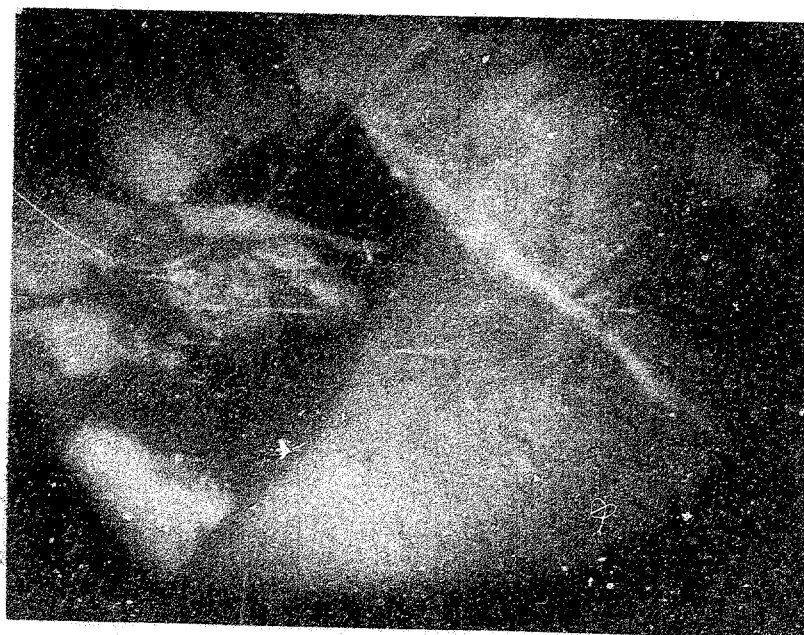
Photograph #6

Caisson 8, El. 217 feet
Broken rock and voids extending
behind the liner

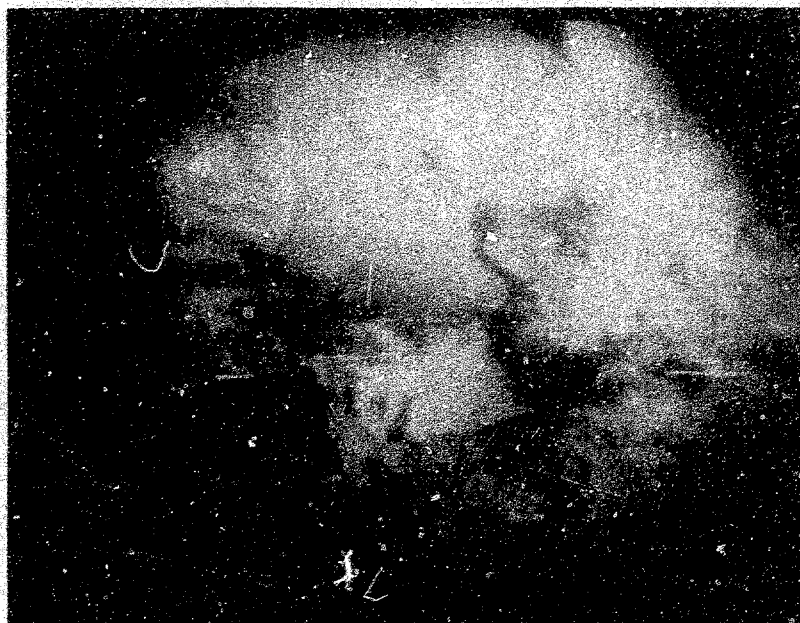
Photograph #7

Caisson 8, El. 216 feet
Radial view of seam filled with soil
and stones (rounded stone visible near
centre of screen)

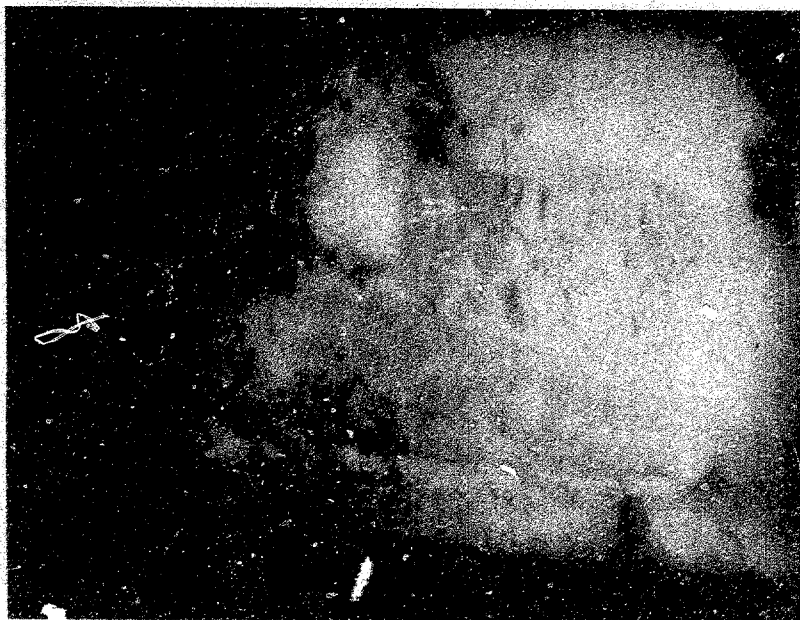
Photograph #8,

Caisson 8, El. 215 feet
Radial view of thin soil seam

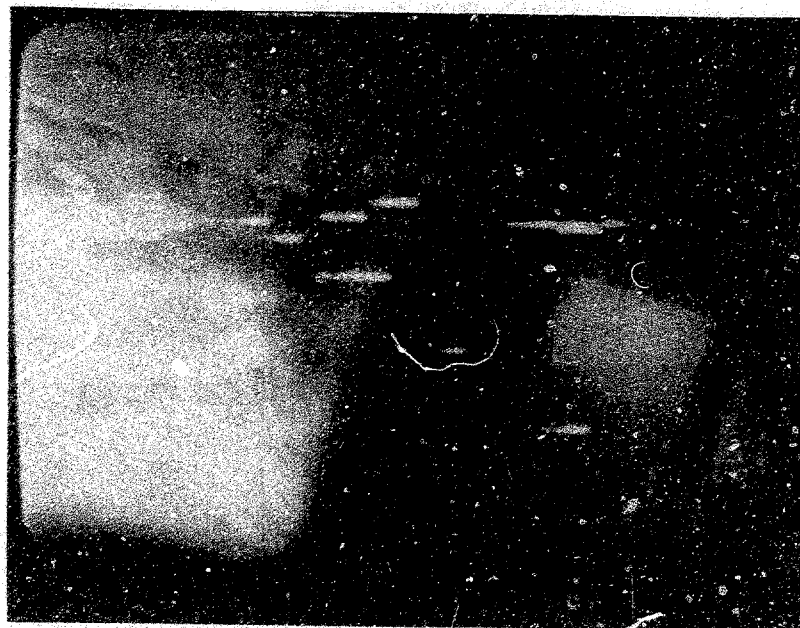
Photograph #10

Caisson 11, El. 236 feet
Radial view of voids behind liner

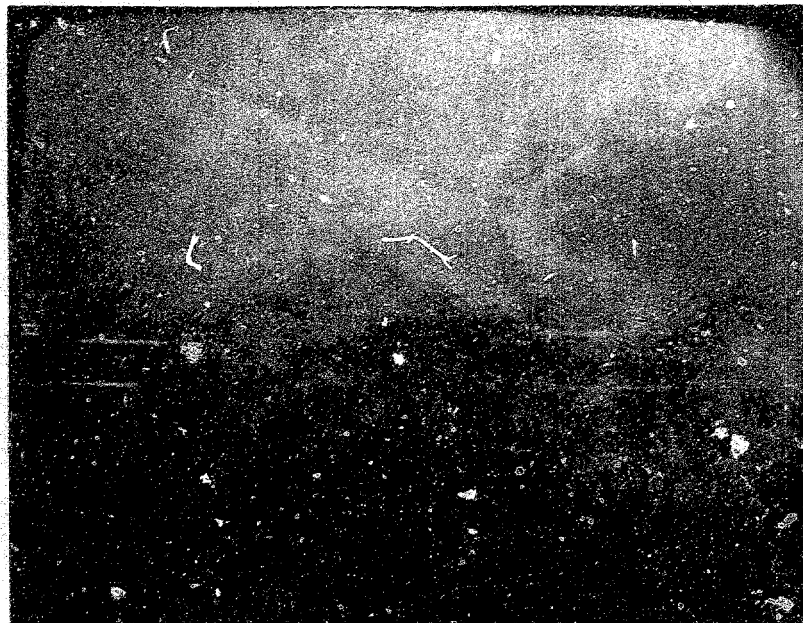
Photograph #11

Caisson 12, El. 215.54 feet
Radial view of sound bedrock at
bottom of caisson

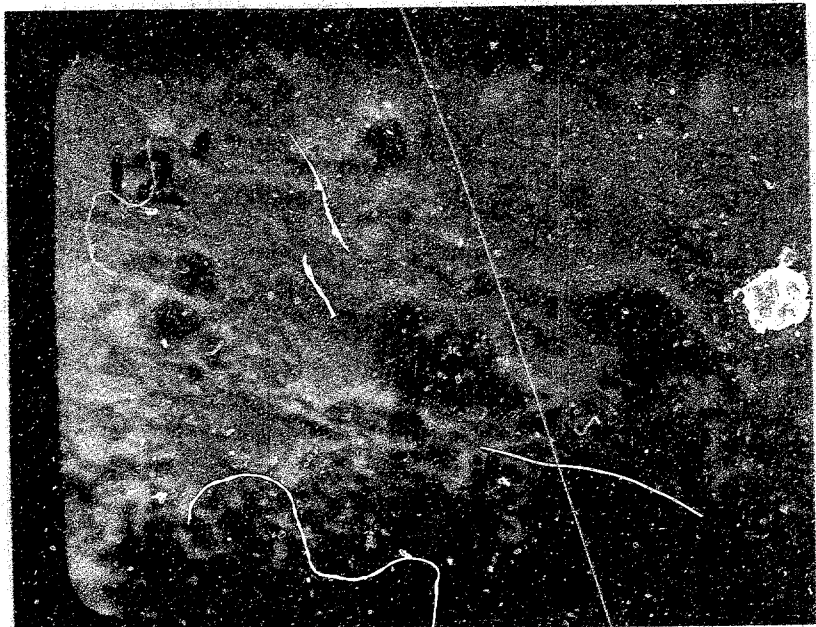
Photograph #12 Caisson 5, El. 240 feet
Radial view of small voids in concrete

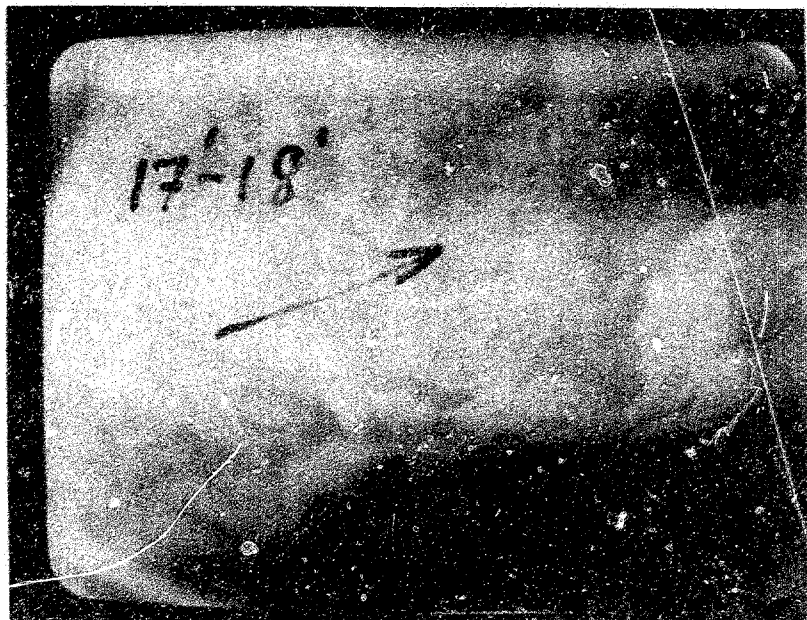
Photograph #13 Caisson 5, El. 234 feet
Radial view of void at top of
tremied concrete

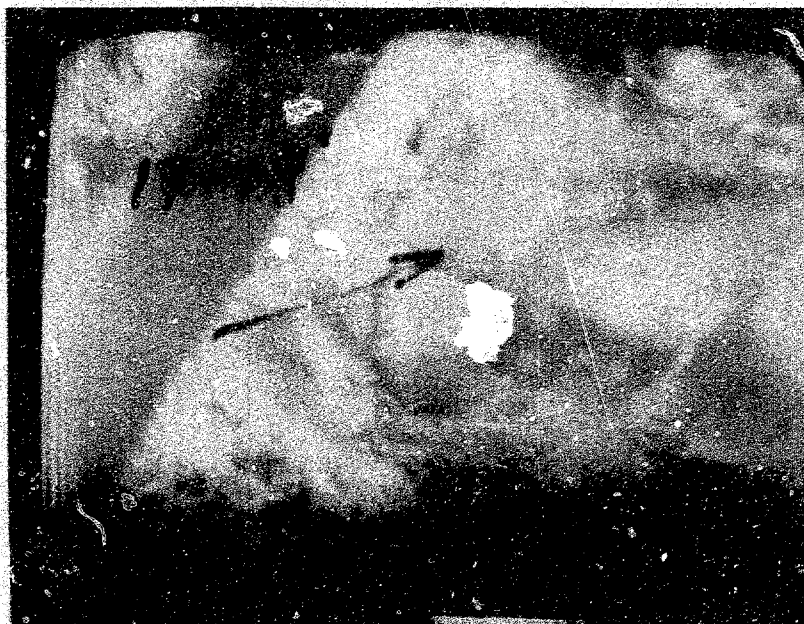
Photograph #14

Caisson 5, El. 234 feet
Radial view of loose aggregate in
void at top of tremied concrete

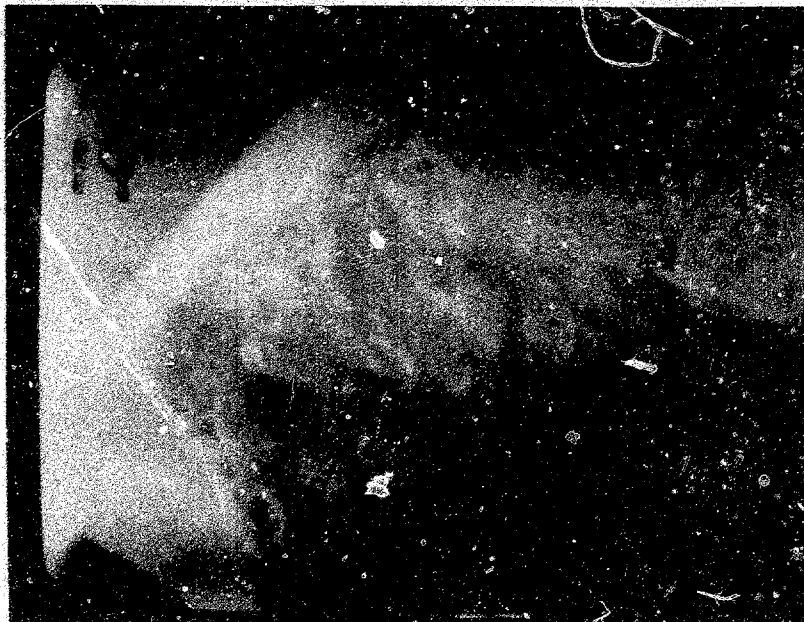
Photograph #15

Caisson 5, El. 232 feet
Radial view of crack in concrete
at edge of void

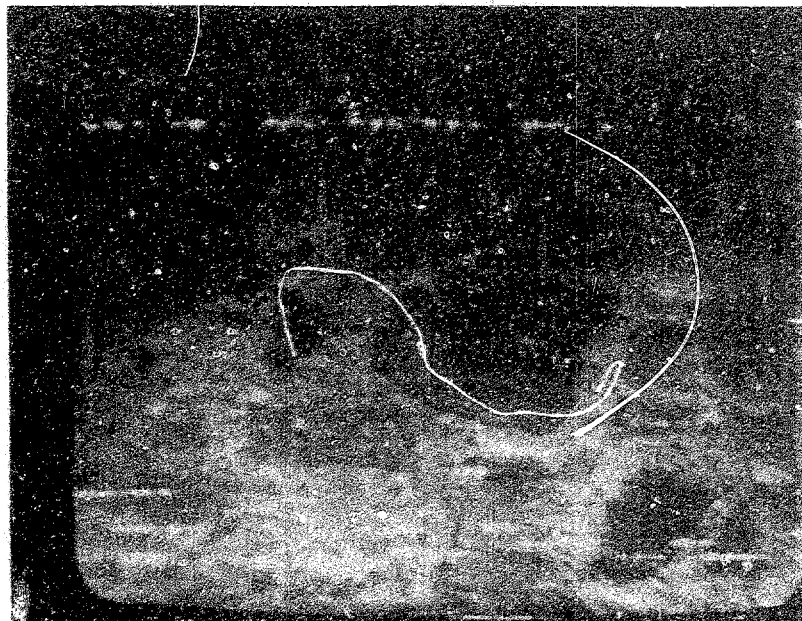
Photographs #16

Caisson 8,
Radial view of typical good quality
concrete

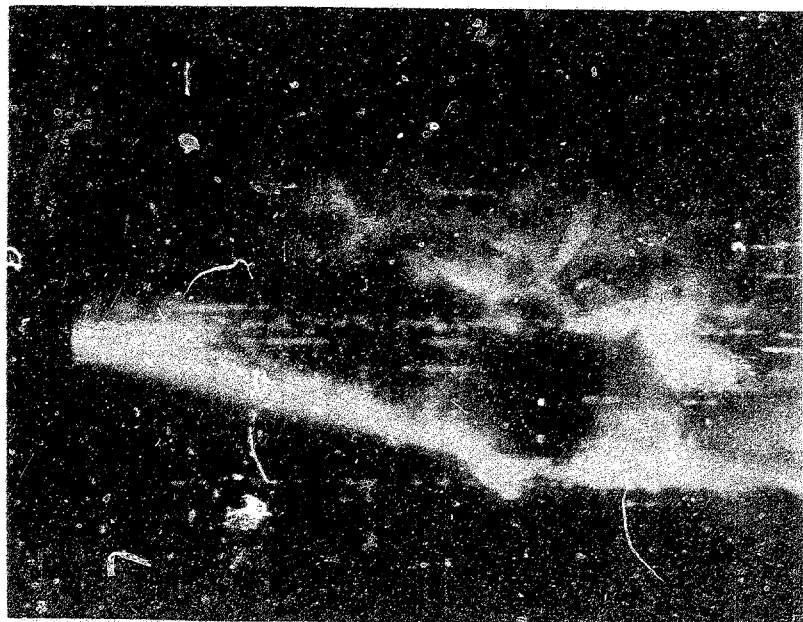
Photograph #17

Caisson 8, El. 195 feet
Radial view of steel plate and plastic
tremie tube cover at concrete to rock
interface

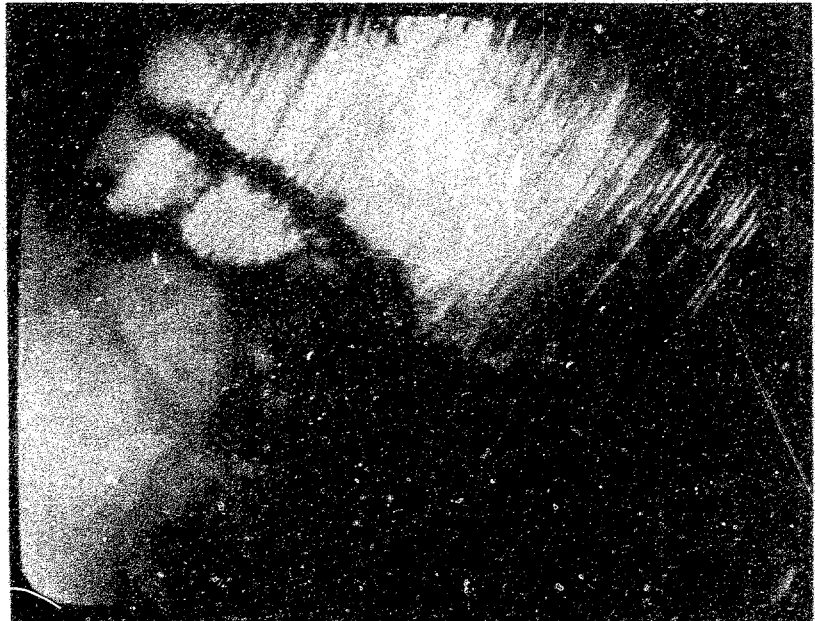
Photograph #18 Caisson 1, El. 221 feet
Radial view of reinforcing bar and sound
concrete indicating good bonding

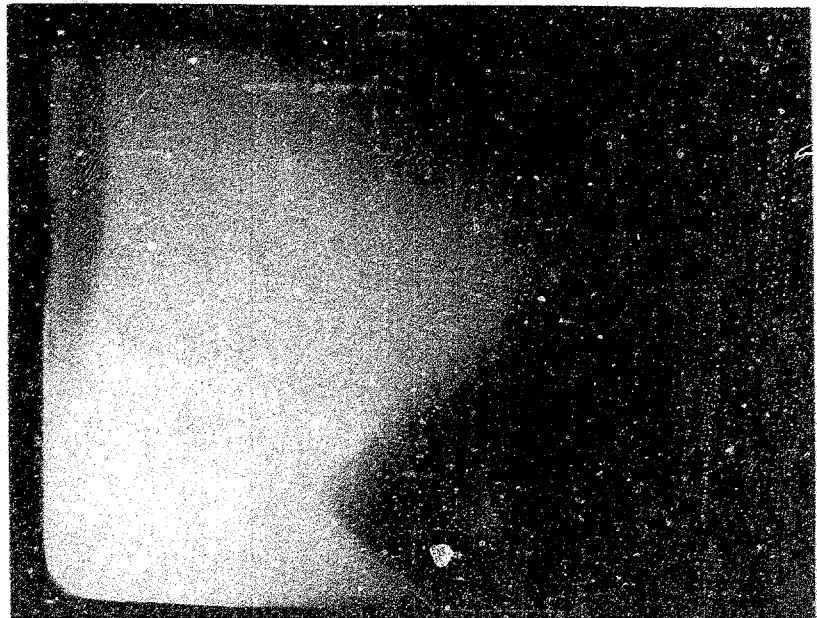
Photograph #19 Caisson 1, El. 215 feet
Radial view of void at concrete to rock
interface focusing on concrete in foreground

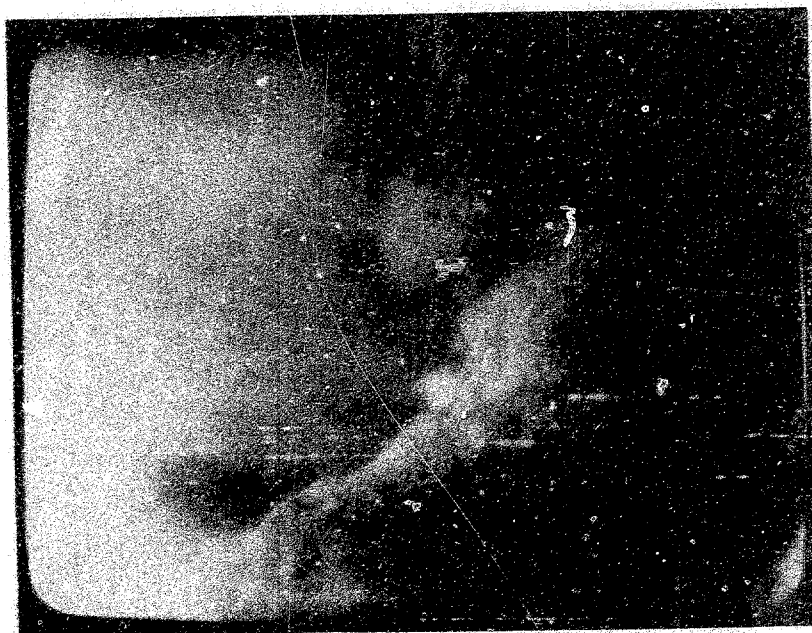
Photograph #20

Caisson 1, El. 215 feet
Radial view of loose aggregate in void at
concrete to rock interface

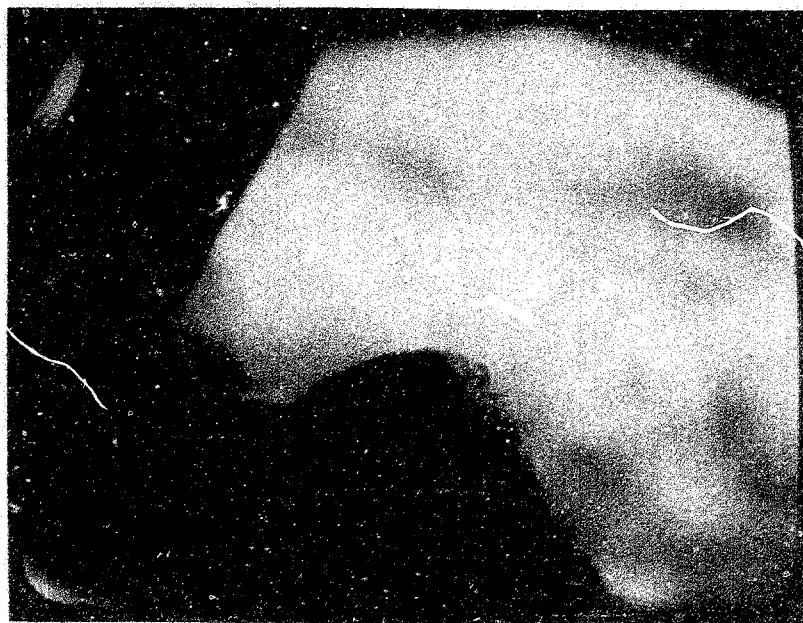
Photograph #21

Caisson 1, El. 215 feet
Radial view of void at concrete to rock
interface focusing on material in foreground

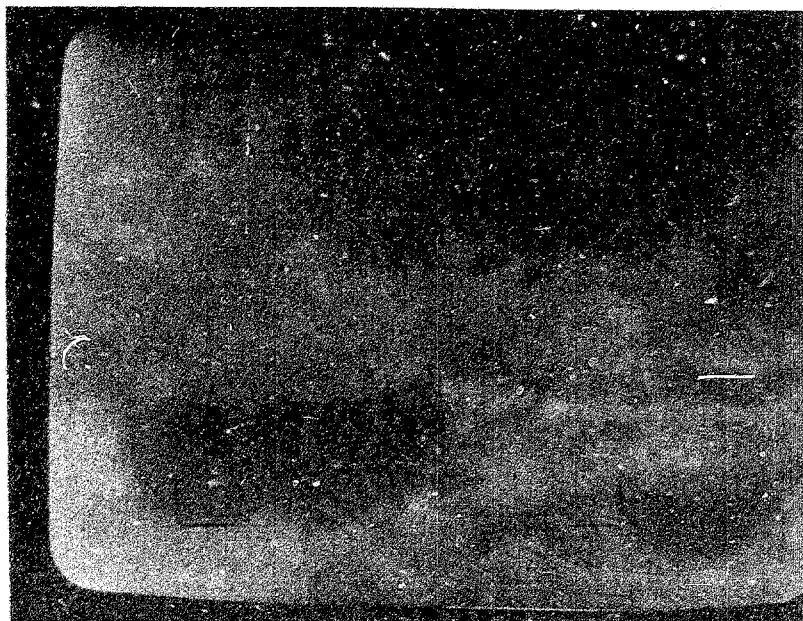
Photograph #23

Location of Cored Hole	Date of Inspection 1972	Elevation (ft.)		Remarks
		Top of Concrete	Concrete to Rock Inter face	
Bridge 1, Pier E Caisson 5	October 27	Approx. 242	183.55	Good quality concrete above & below the joint in tremie concrete, voids & loose aggregate from El.225 to 222ft. approx. (See Photographs 12, 13, 14 & 15)
Caisson 8	November 11	241.33	195.52	Good quality concrete to El.195.2, small voids at this level, adjacent to steel plate, flow of particles from voids observed. (See Photographs 16 & 17)
Bridge 3, Pier 4 Caisson 1	November 28	Approx. 252	215.24	Good quality concrete & bond with reinforcing to El.214ft. approx. large voids observed from El.215 to 216, frayed reinforcing bars visible, washed concrete with small shale pieces. (See Photographs 18, 19, 20 & 21)
Caisson 6	December 28	Approx. 252	200.34	Cored hole terminated at El.215 approx., on reinforcing steel; washed concrete encountered from 22 to 27 ft, compressive strength test results on core samples from depths of 22, 25 & 27 ft., were 5040, 4560 and 4230 psi respectively. (See Photographs 22, 23 & 24)

Caisson 6, El. 231 feet
Radial view of poor quality honeycombed
concrete where water had gained access to
tremie tube

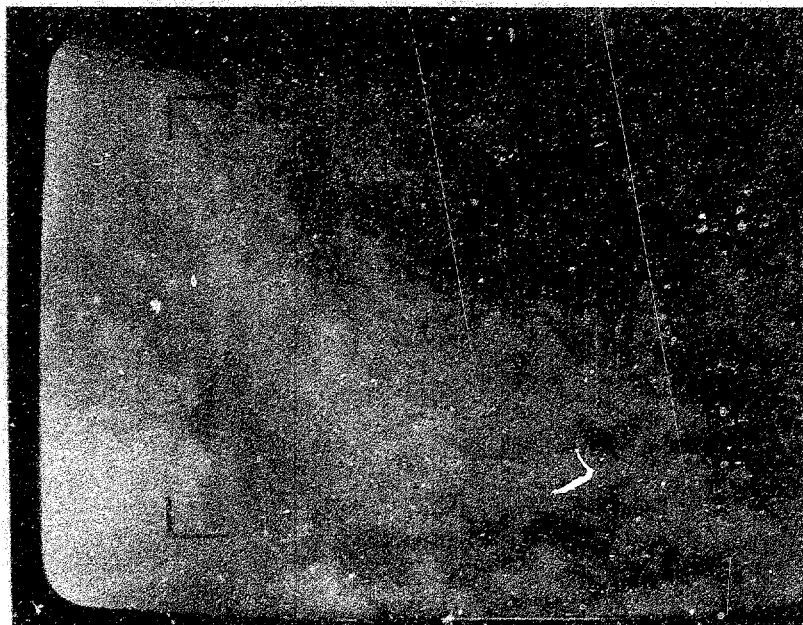
Photograph # 24

Caisson 6, E1.228 feet
Radial view of poor quality honeycombed concrete
where water had gained access to tremie tube
showing tie wire for reinforcing in lower left
hand corner
