GEOCRES No. 30M5-97DIST. 4 REGION W.P. No. CONT. No. W. O. No. 74-11026STR. SITE No. HWY. No. 403LOCATION SLOPE FAILURE ATEAST SLOPE OF HWY 403 EBL~~NEAR HWY 6 JUNCTION~~ NEAR HWY 6 JUNCTION=====OVERSIZE DRAWINGS TO BE INCLUDED WITH THIS REPORT. REMARKS:

SUBJECT: RE: Slope Failure at East Slope
of Highway 403 E.B.L. near
Highway 6 Junction,
(Sta. 3+30 to 4+25).
W.O. 74-11026, W.P. Nil.

SLOPE FAILURE
STA. 3+30 TO STA. 4+25

BORE HOLE LOCATIONS & SOIL STRATA

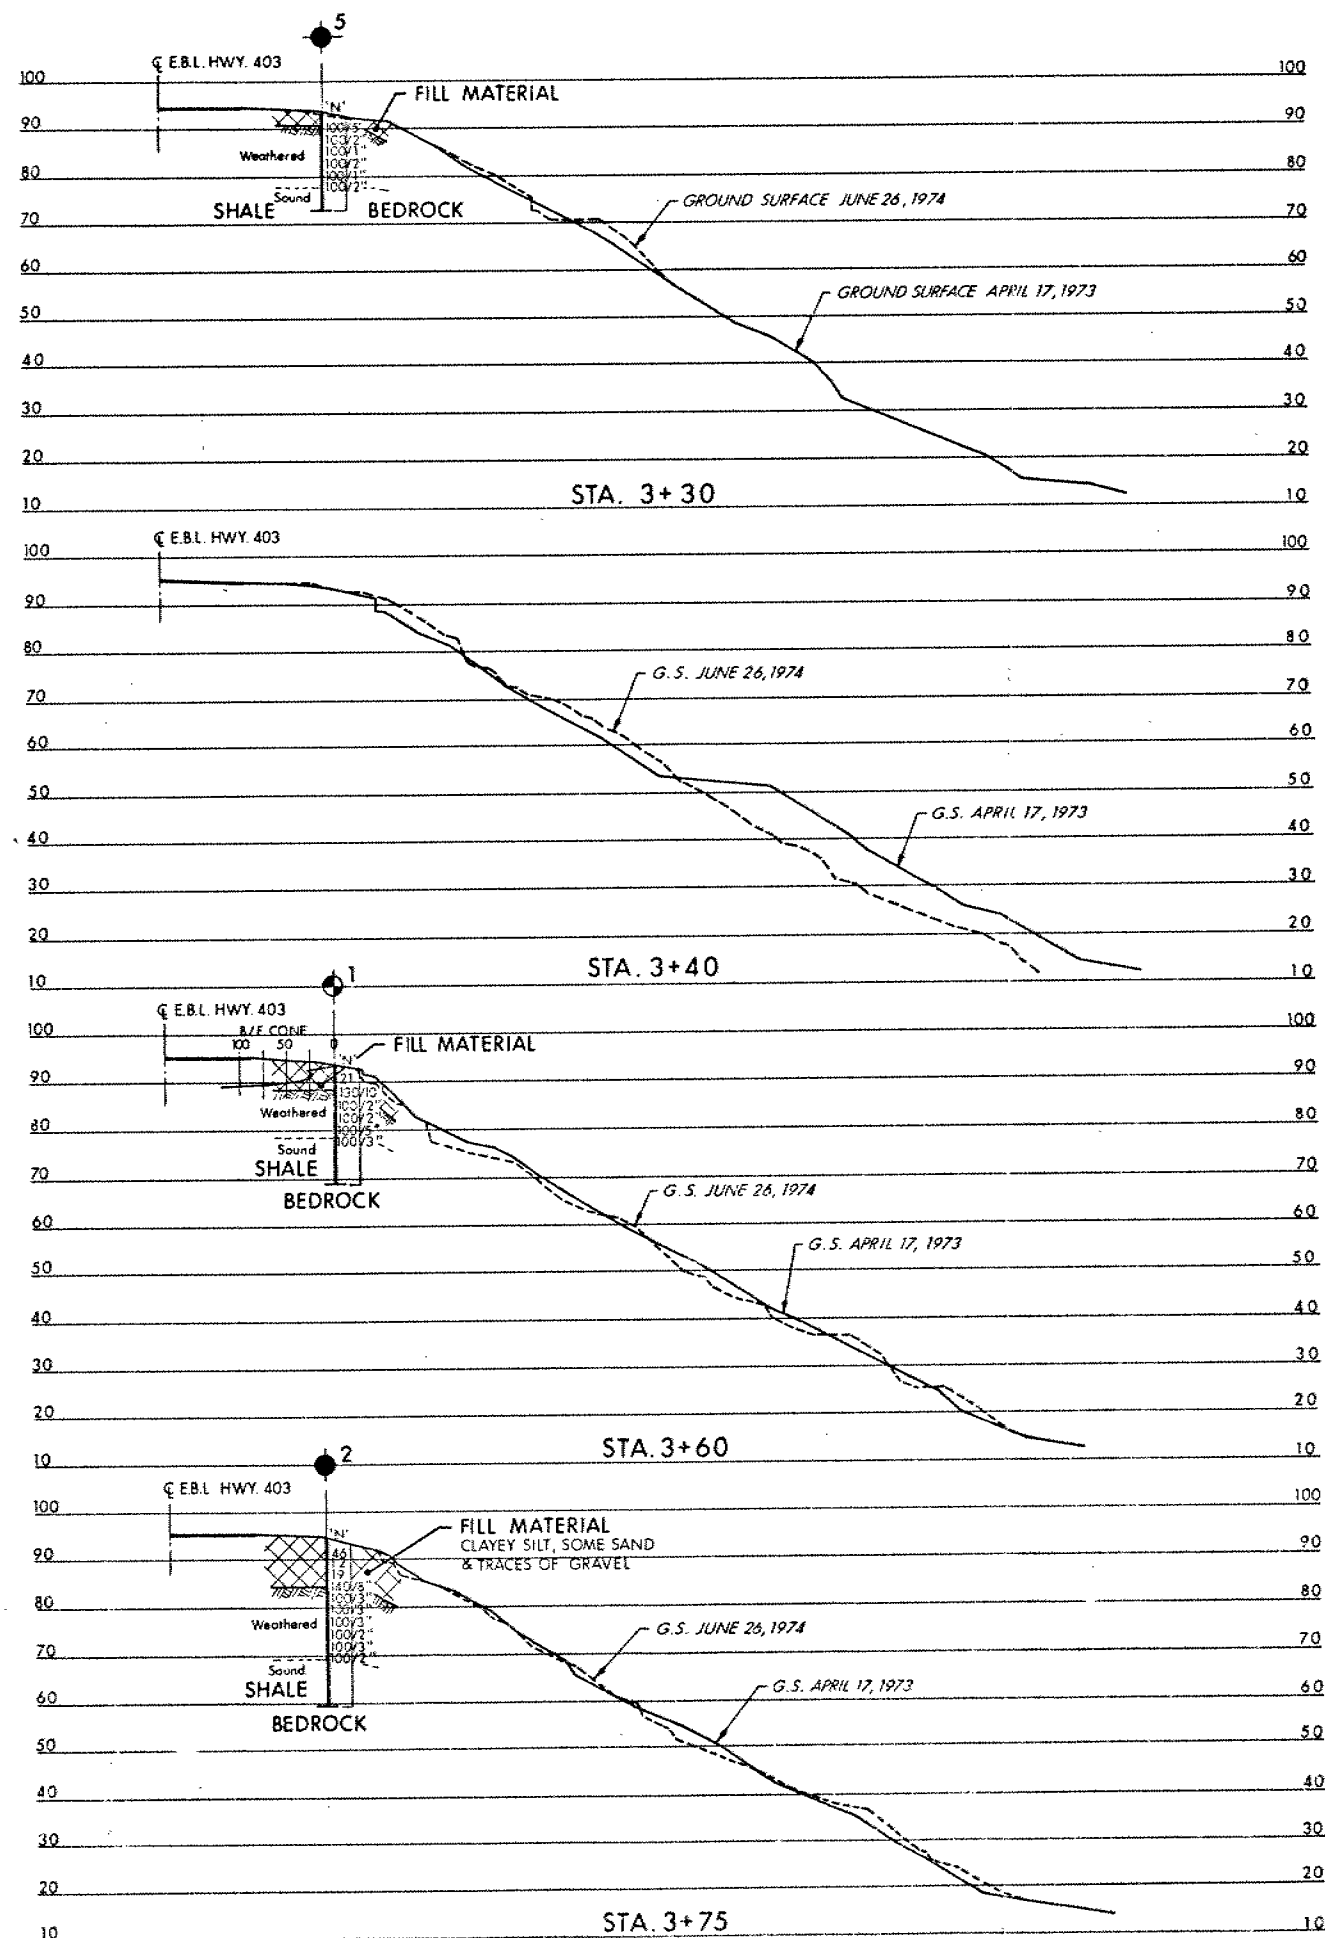
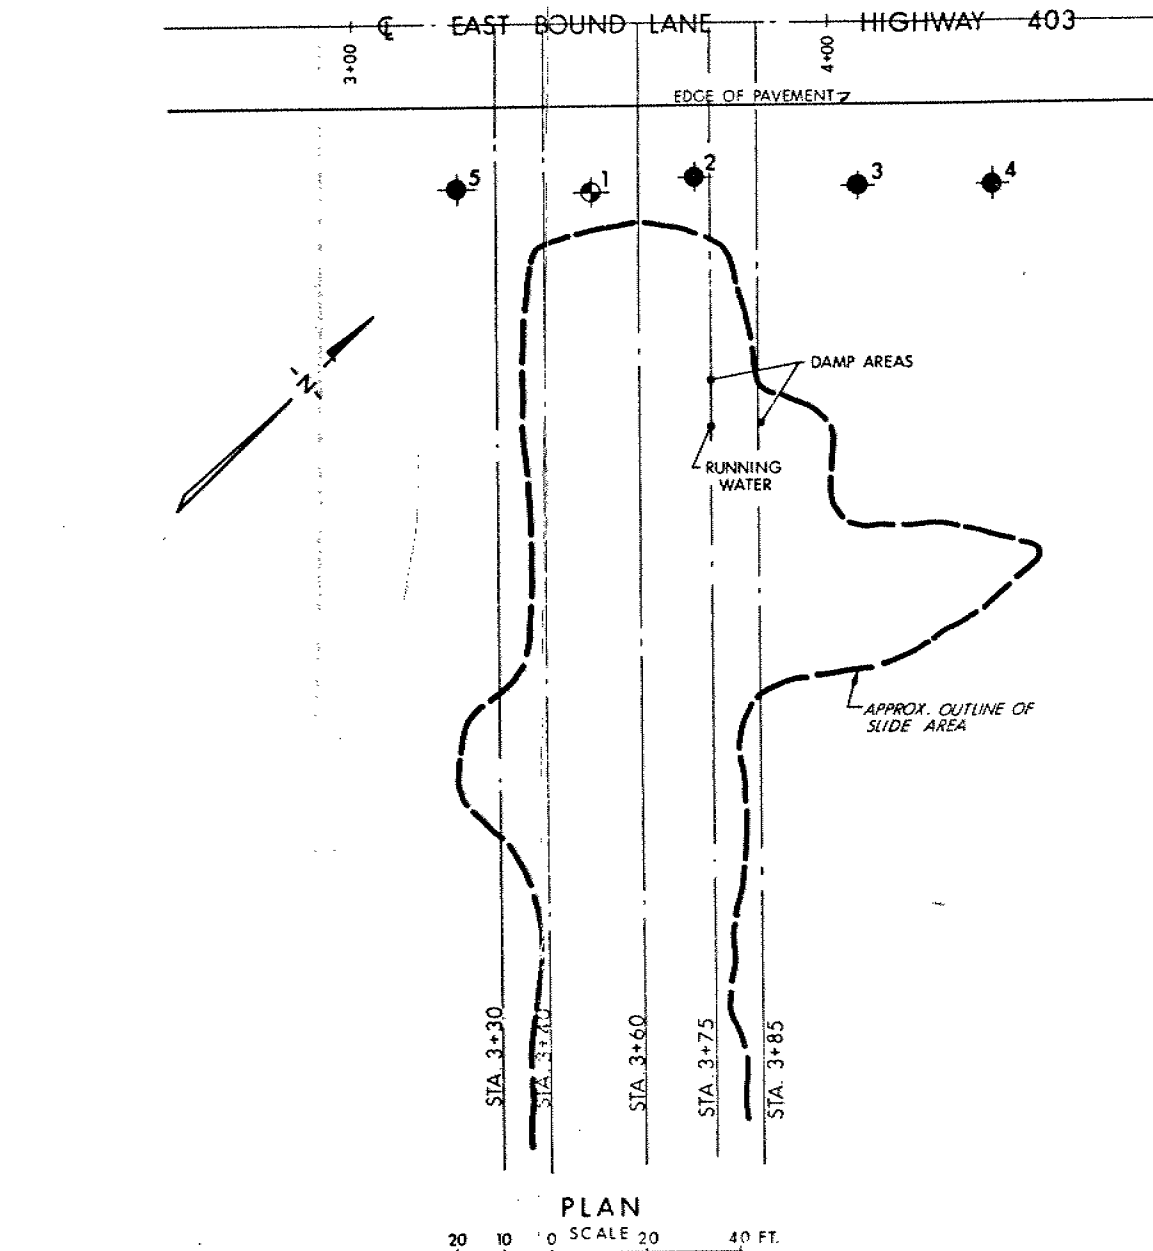
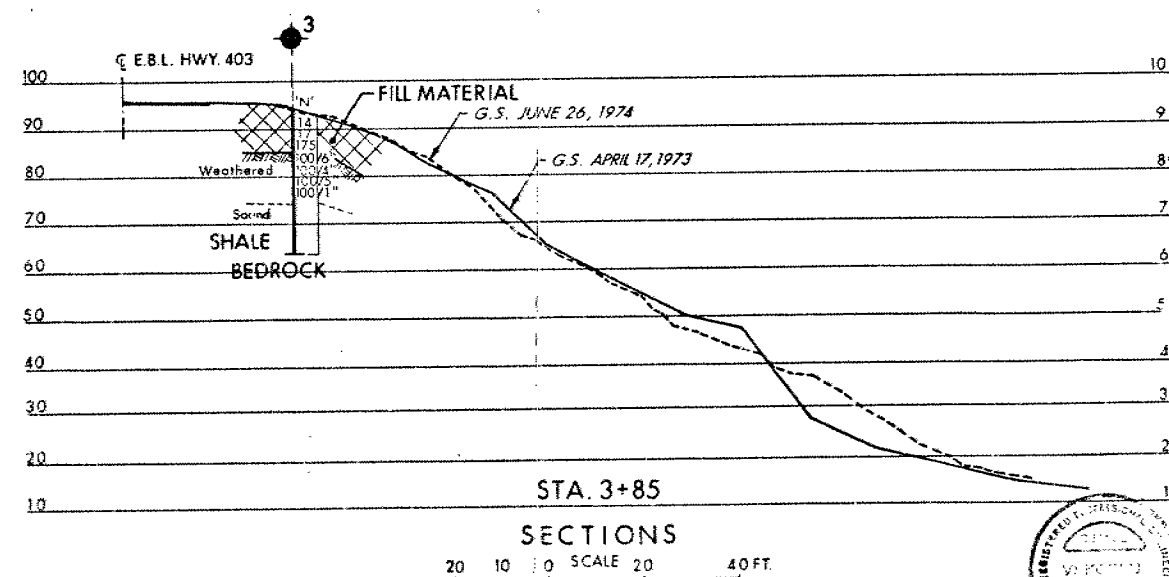
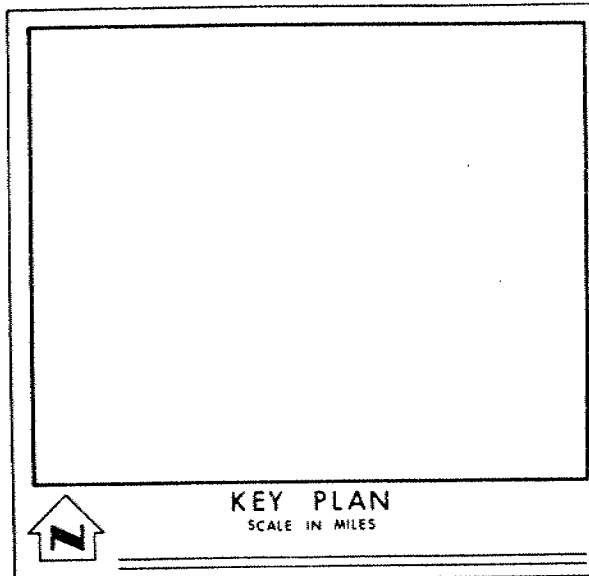
SUBNO. V.K. <u> </u>	CHECKED <u> </u>	W.P. NO. <u> </u>	DRAWING NO. <u>74-11026A</u>
DRAWN S.O. <u> </u>	CHECKED <u> </u>	W.O. NO. <u>74-11026</u>	BRIDGE DRAWING NO. <u> </u>
DATE <u>23 JULY 1971</u>	SITE NO. <u> </u>	CONT. NO. <u> </u>	
APPROVED <u> </u>

An investigation consisting of five sampled boreholes was carried out at the site by means of a C.M.E. 55 auger machine, in order to determine the subsoil and groundwater conditions. The boring locations are shown on Drawing No. 74-11026A appended to this memo. The borings revealed that the overburden consists of 2.5 feet (B.H.#5) to 10.5 feet (B.H.#2) of fill material, which is a clayey silt, some sand and traces of gravel and organics. The fill material is underlain by shale bedrock. The upper 9.8 feet (B.H.#1) to 14.6 feet (B.H.#2) of the shale bedrock has been

badly weathered. During the field investigation, a front end loader was used to excavate test pits in the affected area. Several wet zones were exposed and their locations are shown on Drawing No. 74-11026A. At about Sta. 3+75, some 20 feet below the shoulder, a source of continuous seepage water was observed.
