**FOUNDATION INVESTIGATION AND DESIGN REPORT
for
LONGWOOD CHANNEL REHABILITATION, SECTION 3
HIGHWAY 403
GWP 2054-14-00
TASK NO. 2054-14-00-001
HAMILTON, ONTARIO**

PML Ref.: 16TF023A-1
Index No.: 027FIR and 028FDR
GEOCRES No.: 30M5-324
March 20, 2017

FOUNDATION INVESTIGATION REPORT
for
Longwood Channel Rehabilitation, Section 3
Highway 403, GWP 2054-14-00
Hamilton, Ontario

FOUNDATION DESIGN REPORT
for
Longwood Channel Rehabilitation, Section 3
Highway 403, GWP 2054-14-00
Hamilton, Ontario

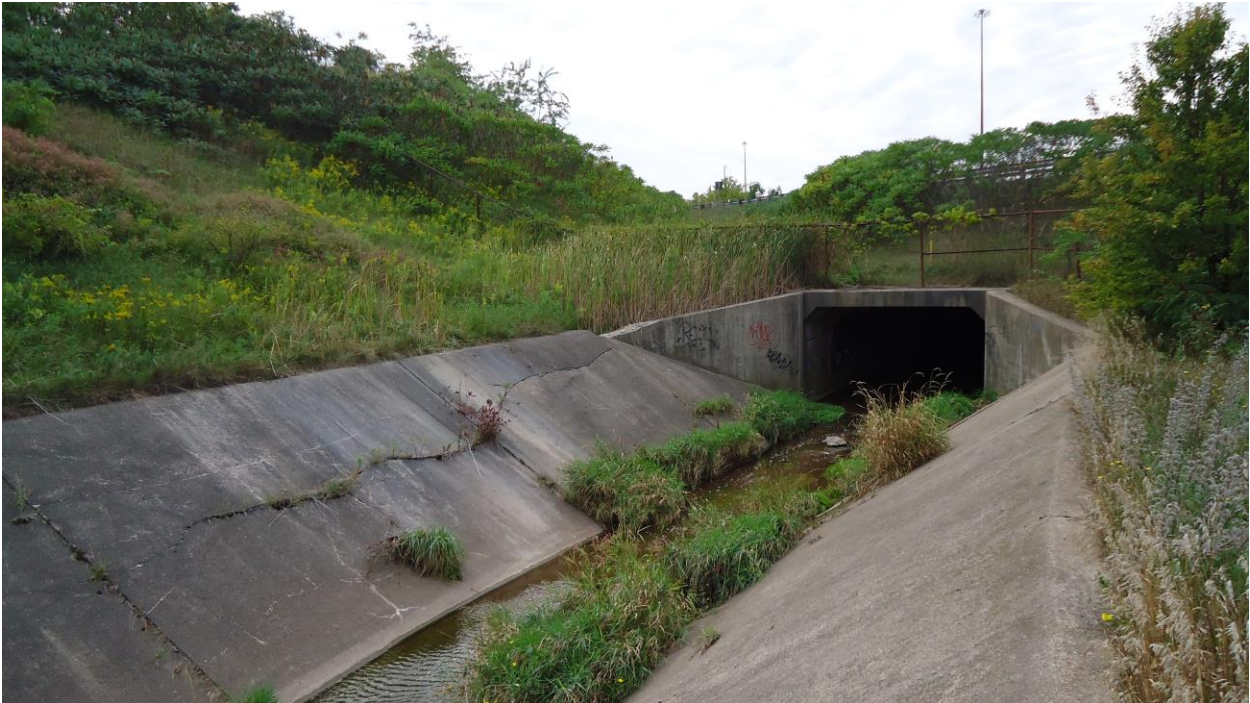
Photograph No.1: Looking west to Longwood Channel Section 3 outlet. Grass grows on the side slope and base of channel. Cracks are observed on south channel wall (September 14, 2016).

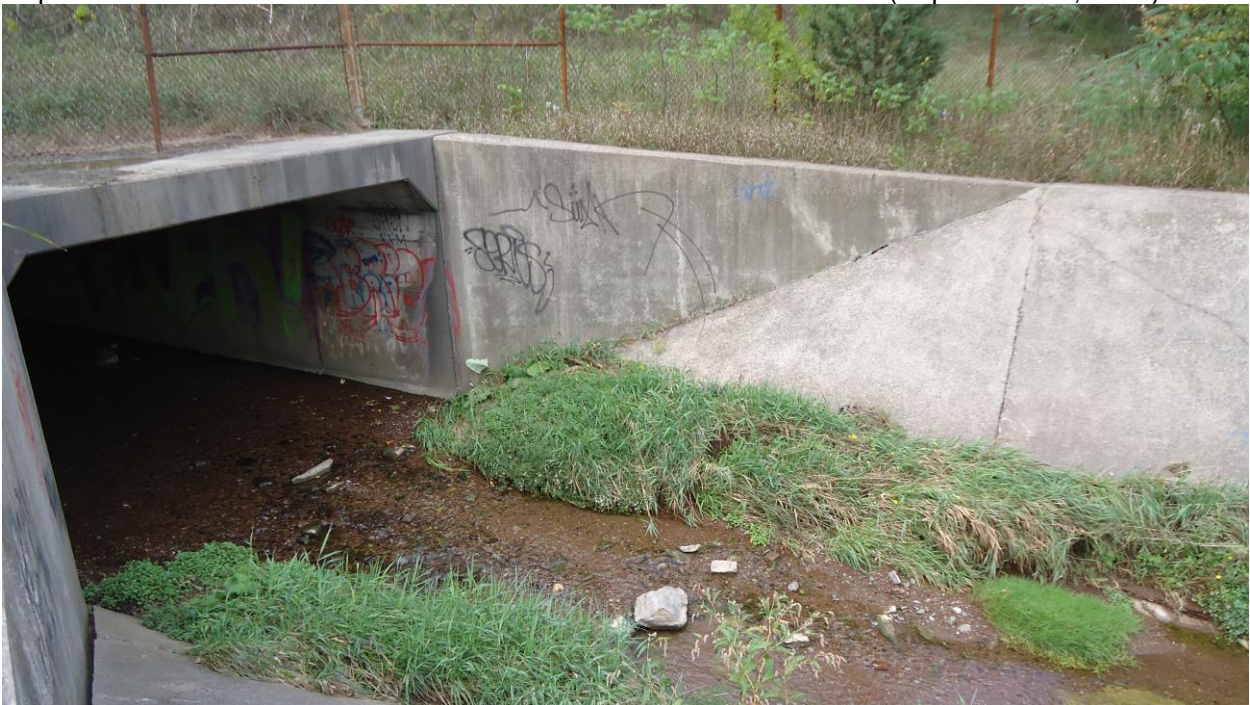
Photograph No. 2: Looking northwest to Longwood Channel outlet. Slight movement is visible on south side wall (September 14, 2016).

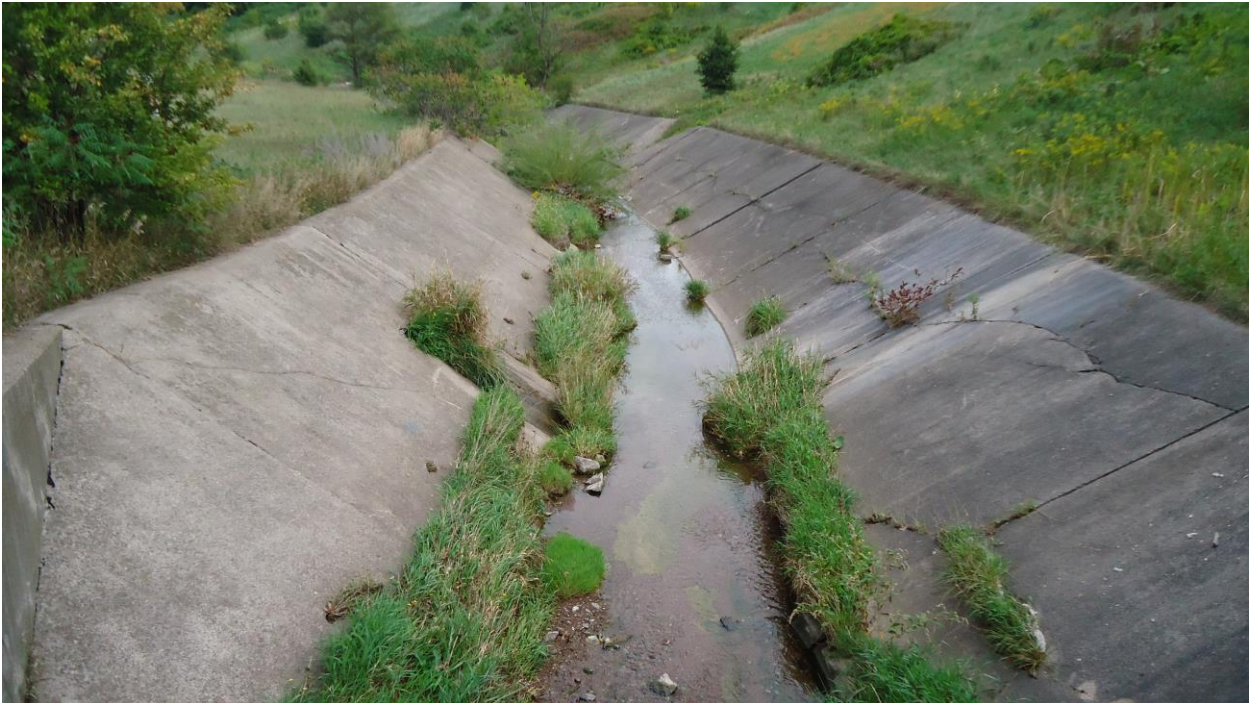
Photograph No. 3: Looking east to Longwood Channel from outlet. Grass grows on side wall surface and toe. Cracks are visible on channel wall (September 14, 2016).

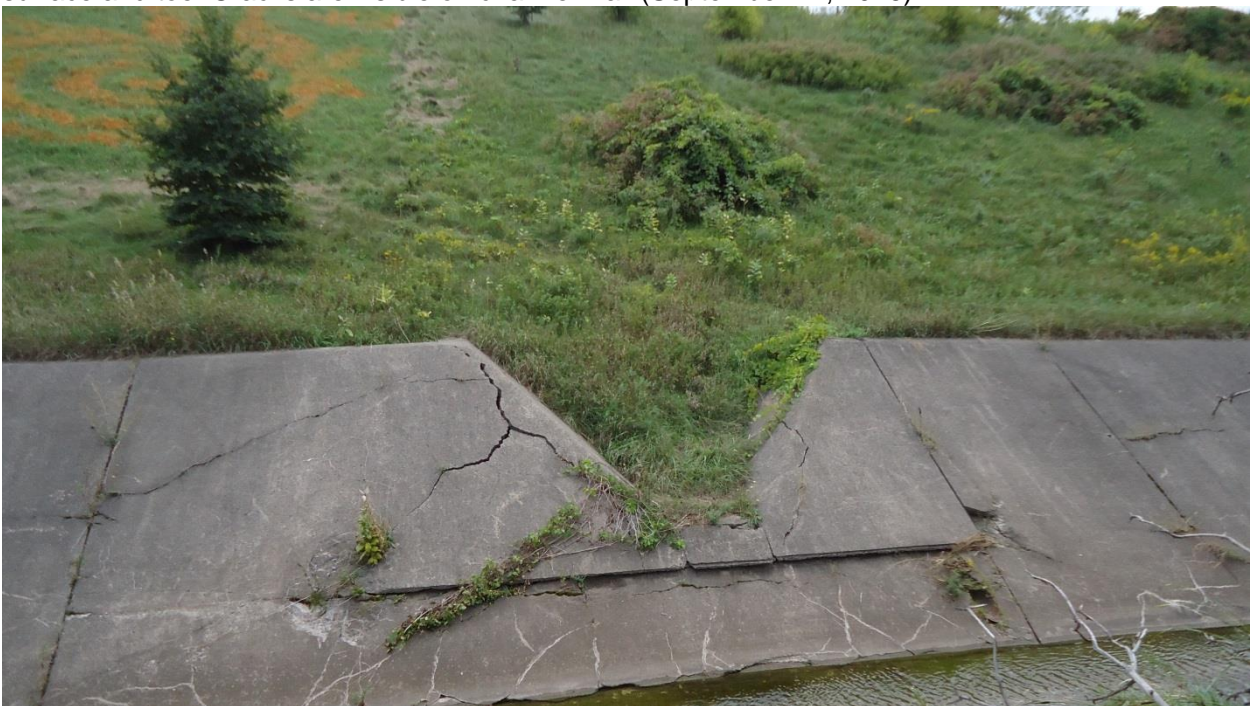
Photograph No. 4: Looking south to the beveled section at south side wall. Concrete deterioration and map cracks are observed on channel wall. Wall base rotated and upper section moved down (September 14, 2016).

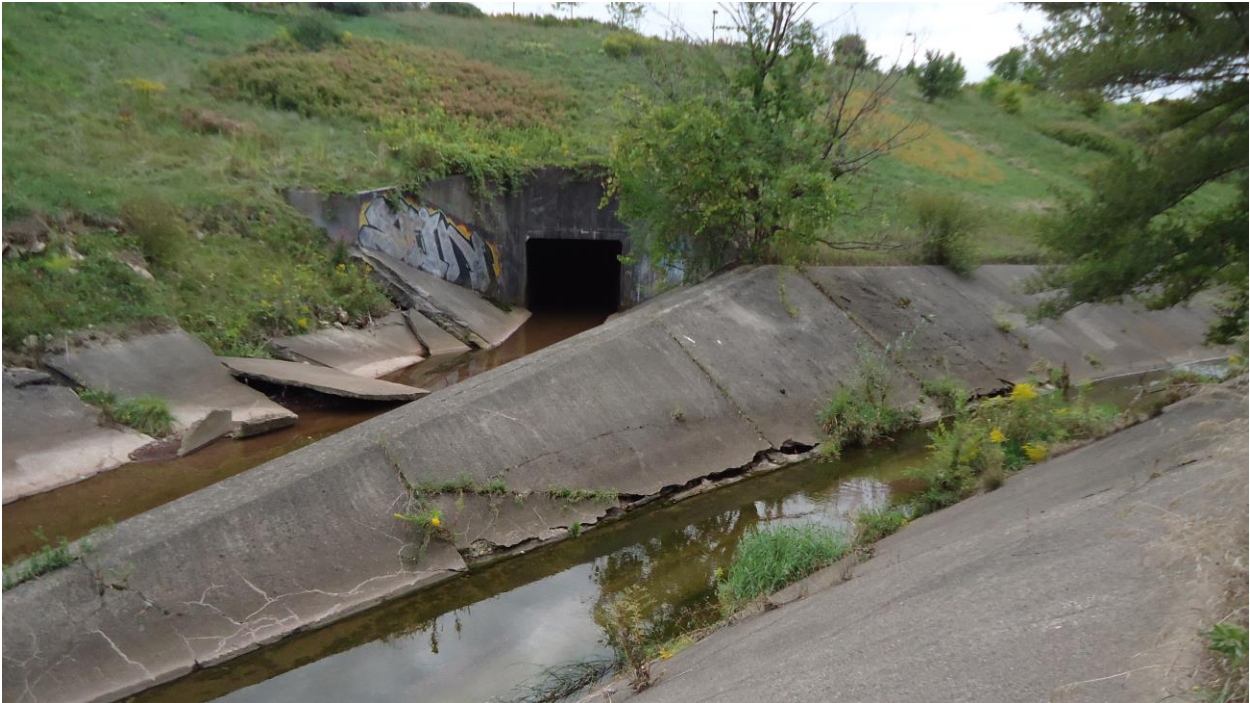
Photograph No. 5: Looking south to Chedoke storm sewer outlet. Side walls slipped over and fell in channel. Concrete wall at divider section is undermined and cracked section visible (September 14, 2016).

Collapse of the lining has occurred in Section 3 of the Longwood Channel within an approximate 90 m long segment where the municipal drain joins the channel. Boreholes 15-04 and 15-05 put down on the north side of the channel indicate that the soils behind the lining and underneath the channel base comprise silty clay / clayey silt fill and native silty clay. Taking into account a relatively low sensitivity of these soils to erosion owing to high clay content and cohesiveness, the lining failure is likely due to high turbulence during periods of intensive flows.

Since there have been no capacity issues or flooding in Section 3 of the Longwood Channel, the channel lining repair or replacement is considered to be the preferred improvement solution. This method should include filling the scour holes, repairing the eroded concrete (cracks and toe erosion) and replacing the collapsed plates without changing the channel configuration. This approach has a relatively low capital cost while maintaining the existing hydraulic conditions of the drainage system.

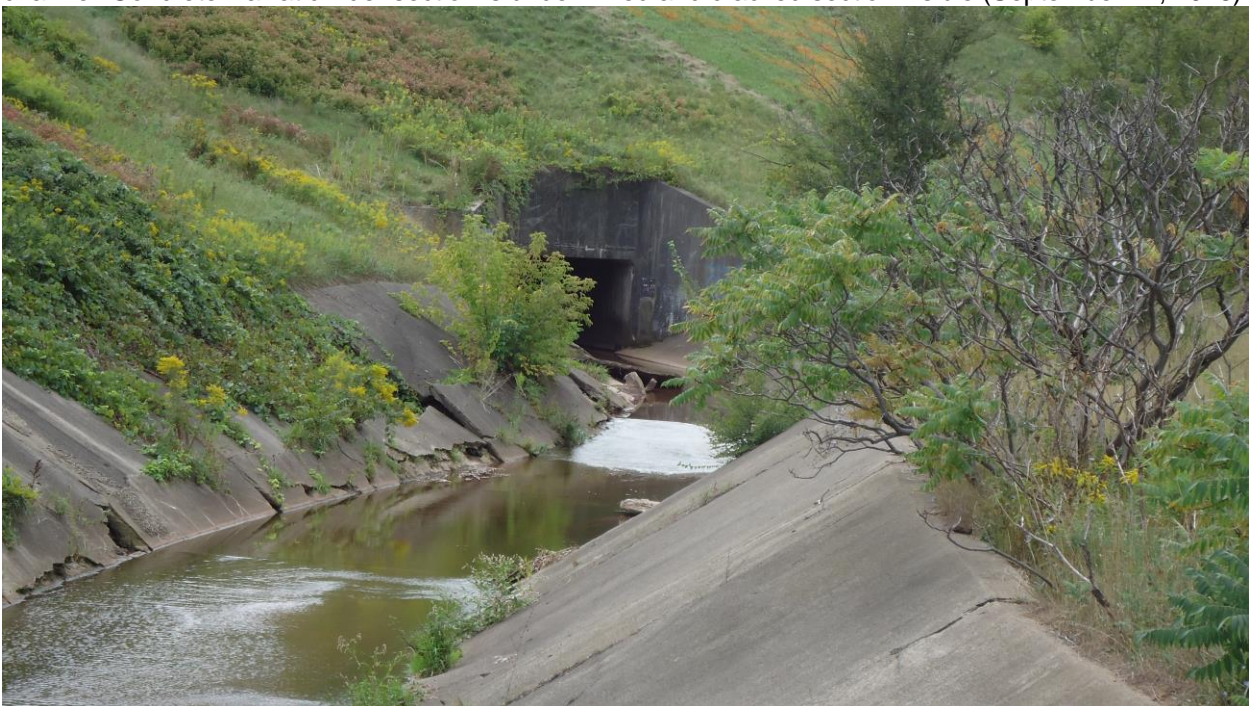
Photograph No. 6: Looking south to south wall at Chedoke storm sewer outlet. Wall almost completely deteriorated and the concrete slab turned apart. Wall is undermined and backfill material washed out. Wall slid to channel base (September 14, 2016).

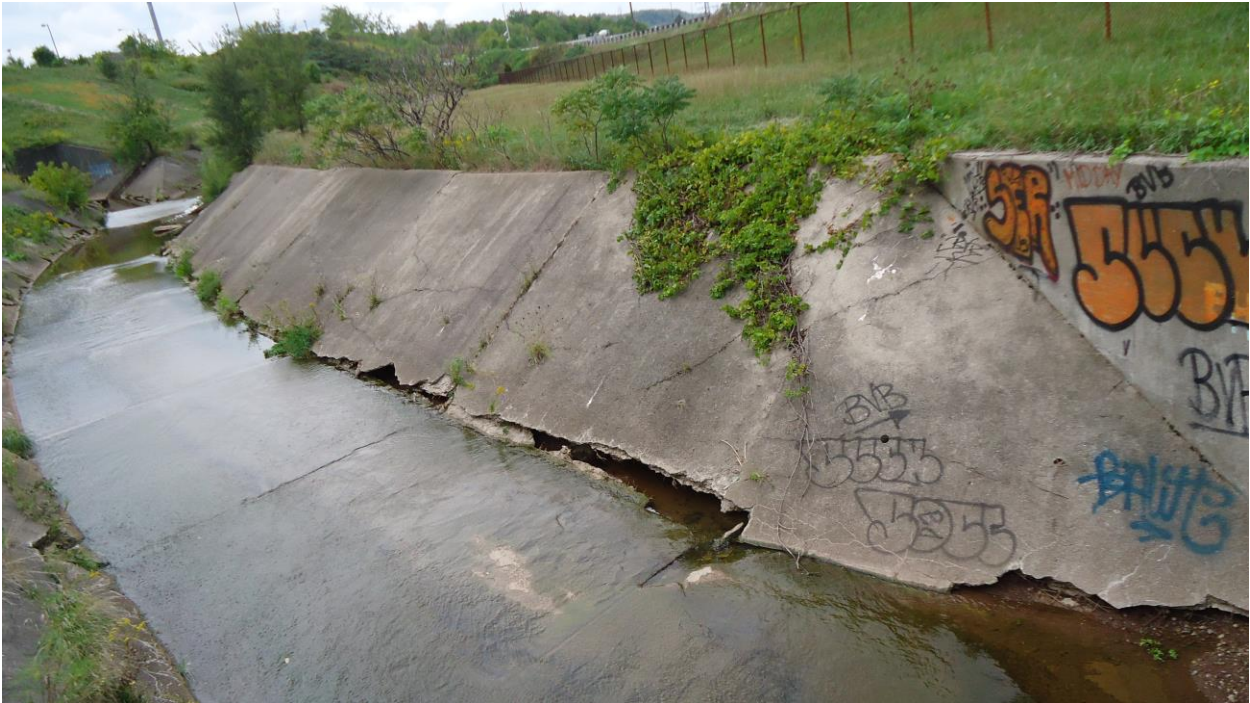
Photograph No. 7: Looking west to north wall at east inlet. Wall is undermined and the base slab separated from walls (September 14, 2016).

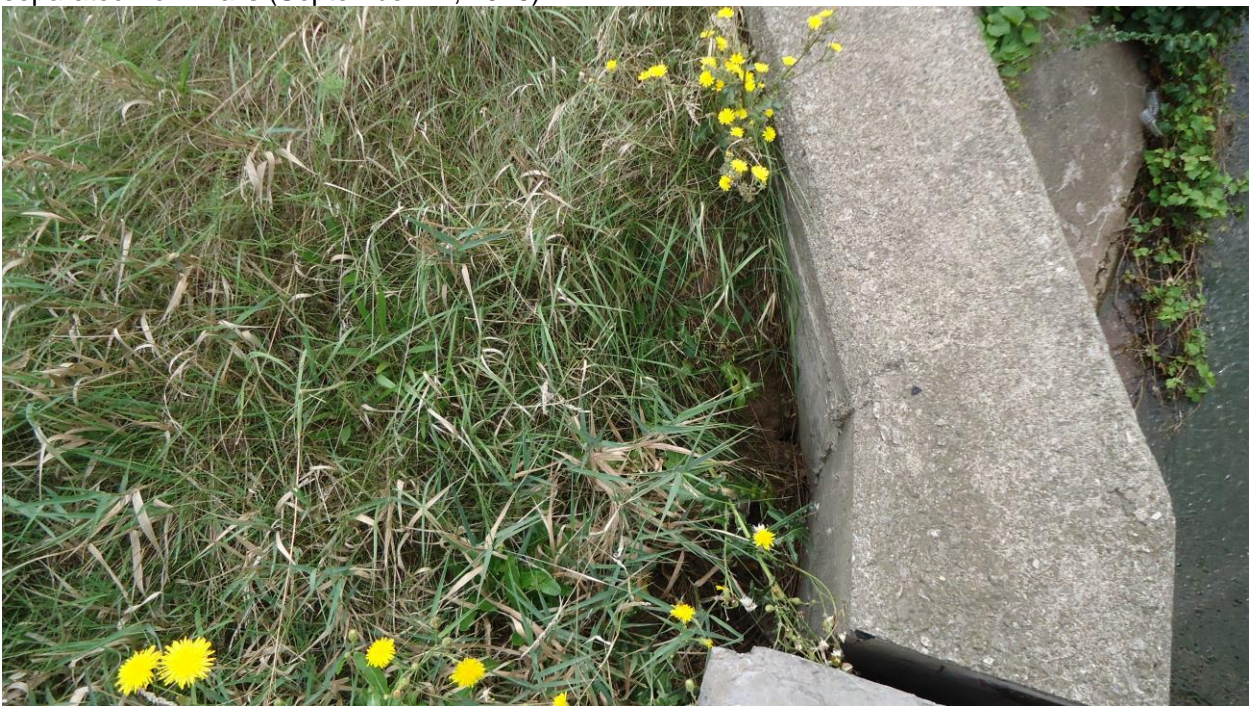
Photograph No. 8: Looking east to inlet wing wall. Wall rotated slightly and backfill material washed out (September 14, 2016).

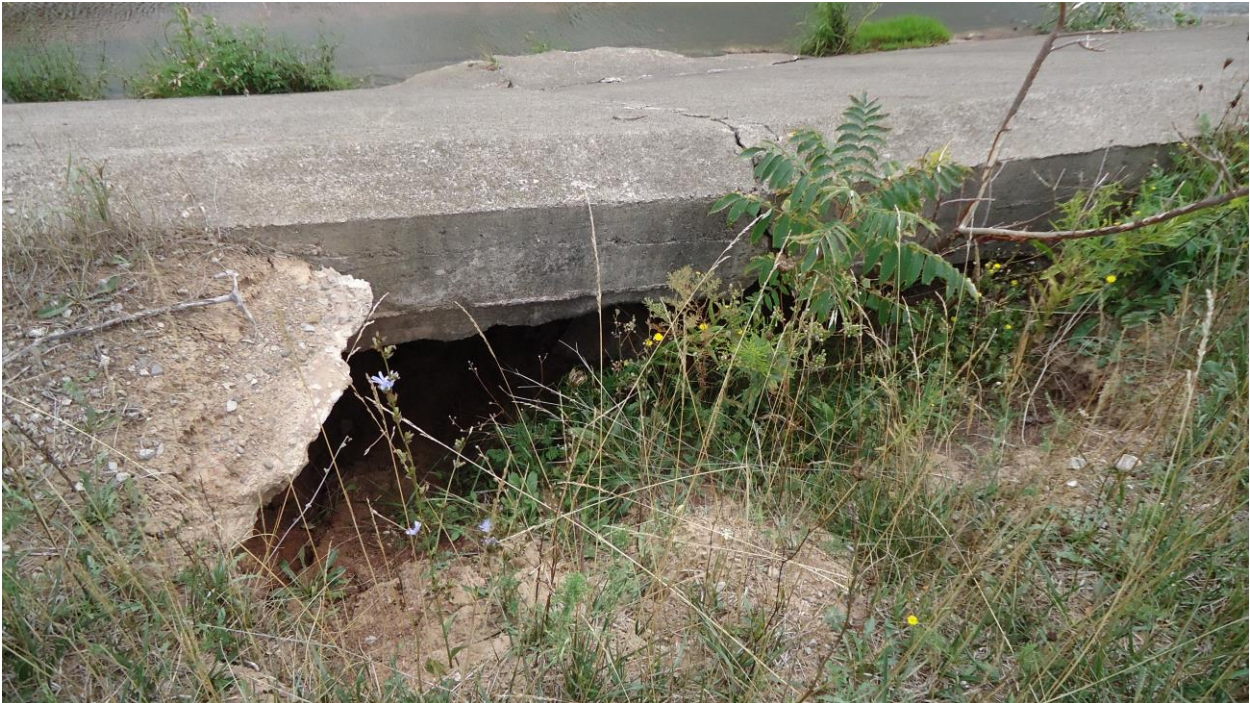
Photograph No. 9: Backfill material washed out and the wall has lost the support. (September 14, 2016).

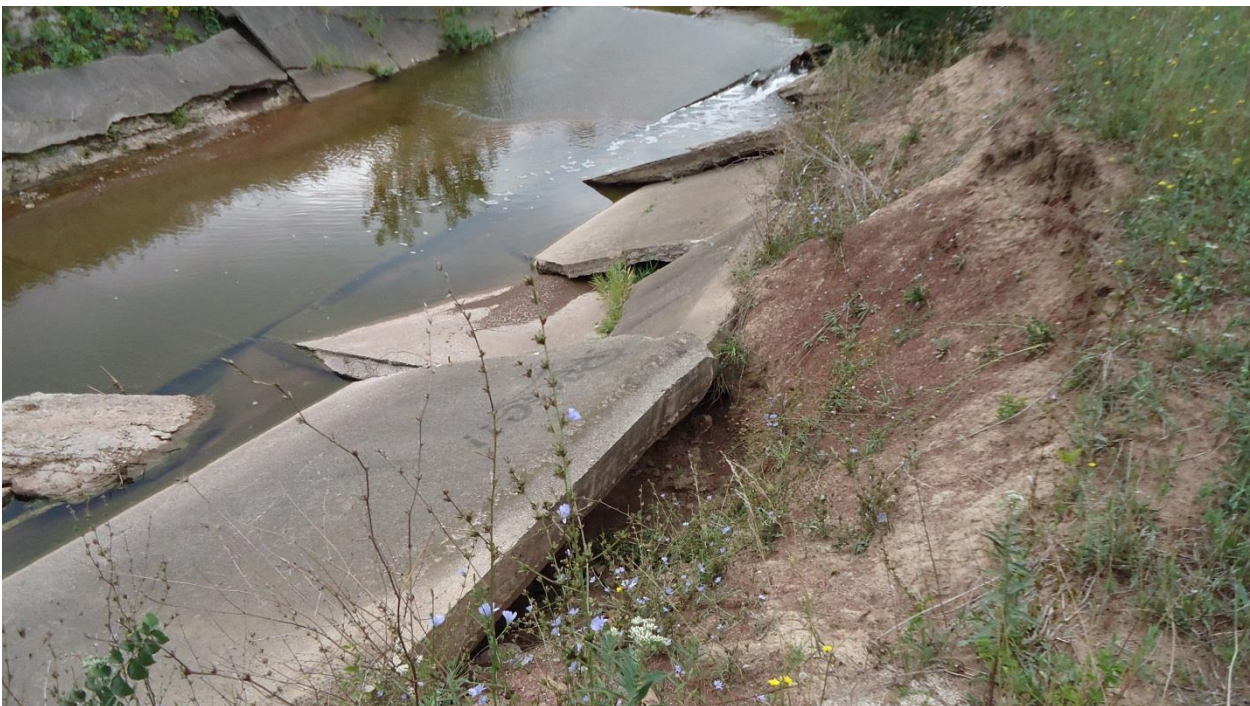
Photograph No. 10: The north section of wall located at the middle of channel totally moved from its place and backfill material washed out (September 14, 2016).

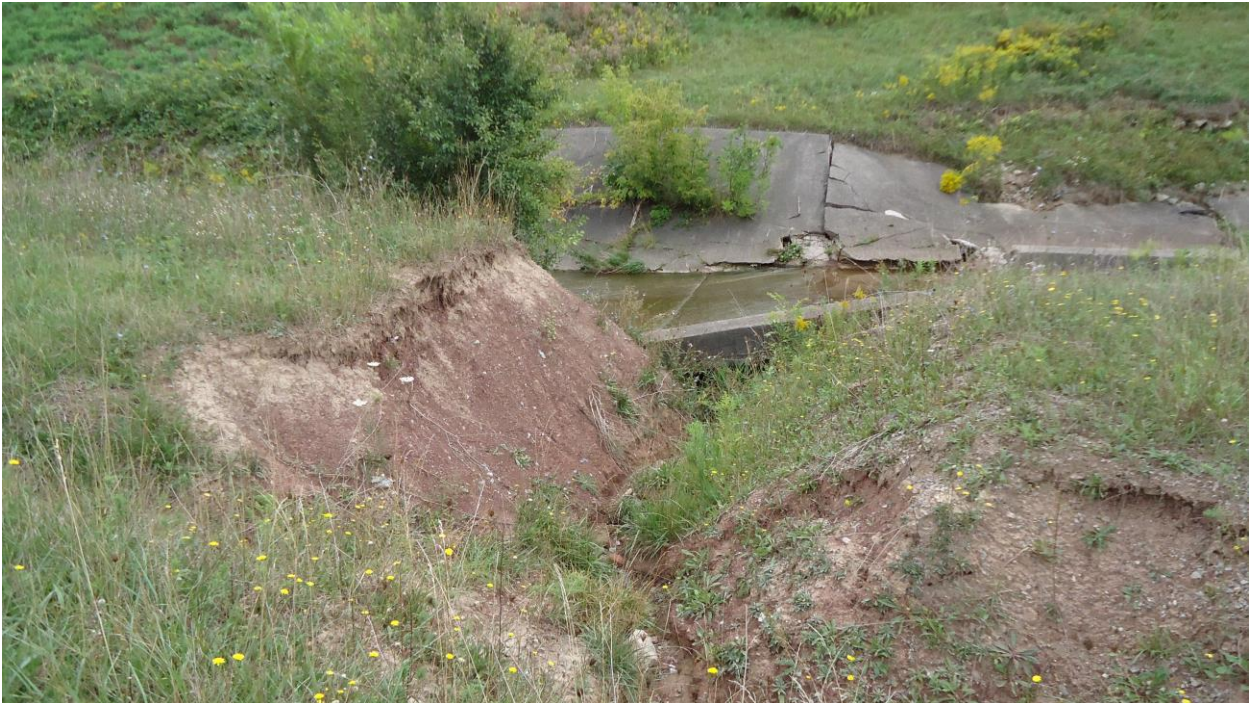
Photograph No. 11: The soil was washed out and the gully created by surface water runoff on north crest of channel (September 14, 2016).

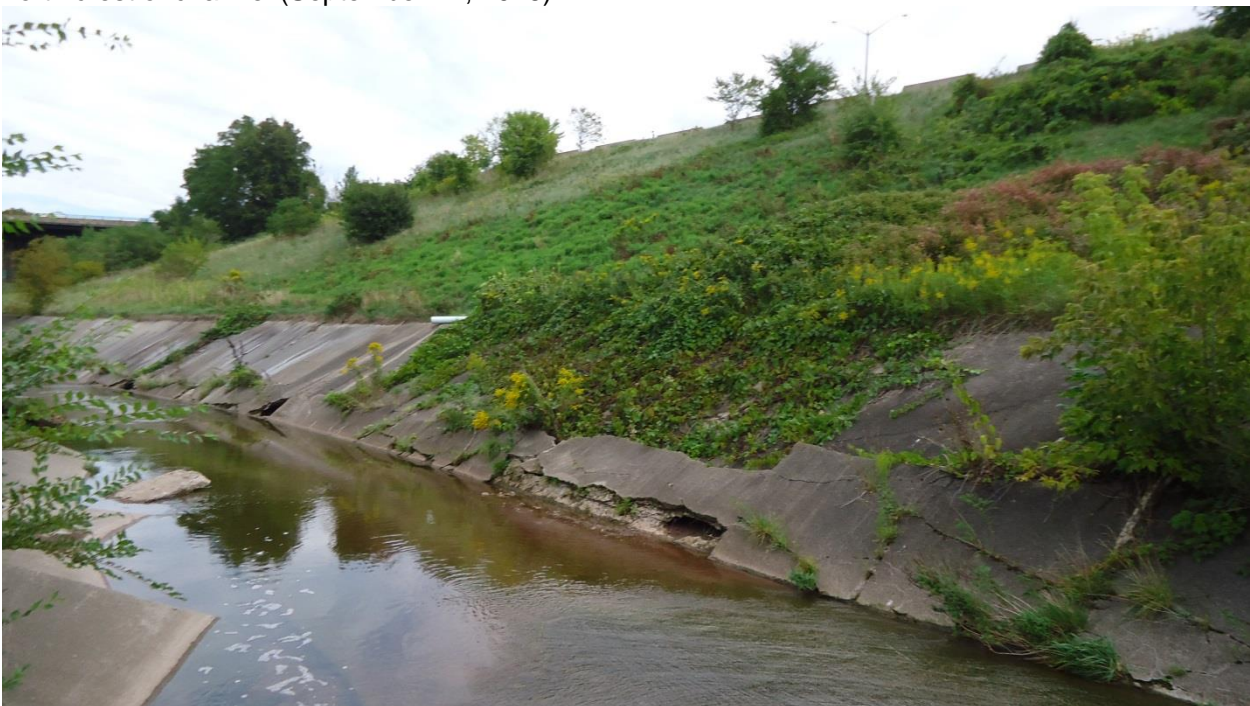
Photograph No. 12: Looking south to channel south wall. Concrete totally cracked and plants grew on the surface (September 14, 2016).

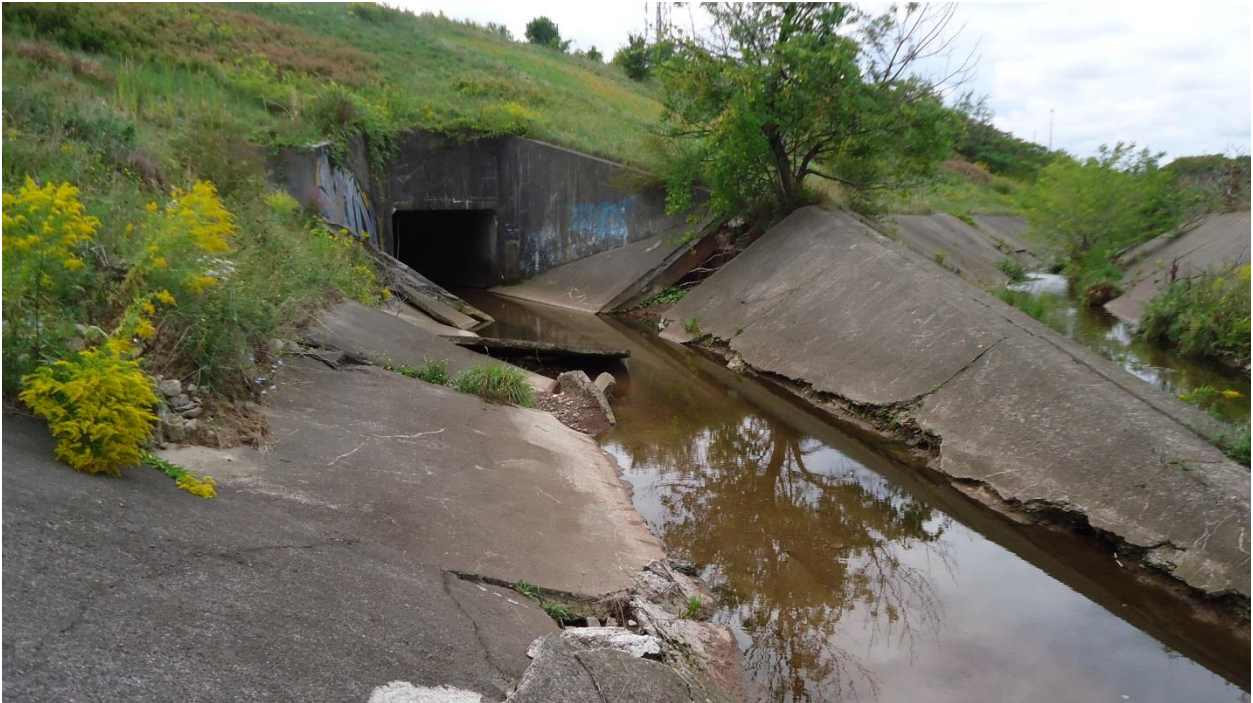
Photograph No. 13: Looking west to Chedoke storm sewer outlet and divider section. Concrete slab cracked and subgrade soils are washed out (September 14, 2016).

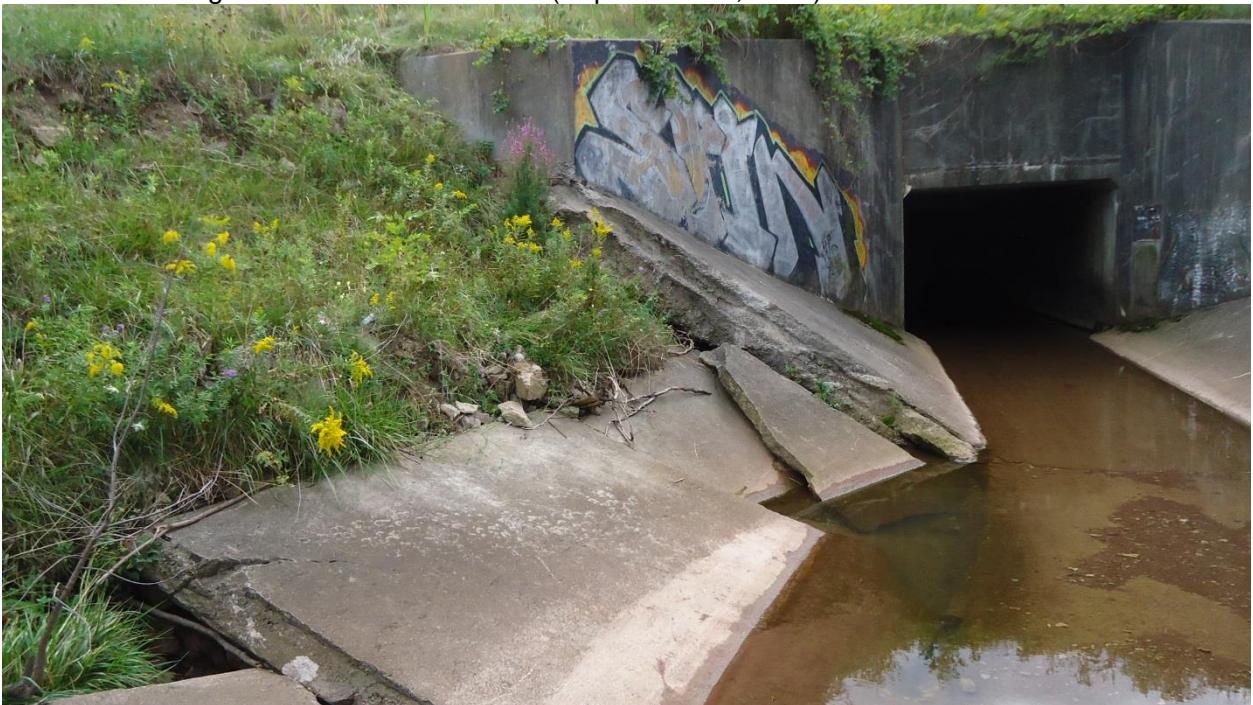
Photograph No. 14: Looking west to Chedoke storm sewer outlet. Concrete slab cracked and slid to the channel and subgrade soils are washed out (September 14, 2016).

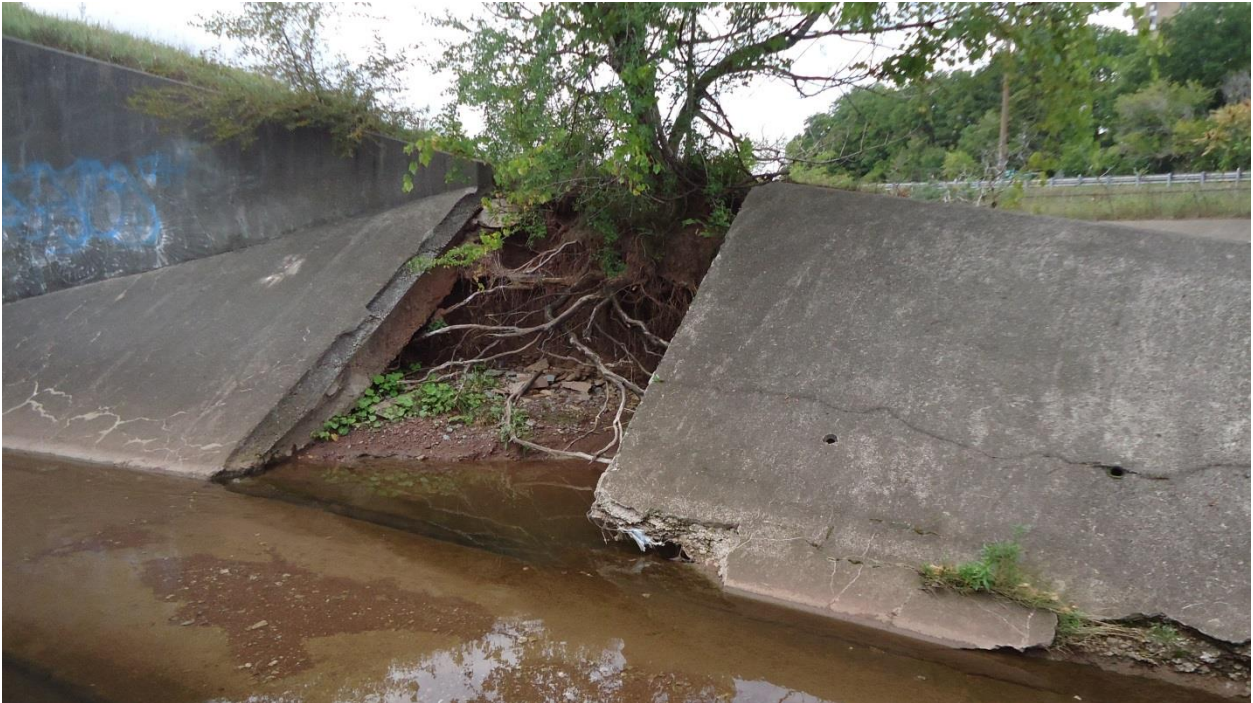
Photograph No. 15: Looking northwest to the north wall of divider section. Concrete slab is missing and subgrade soils are washed out (September 14, 2016).

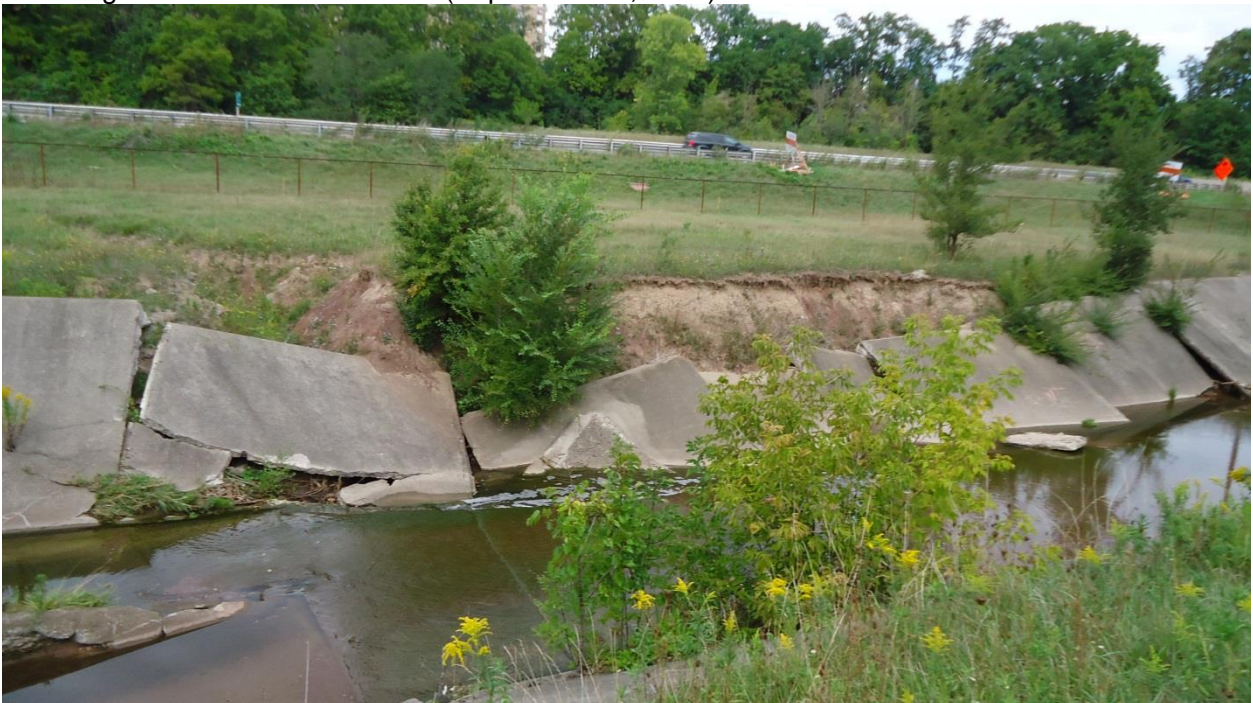
Photograph No. 16: Looking north to channel north wall. Concrete slabs slid to the channel and subgrade soils are washed out (September 14, 2016).
