December 23, 1964

64-F-102

Site Inspection - Thursday, December 17, 1964.
Bridge No. 7, Hwy. 401 & Hwy. 400 Interchange,
Toronto. (Soils Report by H. G. Colder & Assoc. -
Bridge Design by De Leuw, Cather & Co. of Canada)

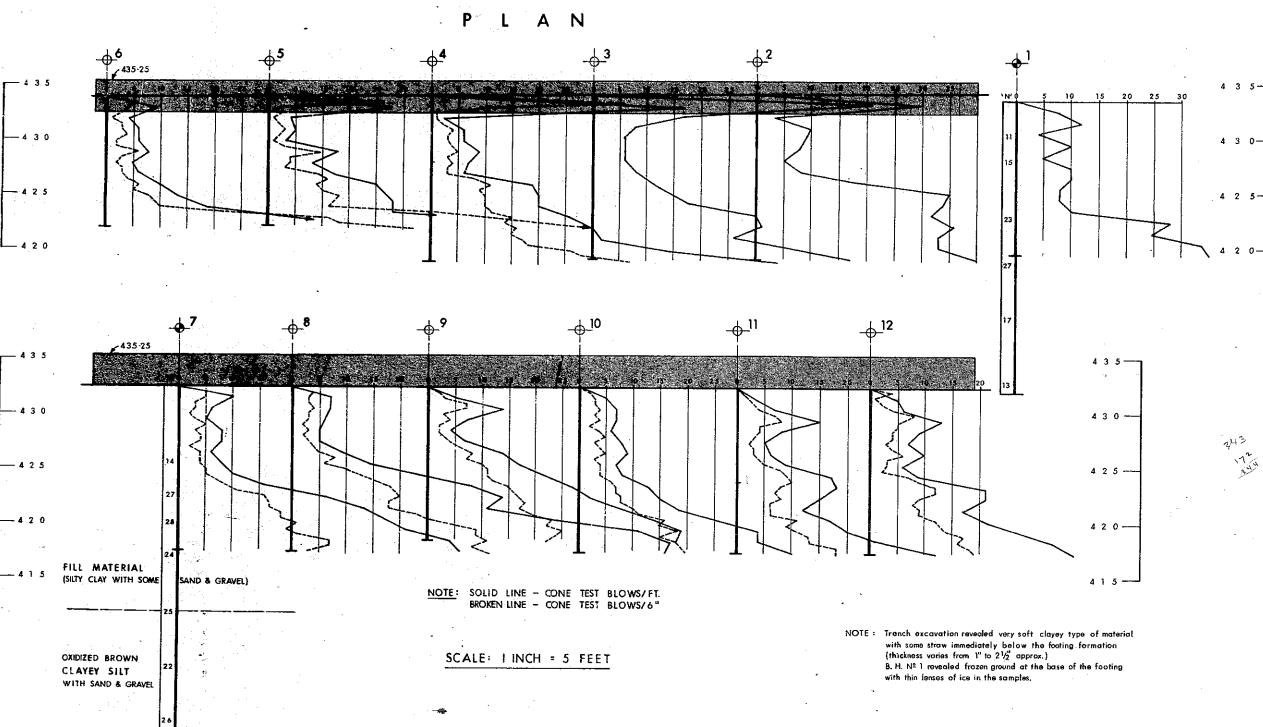
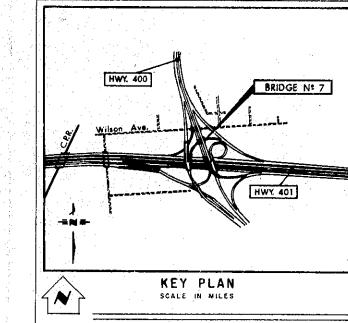
The inspection was requested because a crack across the footing, approximately in the middle of it, was noticed. From the location of the crack and its shape (open at the footing top, closing and disappearing towards the bottom), it became obvious that either the middle portion of the footing had lifted, or one or both far ends of the footing had settled.

The inspection of the shafts has revealed a thin (1 - 2 inches thick) very soft layer. It was easy to scoop this material from underneath the footing. The cone tests also indicated lower resistance at the elevation corresponding to the footing bottom, or slightly below.

It is practically impossible at this stage to explain how and why such a soft layer has formed. The fact remains that the footing has cracked and that the pressure on the soil was only about 450 p.s.f. When the entire structure is built, the load will be approximately tenfold - i.e., about 4,000 p.s.f., and it can be reasonably assumed that further movements could occur. The structure is a three-span continuous bridge, and movements of the expected magnitude would be prohibitive.

NOTE: Trench excavation revealed very soft clayey type of material with some silt immediately below the footing formation (thickness varies from 1' to 2½' approx.)
B.H. #11 revealed frozen ground at the base of the footing with thin lenses of ice in the sample.

It is therefore recommended that the present footing be taken out and the excavation deepened for an additional two feet or more, should the inspection indicate this to be necessary. Very careful precautions should be taken to prevent any freezing of the foundation soil. After the completion of the excavation and prior to concrete pouring, one foot of clean granular material should be placed and well compacted.

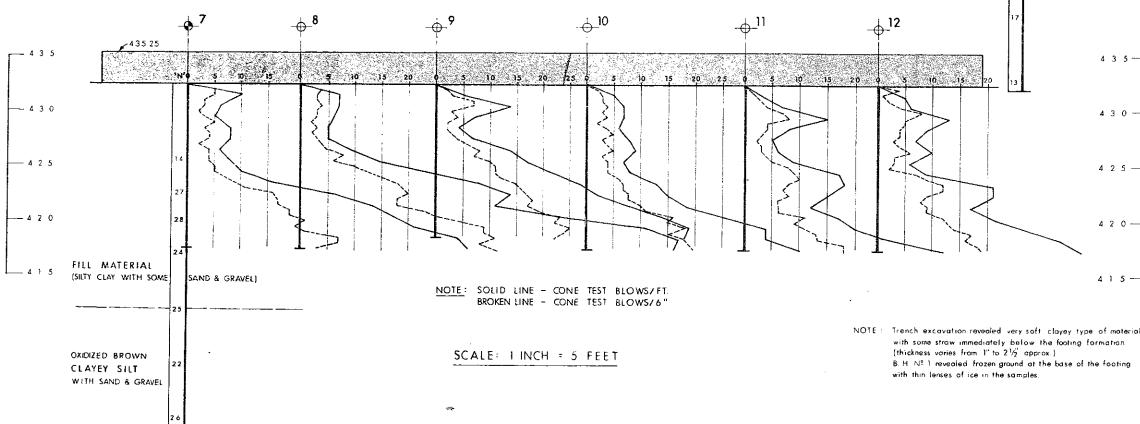
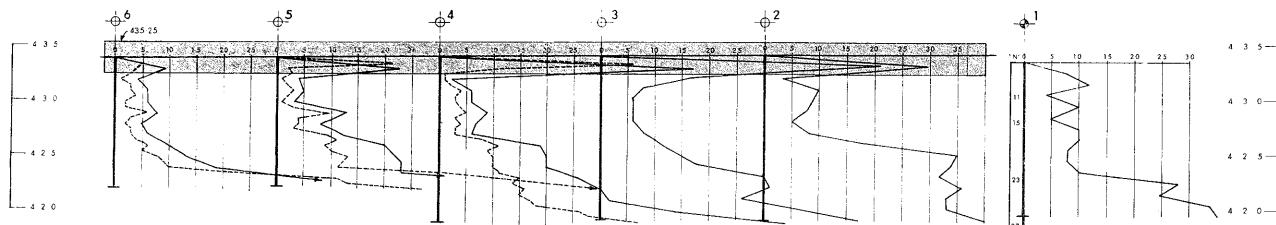
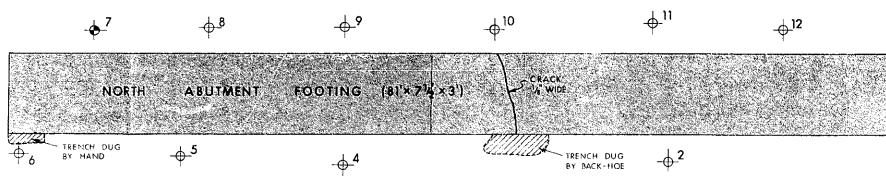
P L A N

NOTE: Trench excavation revealed very soft clayey type of material with some straw immediately below the footing formation [thickness varies from 1' to 2 1/2' approx.]
B.H. #1 revealed frozen ground at the base of the footing with thin lenses of ice in the samples.
