SOILS DESIGN REPORT

APPROACHES TO THE CREDIT RIVER BRIDGE

IN THE TOWN OF PORT CREDIT

February 1967

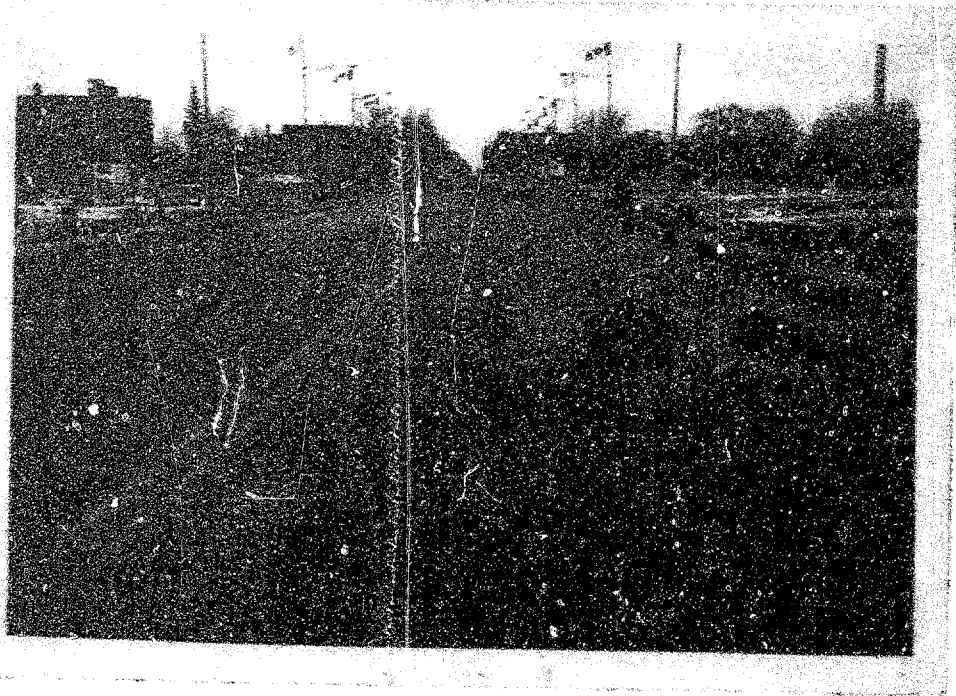
The Credit River bridge is located on Lakeshore Road, Highway No. 2, and spans the Credit River within the Town of Port Credit. The approaches have been settling ever since their construction and, at present, the pavement is distorted and uneven. In addition, several severe longitudinal cracks and differential settlements over the old bridge abutments (which were not removed) are present. (See photographs)

STATION 1+50 - View To The West Showing Longitudinal Cracks.

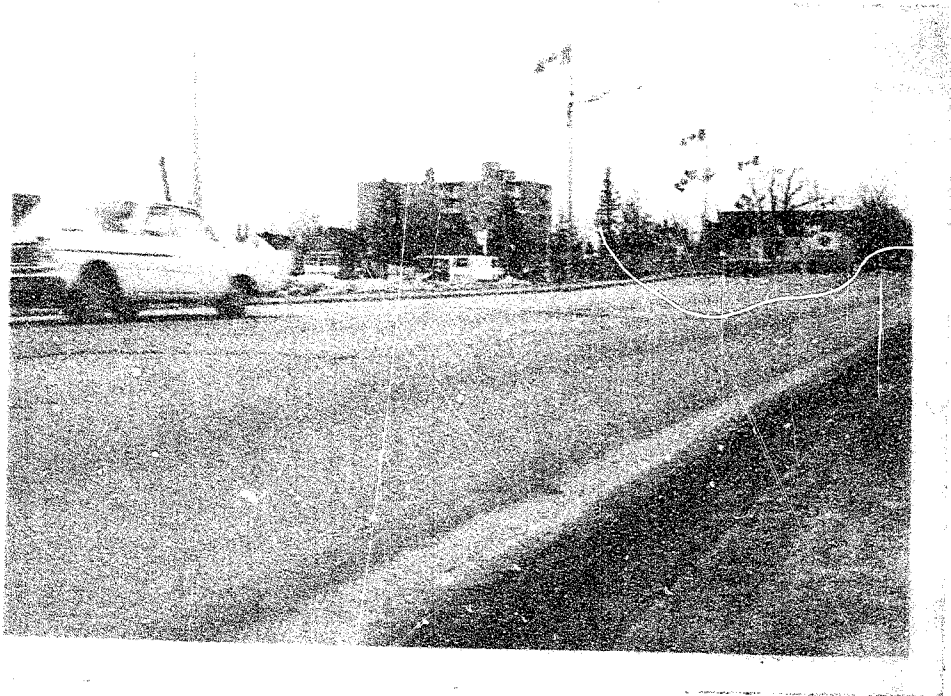
STATION 3+50 - View To Southwest Showing Old Abutments Reflecting Onto The Surface

It is recommended that the old bridge abutments between Station 3 + 60 and 4 + 50 be removed to at least 5 feet below profile grade to reduce their effect on any future settlement.

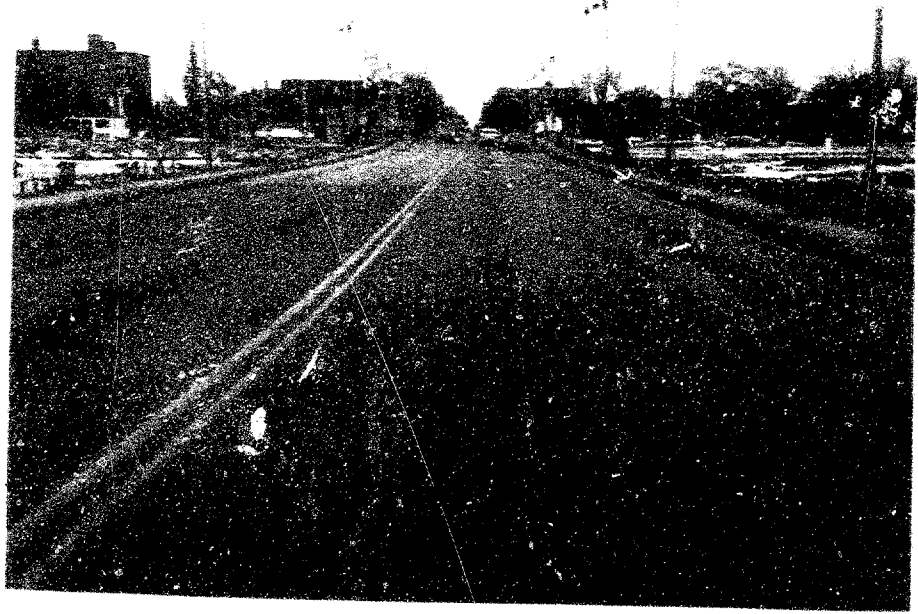
STATION 1+50 - View To The West Showing Longitudinal Cracks.

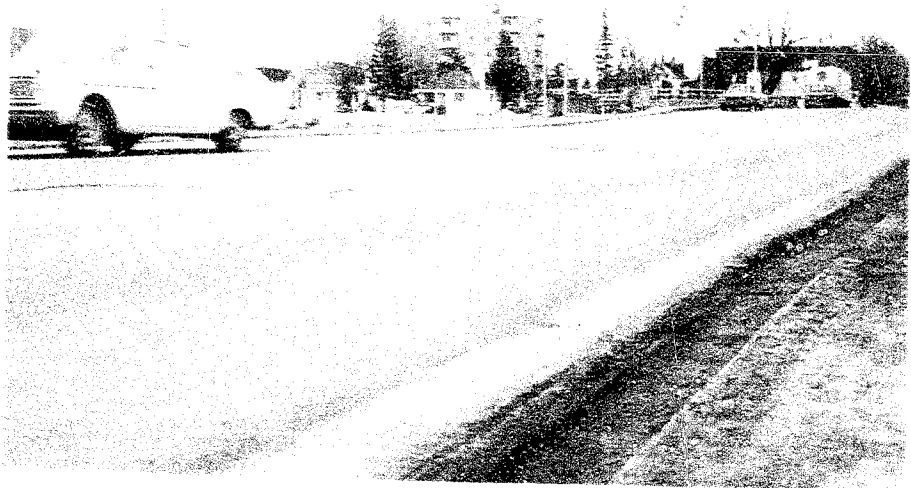
STATION 3+50 - View To Southwest Showing Old
Abutments Reflecting Onto The Surface

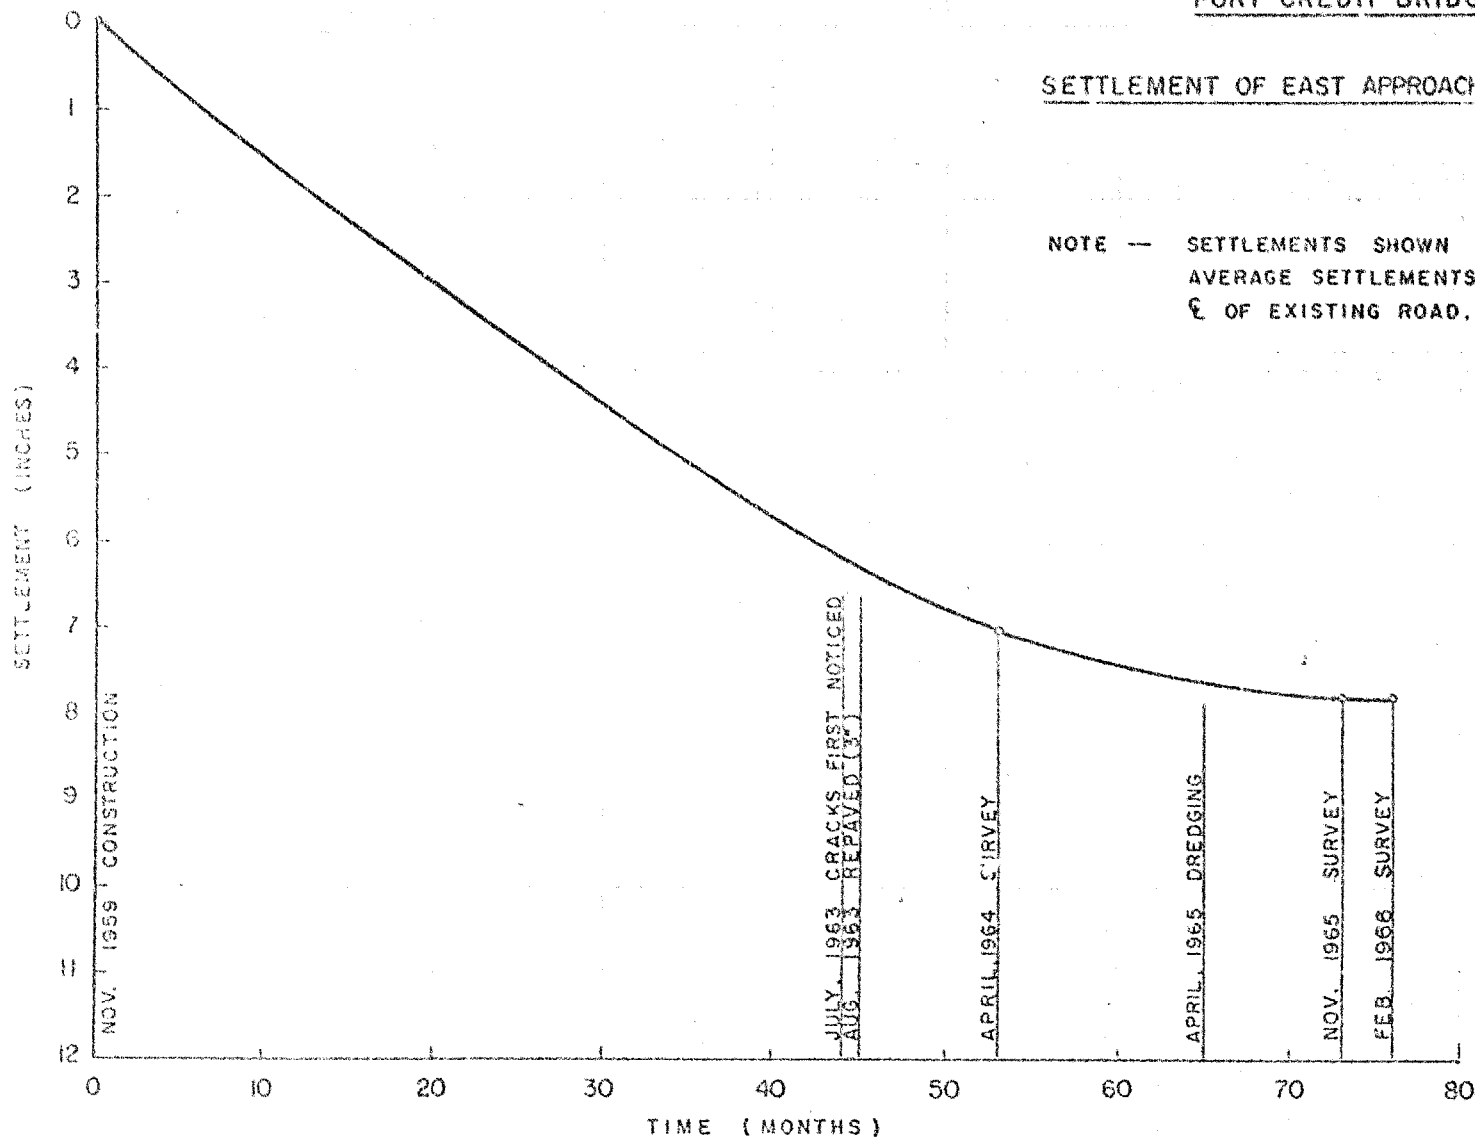
SETTLEMENT OF EAST APPROACH EMBANKMENT

was placed over the cracked and deformed pavement. Settlements of decreasing magnitude have taken place since then. A time-settlement curve prepared by Peel County shows a virtually balanced condition in February 1966. In the spring of 1965, the Port Credit Yacht Club dredged approximately 2 feet in the dock areas approximately 25' south of the retaining wall. No changes were noted in the pavement elevation.

The following recommendations are based on the assumption that the embankment is relatively stable under the existing loading conditions (see the time-settlement curve) and that some settlements will be tolerated.
