Rexdale, Ontario,
April 29th, 1963.

Re: Investigation of Slip Area,
Don Valley Parkway at Minton Place,
Toronto, Ontario.

SOIL CONDITIONS AND STABILITY STUDIES

DON VALLEY PARKWAY SLOPE AT MANTON PLACE

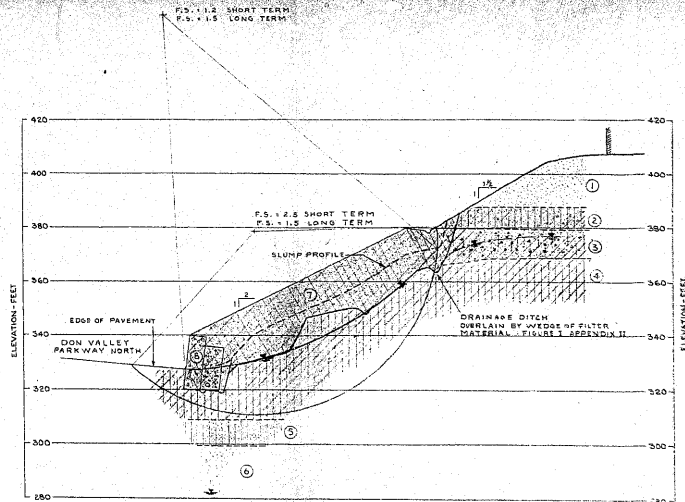
TYPICAL SECTION
REPAIRED SLOPE WITH CRIB WALL
HORIZ. AND VERT. SCALE 1" = 20'-0"

- ③ VERY DENSE, STRATIFIED GRAVELLY TO SILTY SAND
 $\gamma_s = 130 \text{ LBS./CU. FT.}$ $\gamma' = 68 \text{ LBS./CU. FT.}$ $\phi = 40^\circ$
- ④ VERY STIFF TO HARD LAMINATED SILT AND CLAY
COHESION ALONG FAILURE SURFACE = 560 LBS./SQ. FT. $\phi = 34^\circ$ $\gamma_s = 135 \text{ LBS./CU. FT. (AVERAGE)}$
COHESION OUTSIDE FAILURE SURFACE = 3000 LBS./SQ. FT.

A cross section showing the proposed retaining wall and the slope repairs is shown on Drawing T7489-2. The following considerations have been included in the design.

1. The recommended profile for the slope is shown on the cross section. The original slope of 1 vertical to 1.5 horizontal has been retained at the top of the slope in the sands above the water table. The lower slope which consists of granular fill is inclined at 1 vertical to 2 horizontal. A bench, and drainage ditch consisting of half round corrugated pipe, having a total width of 10 feet should be constructed at the change in slope as shown on the drawing. The lower portion of the slope may be protected by a crib wall founded at a maximum elevation of 320 feet. If any softened clay is encountered during excavation for the crib wall it should be removed and the crib wall founded at a lower elevation on very stiff soil. The height of this wall above the shoulder of the parkway will be about 13 feet. The overall height of the wall including the buried portion would be at least 20 feet.

7. The backfill used within the crib wall itself should consist of well compacted sandy gravel. The drains beneath the walls, should drain along the length of the wall. It is recommended that the wall itself consist of a double crib as illustrated on the cross section in order to provide greater strength.

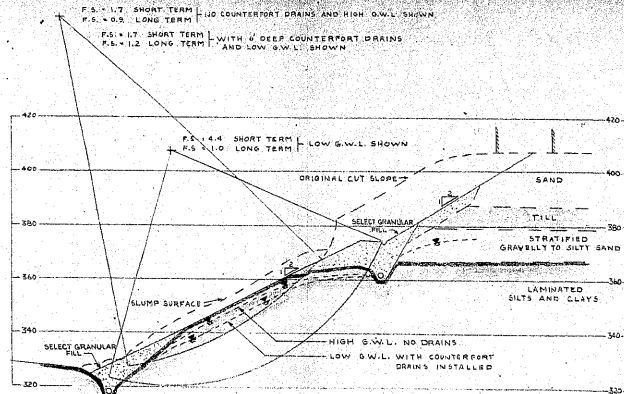
EXPROPRIATE AND CUT BACK TOP OF SLOPE
FAILED SECTION OF SLOPE

- 5) EVEN WITH COUNTERFORT DRAINS OR A GRAVEL BLANKET, THE COMPUTED LONG TERM STABILITY OF THE SLOPE AGAINST DEEPER FAILURE IS MARGINAL.
- 6) COUNTERFORT DRAINS ARE RECOMMENDED FOR THE UPPER SLOPE AS PREVIOUSLY DISCUSSED.

IN VIEW OF THE HISTORY OF RAPID SOFTENING IT IS NOT RECOMMENDED THAT THIS SCHEME BE USED ON THIS PARTICULAR SLOPE FOR REASONS GIVEN IN THE SOILS REPORT

- 7) IT IS RECOMMENDED THAT THE DRAINAGE DITCH BE COATED WITH AN IMPERVIOUS LINING TO PREVENT SOFTENING OF THE UNDERLYING CLAY.

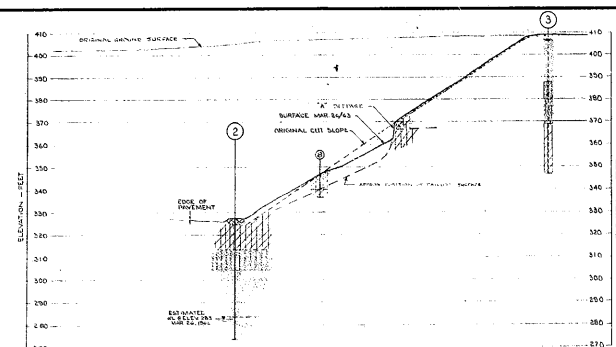
PARKWAY STATION 251+50 (APPROX.)
HORIZ. AND VERT. SCALE 1"=20'-0"

Two cross sections of the area showing the soil stratigraphy and the nature of the slip are shown on Drawing T7489-1.
