-- FOUNDATION INVESTIGATION --
To

Determine Causes of Subsidence in
Vicinity of Toronto International
Airport Expressway - Indian Line Road
Complex, Co. of Peel, Twp. of Toronto
District No. 6 (Toronto)

W.J. 69-F-59 -- Contract 62-267

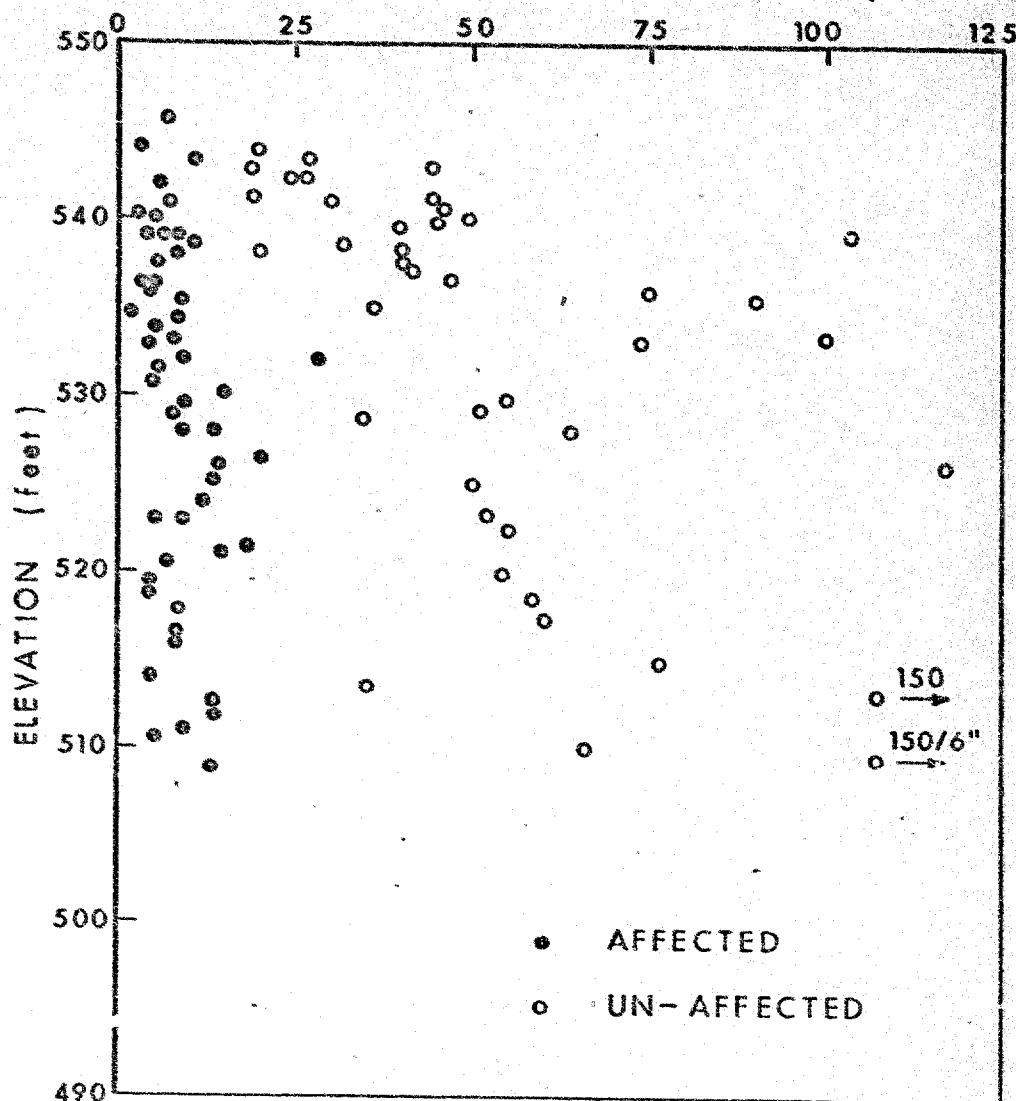
FIG. 1

Standard penetration tests were carried out. The results of this testing indicated that the 'N' values, within the affected area, randomly vary from 4 to 20 blows/ft., being on the average, about 8 blows/ft., while in the unaffected subsoil, the 'N' values range from 20 to 103 blows/ft., being on the average, approximately 45 blows/ft. A figure showing the relationship between the 'N' values recorded in the affected and unaffected areas, is shown in the Appendix of this report. Based on these results, it is estimated that the consistency of the subsoil, within the plan limits of the subsidence, varies from soft to firm, while outside this area, it is in the very stiff to hard range. Further, inspection of the samples obtained, indicates that the moisture content of the former material is, generally, considerably higher than that of the parent material - i.e., it is in a much wetter state.

SUMMARY PLOT OF STANDARD PENETRATION RESISTANCE VALUES (Affected and Un-Affected Areas)
