D.H.O. FOUNDATION INVESTIGATION REPORT --
Kleinburg Side Road Embankment Failure,
Twp. of Vaughan, Co. of York, Dist. #6.
W.J. 63-F-53

Kleinburg Side Road
Embankment Failure,
Twp. of Vaughan, Co.
of York, District #6.
W.J. 63-F-53

KLEINBURG SIDE ROAD EMBANKMENT FAILURE

SECTIONS & PLAN

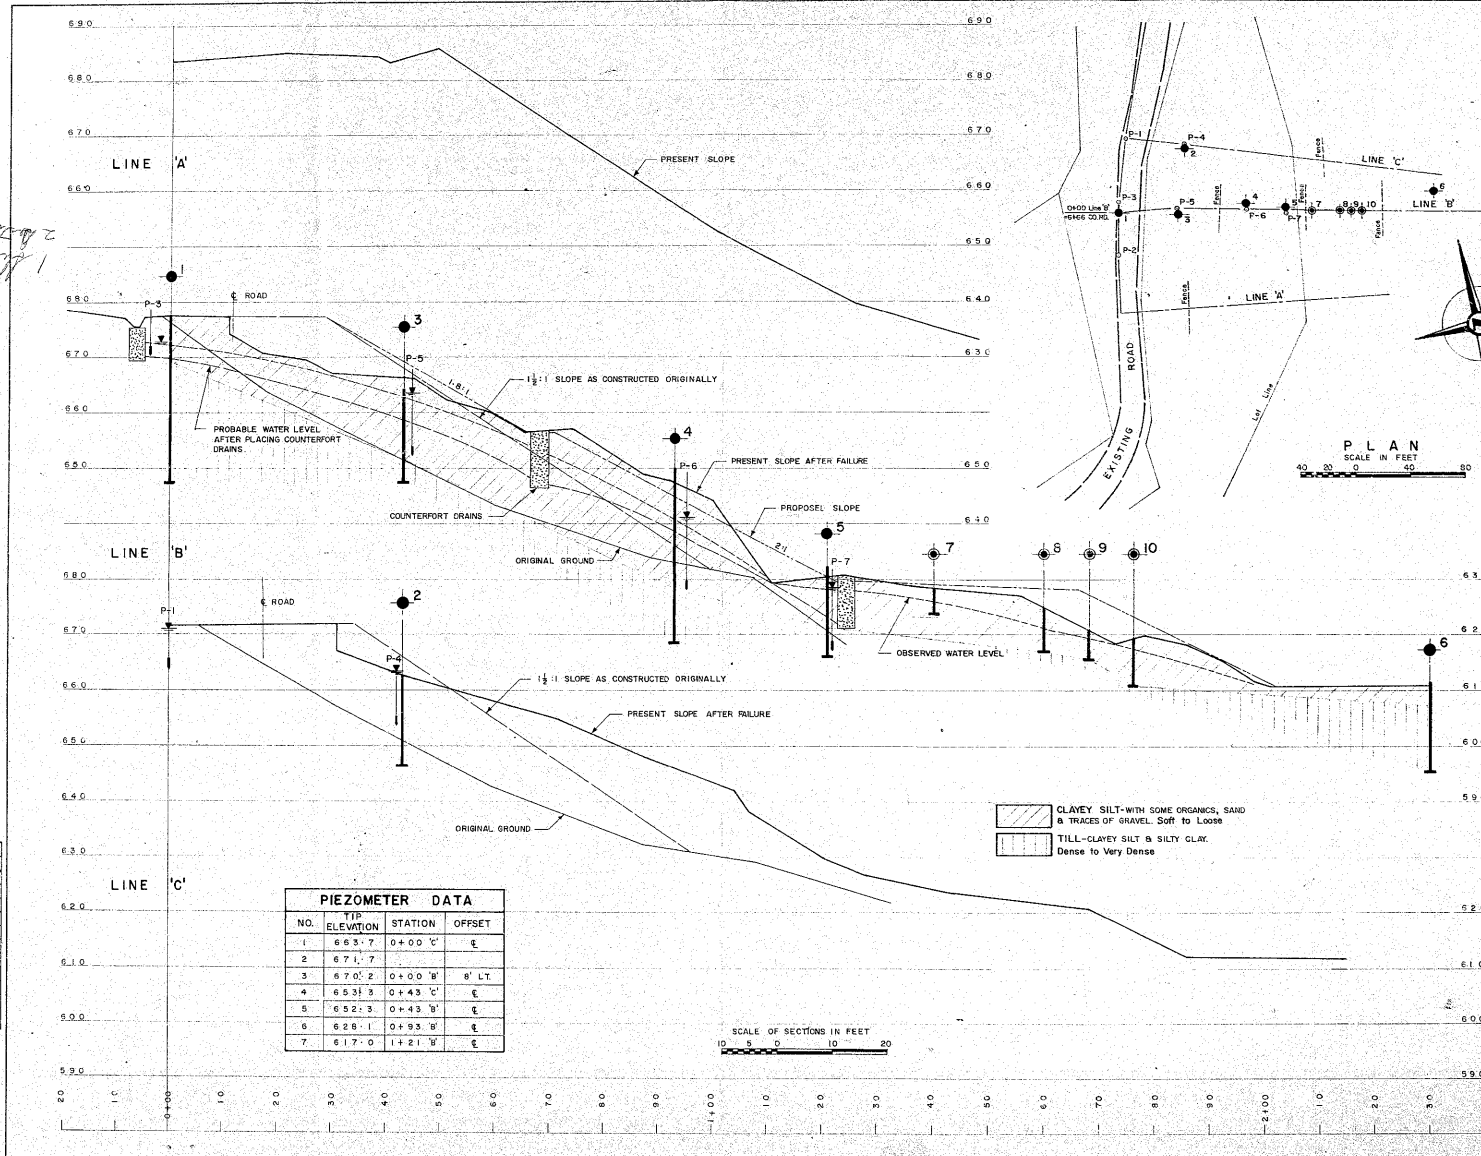
Nine boreholes were placed along cross section 'B' through the middle of the slide, while one borehole (No. 3), was placed on the downhill edge of the slide. Three piezometers were placed along the hillside road ditch, one adjacent to B.H. 3, and the rest along line 'B'. The locations of all the boreholes and piezometers are shown on the attached drawing. The borehole logs are given in the Appendix to the report.

At the location of piezometer No. 4, adjacent to B.H. 3, the water was actually above the ground surface. A probable phreatic line connecting all the established water elevations is shown on the attached drawing. It is believed that this line

must have been appreciably higher prior to the failure. Due to the subsidence of the road surface, new boundary conditions were created, resulting in a gradual lowering of the ground water table.

The investigation has confirmed that one of the main causes for the slope failure was the very high ground water table and, therefore, the remedial measures will have to include provisions for lowering it permanently. It is recommended that a drainage system be constructed which will fulfill this purpose. Some details of the proposed system are shown on the attached drawing, while additional information is given below:

The drainage ditch along the hill side of the road should commence at the top of the hill - i.e., just around the corner of the road at the road junction, and should be taken down into the valley. The average depth of this trench should be around 8 ft., which is believed to be the depth of overburden overlying the dense till stratum as established by borehole No. 1 and the penetration resistance of piezometers No. 1, 2 and 3.

Two additional drainage trenches, parallel to the one described above, should be constructed through the failed zone at the respective locations shown on the drawing. The minimum depth of these trenches should be 10 feet, and they should be drained into a trench running down the slope at right angles to the road centre line. This trench should commence at the hill side of the road, thus connecting all three trenches and ending at the

Apart from the drains, it is also recommended that the embankment be rebuilt with an average 2:1, instead of the original 1½:1 slope, and the material at the bottom of the slope be shaped as shown on the drawing.
