Hwy. #50

AT BOLTON

D.E.C. FOUNDATION INVESTIGATION
REPORT,
W.J. 62-F-9 -- W.P. 44-58-2.

Re: Hwy. No. 50 at Bolton, Ontario,
Sta. 136+00 to Sta. 149+00.,
District #6.

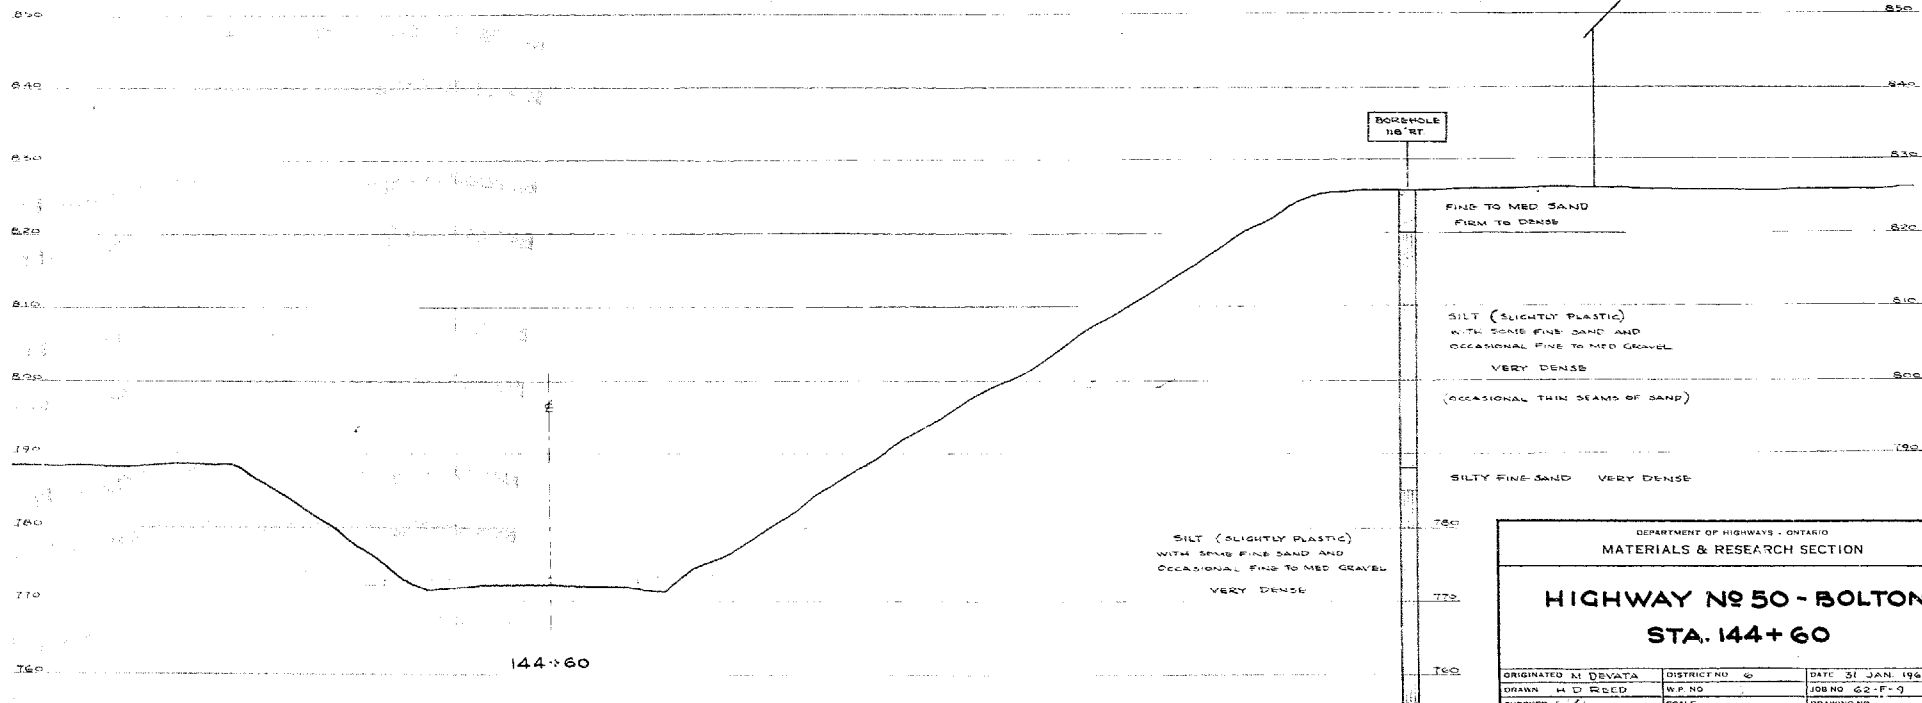
HIGHWAY NO 50 - BOLTON **STA. 144+60**

One borehole was put down at Sta. 144+60, some 10 ft. from the edge of the slope. The location of the borehole in relation to the existing house on the top of the slope, as well as the determined soil stratigraphy, are shown on the attached Drawing No. 62-P-9A. As can be seen from the subsoil profile, the material is predominantly silt and very dense. On the top, a 6-ft. layer of sand was found. Another thin (3 ft.) sand layer was encountered at a depth of 35 ft. below the surface.

Bearing in mind the material and its properties, it becomes evident that no deep-seated failures are taking place, or can take place, but that the slope surface, which is very long and exposed, becomes unstable due to the influence of surface water and also of water that penetrates into the soil during prolonged precipitations and finds its way out of the ground somewhere on the slope. The detrimental influence of the surface sand layer can now easily be assessed.
