## MEMORANDUM

To: Mr. F. G. Allen,  
District Engineer,  
District #6 (Toronto).

FOUNDATION INVESTIGATION REPORT  
For  
Slope Failures of Fill Section  
Between Stations 350+00 and 362+00  
Hwy. #401 Crossing of Hoggs Hollow  
Contract 62-252  
District No. 6 (Toronto)  
W.J. 68-F-46 -- W.P. 85-59-1

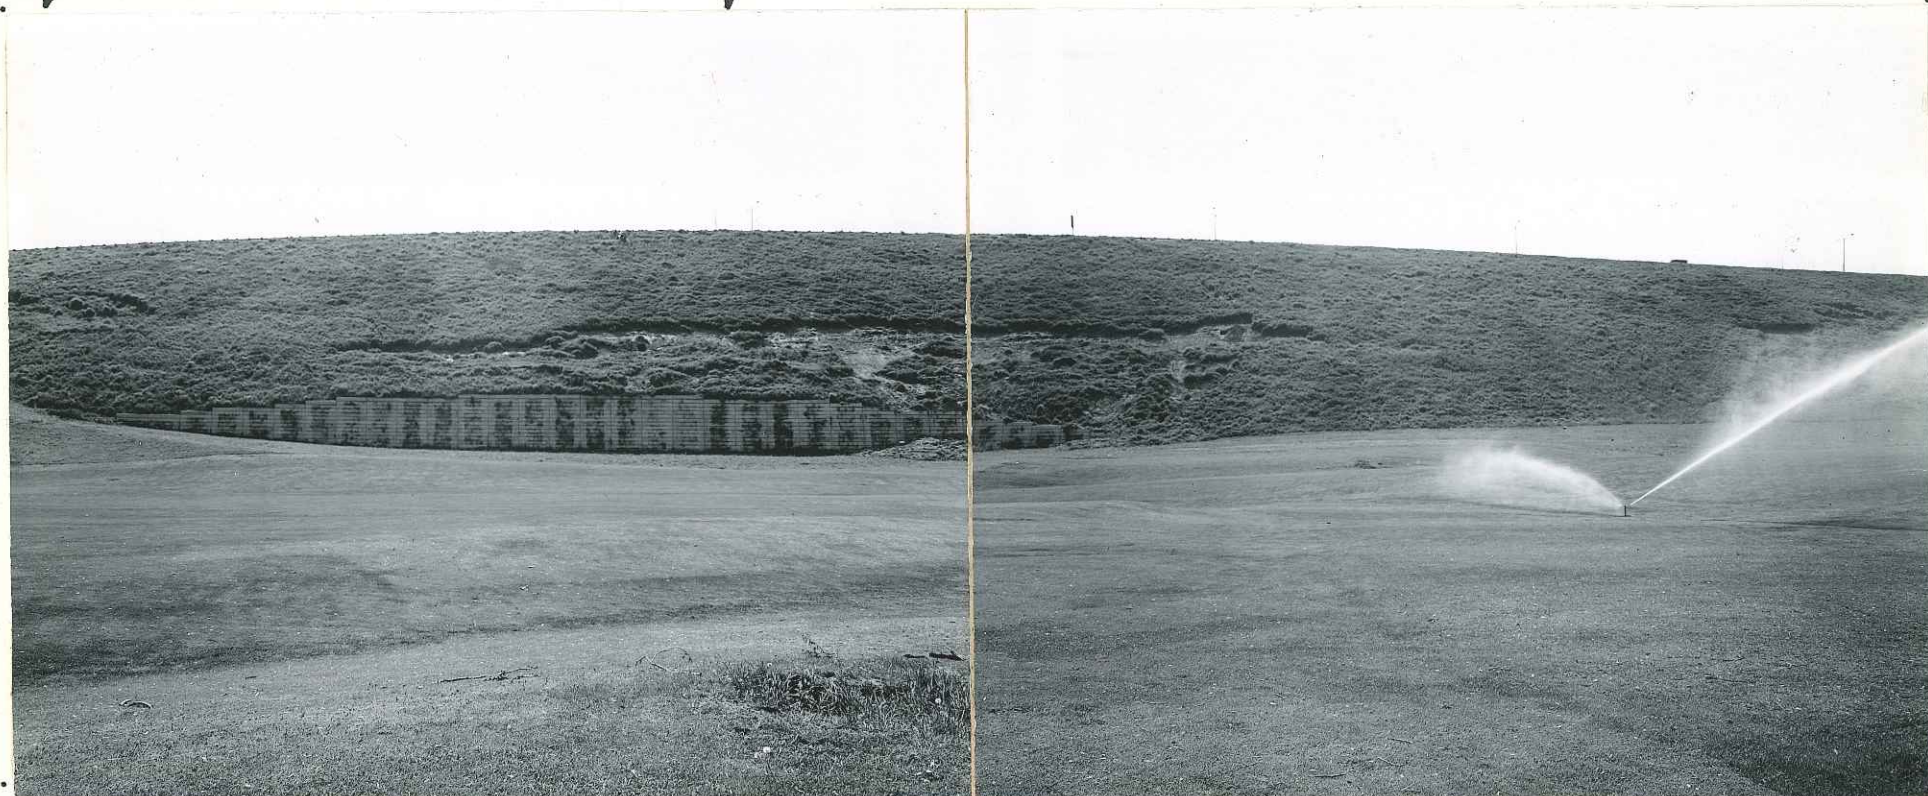
VIEW LOOKING SOUTH AT NORTH SLOPE AND RETAINING WALL

<u>Station</u>	<u>Approx. Location on Slope</u>	<u>Max. Length of Area</u>	<u>Approx. Date Noted:</u>
i)	352+00 to 354+00 (See Section D-D)	Mid-third - 30 ft. wide	200 ft.	Spring, 1964.
ii)	355+00 to 358+00 (See Section B-B)	Lower Third - 60 ft. wide	250 ft.	Major movement in Spring, 1964.
iii)	358+00 to 359+45 (See Section A-A)	Lower Half - 40 ft. wide	85 ft.	Noticed in 1966 - Major movement in Spring, 1967.

These failures are surficial in nature - i.e., extend only 3 to 4 feet below the face of the slope; the causes of the failures will be discussed in detail - Section 6.1) to follow.

The sloughed material has, in the vicinity of Section B-B, spilled over the retaining wall onto the fairway of the golf course.

FAILURE  
AREA 'A'

FAILURE AREA 'B'

FAILURE  
AREA 'C'

In order to control the groundwater seepage within the fill, it is recommended that a granular drainage blanket, at least 2 feet thick, be provided across the north face. The composition of the material within this blanket should be such that it acts as a filter to the fill material on the north slope. The optimum gradation for granular material to be used for such purposes is shown on Figure 4. A typical grading curve for the two most readily available granular sources in the Metro Toronto area, namely:

In addition to the drainage blanket, it is recommended that a properly designed drainage ditch be provided at the toe of the slope. The surface run-off and groundwater seeping through the drainage blanket could then be channelled to this ditch. Provision should be made to lead the water from the ditch into the storm sewer system in the area.

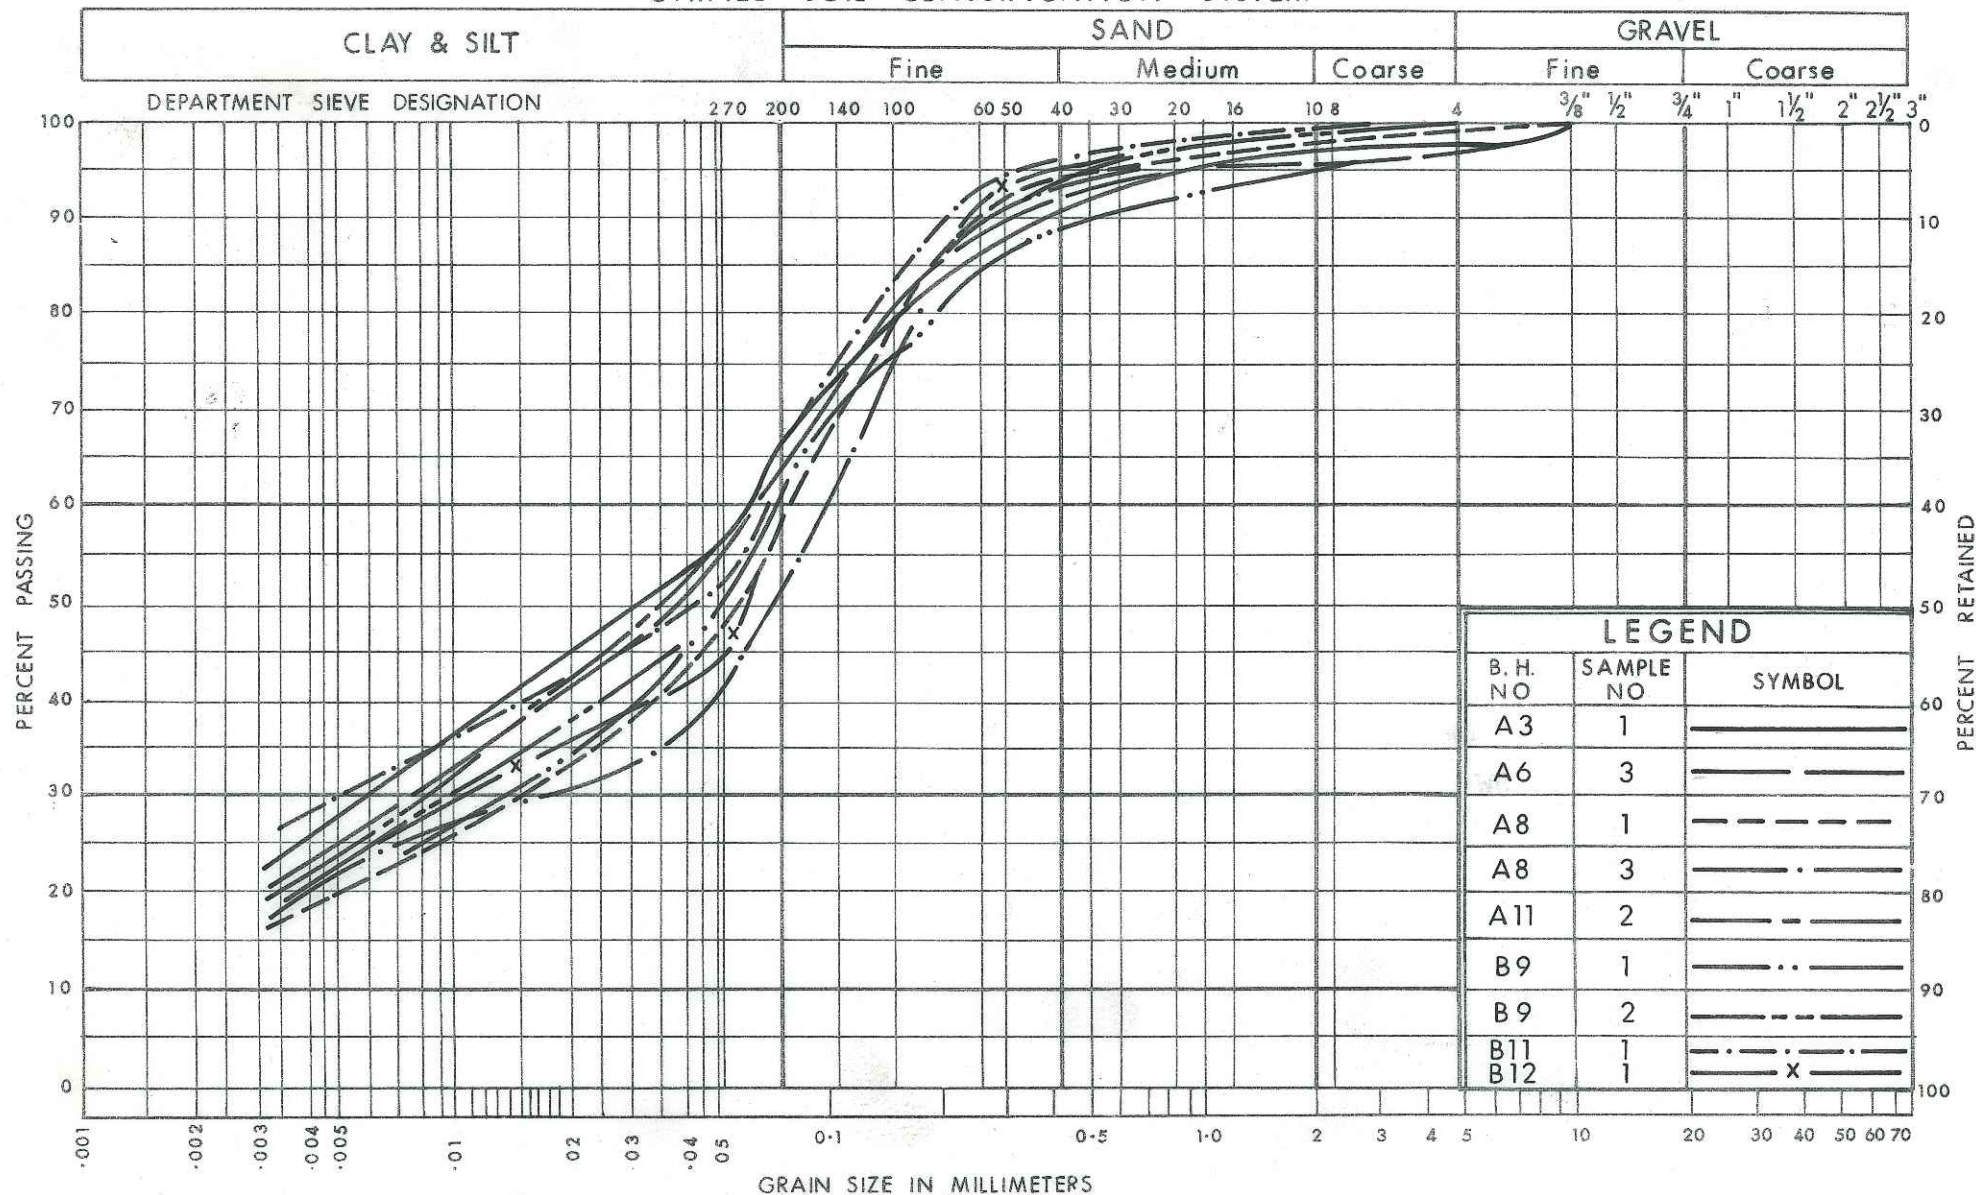
FIG. 1

distribution curves obtained on samples of the glacial till, are plotted on Figure 1.

GRAIN SIZE DISTRIBUTION  
CLAYEY SILT  
WITH SAND & TRACE OF GRAVEL

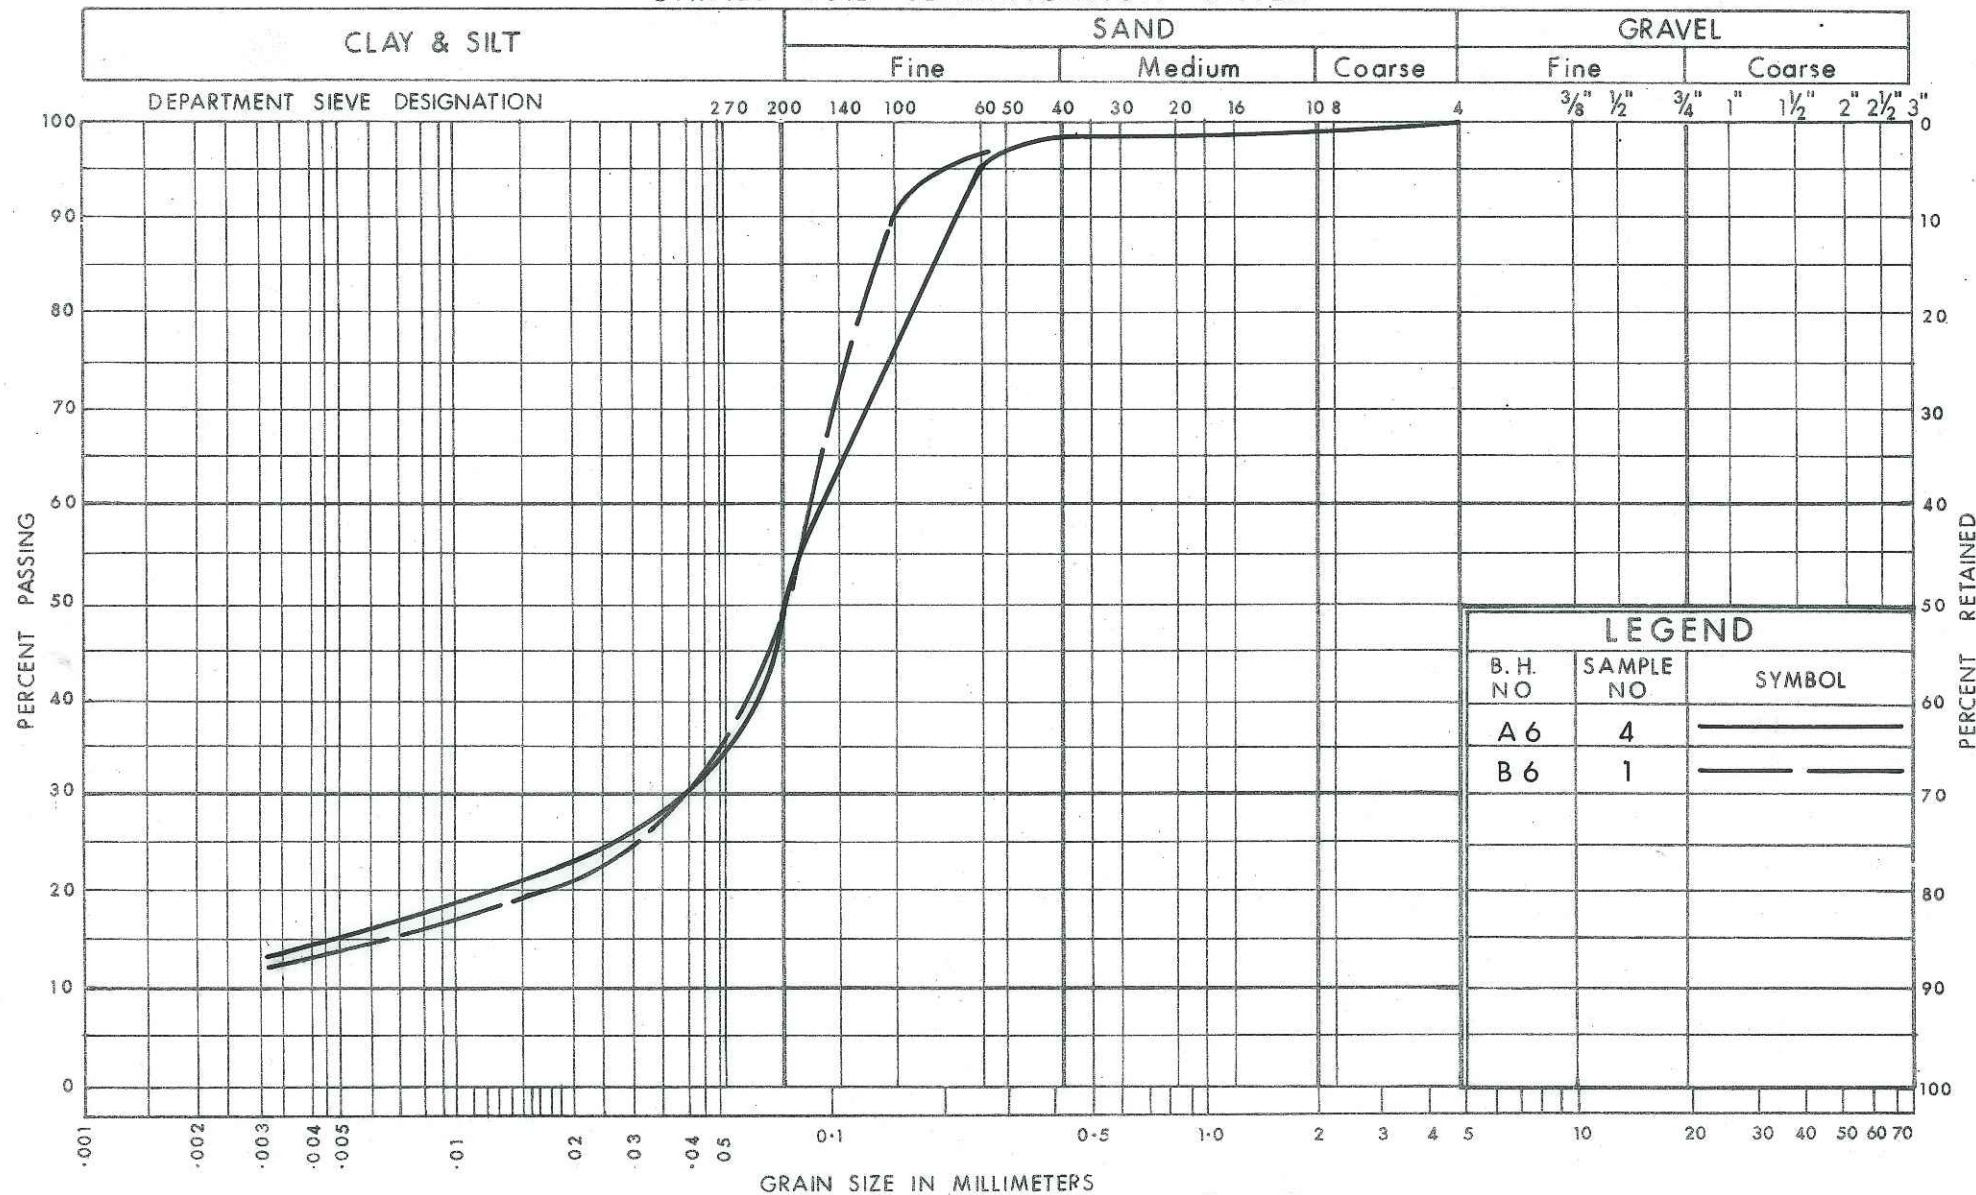
FIG. 2

The continuity of the clayey silt material is intermittently interrupted, particularly in the lower half of the slope, by pockets and seams composed of pervious silty sand and sandy silt material (see the sections shown on Drawing No. 68-F-46B). The thickness of the granular zones, varies from a few inches up to 1-1/2 feet. Two typical grain-size distribution curves for samples of the granular deposits are shown on Figure 2.

GRAIN SIZE DISTRIBUTION  
SILTY SAND  
TRACE OF CLAY

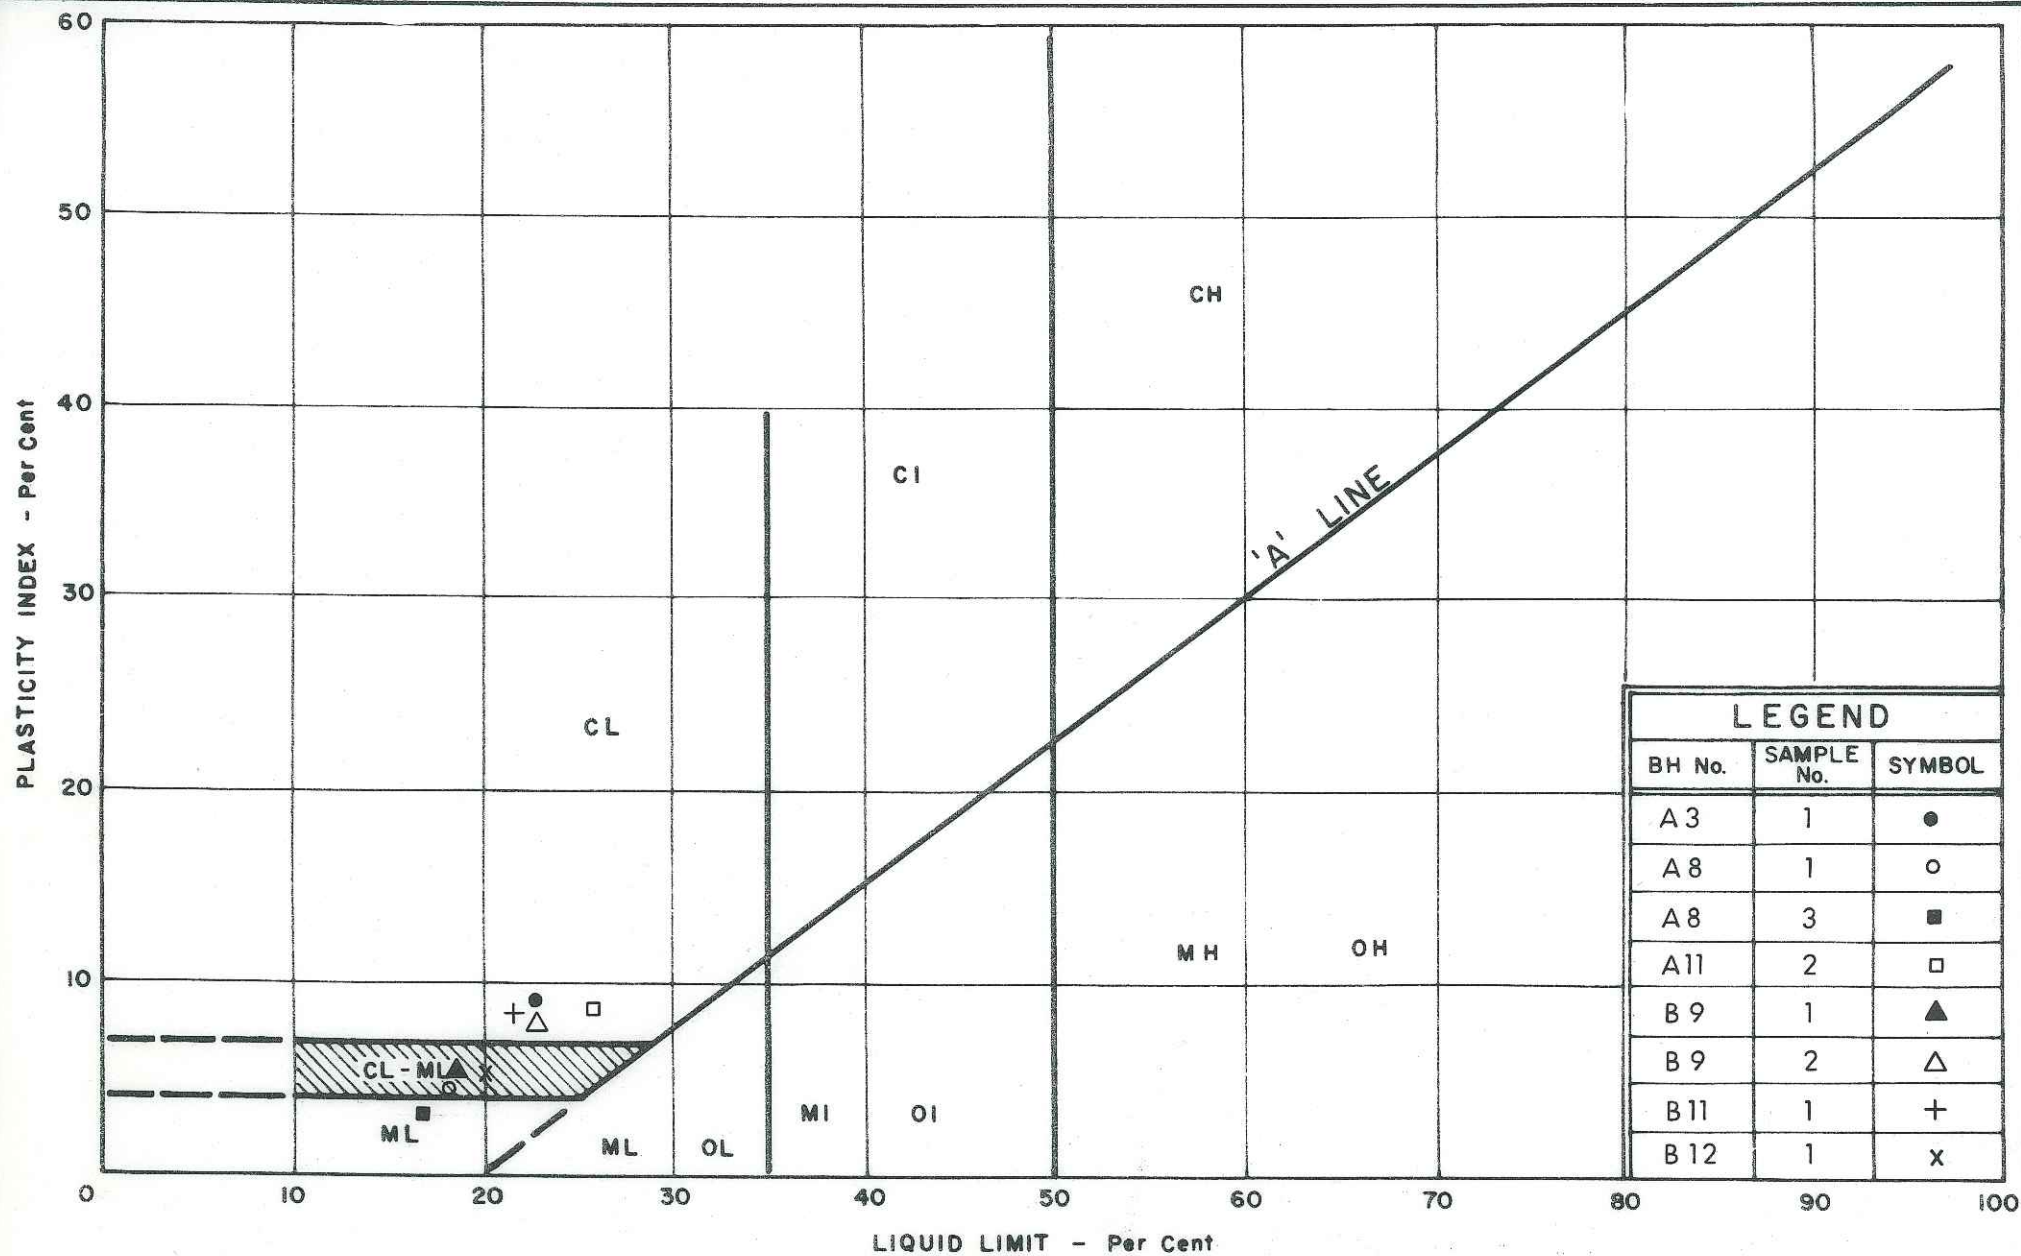
FIG. 3

Atterberg limit tests, carried out on samples of the glacial till, are summarized on the Plasticity Chart, Figure 3. The liquid and plastic limit varies from 17 to 26 and 13 to 18, respectively. These results indicate that the clayey silt is inorganic and of low plasticity. The natural water content varies from 14 to 23 percent - i.e., from a few percent above the plastic limit to a few percent above the liquid limit. The higher moisture content values were encountered in areas associated with a high groundwater level where unstable conditions prevailed, as discussed in detail later in this report.

# PLASTICITY CHART CLAYEY SILT WITH SAND & TRACE OF GRAVEL

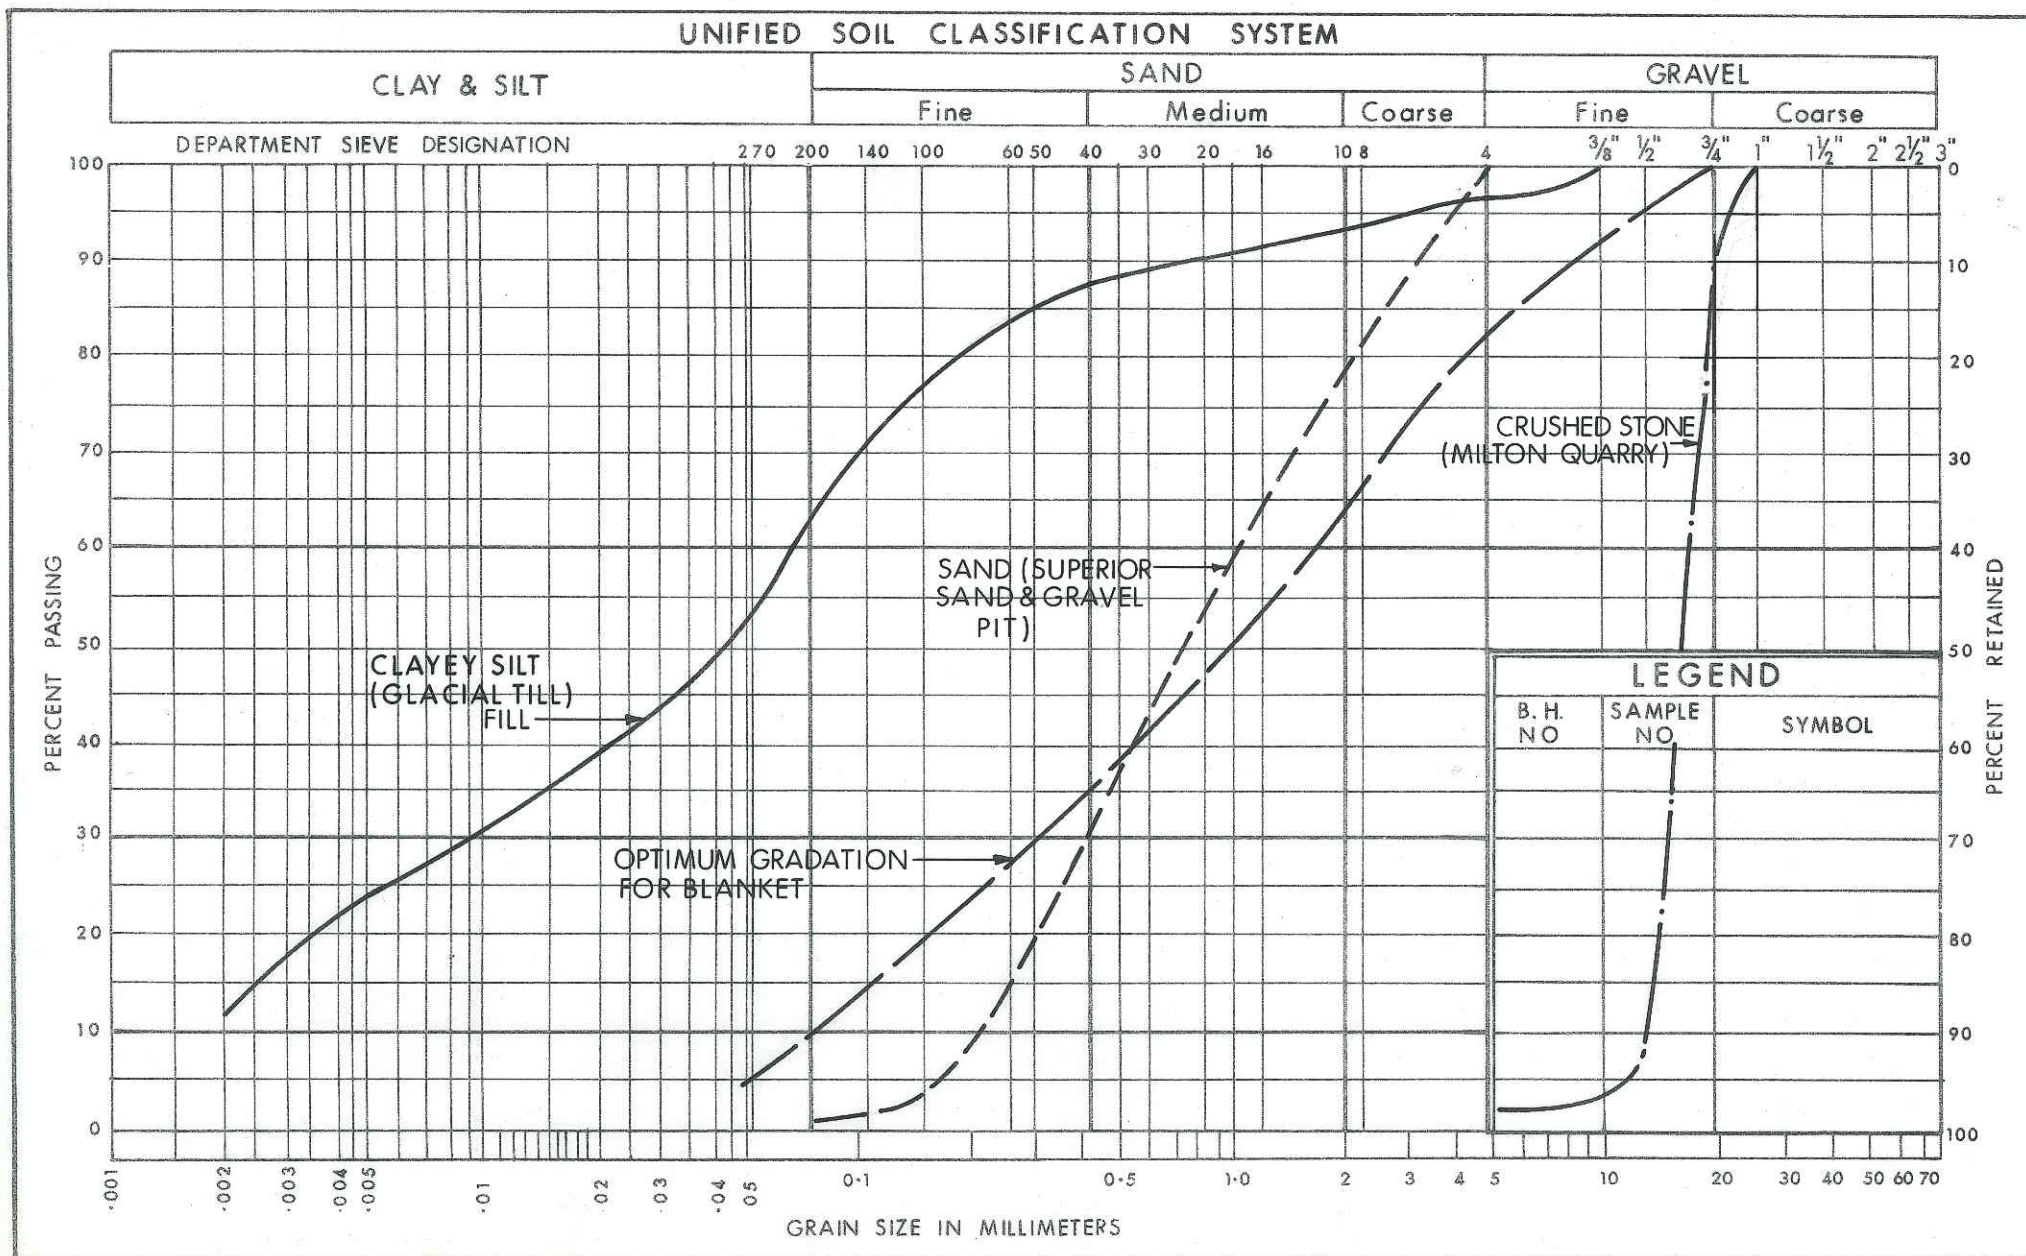
FIG. 4

plotted on Figure 4. Referring to this Figure, it can be seen that the Superior sand most closely approximates the optimum gradation. The drainage blanket should extend from the toe of the slope to a point about 10 feet above the crest of the failure areas. In the failure areas, prior to placing the granular blanket, all softened and loosened areas should be removed.

RECOMMENDATION GRADATION FOR GRANULAR BLANKET —  
TYPICAL GRADATION OF AVAILABLE GRANULAR BORROW
