Re: Patrol Yard Garage  
Hwy. 404 and Regional Rd. 25  
W.P. 2723-76-03

Subject: W.P. 2723-76-01  
Patrol Yard at Richmond Hill  
Hwy. 404 at Regional Road #25  
District 6, Toronto

## FOUNDATION INVESTIGATION REPORT

"Gormley" Patrol Yard, near New Hwy. #404,  
on Lot 21, Conc. III, Twp. of Markham.  
W.J. 63-F-84 -- W.P. (Nil)  
District #6.

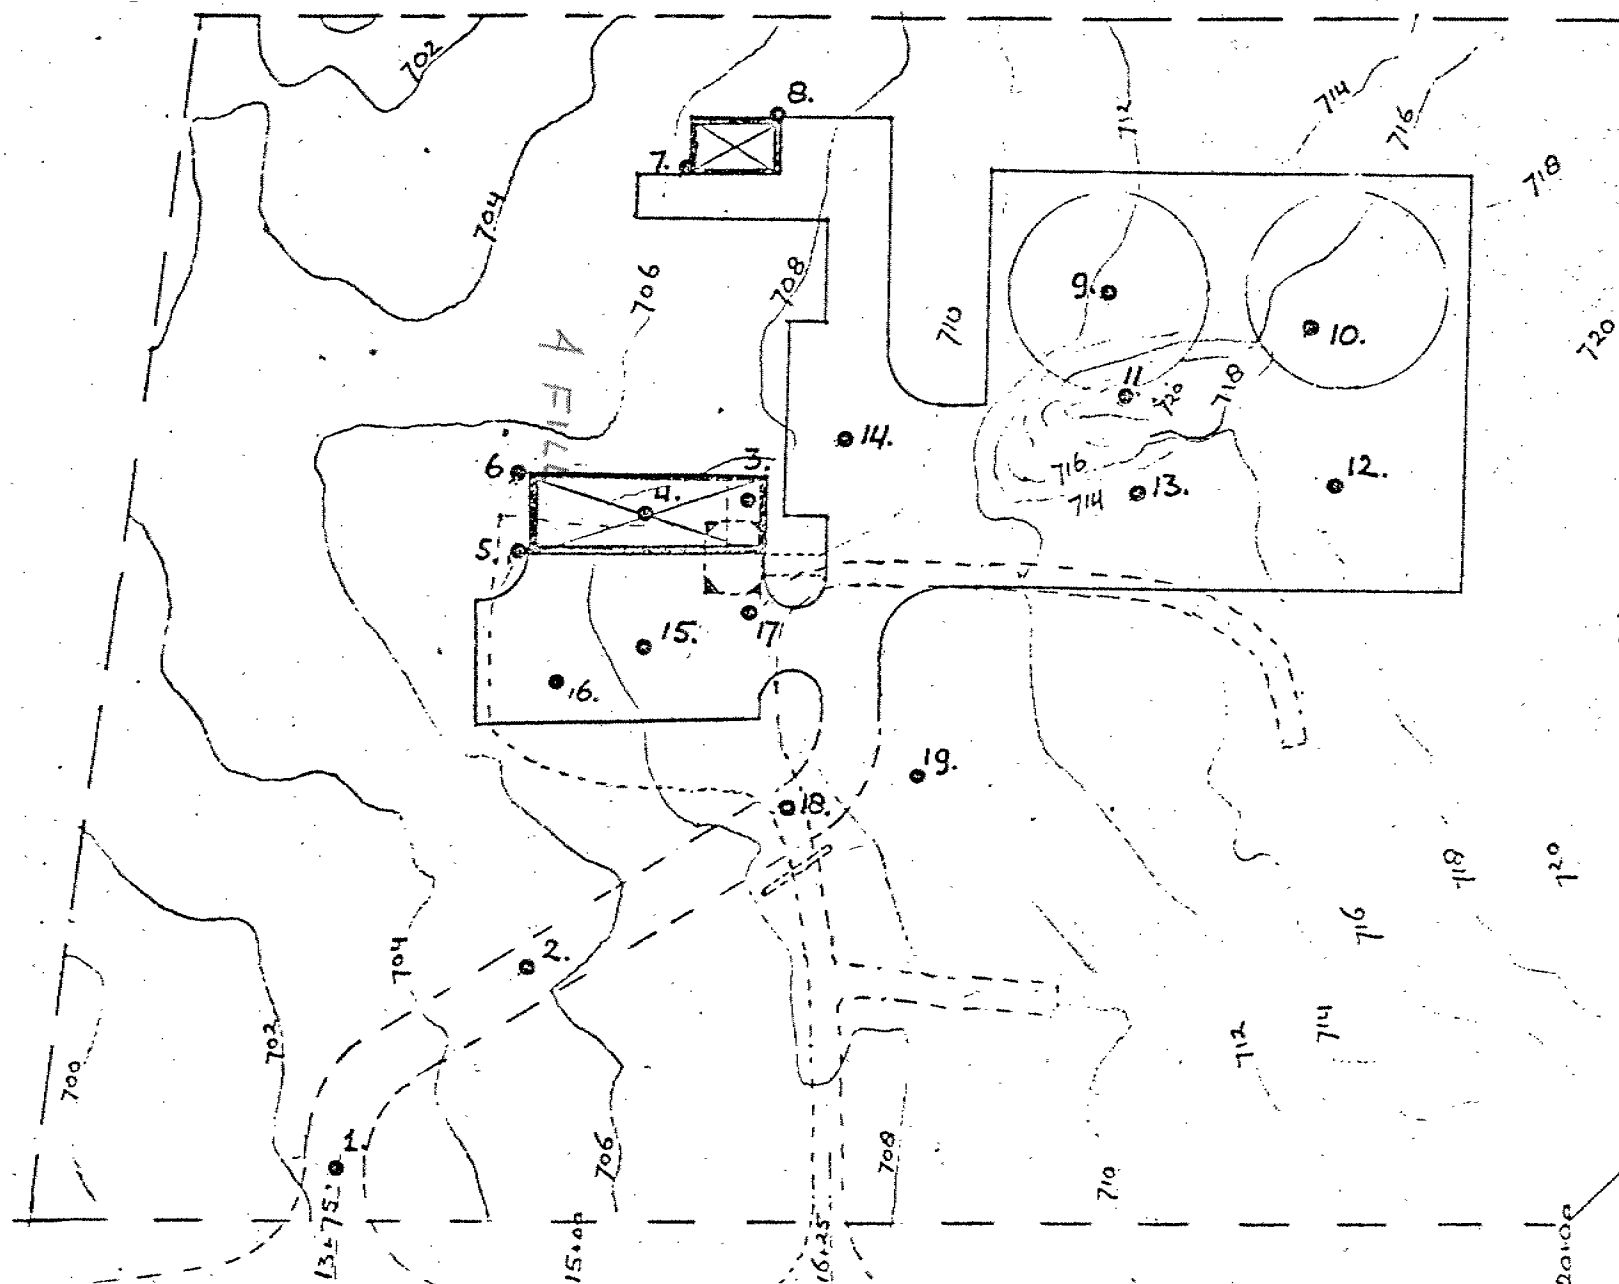
Boring locations,  
New lay-out,  
and contours.  
May 26/77.

Soil borings for the new building sites and the proposed paved areas were made on May 24, 1977. The site plan at one inch equals one hundred feet (1" = 100'), shows the new layout and the bore hole locations. A sheet with the bore hole logs is also attached.

Some previous work was undertaken at this site. There is a gravel entrance roadway, a gravel apron approximately 120' X 150' and a concrete foundation for a small salt shed. The borings show a topsoil depth between 6" and 18" over a clay loam till. At several locations the upper stratum of the clay loam till has been modified into a light to medium clay. The present gravel area has from 12" to 18" of gravel. There is a topsoil stockpile at the sand dome area. The topsoil pile is up to 10' in height and contains approximately 2500 cubic yards of topsoil.

Judging from the new layout and the superimposed contours on our site plan, the sand dome area will be mainly in cut, the contractor area and the garage building are on shallow fill sections. The entrance roadway is at grassroot grade.

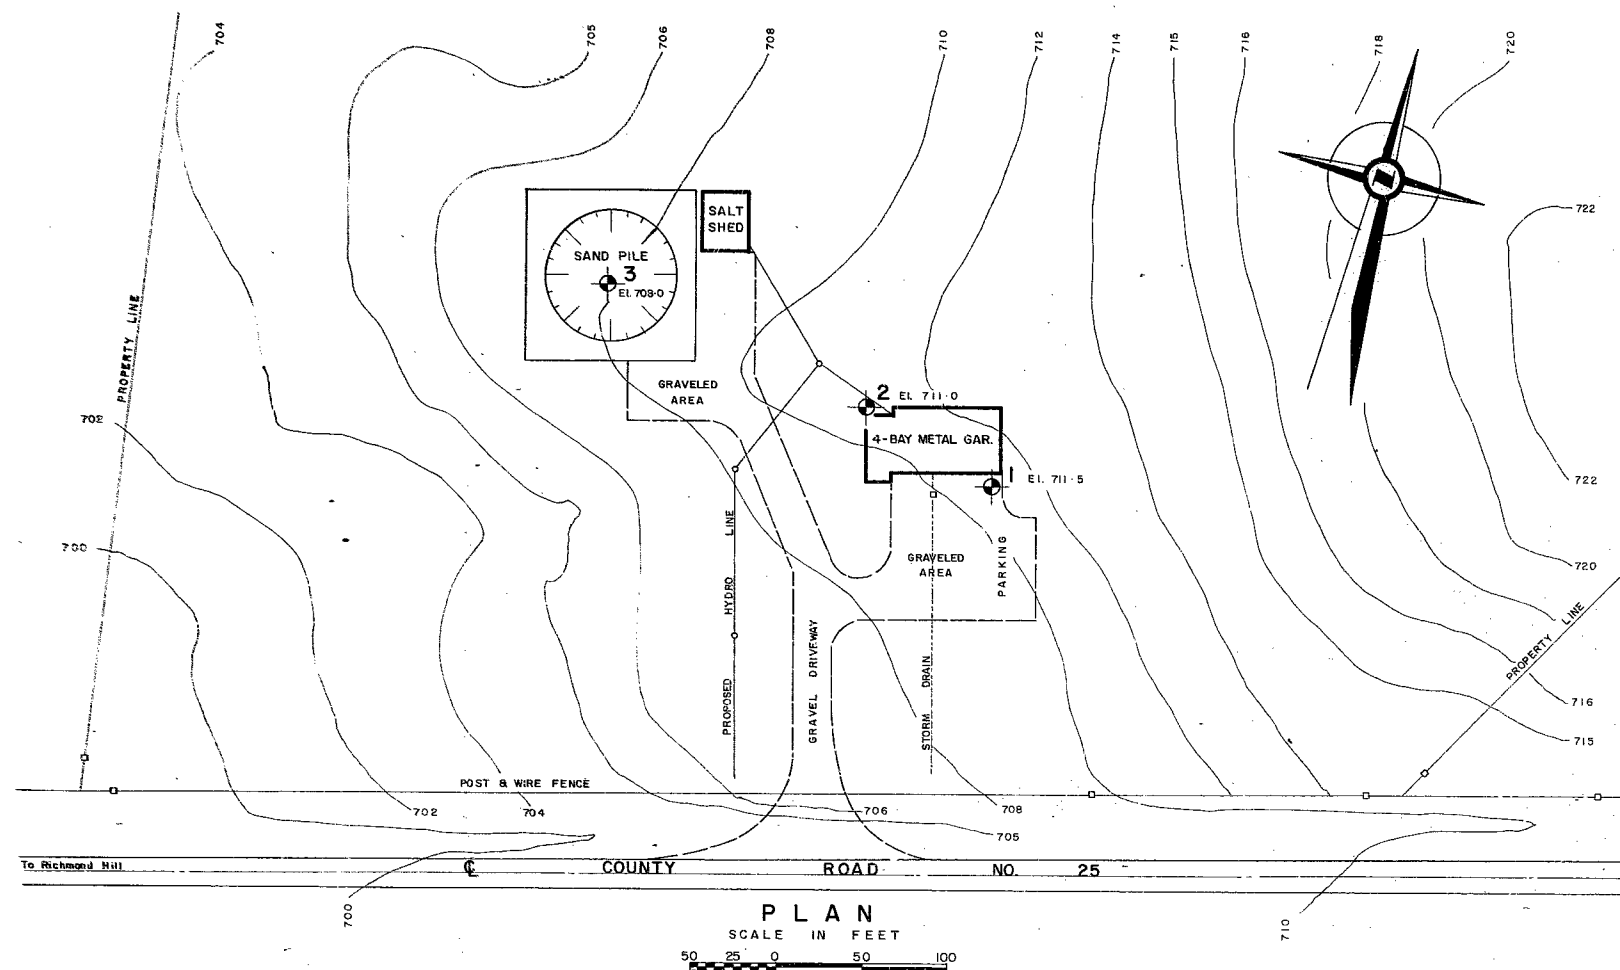
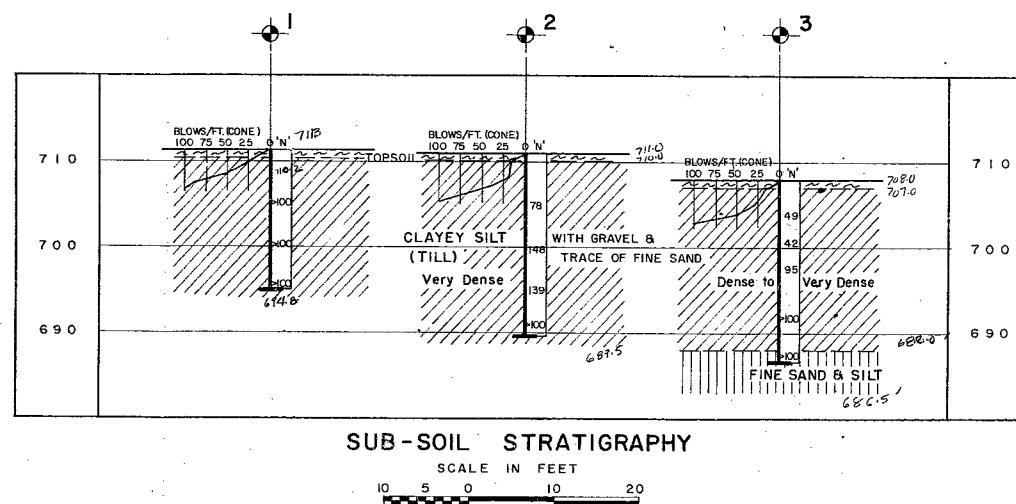
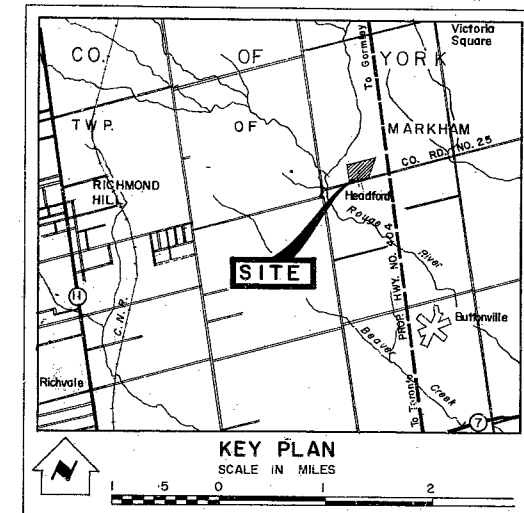
DEPARTMENT OF HIGHWAYS - ONTARIO		
MATERIALS & RESEARCH SECTION		
<b>GORMLEY PATROL YARD</b>		
ORIGINATED V. KORLU	DISTRICT NO. 6	DATE 19 AUG. 1963
DRAWN D. MUMFORD	W.P. NO.	JOB NO. 63-F-84
CHECKED <i>HR</i>	SCALE	DRAWING NO.
APPROVED <i>Alphamac</i>	AS SHOWN	<b>63-F-84 A</b>

The field investigation consisted of three sampled  
borings with three adjacent dynamic cone penetration tests.  
The locations and elevations of the boreholes together with  
the inferred stratigraphy profile are shown on the  
attached drawing #63-F-84A. Subsoil at the site was found  
to consist of a thin layer of topsoil followed by very dense  
glacial till (clayey silt with gravel and traces of fine  
sand). This layer was investigated to a maximum depth

of 21.0 ft. No water was observed in any of the boreholes during the time of investigation.

It is recommended that the garage buildings be supported on spread footings founded in the dense glacial till stratum.

A safe bearing pressure of 3 t.s.f. may be used for design purposes. The foundation for the buildings should be placed at a sufficient depth for frost protection, which would be about 5.0' below finished ground level. No stability problems are anticipated at the proposed sand pile location.
