ROBERT DODDS LIMITED
CONSULTING GEOTECHNICAL ENGINEERS

FOUNDATION INSPECTION
CONSTRUCTION OF HIGHWAY 406 BRIDGE
TWELVE MILE CREEK
CITY OF ST. CATHERINES
REGIONAL MUNICIPALITY OF NIAGARA

Our Reference No. R80168
MTC Contract No. 80-44
August, 1980

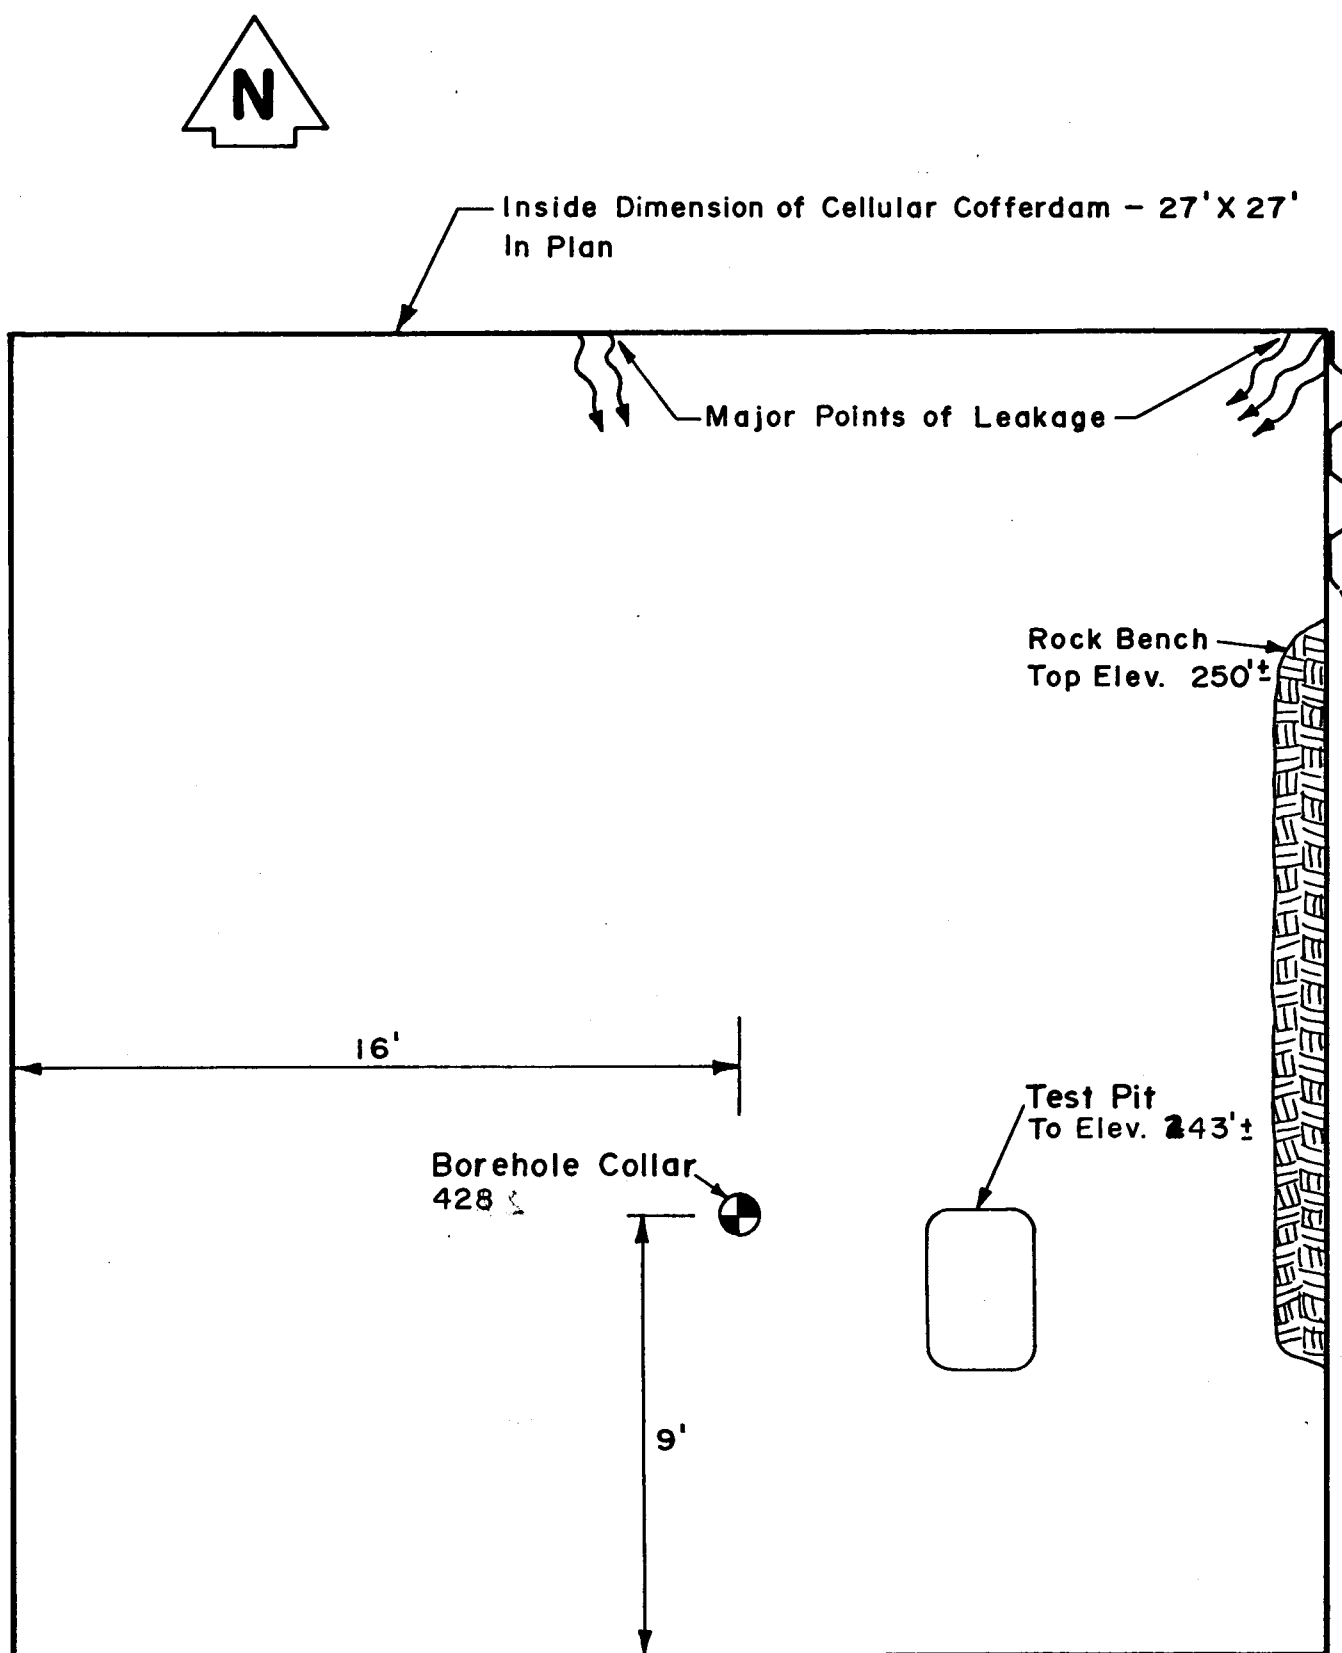
CELL PLAN - PIER No. 2

A test pit was excavated at the location shown on Drawing No. 7. This pit was extended to approximately elevation 243 ft. Throughout the depth of the excavation, the material consisted of rock. The material could be broken up relatively easily with a mechanical spade. The broken up material had no matrix. Photos, Nos. 16 to 19 inclusive, illustrate. The sides of the test pit excavation showed very dry powdery material when the rock was broken by hand.

The apparent location of Borehole 42S was encountered as shown on Drawing No. 7, which is 9 ft. from the south wall and 11 ft. from the west wall of the cell. The Contractor reported that the top of the borehole at approximately elevation 255 ft. was intact. At the time of inspection by the undersigned, excavation had taken place to approximately elevation 249 ft. At that elevation, the sides of the borehole were relatively intact with shale pieces having fallen into the bottom of the borehole. Thin infillings of clay could be felt along the sides below the water which appear to be shale weathered in place. A similar thin seam was encountered in the bedrock bench on the west wall and is shown on Photo No. 15 at the tip of the pencil. Clear water was flowing at a slow rate out of this borehole and is illustrated in Photo No. 21. The measured water temperature was 56°F, whereas the river water temperature was

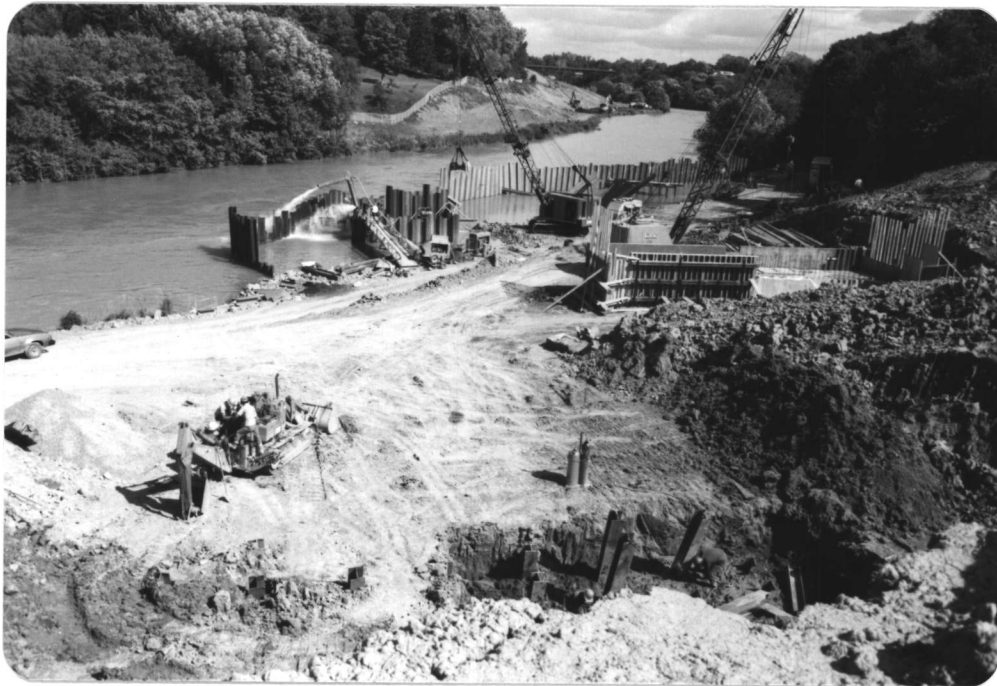
Photo No. 1 - General view of site looking upstream to the south. Cellular cofferdam (cell) inside diversion is at Pier No. 2 of northbound lane.

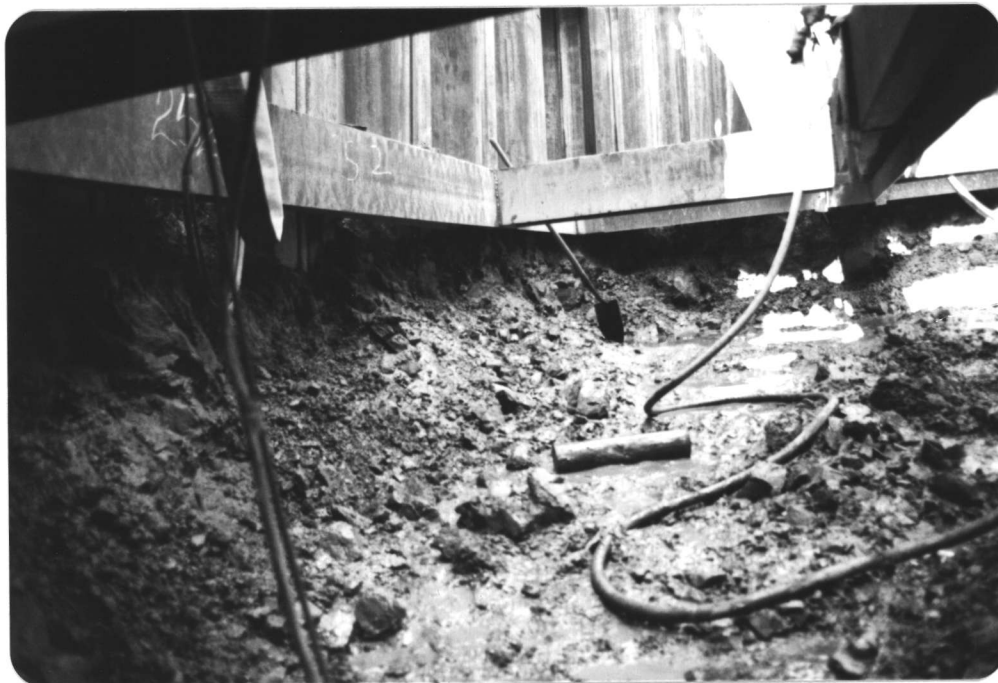
The exposed material at the base of the excavation varied in elevation from approximately 250 ft. to 246 ft. and consisted of massive blocks of rock. Photos, Nos. 2 to 15 inclusive, illustrate the rock conditions encountered. The existence of rock is clearly shown in the bench that was left along the west side of the cell and which

Photo No. 2 - Base of excavation in cell along west wall looking north. Elevation at approximately 250 feet.

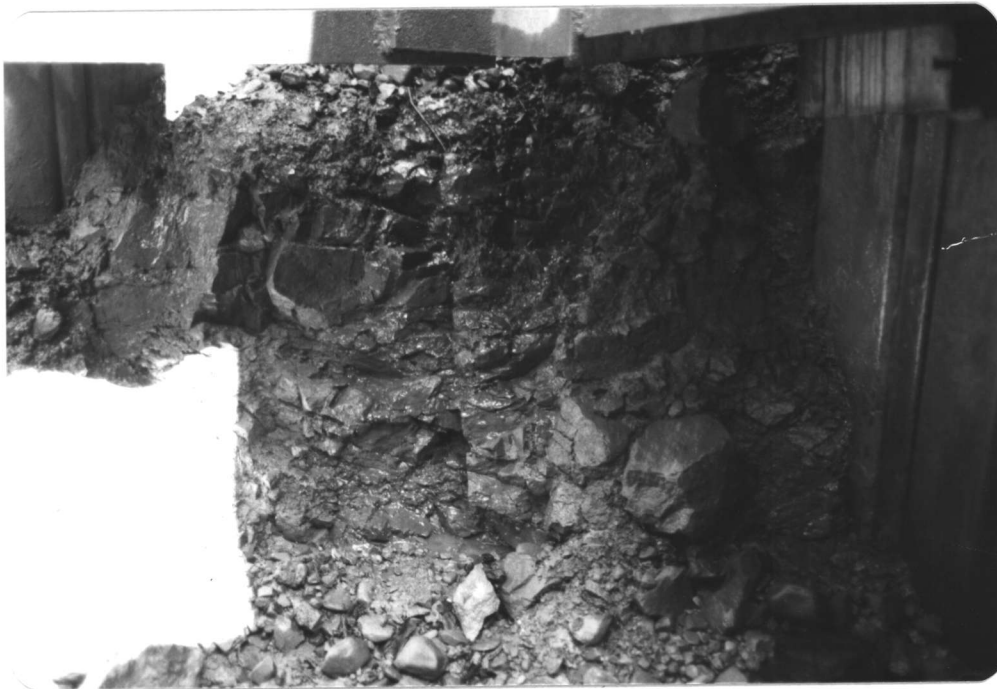
Photo No. 3 - Exposed rock northwest corner of cell.
Base at approximate elevation 248 feet.

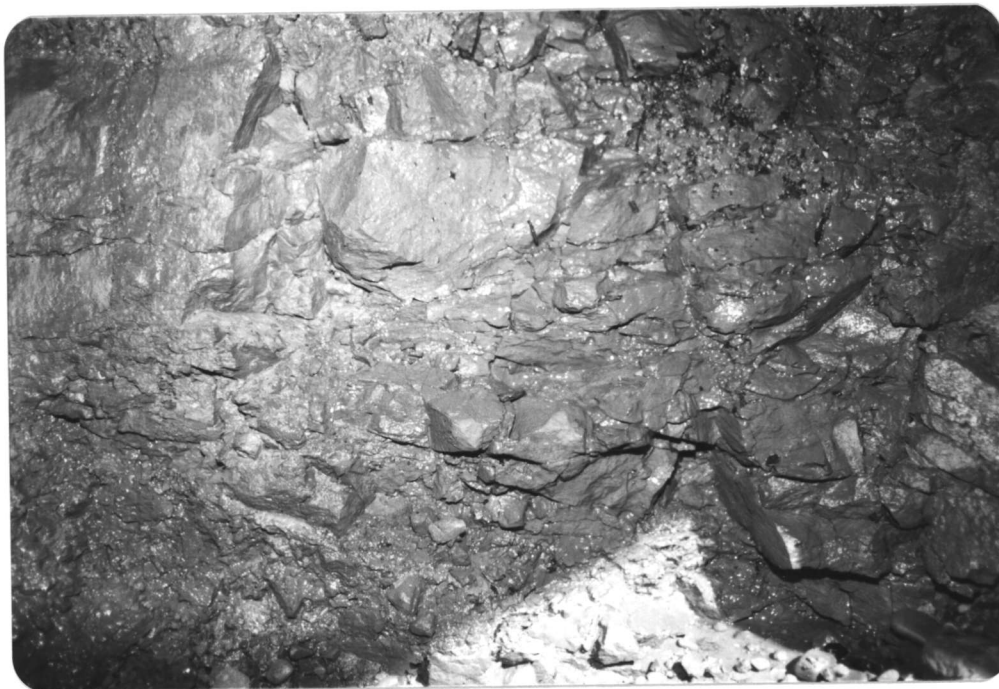
Photo No. 4 - Exposed rock northwest corner of cell.
Base at approximate elevation 248 feet.

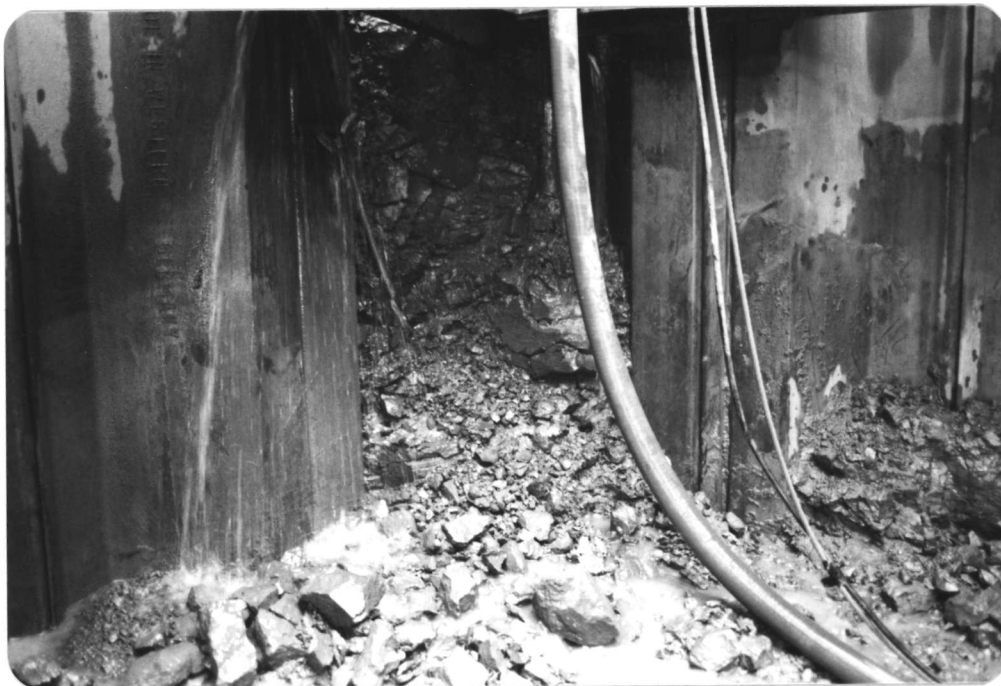
Photo No. 5 - Exposed rock at northeast corner of cell.
Base at approximately 248 feet.

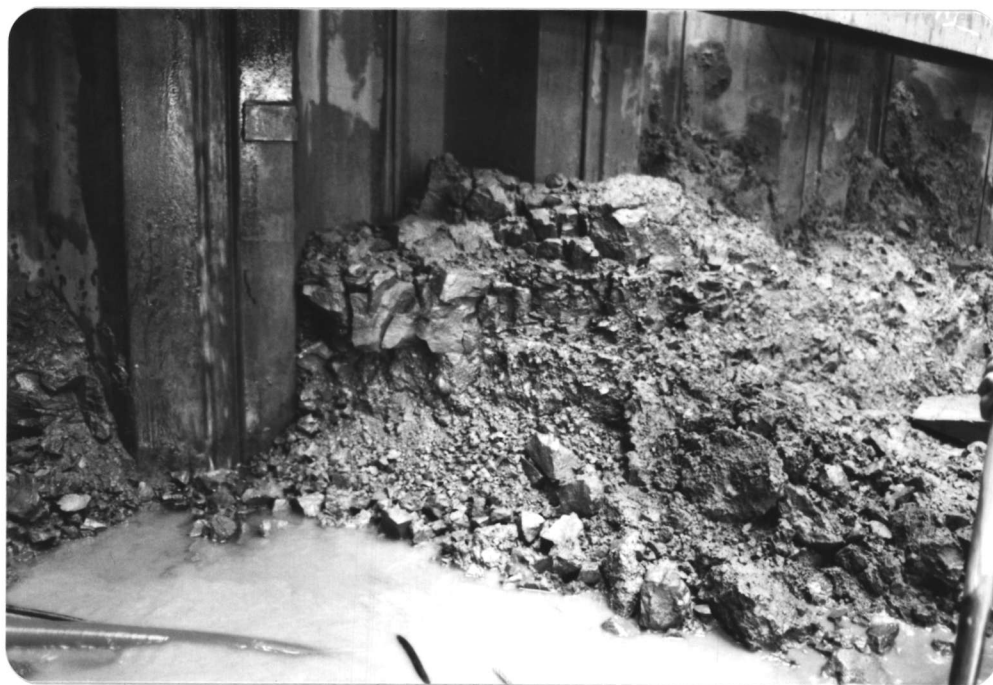
Photo No. 6 - Exposed rock at bench along east wall of cell.
Top at approximately elevation 250 feet.

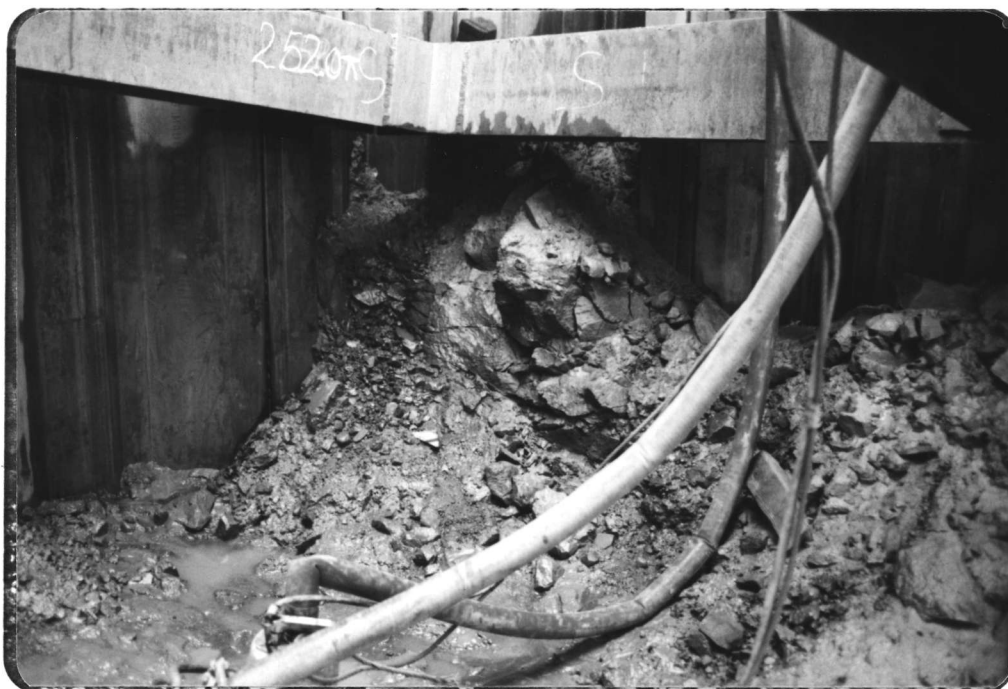
Photo No. 7 - Exposed rock at southeast corner of cell.
Base at approximately elevation 248 feet.

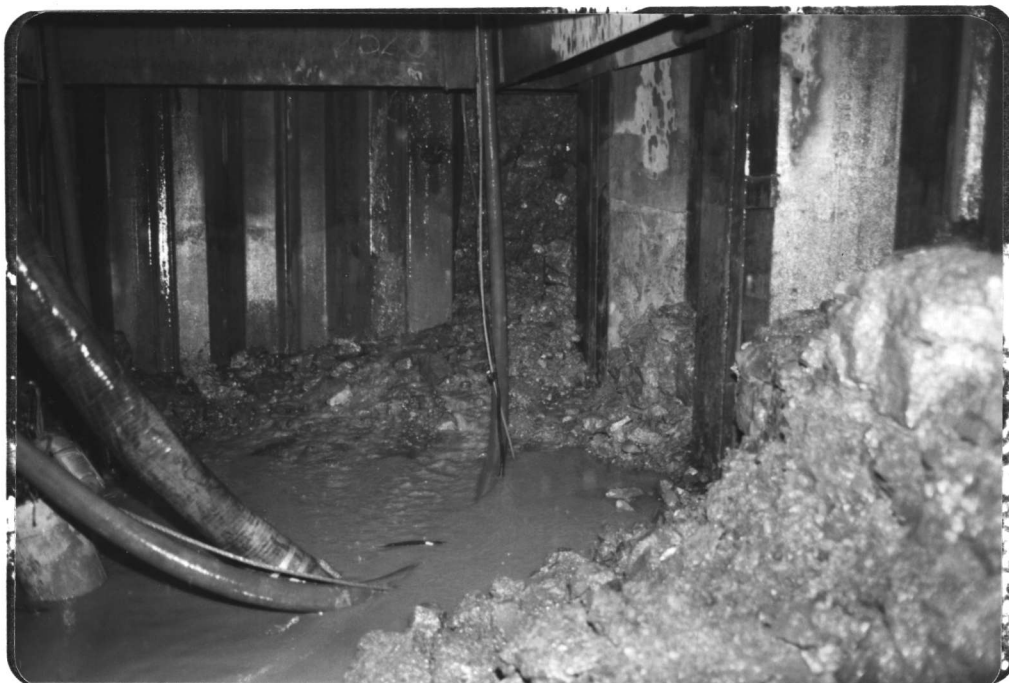
Photo No. 8 - Exposed rock at northeast corner of cell.
Base at approximately elevation 248 feet.
Rock bench in foreground.

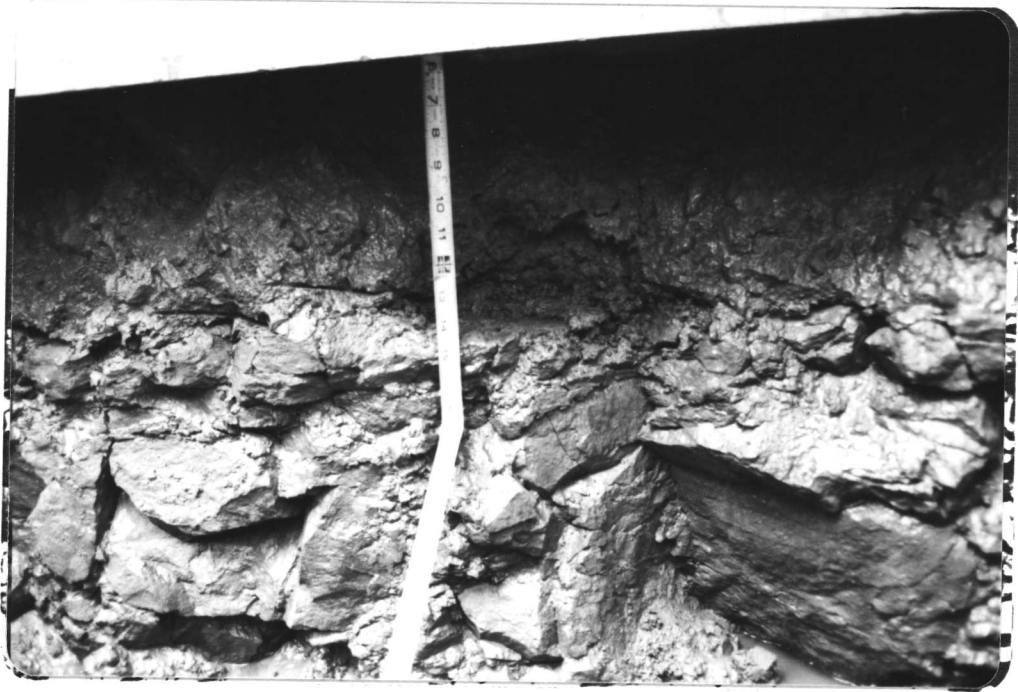
Photo No. 9 - Till overlying rock along south wall. Top of rock at approximately elevation 251 feet.

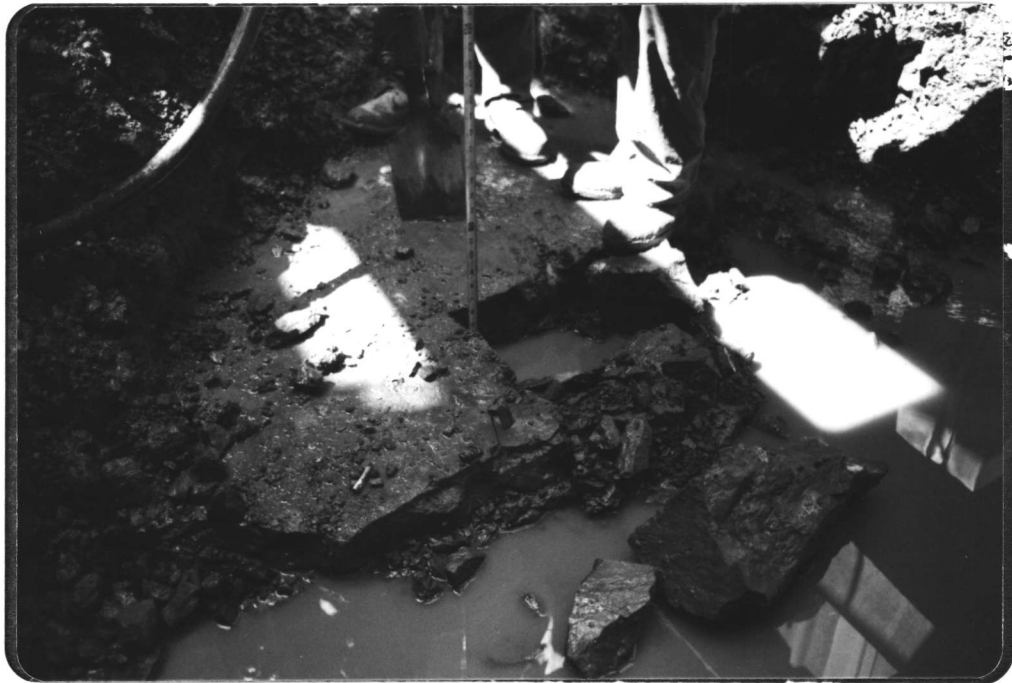
The structure of this rock is blocky, indicative of weathering and construction disturbance. Material exposed by hand excavation maintains integrity as illustrated in Photo No. 10. This rock degrades rather quickly with exposure to air as indicated in the Photos, Nos. 11 to 14 inclusive, which show the exposed bench shortly after dewatering and after approximately 5 hours exposure to air.

Photo No. 10 - Rock being broken up with mechanical spade at northeast quadrant of cell at approximately elevation 248 feet.

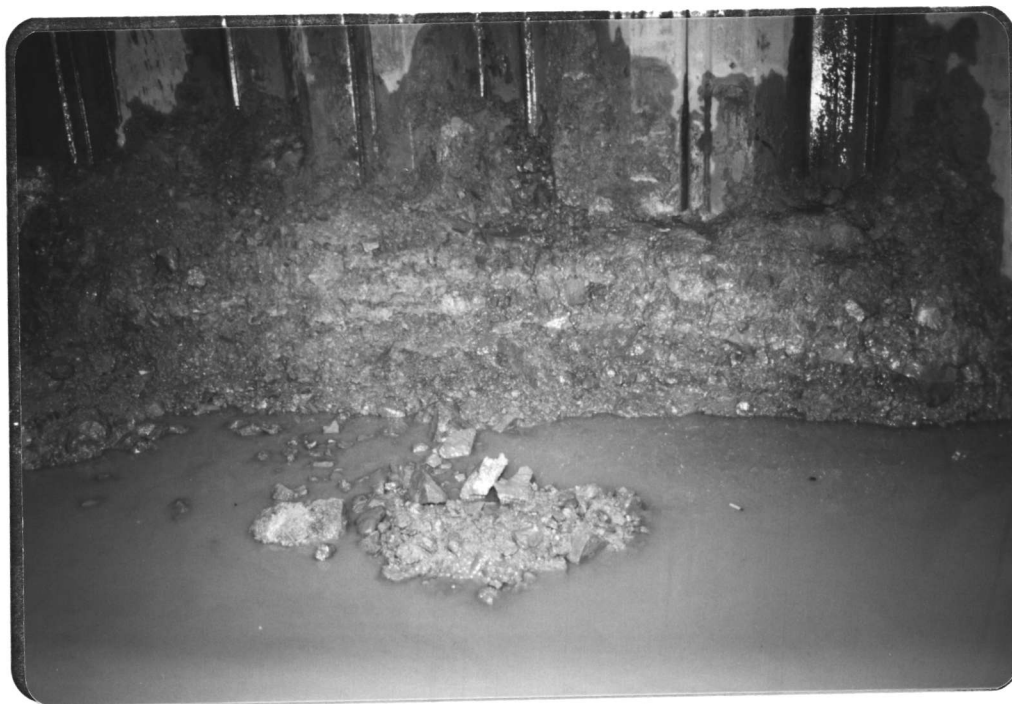
Photo No. 11 - Rock bench along east wall of cell shortly after dewatering. Top at approximately elevation 250 feet.

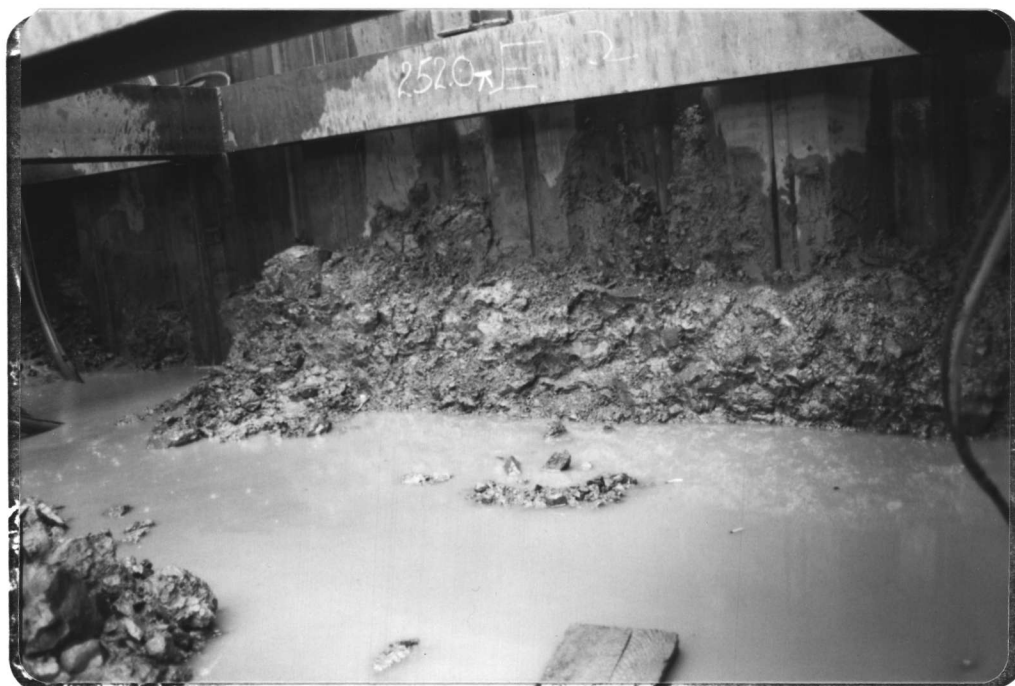
Photo No. 12 - As per Photo No. 11 showing disintegration after several hours exposure to air.

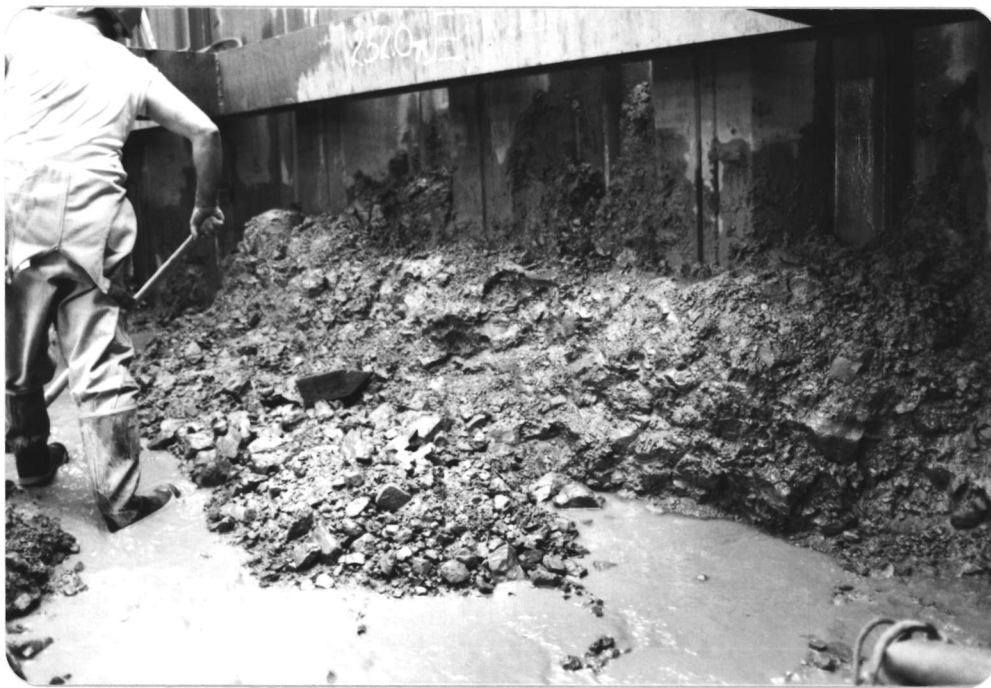
Photo No. 13 - As per Photos, Nos. 11 and 12, showing progressive disintegration after exposure to air.

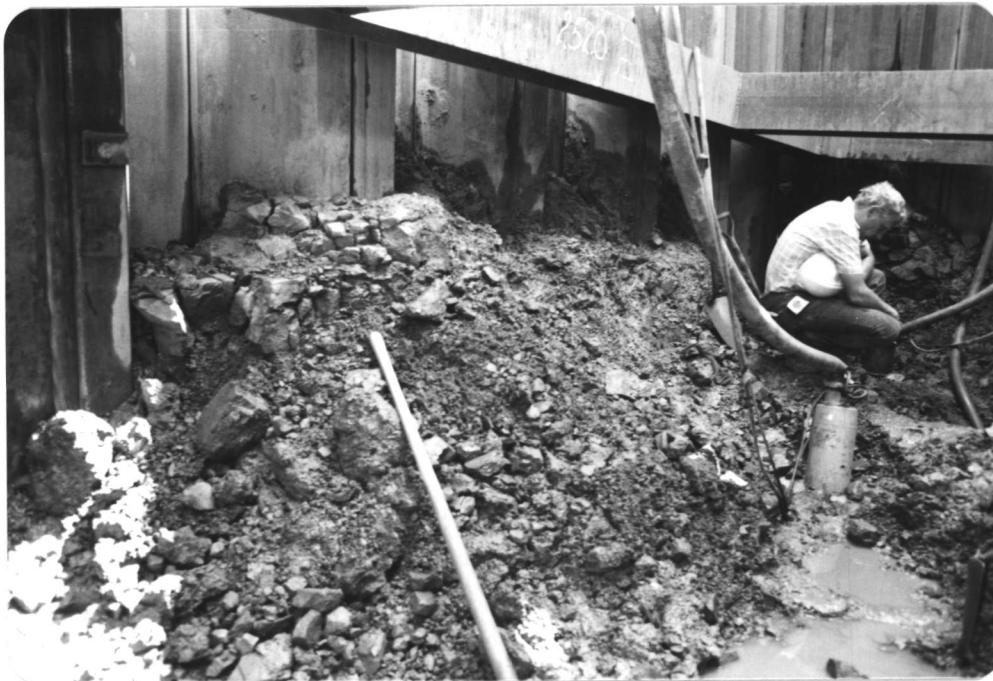
Photo No. 14 - As Photos, Nos. 11, 12 & 13, showing progressive disintegration after exposure to air.

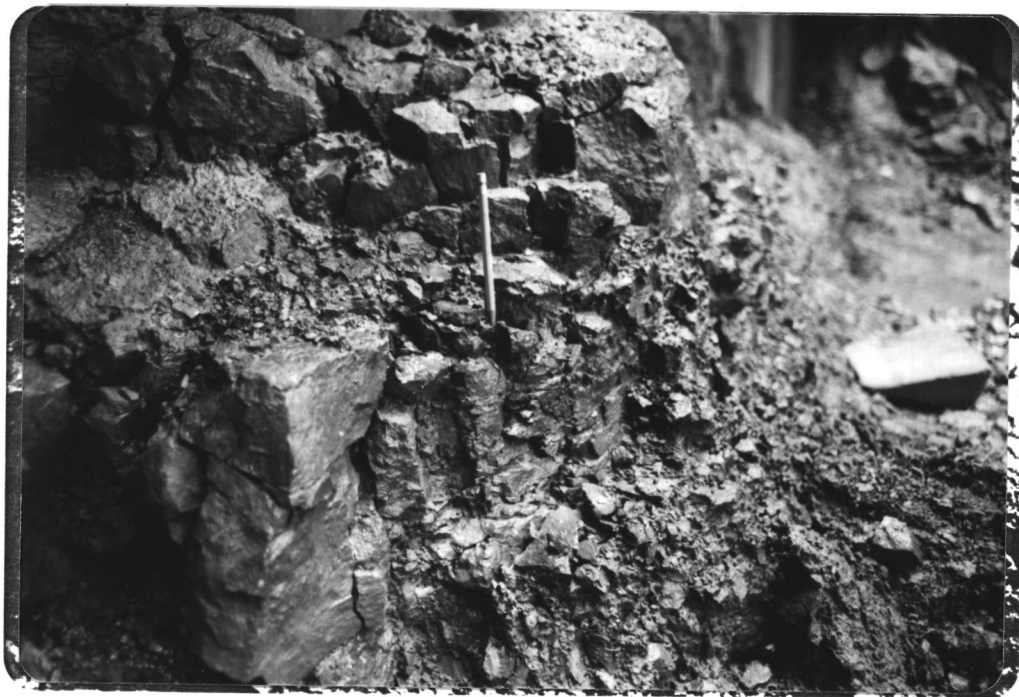
Photo No. 15 - Close up of rock bench along east wall to cell showing thin clay seam at pencil tip.

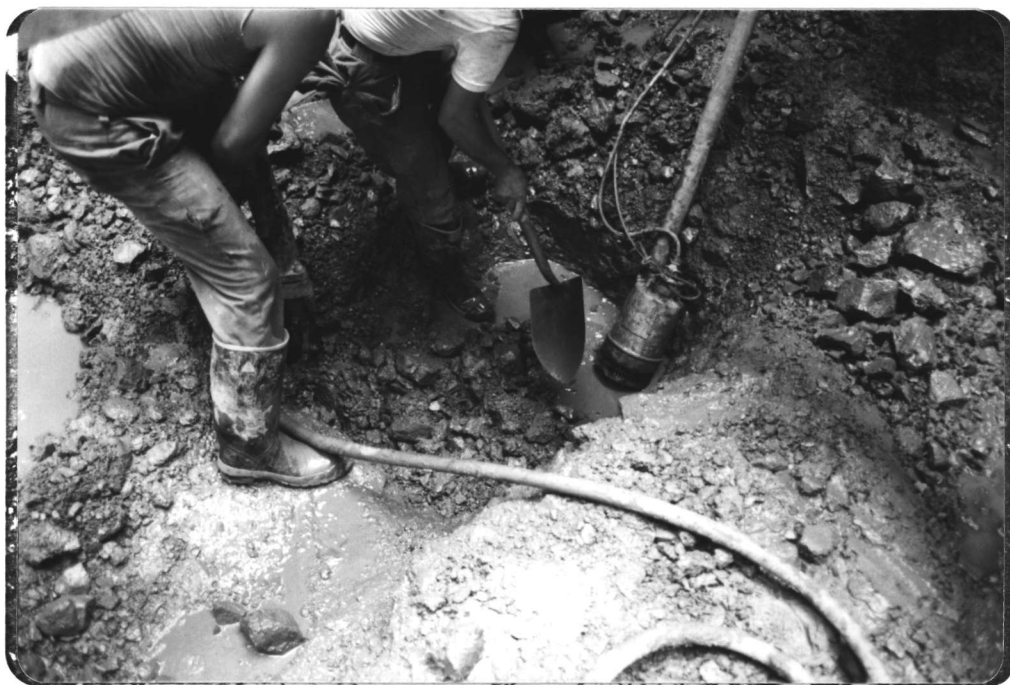
Photo No. 16 - Test pit being excavated by mechanical spade and hand shovelling.

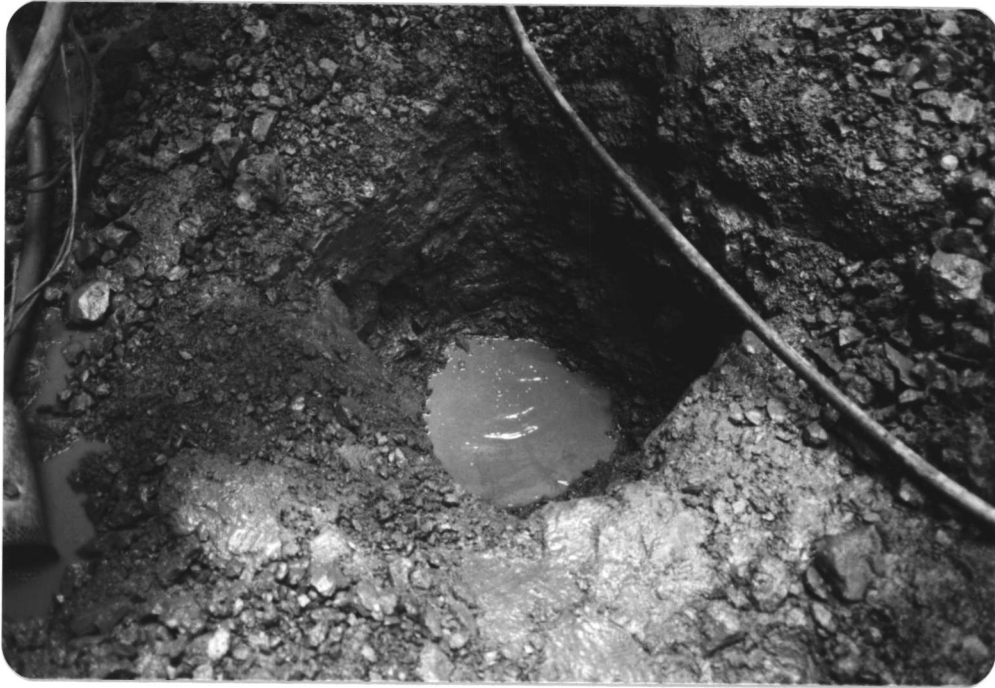
Photo No. 17 - View of test pit excavated to approximately elevation 243 feet.

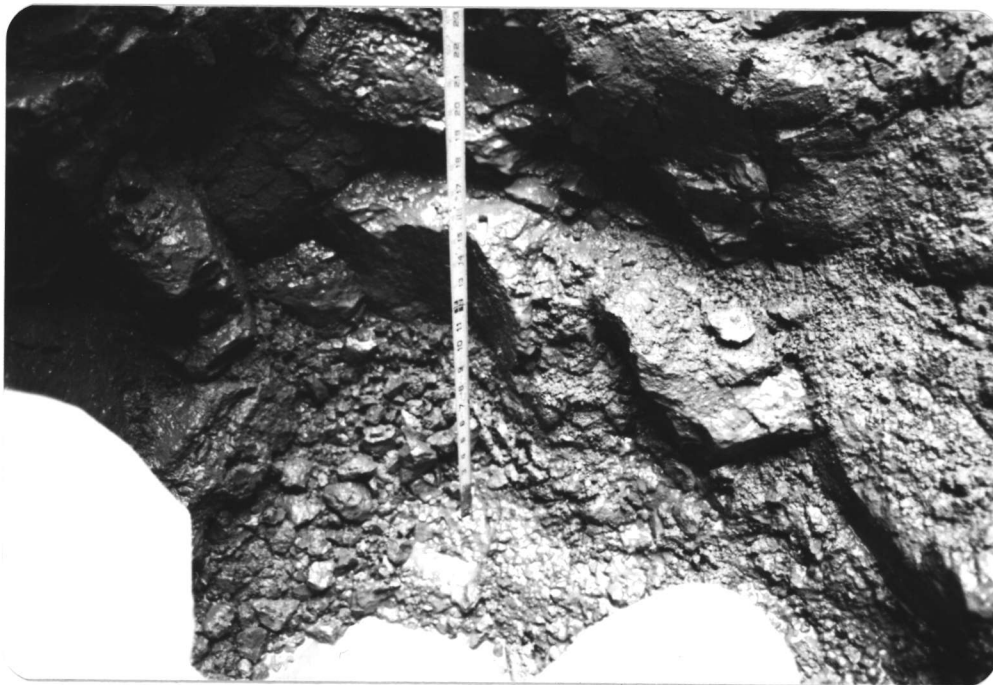
Photo No. 18 - View of north side of test pit from bottom of halfway up. Approximately elevation 246 feet.

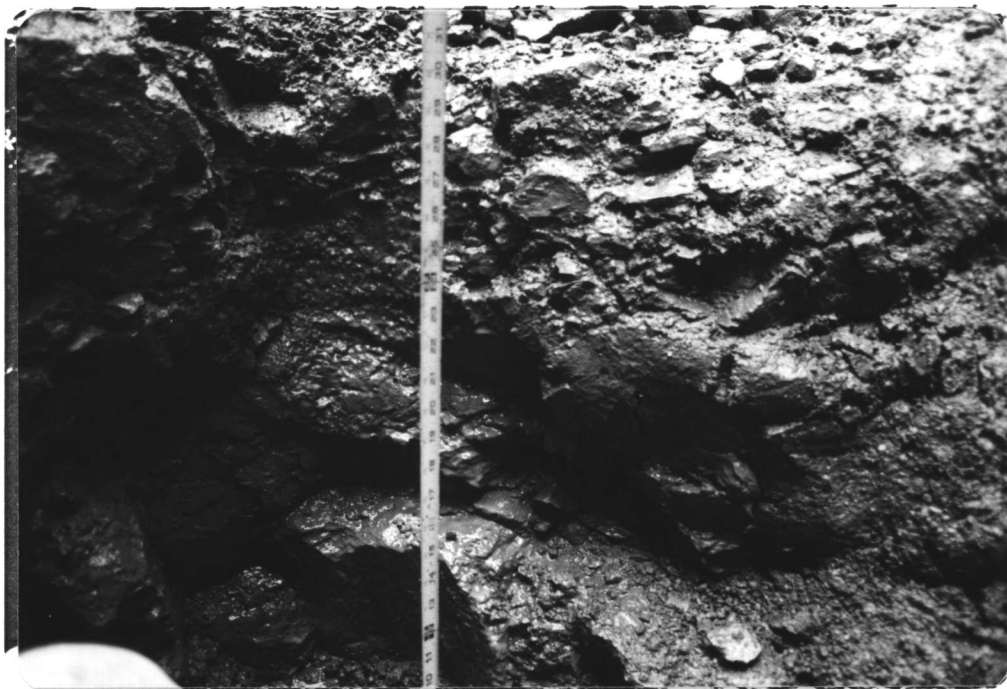
Photo No. 19 - Close-up view of north side of test pit.

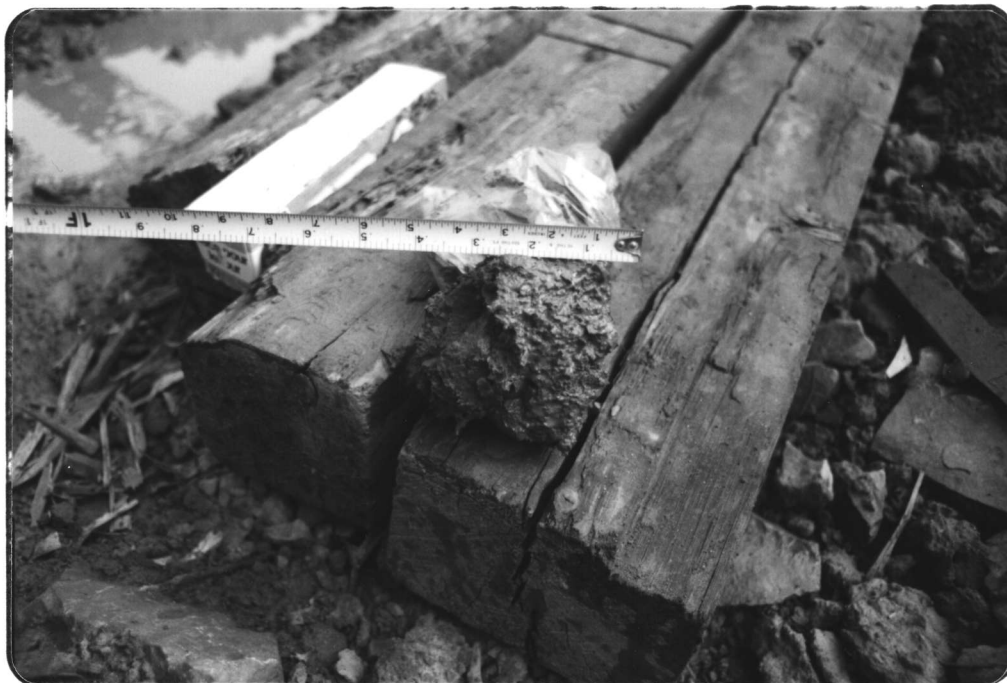
The spaces between some of the blocks of rock were infilled with the reddish silty clay to clayey silt till. A sample of this till was taken from approximately elevation 251 ft. The characteristics are shown in the form of a gradation curve on Drawing No. 6. The material exhibited a low plasticity to feel and is dense, intact and well graded. Photo No. 20 illustrates.

Photo No. 20 - Sample of till taken from south wall
above elevation 251 feet.

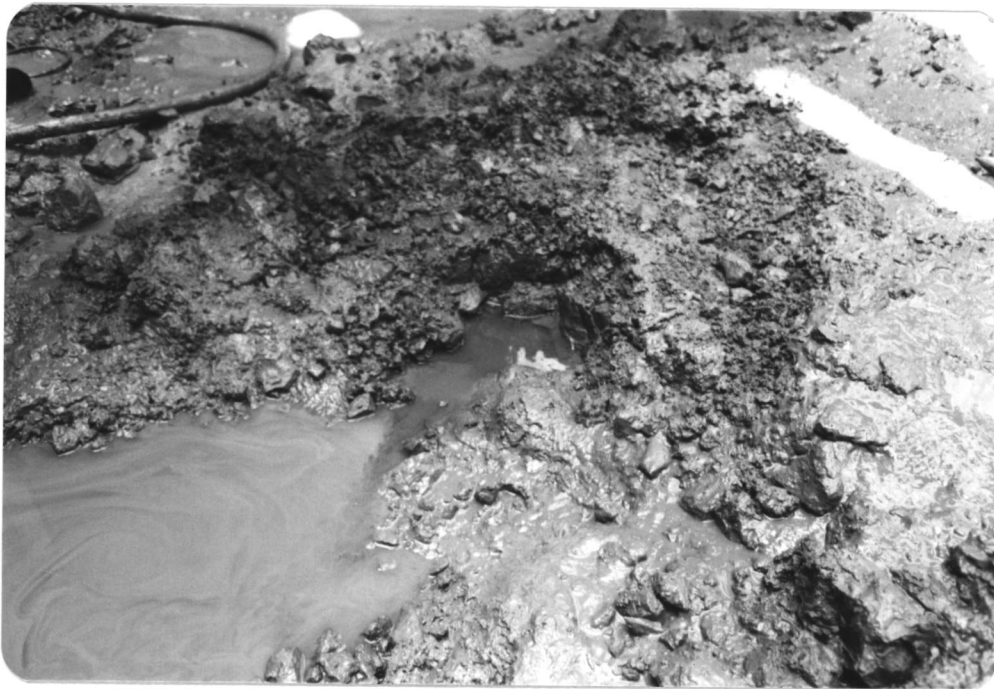
The apparent location of Borehole 42S was encountered in the excavation of the cell with the collar and sides of the borehole intact from approximately elevation 255 ft. (as reported by the Contractor) to elevation 247 ft. The bottom two feet were observed by the undersigned. Should this portion of the borehole have been in till, it is not expected that the borehole would have maintained its integrity since drilling in June of 1978. The swift current at the river surface, together with the upward flow of water from the borehole, would have caused collapse of the portion of the borehole in till. The borehole is able to maintain its integrity due to the surrounding rock. This water flowing out of the borehole does not appear to originate from 12 Mile Creek as evidenced by differences in clarity and temperature.

42 S
Photo No. 21 - Collar of borehole (presumably Borehole, No. 41S) at approximately elevation 248 feet. Note clear water flowing from borehole.

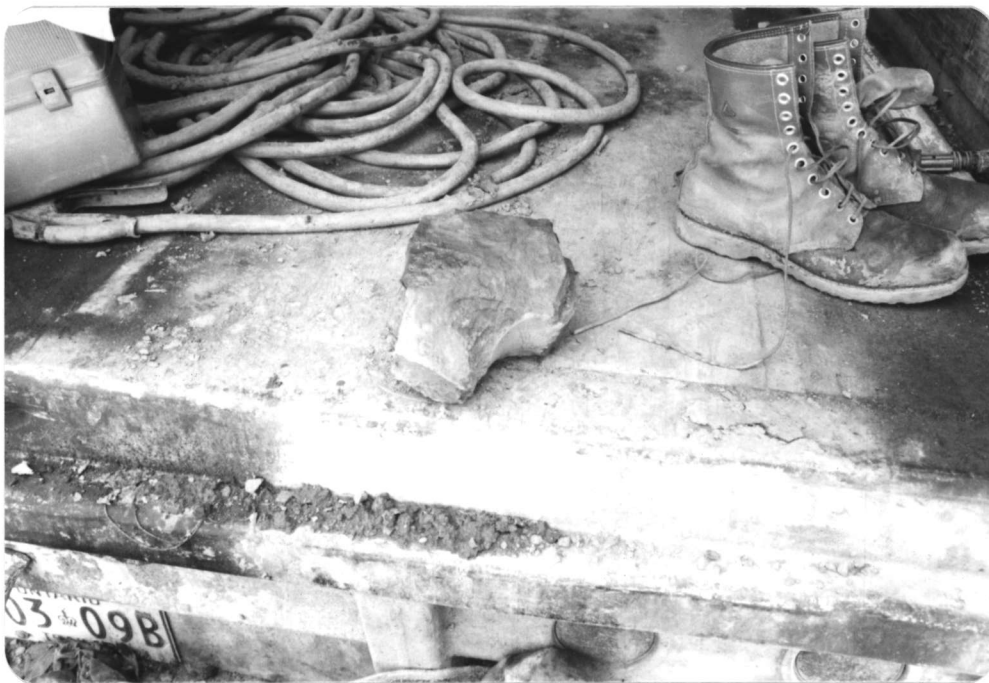
72° F at the same time. The impact of the borehole upon a piece of the weathered shale taken from the elevation 255 ft. by the Contractor is shown in Photo No. 22.

Photo No. 22 - Rock fragment taken by contractor at approximately elevation 255 feet showing borehole edge.
