## THOROLD TUNNEL

Investigations to Determine the  
Cause of Cracking in the Structure

March 1972

Thorold Tunnel  
Investigations to Determine  
the Cause of Cracking

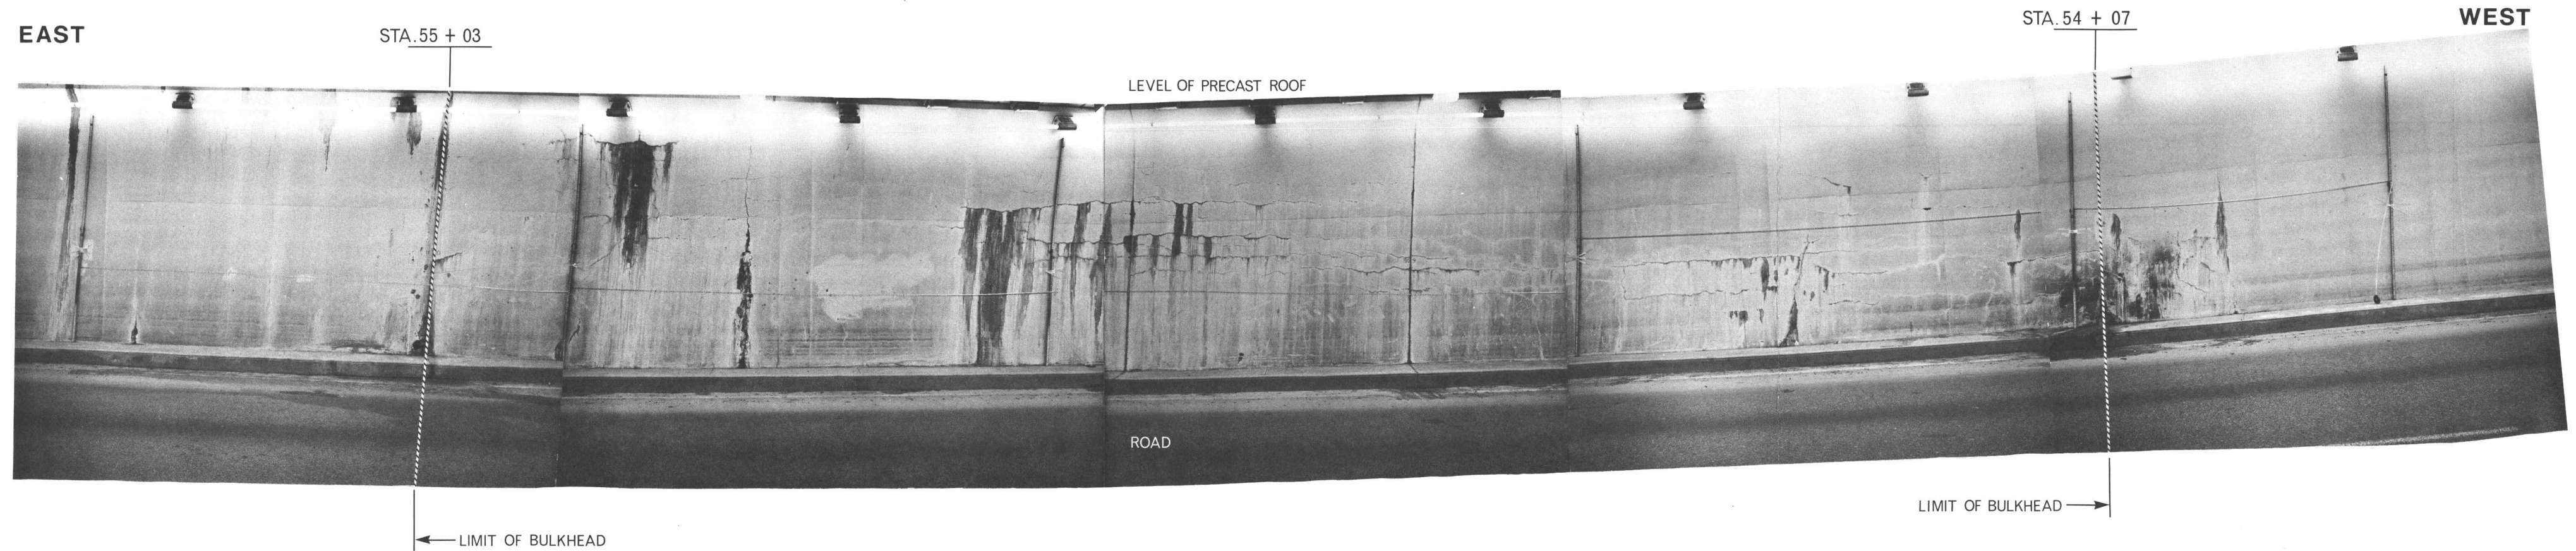
<b>ACRES</b>	DEPARTMENT OF TRANSPORTATION AND COMMUNICATIONS	
	THOROLD TUNNEL STRUCTURAL INVESTIGATIONS	
WEST SERVICE BUILDING VIEW OF SOUTH TUNNEL WALL		
<i>[Signature]</i> ACRES CONSULTING SERVICES LIMITED	FEBRUARY 1972	PLATE 1

Cracking has been observed in the tunnel walls over a period of time, particularly in the outside walls of the tunnel beneath the west service building. Minor horizontal cracking in the walls was noted shortly after the west service building was completed in 1967, and the number and extent of open cracks at that location has increased steadily since. Following an inspection of the cracking at the west service building in May 1971, shown on Plate 1, the Department of Transportation and Communications instructed Acres, by letter dated June 15, 1971, to proceed with investigations to determine the cause of the cracking, and to photograph and map periodically cracked areas elsewhere in the tunnel. The results of the investigations are described in this report.

The investigations had, as a primary objective, the determination of the cause of the cracking observed in the south wall of the tunnel beneath the west service building. In conjunction with this, an assessment was made of the effects of the cracking on the structural integrity of the west service building, and any implications regarding the safety of both west and east service buildings.

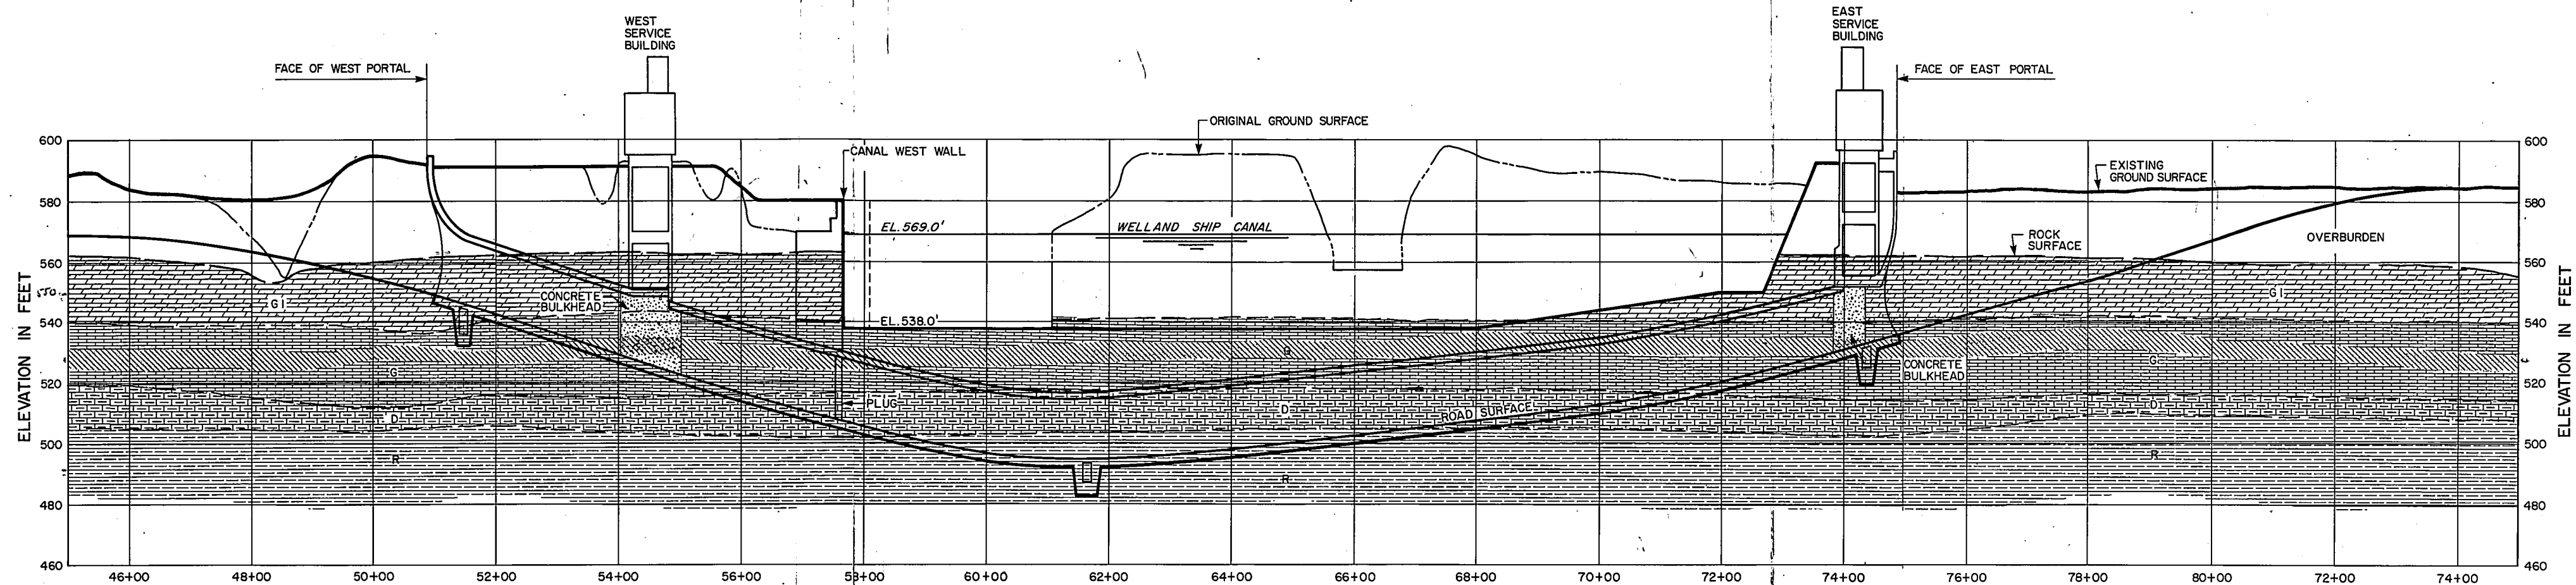
GEOLOGICAL PROFILE ALONG TUNNEL CENTRE LINE

Geological conditions at the tunnel are shown on Plate 3. The tunnel is founded in rock of Middle Silurian age overlain by overburden varying in thickness between 8 and 30 feet. The overburden consists of silty clay of glaciolacustrine origin over a thin layer of silty till. The

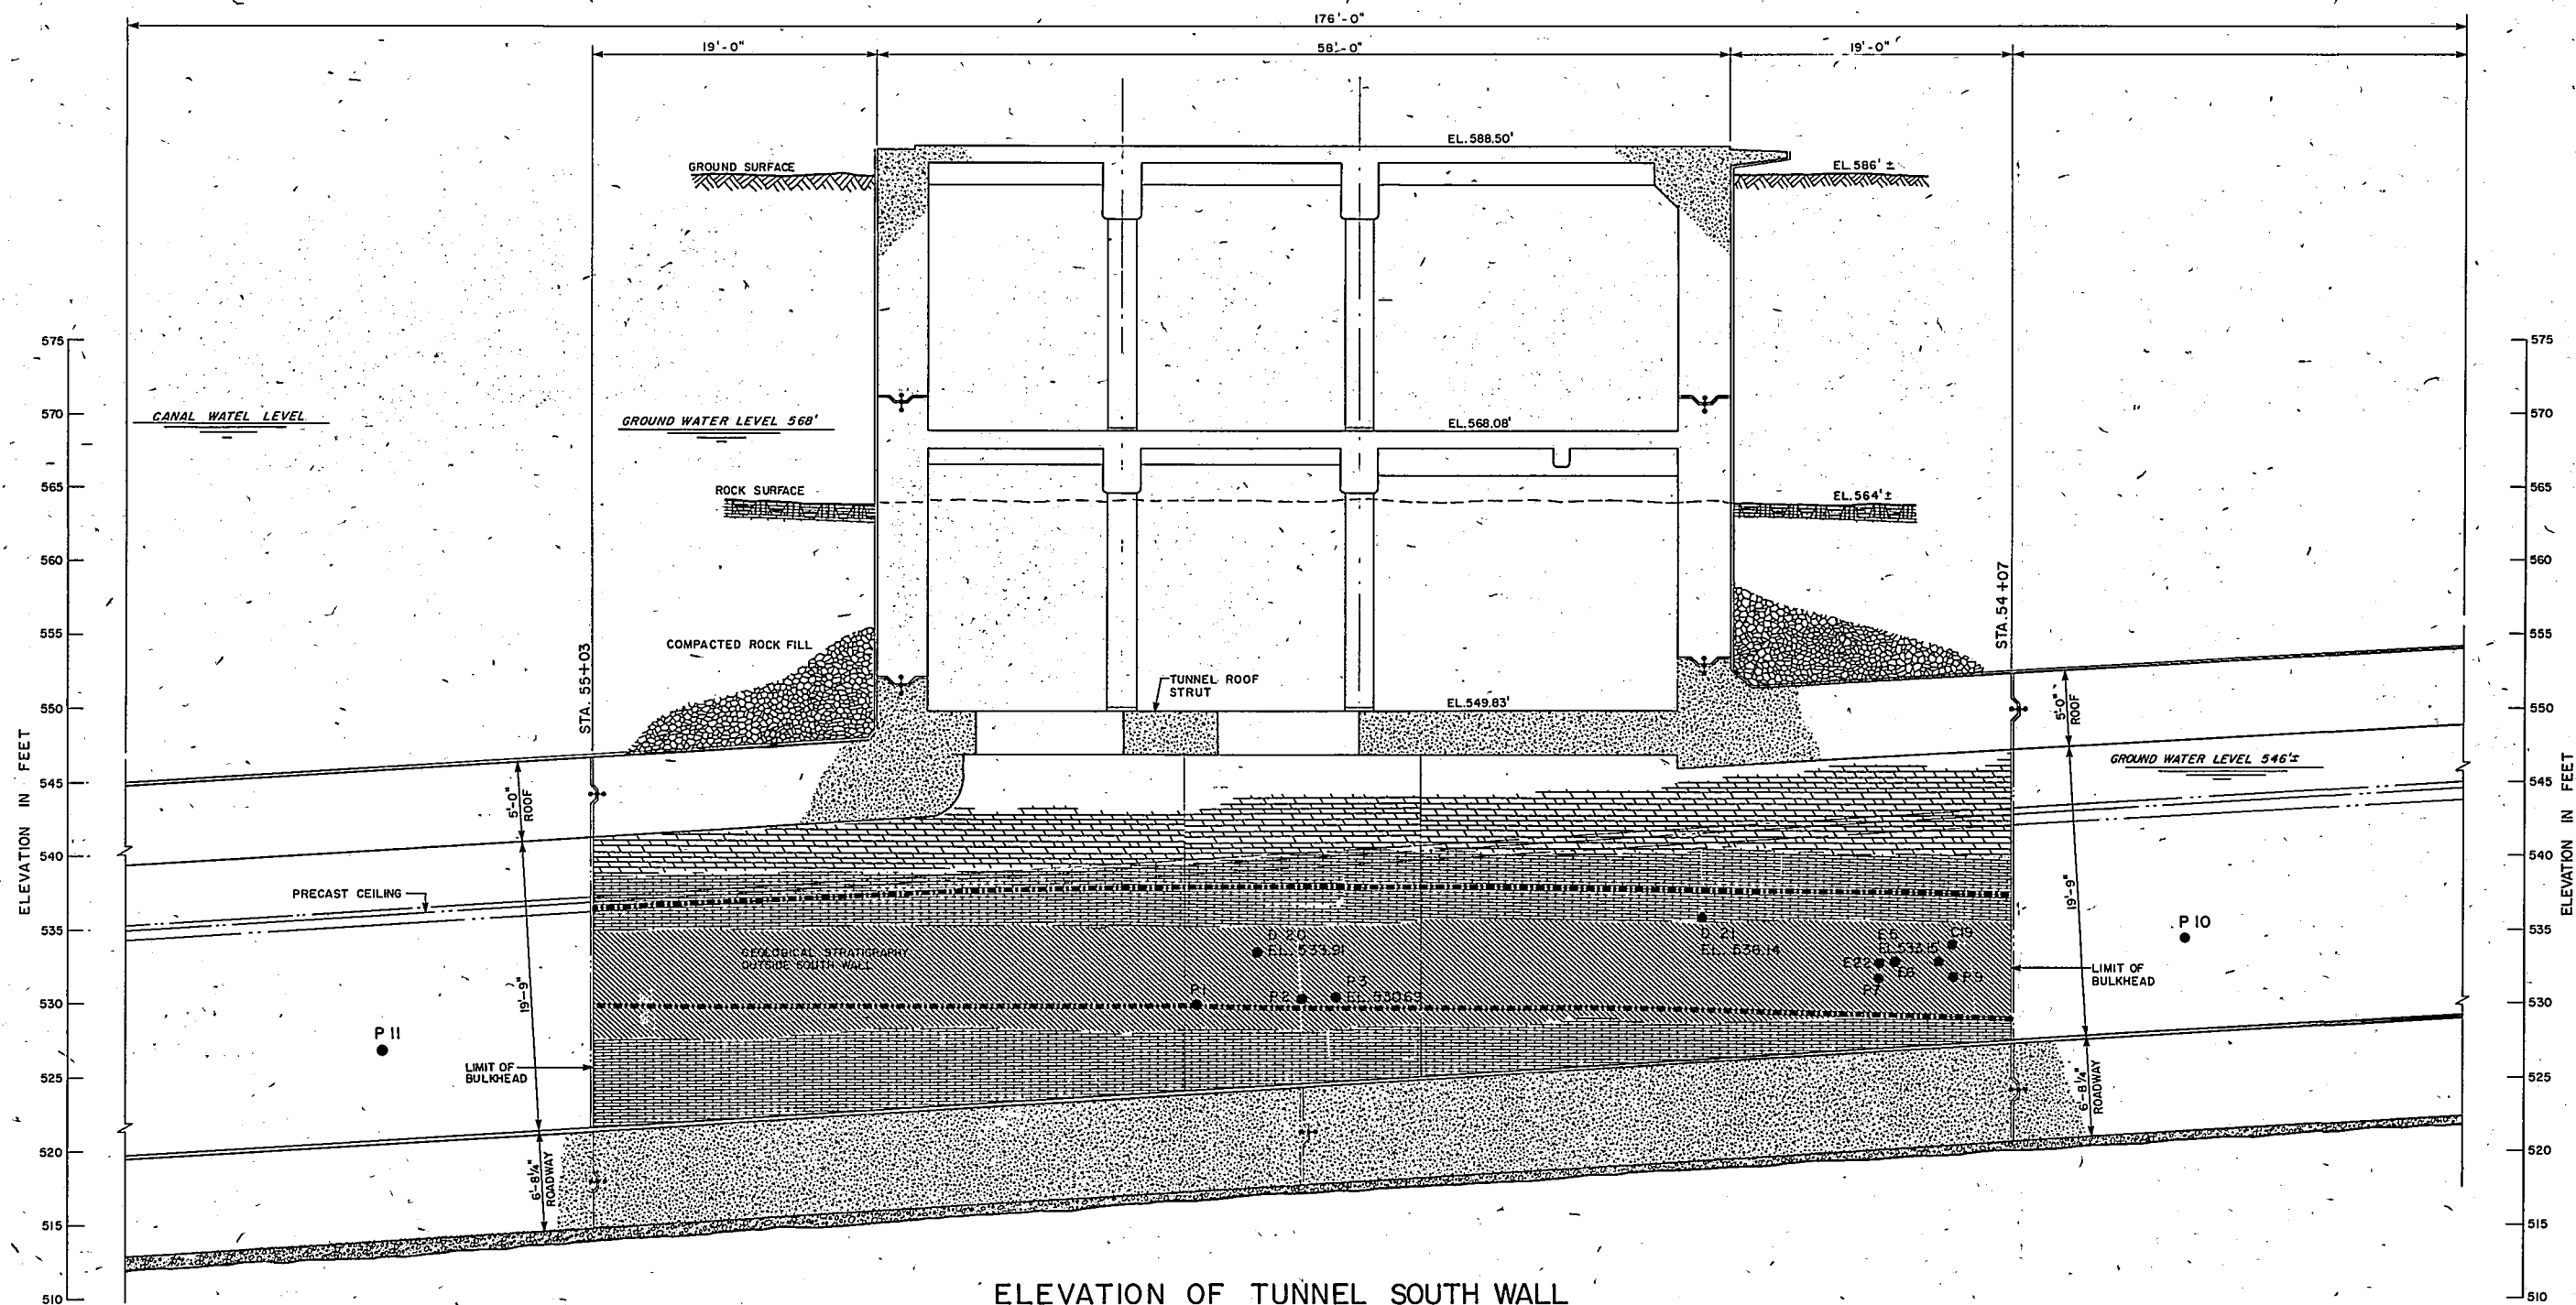
<b>ACRES</b>	DEPARTMENT OF TRANSPORTATION AND COMMUNICATIONS	
	THOROLD TUNNEL STRUCTURAL INVESTIGATIONS	
<b>WEST SERVICE BUILDING FIELD INVESTIGATIONS</b>		
 ACRES CONSULTING SERVICES LIMITED		FEBRUARY 1972 <b>PLATE 4</b>

- (a) - Nowhere in the holes drilled did the piezometric levels exceed the hydrostatic pressures equivalent to canal water level for which the tunnel was designed.
- (b) - At both the bentonite panel/tunnel wall and the concrete bulkhead/rock interfaces, piezometric levels decrease approximately linearly from east to west, indicating a normal flow pattern for the ground water. The piezometric level in the rock, as determined in hole P1, elevation 564.5 feet, is in agreement with that observed during construction, prior to the blanket grouting.
- (c) - During drilling of some of the holes it was noted that seepage from the visible cracks increased. As the drill water pressure was initially as high as 200 psi, it was concluded

that this water was connecting to the crack planes within the tunnel wall. The increased seepage ceased as soon as the drilling stopped.

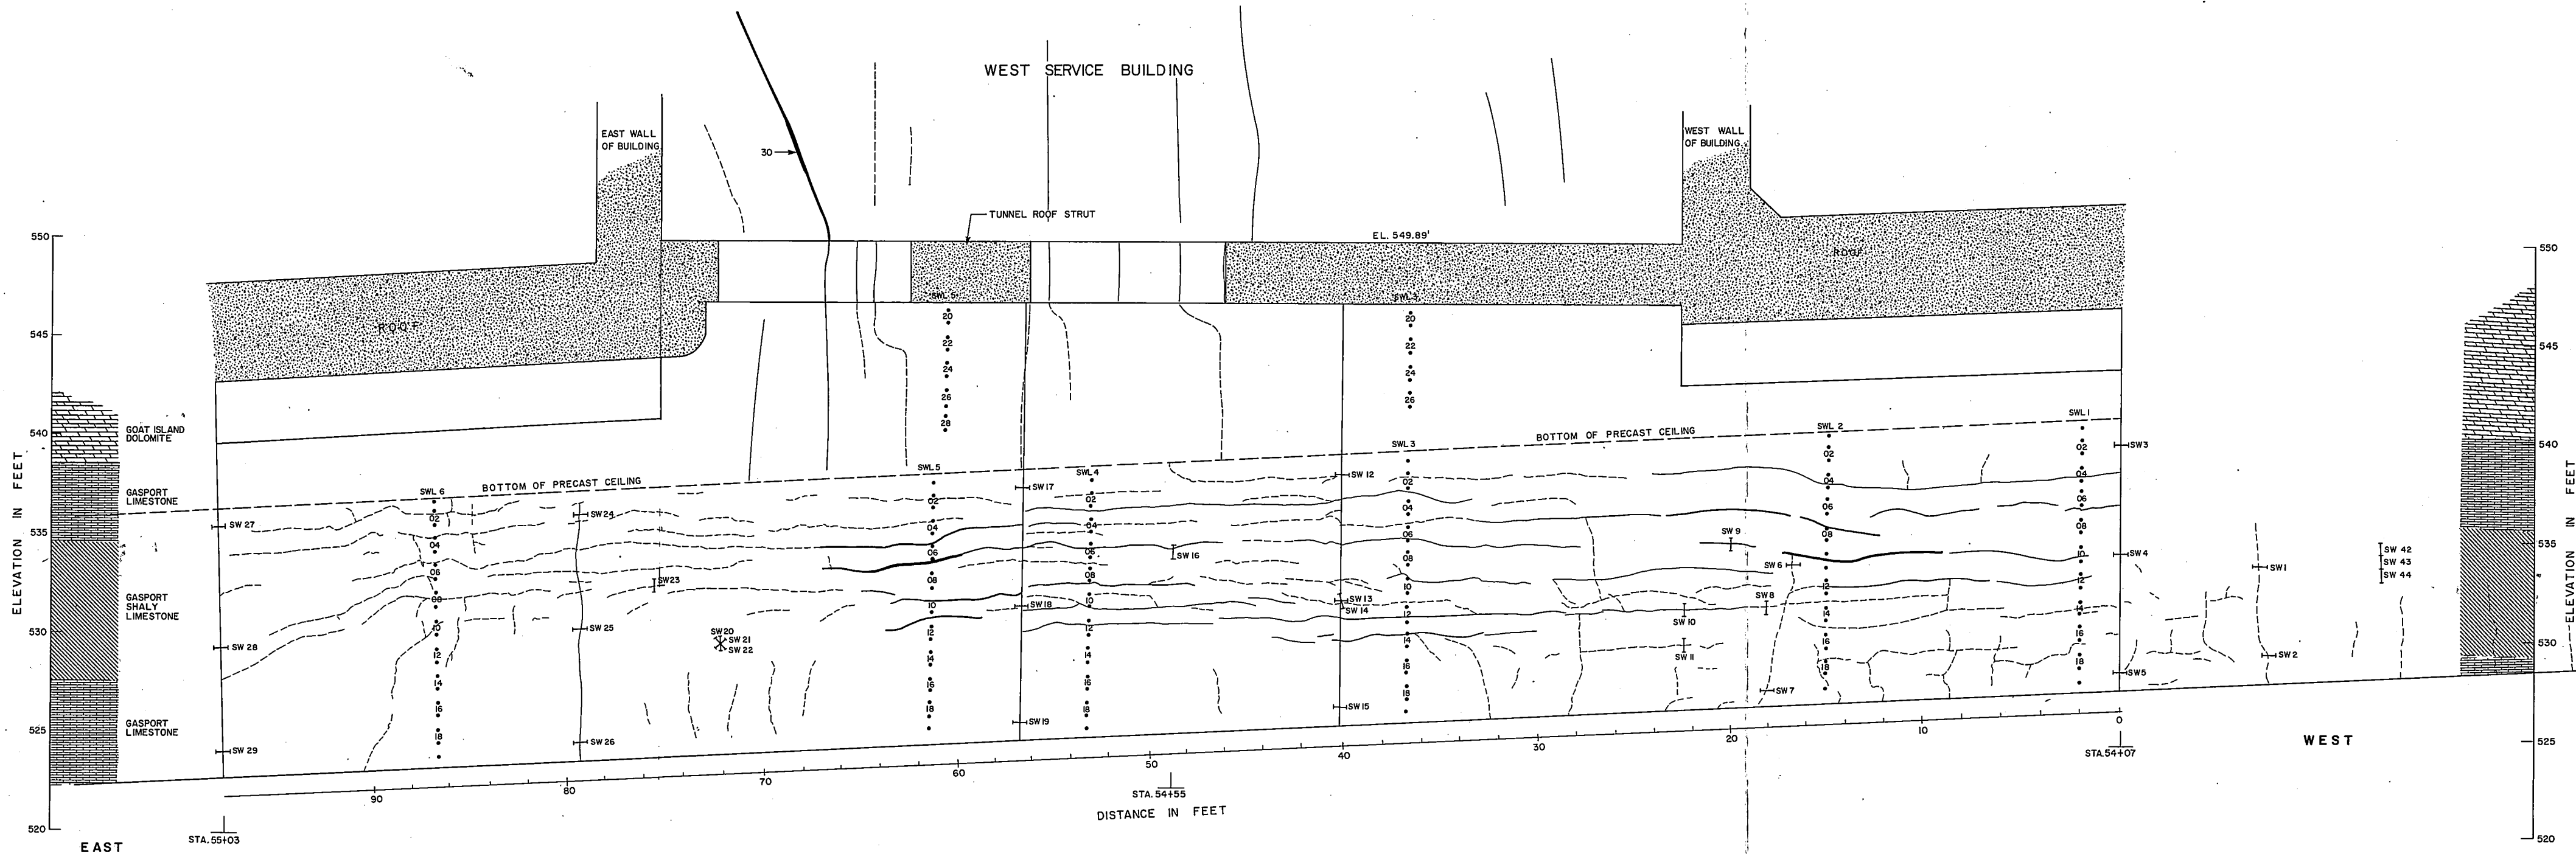
DEPARTMENT OF TRANSPORTATION AND COMMUNICATIONS THOROLD TUNNEL STRUCTURAL INVESTIGATIONS	
	WEST SERVICE BUILDING PATTERN OF CRACKING SOUTH WALL	
	FEBRUARY 1972	PLATE 5

The cracks mapped in the south wall of the tunnel under the west service building are shown in elevation on Plate 5. The trend of the cracking is essentially horizontal rather than parallel to the road surface and is confined to a relatively narrow band. Although attempts were made in the drilling program to follow individual cracks through the wall, they were unsuccessful. However, in a number of drill holes, cracks were intersected at depths up to 3 feet 6 inches from the face of the tunnel wall, and from these it was concluded that the cracked planes were within plus or minus 5 degrees of the horizontal.

To monitor variation in crack widths in the tunnel wall, a series of surface studs was installed and deformations measured by means of a Demec mechanical strain gauge. Results to date indicate that the crack widths are affected by atmospheric temperature changes in the tunnel, with daily variations indicating expansion and contraction of the surface of the tunnel wall, and a seasonal variation indicating that the cracks in the wall are tending to close up in the winter.

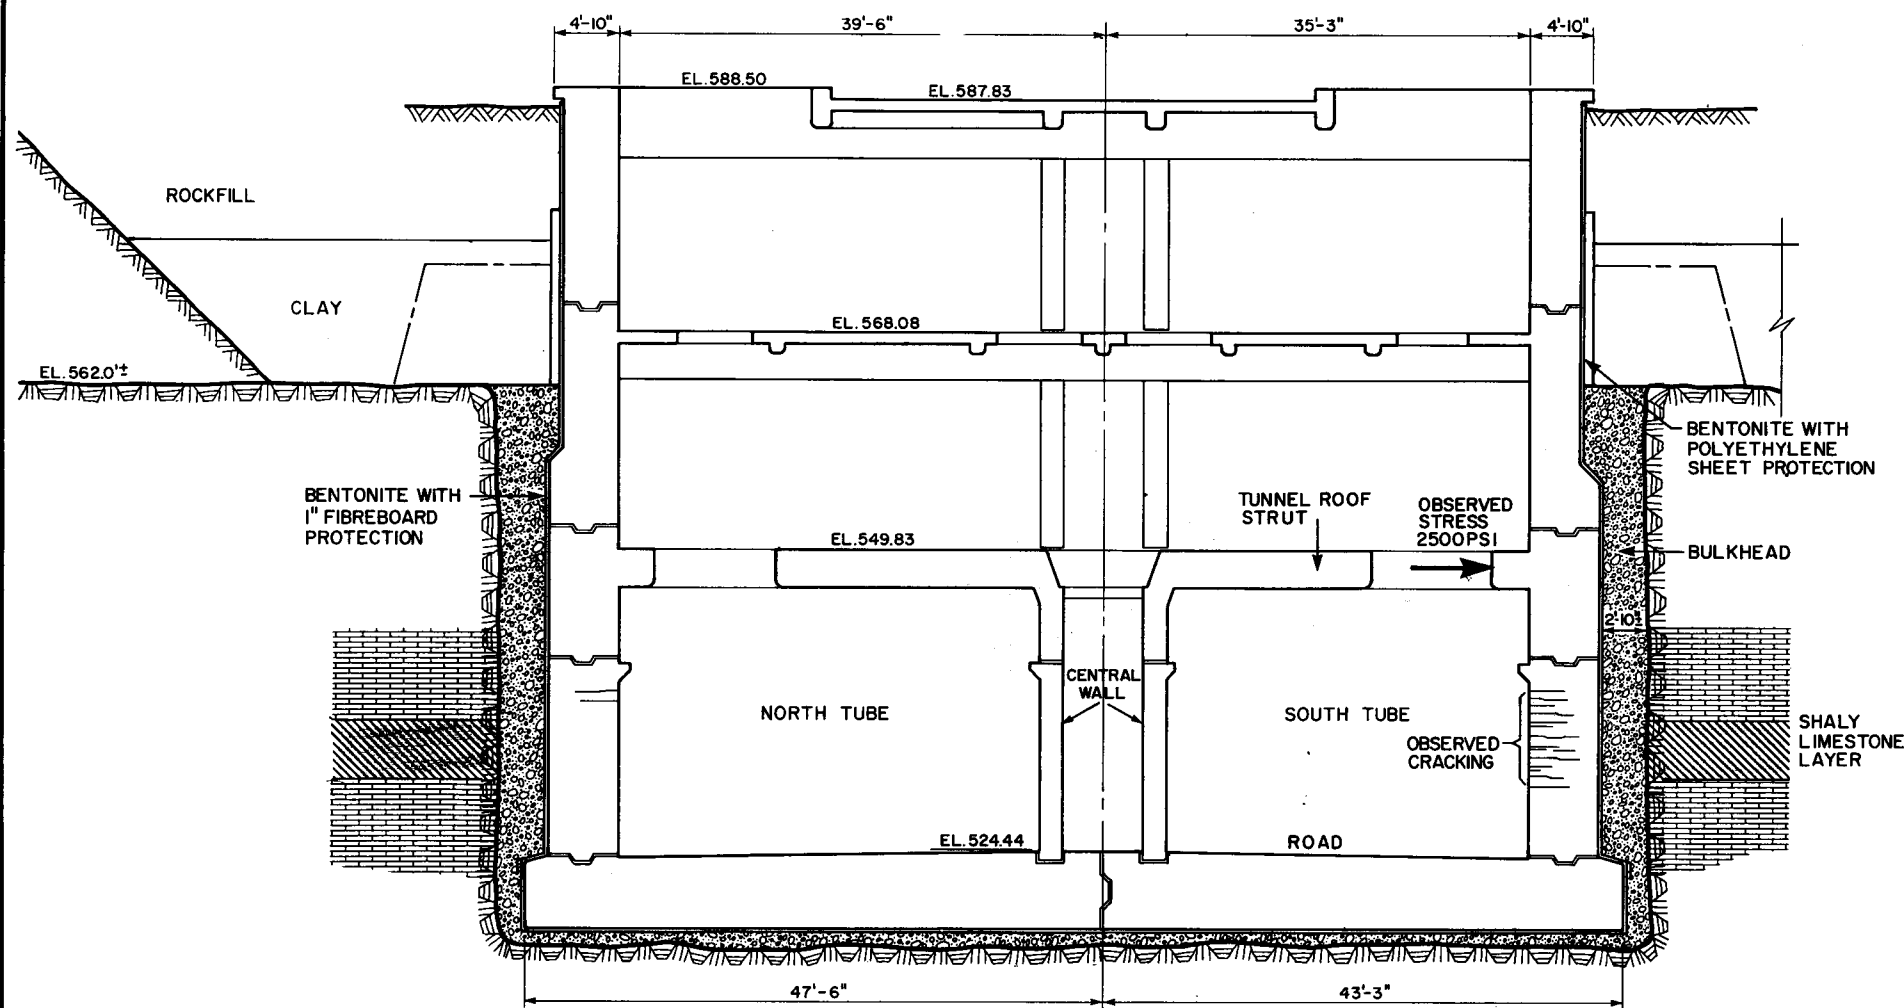
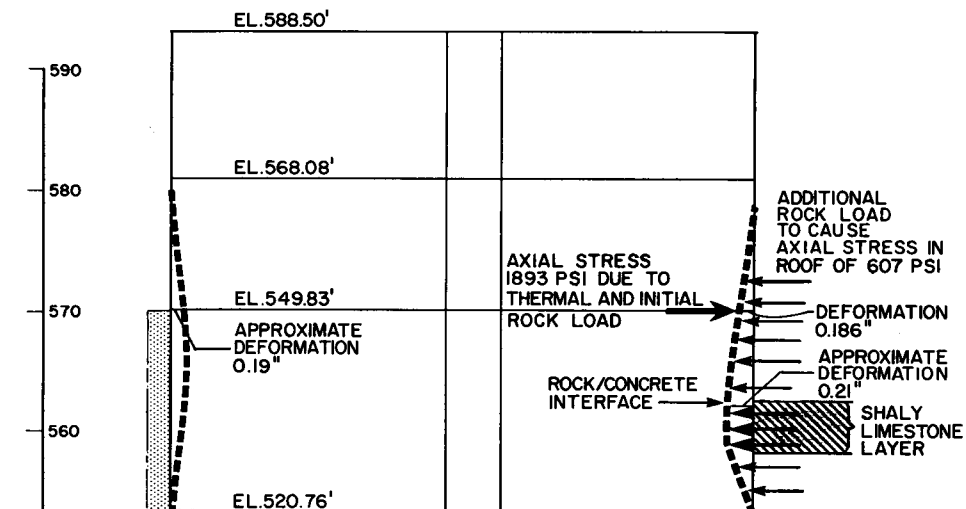
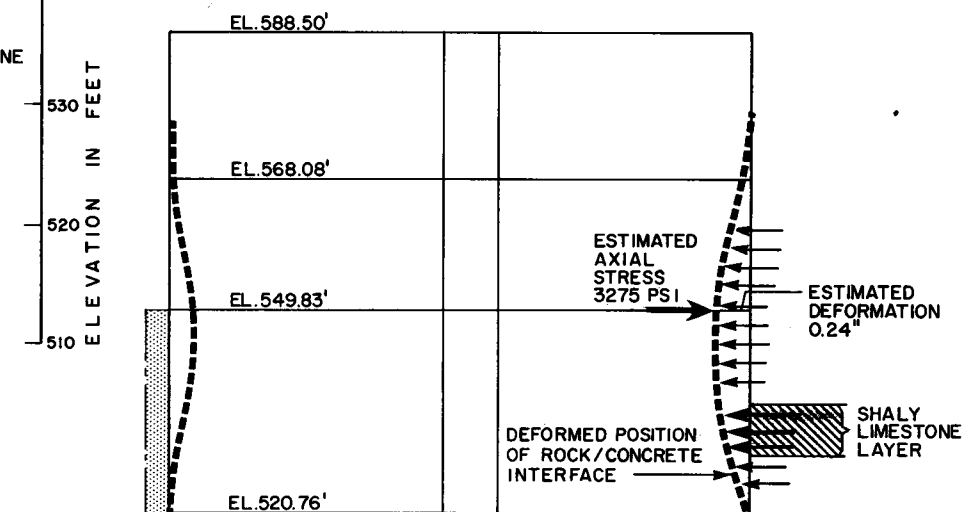
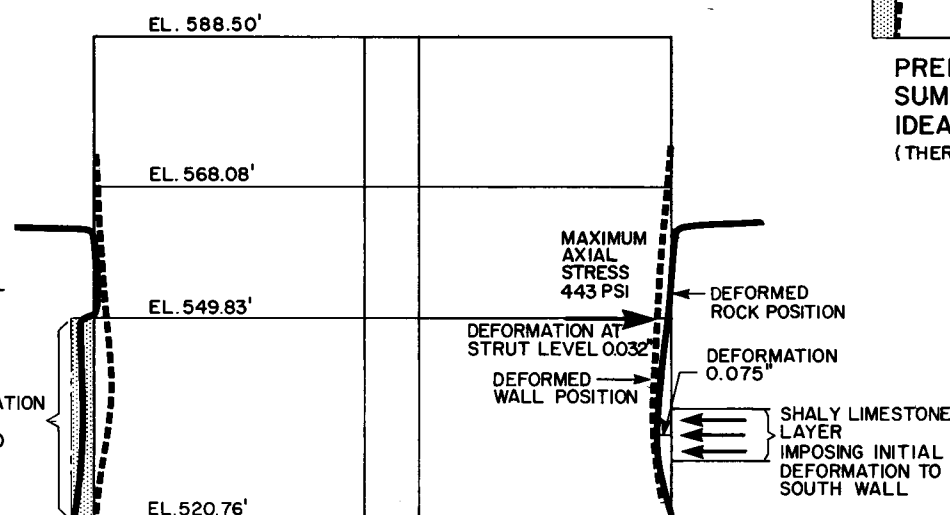
CROSS SECTION OF WEST SERVICE BUILDING - STA. 54 + 65

- (b) - The horizontal cracking is caused by a horizontal deformation imposed on the wall of the structure by rock squeeze, associated with relief of in situ stresses in the rock due to excavation for the tunnel. At the west service building an initial deformation was imposed on the tunnel wall by one particular stratum in the bedrock, namely, a shaly limestone layer of the Gasport formation lying at about elevation 530 feet. Deformations imposed on the west service building at the time of the field investigation result from rock squeeze occurring throughout the full depth of the rock cut.

Inspection of the pattern of cracking and the measured stress distribution indicates that the walls of the structure must be subjected to a severe external loading, causing bending in the wall and resulting in high axial loads in the floor, and particularly the roof of the tunnel. No other loading configuration could be developed to fit the observed conditions.

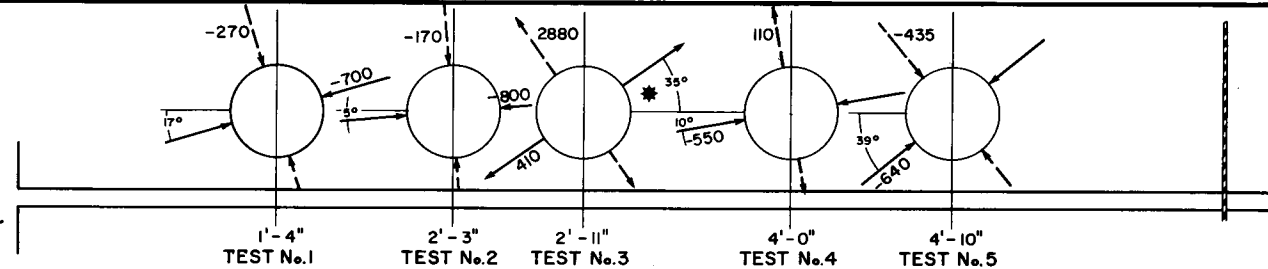
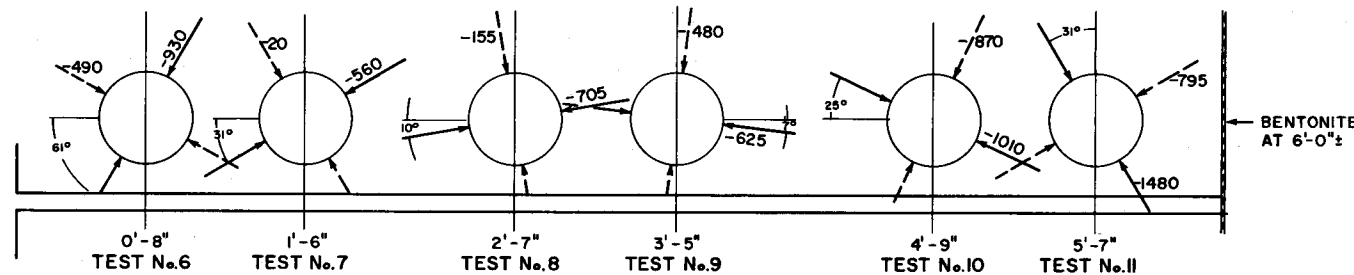
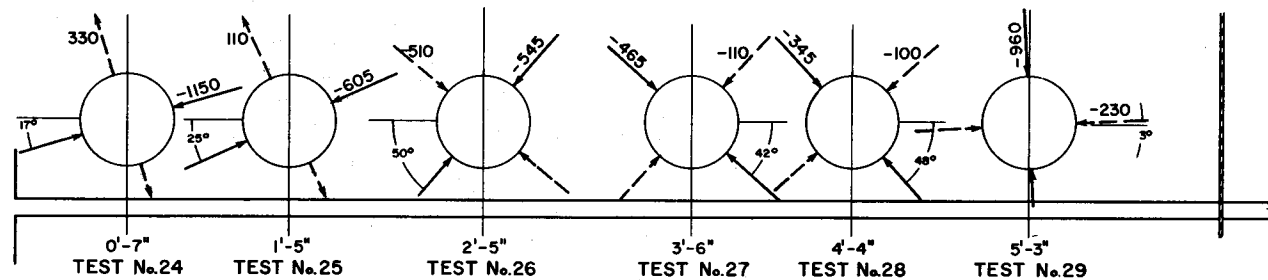
Two test holes in the south wall of the tunnel at the west service building indicated that, despite possible local anomalies due to inaccuracies inherent in using the overcoring method on cracked concrete, vertical stresses in the wall vary from compression at the rear face to tension at the front face. These results are consistent with bending of the wall under an external horizontal load. Axial stresses in the tunnel floor and roof are consistent with the performance of these members as struts, supporting a side load applied to the tunnel wall.

In summary, the stress measurements indicated that the tunnel walls in the bulkhead areas are in bending due to the application of some external load, acting across the tunnel. This load is probably transmitted axially through both the roadway and roof slabs.

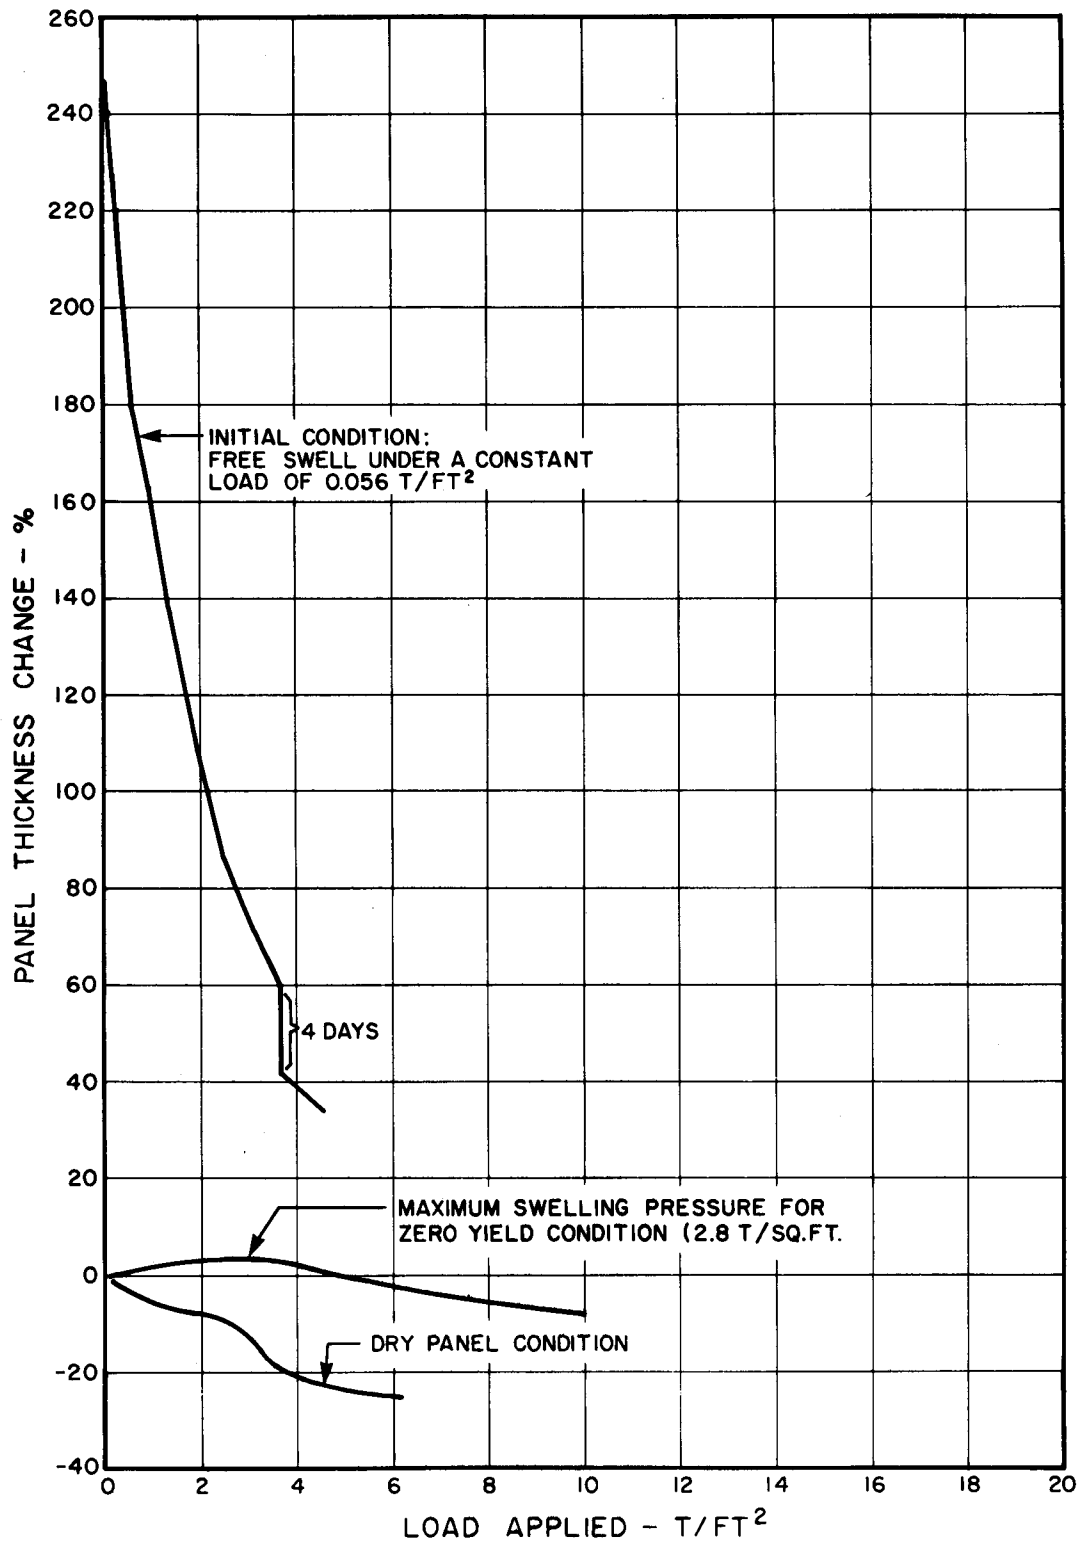
ACRES	DEPARTMENT OF TRANSPORTATION AND COMMUNICATIONS	
	THOROLD TUNNEL STRUCTURAL INVESTIGATIONS	
EXPERIMENTAL RESULTS FOR LOAD TESTING OF "VOLCLAY" BENTONITE PANEL		
 ACRES CONSULTING SERVICES LIMITED		FEBRUARY 1972 PLATE <b>B-1</b>

It was concluded that active pressure exerted by bentonite swelling due to action of water is a maximum of 2.8 tons per sq ft, and that passive pressure to cause bentonite to consolidate is a maximum of 6 tons per sq ft.

Tests performed by Acres, using 3-inch diameter samples, indicate that the maximum swelling pressure is 39 psi at 84 hours. The moisture content of the bentonite, once equilibrium had been reached, was 78 per cent, see Plate B-1.

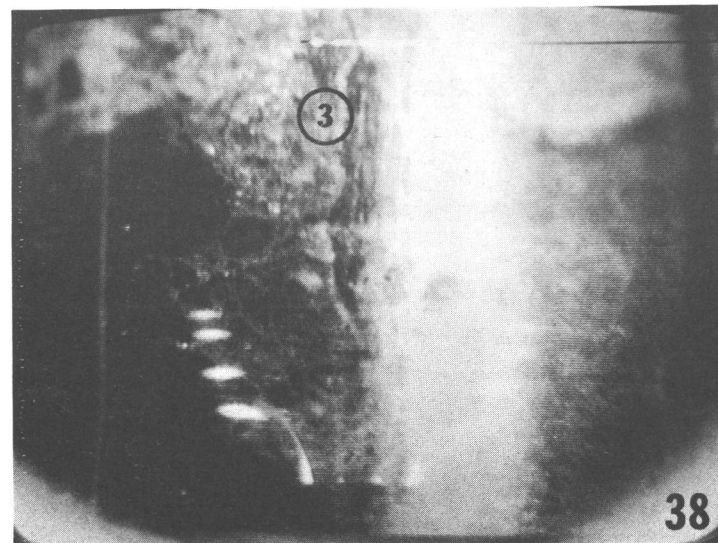
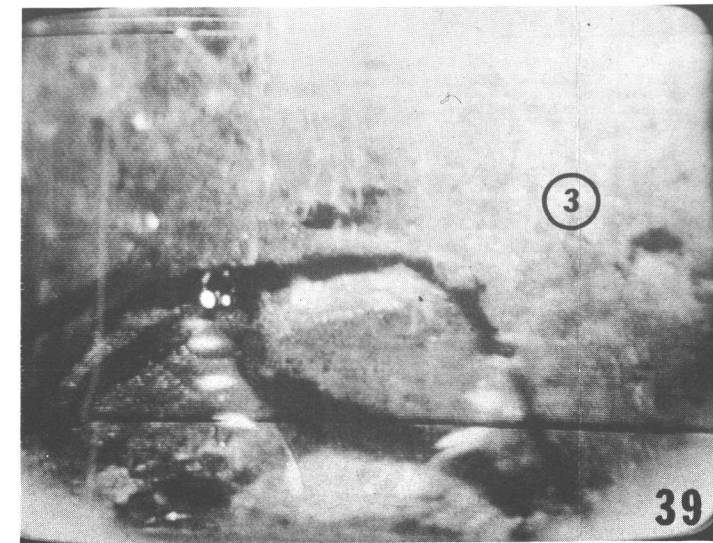
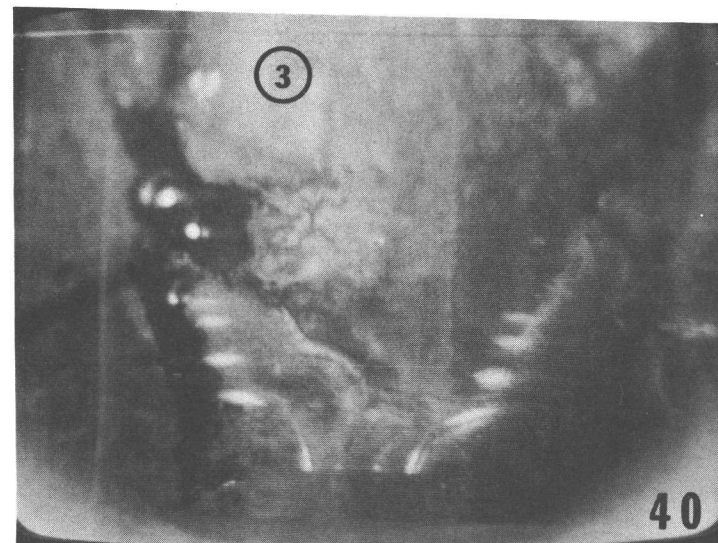
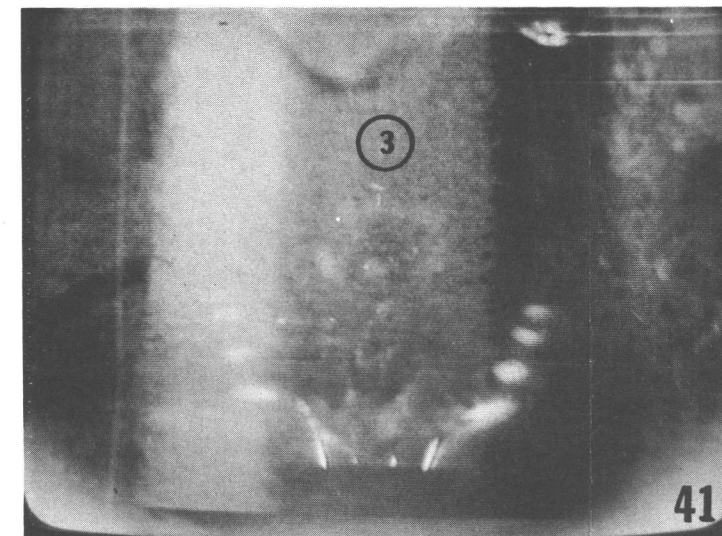
OBSERVED CRACKS IN D20  
INCLINATION + 26°

In the south wall of the tunnel at the west service building, cracks were intersected in a number of drill holes. A visual inspection of these holes, using the Ontario Hydro borehole television camera, confirmed the existence of cracks to a considerable depth. In the case of hole OC14 cracks were visible, using the above equipment, to a depth of 3 feet 6 inches from the face of the tunnel. The inclination of the crack was assessed to be rising at 5 degrees from the tunnel wall face toward the rock. Also in hole OC14, there was an indication of a crack plane dipping at 5 degrees away from the tunnel wall. This crack appeared tightly closed and could not be seen on the surface of the tunnel wall.
