REPORT TO  
MINISTRY OF TRANSPORTATION AND COMMUNICATIONS

STUDY OF WATER SEEPAGE  
THOROLD TUNNEL  
(WELLAND CANAL)  
THOROLD, ONTARIO

April, 1983

831-1038

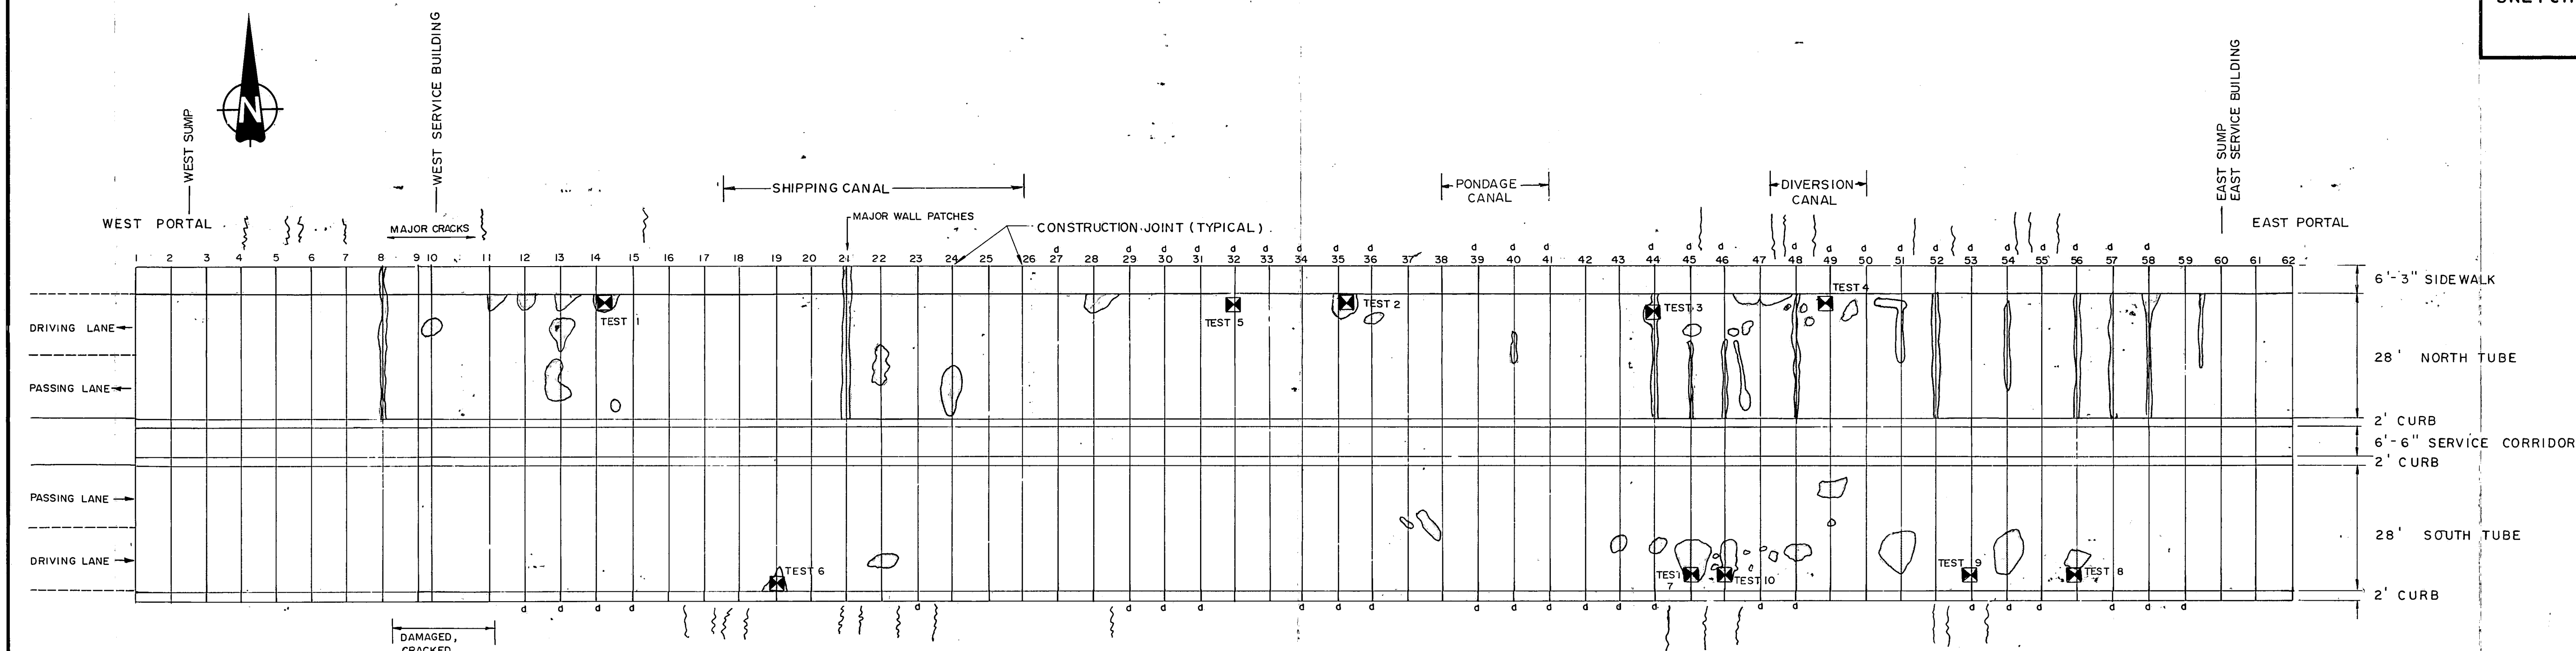
FIGURE 4

The tunnel floor surface was inspected and repair patches and wet spots were noted. A plan detailing the locations of the distressed areas was prepared as shown on Figure 4.

Visual inspection of each patched area in the tunnel floor showed that, in the majority of cases, the patching is associated with a construction joint. There are two types of patches. These are patches approximately 6 in. wide across the width of the tunnel over a construction joint, and isolated patches over or close to a construction joint. It was noted that the repair areas at the construction joints over the width of tunnel occur only in the north tube. It was also noted that the isolated patches occur with considerably greater frequency in the driving lanes of both tubes.

SKETCH SHOWING ASPHALT PATCHES  
AND TEST LOCATIONS  
TUNNEL FLOOR

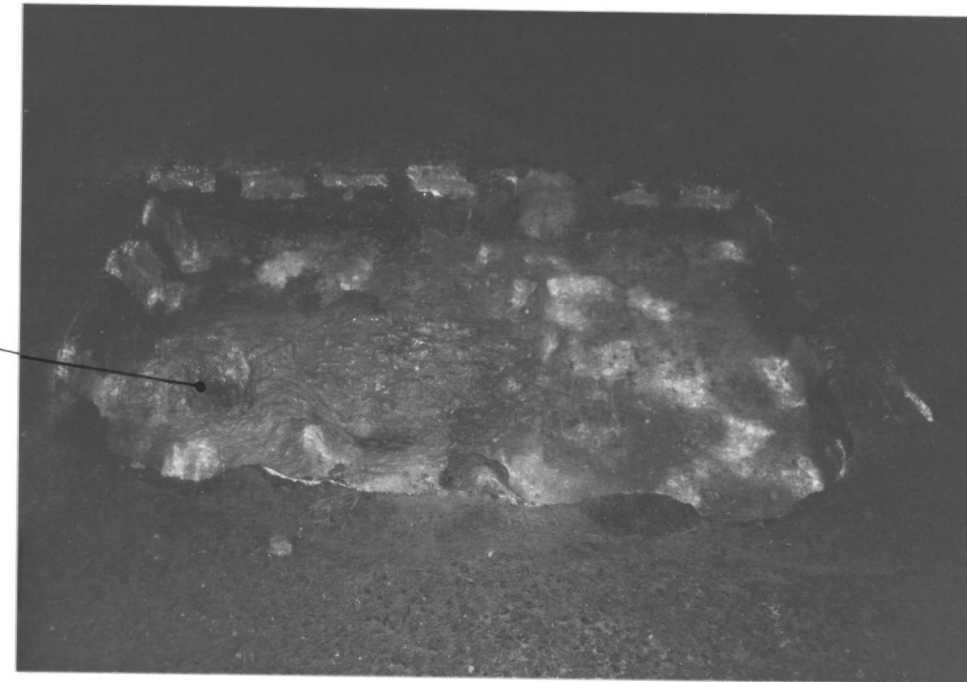
TEST LOCATION 2  
ASPHALT PATCHING CLOSE TO JOINT

1. Water seeping from previous grout hole within test patch.
2. Surrounding area immediately around the grout hole severely scaled.
3. Concrete surface outside the scaled area in good condition.
4. No exposure of reinforcing steel.
5. Quality of extracted concrete core good.
6. Cold joint at 13 in.
7. Compressive strength of core section, 46.5 MPa.

WATER SEEPING  
FROM PREVIOUS  
GROUTHOLE

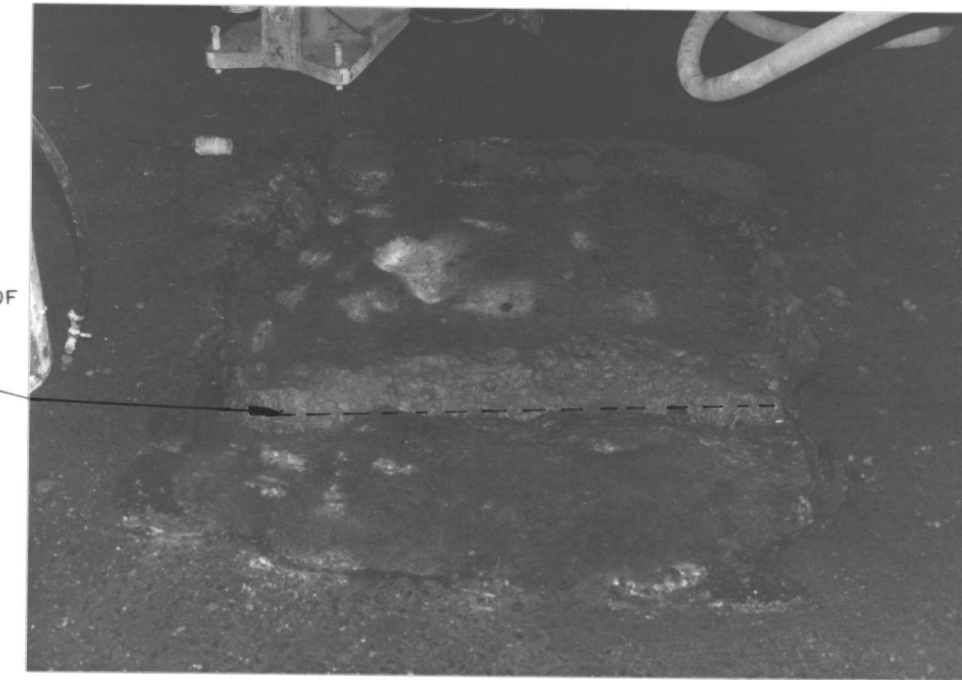
TEST LOCATION 3  
ASPHALT PATCHING ACROSS JOINT

1. Asphalt patching extended across the width of the north tube.
2. Severe scaling along the exposed length of the joint.
3. Water lying in the joint.
4. Concrete surface adjacent to joint in fairly good condition.
5. No reinforcing steel exposed.
6. Core taken at the joint showed that scaling occurred to a depth of 8 in.

DETERIORATION  
ALONG LENGTH OF  
JOINT

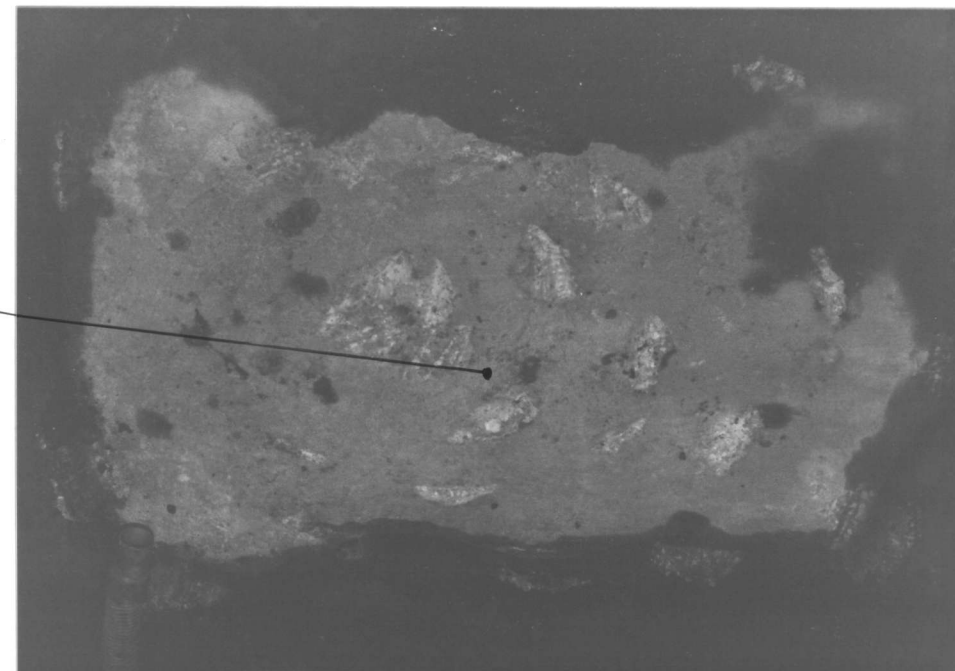
TEST LOCATION 4  
NO REMEDIAL WORK AT THIS LOCATION

1. No previous history of repair at this location.
2. Surface of concrete sound - no scaling.
3. No water present.
4. Extracted core showed good quality dense concrete.

NOTE SOUND  
SURFACE

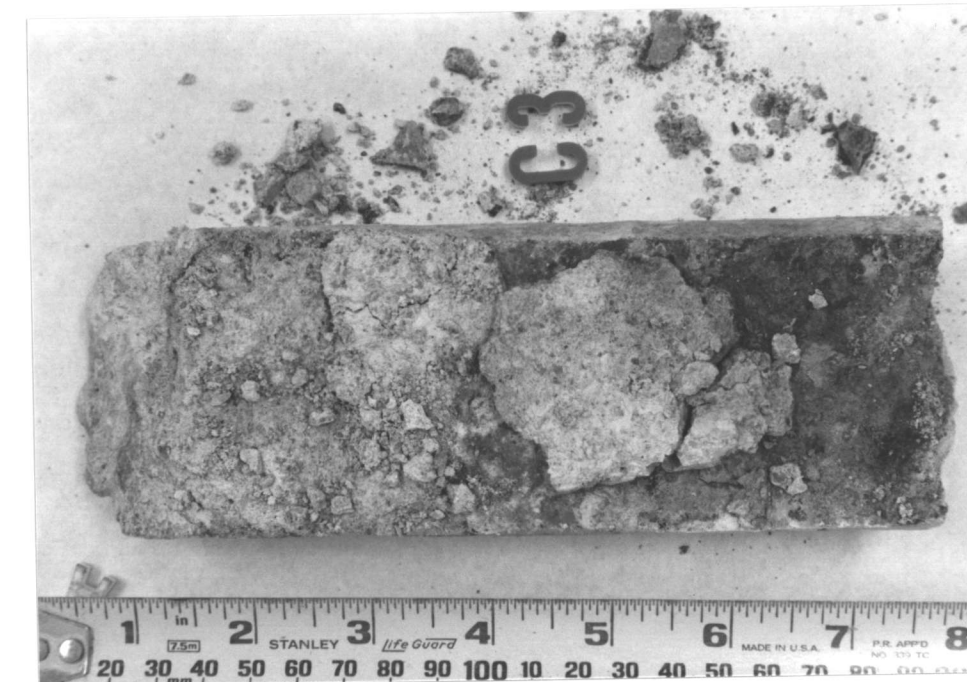
TEST LOCATION 3  
CORE THROUGH JOINT

NOTE CONCRETE  
DETERIORATION AT  
JOINT.

APPROXIMATE  
LOCATION OF JOINT

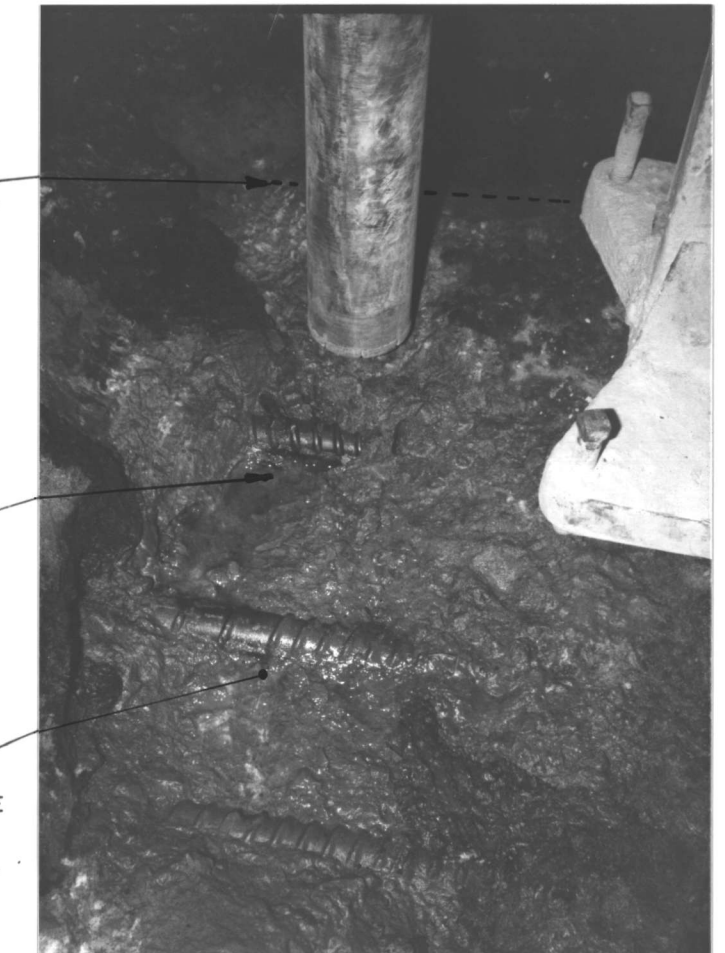
TEST LOCATION 1

1. Water weeping from honeycombed area approximately 1 ft. from the construction joint.
2. Three transverse reinforcing bars exposed in area of water flow.
3. No evidence of reinforcing steel corrosion.
4. Scaled concrete in vicinity of water flow.
5. Construction joint in good condition.
6. Following coring and evacuation of drillwater, core hole was observed for one hour. Approximately 7 in. of water inflow occurred during this period.
7. Area of honeycombing observed in extracted core at approximately 10 in. Cold joints noted at 21 in. and 30 in. Honeycombed region at 47 in.
8. Compressive strength of core section, 32.1 MPa.

WATER SEEPING  
FROM SMALL  
HONEYCOMB AREA

CONCRETE SURFACE  
SCALED EXPOSING  
REINFORCING STEEL

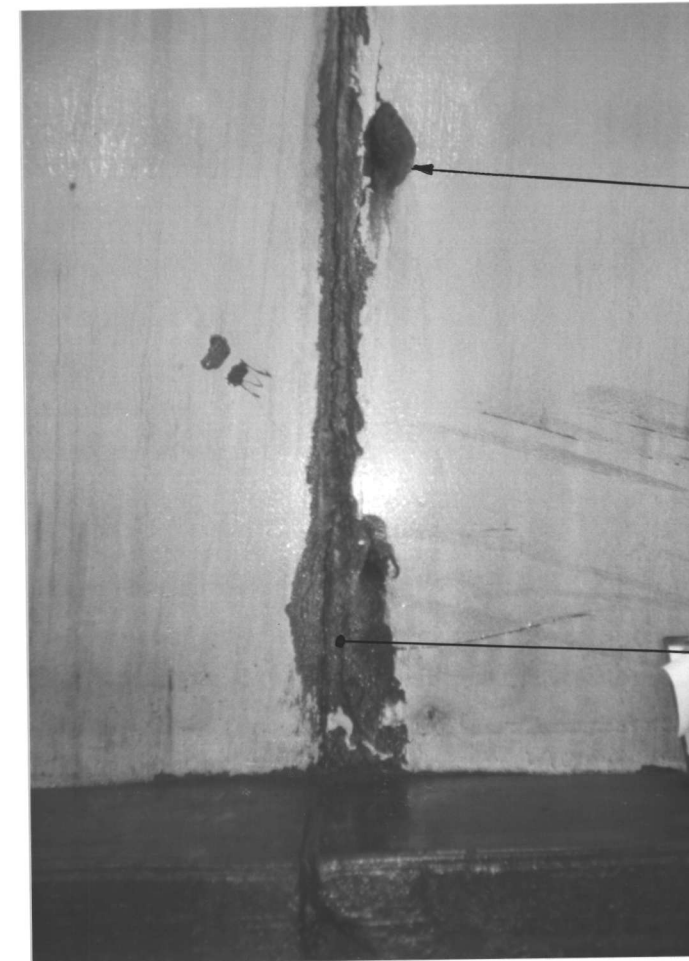
Visual inspection of the vertical wall joints showed that many joints were weeping. It was observed that these joints had caused problems over a lengthy period of time since some had been grouted to attempt a seal behind the water stop. Most joints had cementitious and/or elastomeric materials in their lower sections. It was also noted that deterioration in the form of spalling had occurred at many joints. Photographs of typical wall joint defects are given on Figure 8.

GROUT HOLE

LOWER JOINT FILLED  
TO PREVENT WATER  
SEEPAGE

TYPICAL DISTRESS AT JOINT

In addition to the remedial work on the concrete base, it is recommended that the repair materials in the vertical joints be removed since they are serving no useful purpose. Their presence retains water in the joints, thus allowing saturation of the concrete surrounding the joint to take place, with resultant freeze/thaw damage.

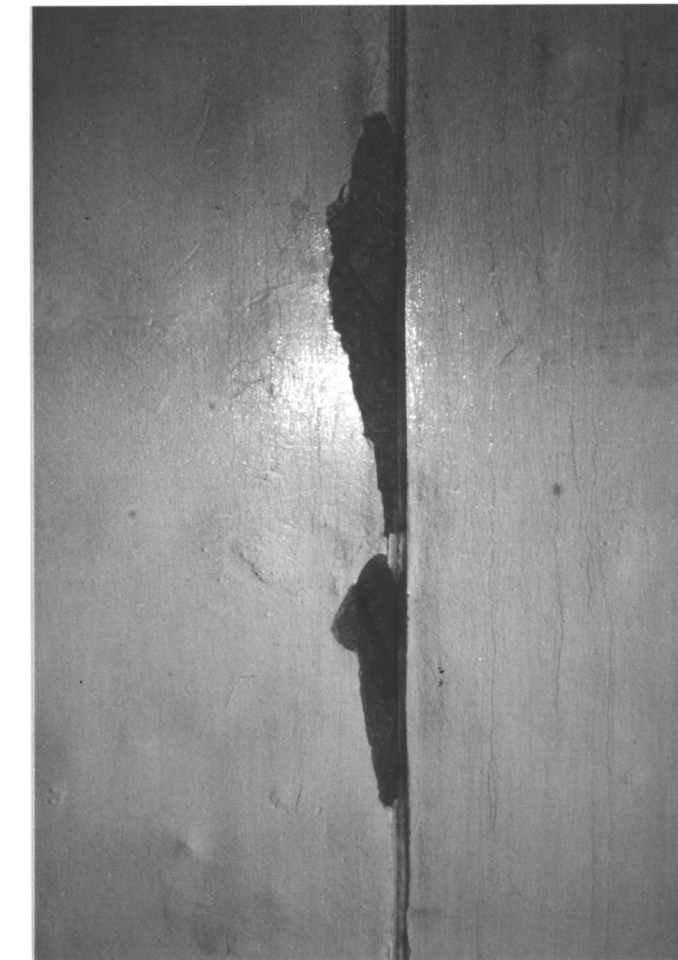
TYPICAL DISTRESS AT  
EDGES OF JOINT

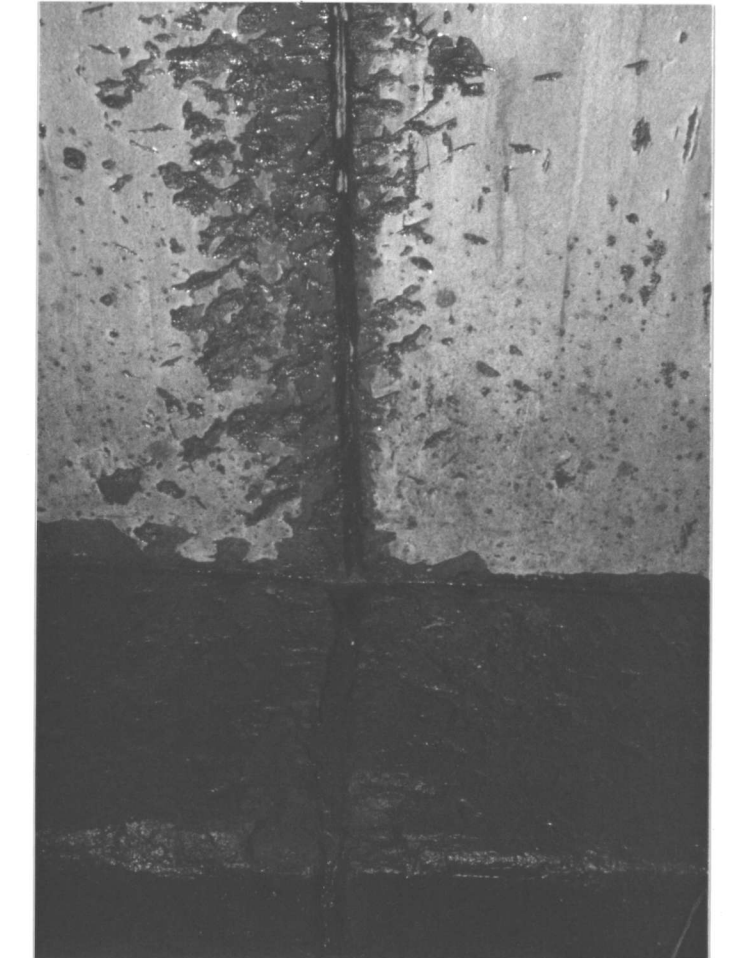
TYPICAL DISTRESS AT CURB
