**FOUNDATION INVESTIGATION AND DESIGN
SLOPE RESTORATION AT STATION 15+718
HIGHWAY 405 W-N/S RAMP AT STANLEY AVENUE
HIGHWAY 405 REHABILITATION FROM QEW TO
QUEENSTON-LEWISTON BORDER CROSSING
G.W.P. 2445-04-00**

January 2007

06-1111-036

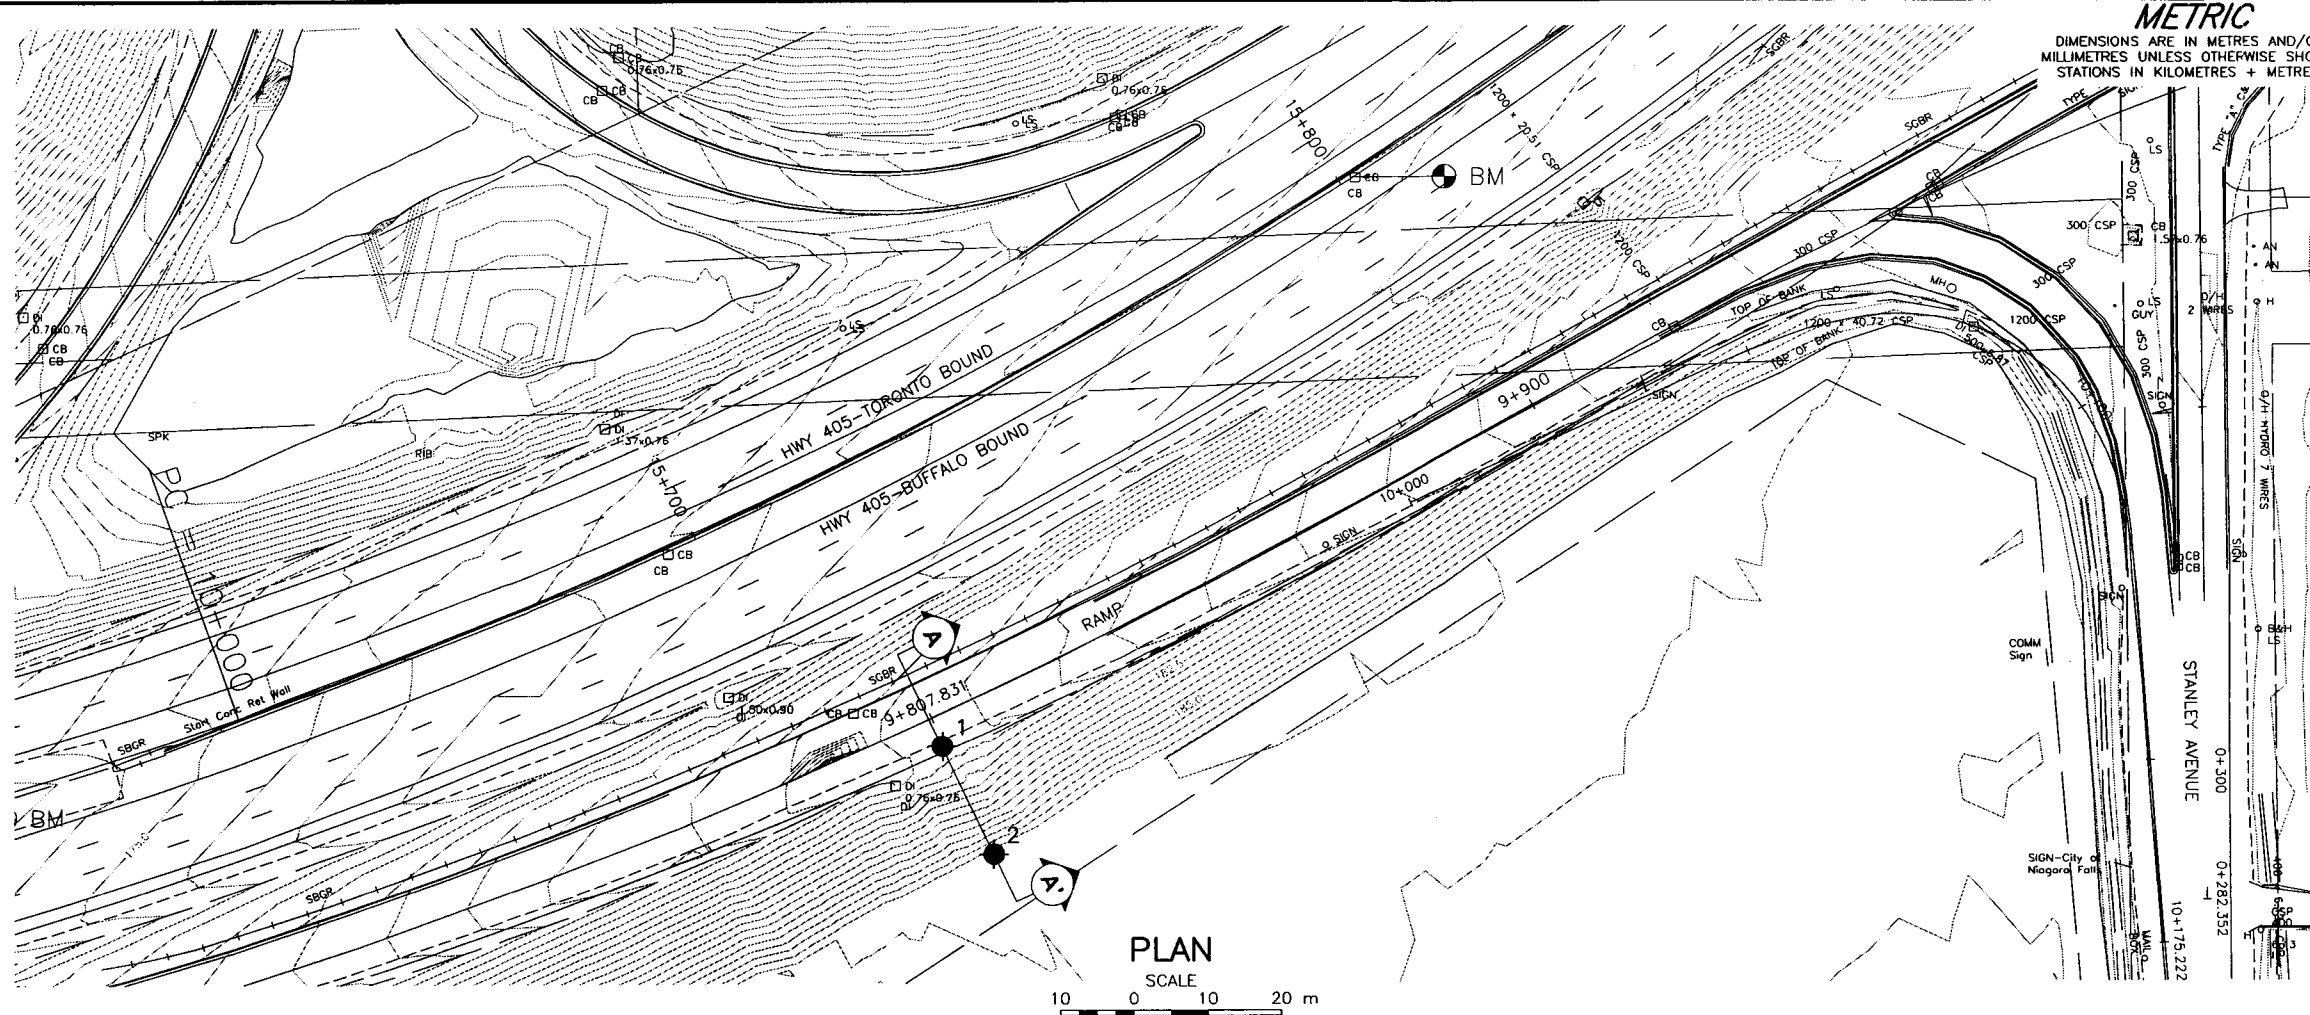
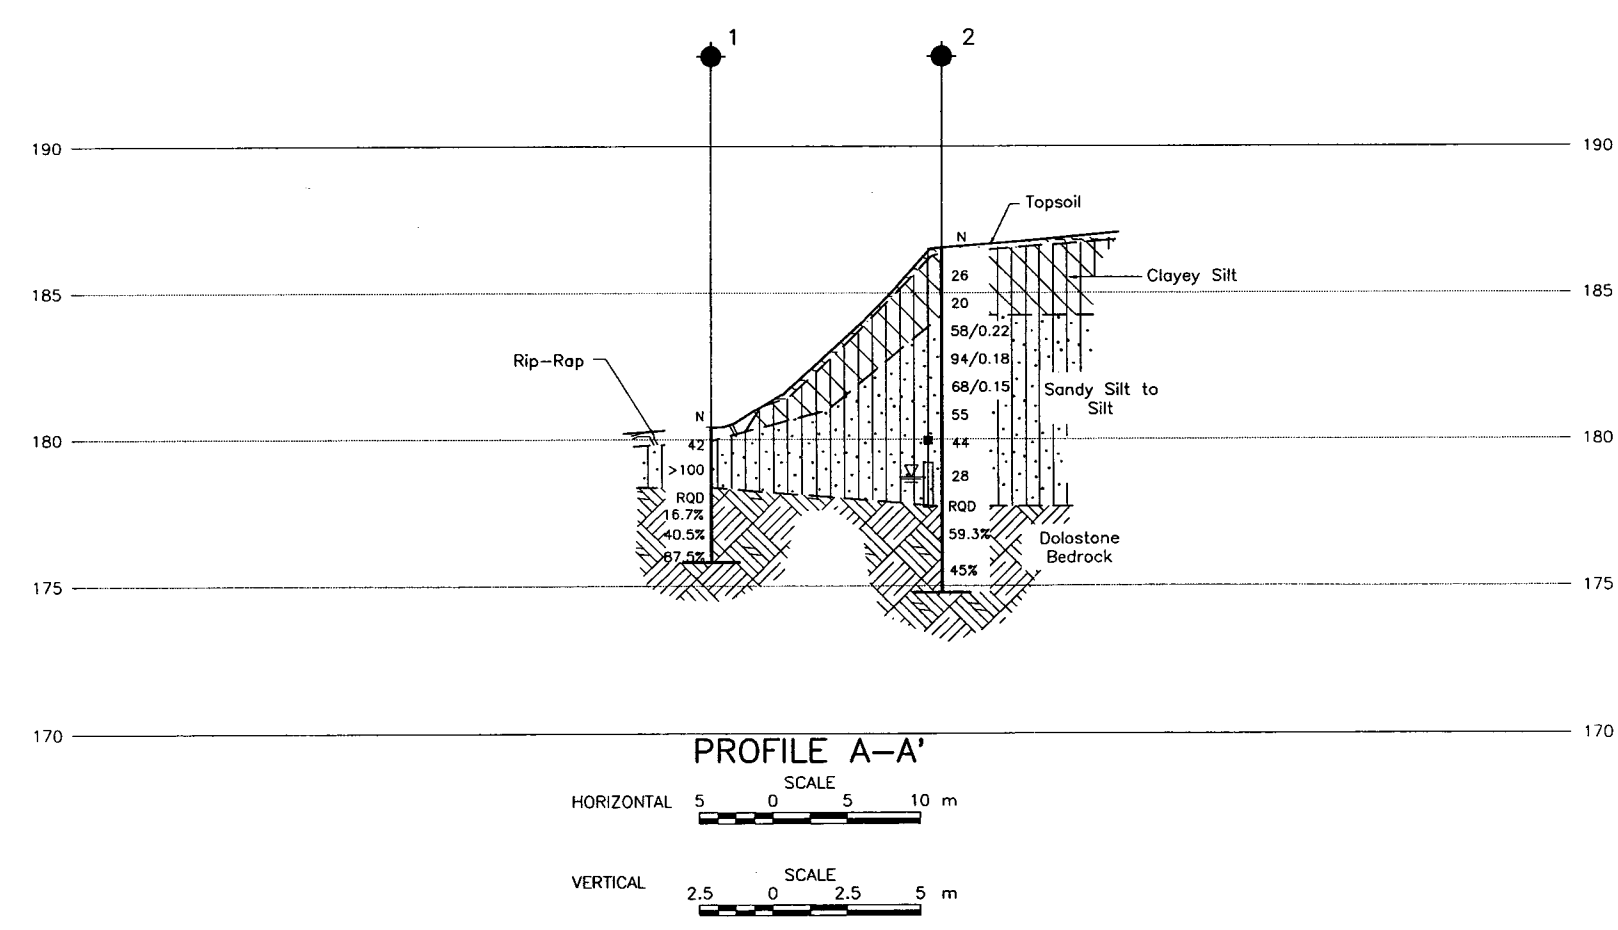
HIGHWAY 405
SLOPE RESTORATION AREA STA. 15+718
BOREHOLE LOCATIONS AND
SOIL STRATA

The detailed subsurface soil and groundwater conditions encountered in the boreholes, and the results of in-situ and laboratory testing carried out on selected soil samples, are given on the Record of Borehole/Drillhole sheets and Figures 1 and 2. The stratigraphic boundaries shown on the borehole records are inferred from non-continuous sampling and, therefore, represent transitions between soil types rather than exact planes of geological change. Subsoil conditions will vary between and beyond the borehole locations. The inferred soil stratigraphy based on the results of the boreholes at the toe and crest of the slope is also shown on Drawing 1.

In summary, the soils encountered in Borehole 1 drilled at the toe of the slope consist of a layer of rip-rap at the ground surface underlain by a sandy silt deposit, and by bedrock at about Elevation 178.5 m. In Borehole 2 at the crest of the south embankment slope, the subsoils encountered consist of a layer of topsoil underlain by a clayey silt deposit which is in turn underlain by a silt deposit. The silt deposit extends to approximately Elevation 178.1 m where bedrock was encountered.

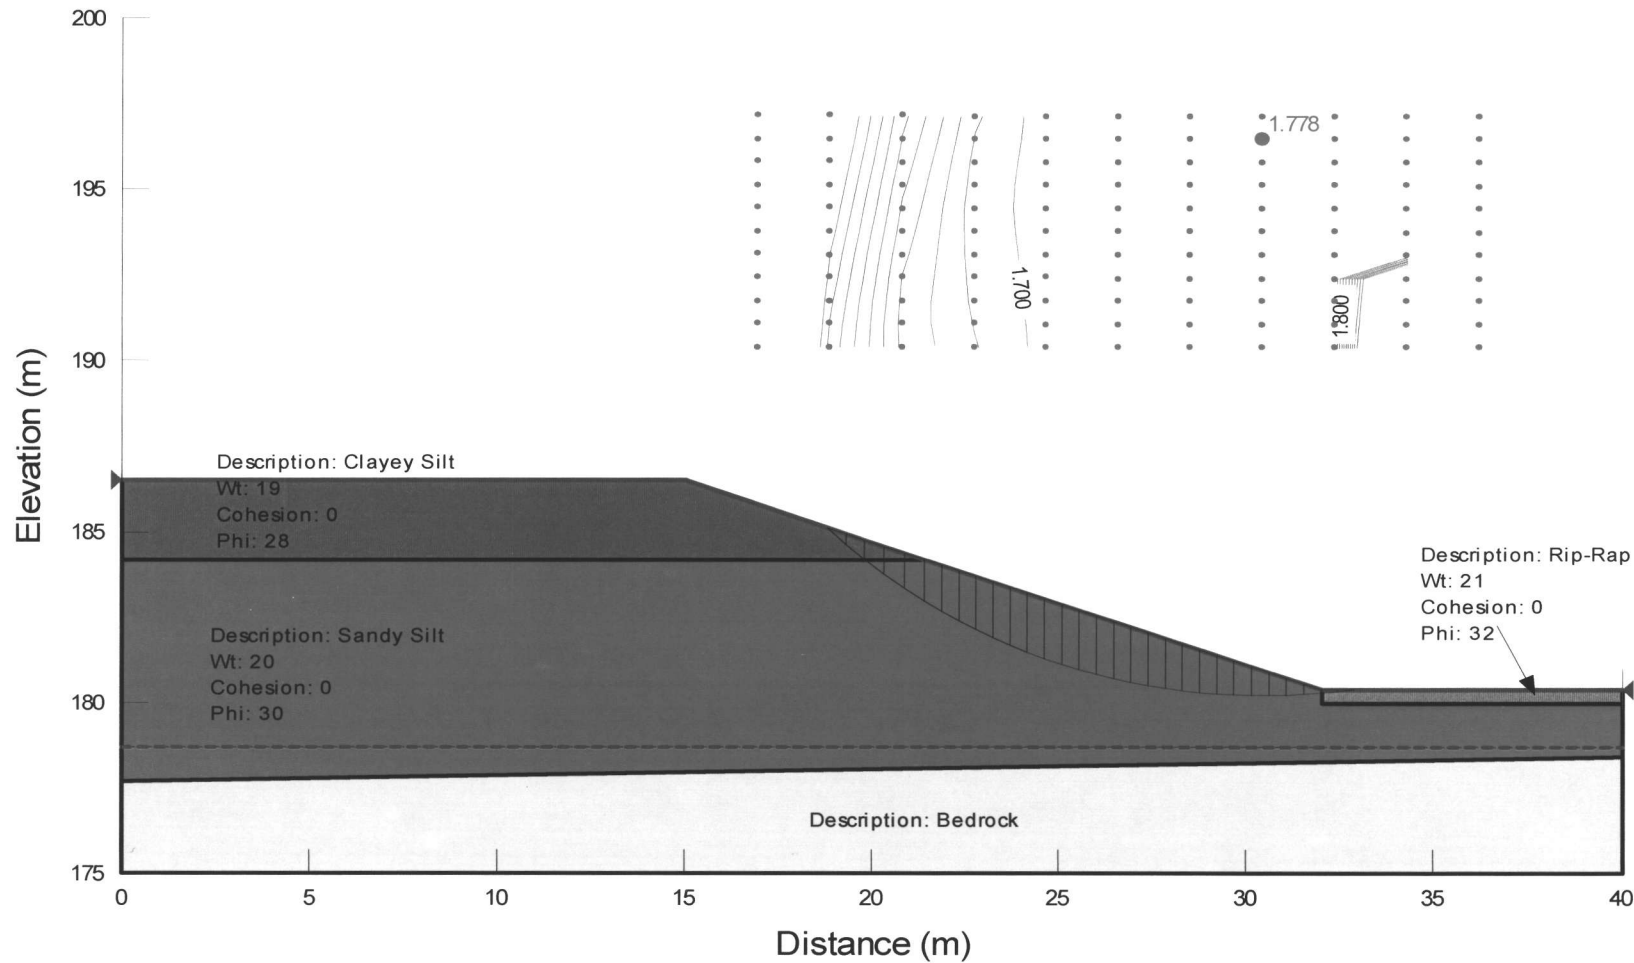
Figure 3

The results of the slope stability analyses, presented on Figure 3, indicate that the approximately 6.5 m high embankment with a side slope inclination at about 2 horizontal to 1 vertical (2H:1V) has a factor of safety of 1.7 against deep-seated instability. Therefore, the analyses indicate that global slope instability is unlikely given the subsurface conditions present at the site, and confirms that the observed distress is related only to localized erosion of the embankment as a result of the drainage tile discharge.

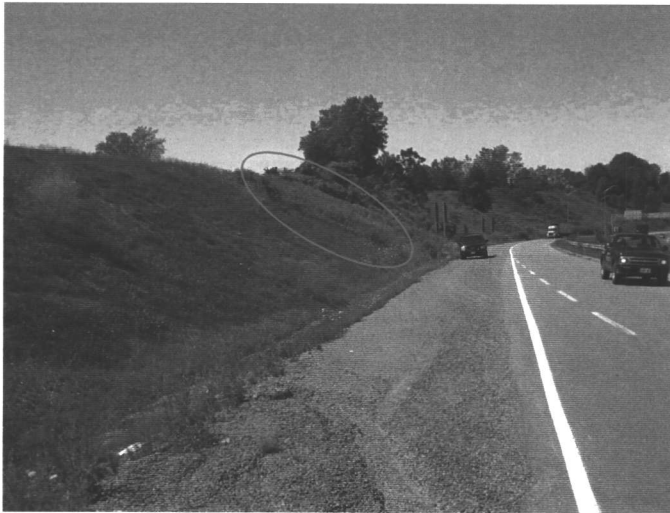
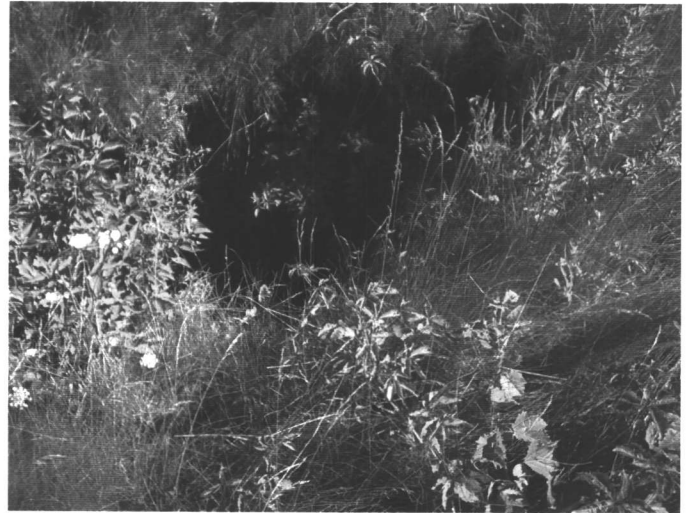
A site visit by Golder geotechnical staff was conducted on September, 7 2006 to observe the conditions of the embankment slope. The embankment slope was approximately 6.5 m in height and was inclined at about 25.5 degrees to the horizontal (approximately 2.3 horizontal to 1 vertical), based on slope inclination measurements taken using a hand-held Abney level. The distress has manifested as an erosion gully that is about 4 m wide within the upper slope and approximately 1.5 m to 2 m deep; the erosion gully extends down-slope becoming narrower near the toe of the slope. A 200 mm diameter clay drainage tile was protruding from the face of the eroded area at a depth of about 1.5 m from the crest of the slope; a broken piece of the clay pipe had been placed at the top of the slope during our site visit and sloughed soils were observed on the erosion gully below the tile. The erosion gully was partially filled with rock blocks. During the site visit, about 25 mm depth of water was flowing from the drainage tile; during a subsequent visit while taking water level measurement in a borehole on October 19, 2006, the drainage tile appeared to be flowing about one-quarter full and the outflow appeared to be relatively free of sediment. Tall vegetation surrounded the sloughed area (refer to Photographs 1 to 4 in Appendix A).

Photo Nos. 1 & 2 - General View, September, 2006

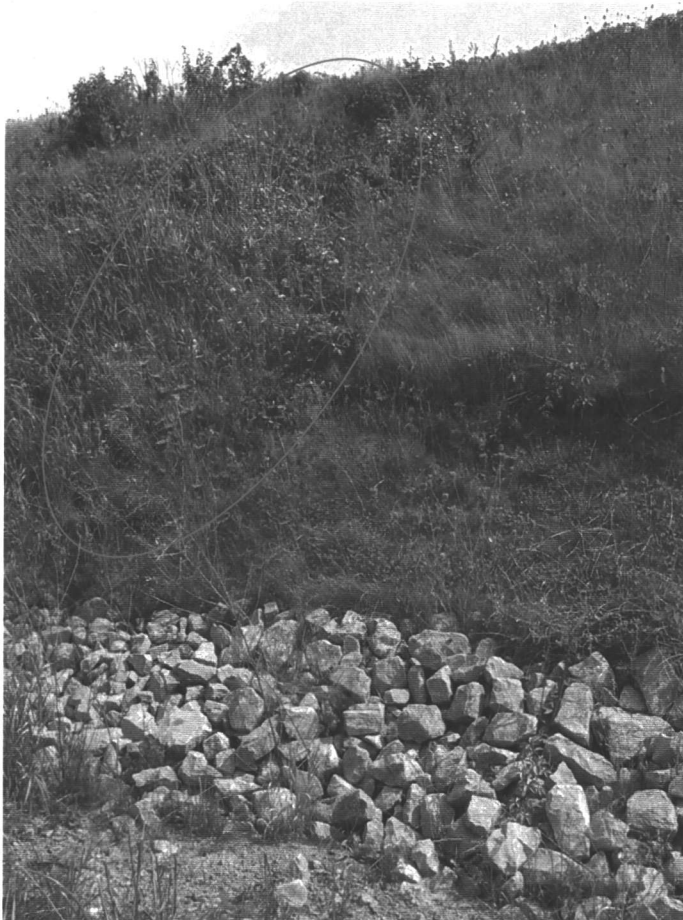
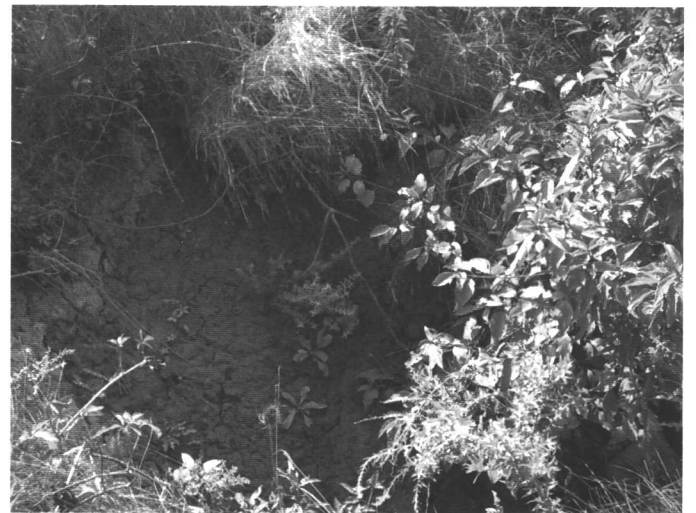
Based on the observations during our site visit on September 7, 2006 and the results of the borehole investigation, the cause of distress of the slope (manifested as erosion gullying) is considered to be directly related to the existing clay drainage pipe discharging onto the slope. This clay pipe likely forms part of a tile system draining the large area of formerly farmed land immediately south of the slope. Water flowing from the pipe appears to have caused erosion of the soil surrounding the pipe. Over time, the discharge from the pipe caused loss of supporting soils below the pipe and sloughing of the soils above and around it, leading to the fracture of the pipe at the edge of the sloughed area. Erosion and widening of the existing gully appears to be on-going as water continues to discharge from the pipe (refer to Photographs 5 and 6 in Appendix A). The volume of water discharged from the pipe varies, and appears to increase following rainfall events.

**Photo Nos. 3 & 4 – Top of the Erosion
Gully, September, 2006**

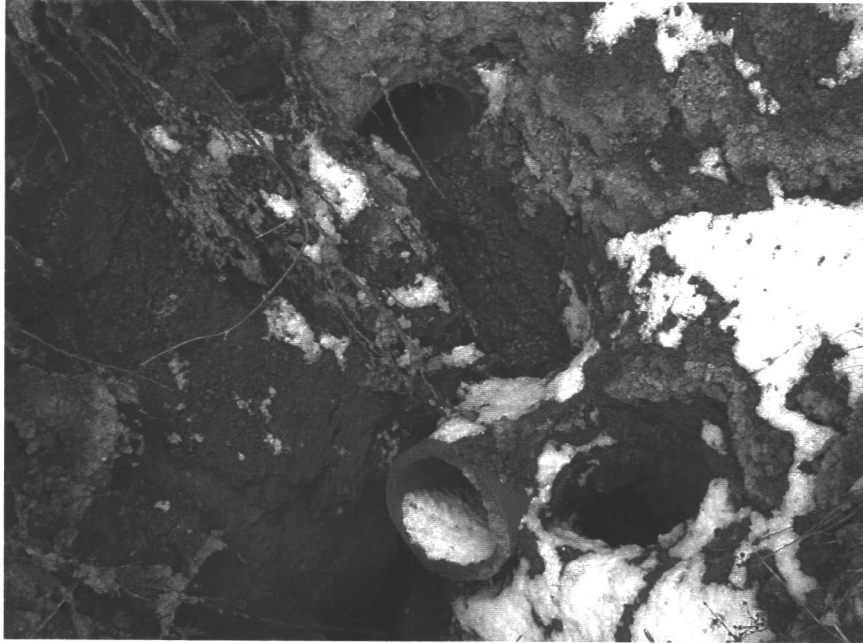
Photo No. 5 - Clay Drainage Tile- March, 2006 (Photo taken by MTO)

The preferred slope restoration option consists of extending the existing drainage tile and reinstating the slope with a rip-rap protected channel to direct the discharge water from the pipe to the toe of the slope and into the drainage structure immediately west of the distressed area.

The existing 200 mm diameter drainage tile can be extended using a high density polyethylene (HDPE) pipe (or a vitrified clay pipe) to be connected to the existing drainage tile with an appropriate banded rubber coupling and elastomeric bushing to ensure a self centering tight fit and full circumference seal. Typical pipe transitional connections are presented in Appendix B.

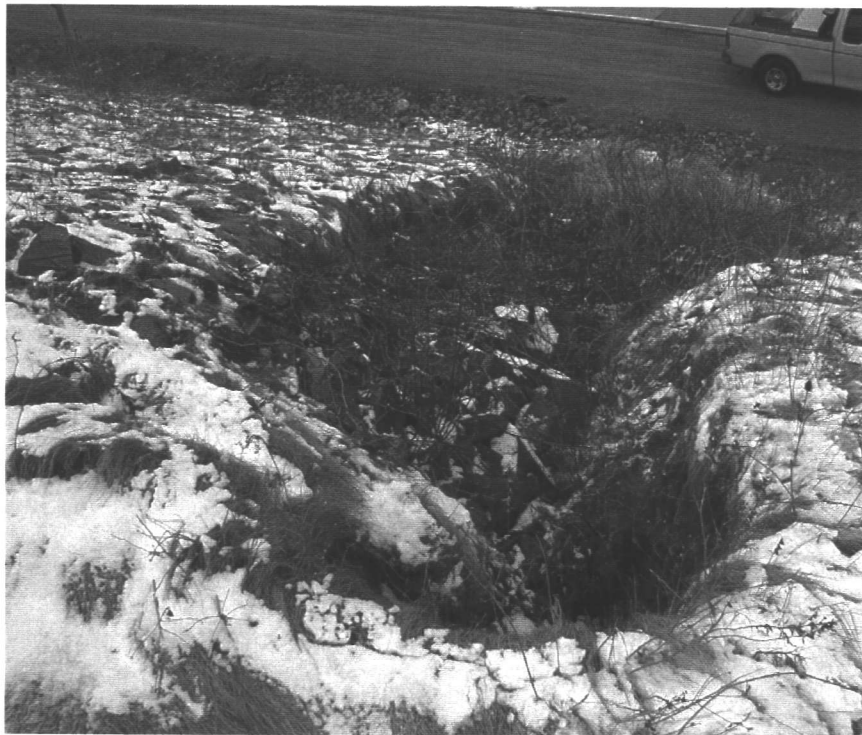
Photo No. 6: Erosion Gully- March, 2006 (Photo taken by MTO)

The discharge water from the drainage pipe should be directed down the slope through a rip-rap protected channel with a geotextile fabric or half pipe installed under the rip-rap; alternatively a pipe slope drain directly connected to the drainage tile may be used. The rip-rap protected channel should be about 300 mm deep and have a bottom width of 1.5 m with side slopes no steeper than 2 Horizontal to 1 vertical as illustrated in the typical cross sectional profile shown on Drawing 2. The channel should be worked into the erosion gully to achieve as flat a slope as practical. Rip-rap should consist of 100 mm to 300 mm angular stone with a minimal thickness of 350 mm, and should extend below the outlet of the drainage tile. A geotextile fabric, such as Terrafix 360R or equivalent, should be installed under all rip-rap to separate it from the native subgrade and should be keyed at least 300 mm into the ground at the edges of the channel and down the slope; the geotextile fabric should be installed according to the manufacturer's recommendations. An HDPE or vitrified clay half pipe may alternatively be used in lieu of the geotextile fabric. The half pipe should have a minimal diameter of 0.6 m and should be positioned such that it extends under the outlet of the existing drainage tile with excavation side slopes no steeper than 2 Horizontal:1 Vertical. The half pipe should be securely anchored to the slope according to the manufacturer's specifications.

Backfill to re-shape the slope along the down-slope channel should consist of Select Subgrade Materials (SSM) compacted in place as practical; where silt or sandy silt soils are encountered immediately below the drainage channel, these should be subexcavated and replaced with silty clay / clayey silt materials to prevent potential wash out of the sandy silt soils from below the rip-rap channel.
