MEMORANDUM

Claim on Contract 72-216 by Becker Drills Ltd.
Rock Slotting, Thorold Tunnel
Hwy. 58 and Welland Canal
District #4 (Hamilton)
W.O. 72-11096 -- W.P. 48-72-02

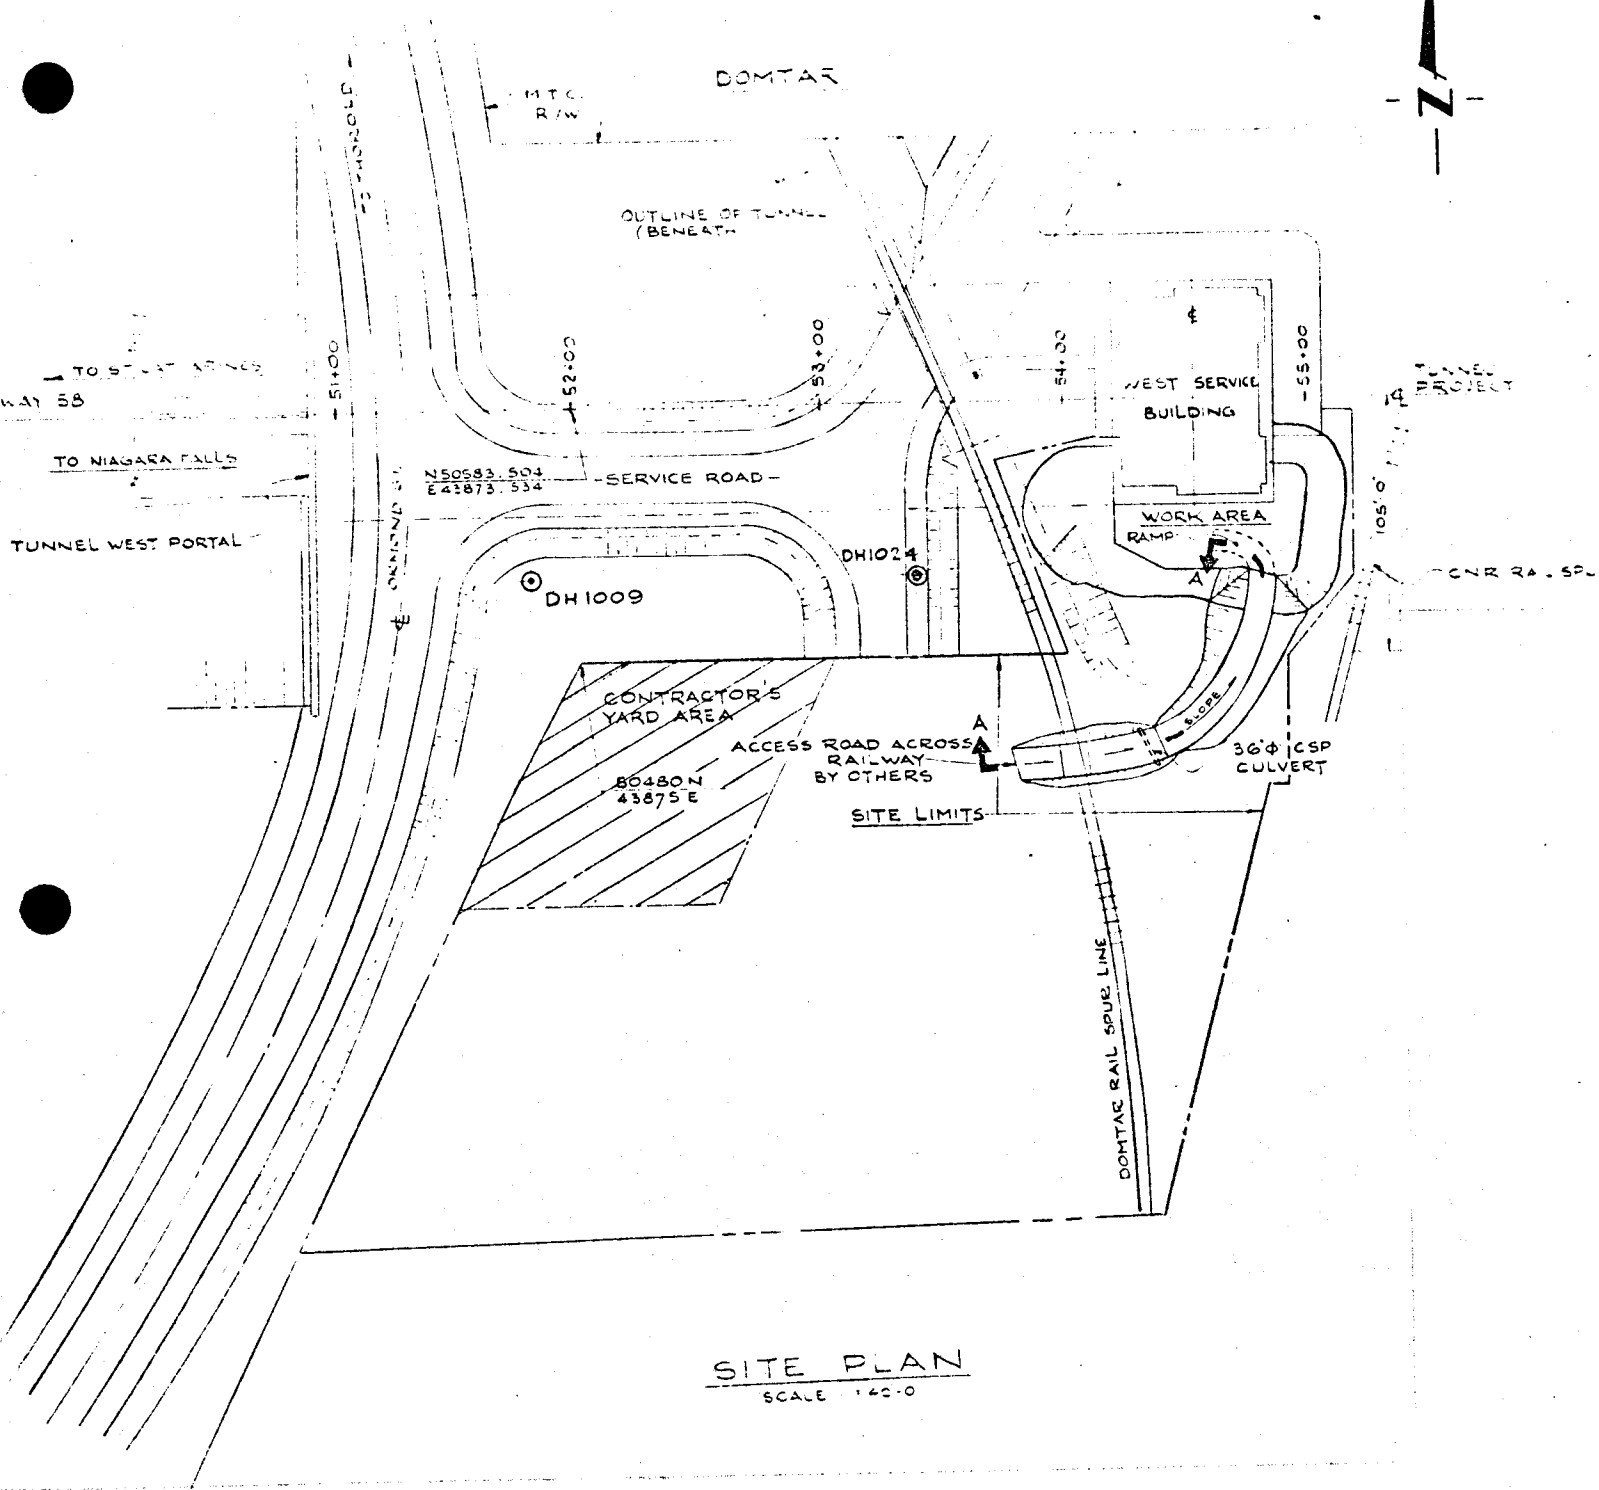
BORE HOLE LOCATIONS
 (BY F-E JOHNSTON DRILLING CO. Ltd. in 1964)

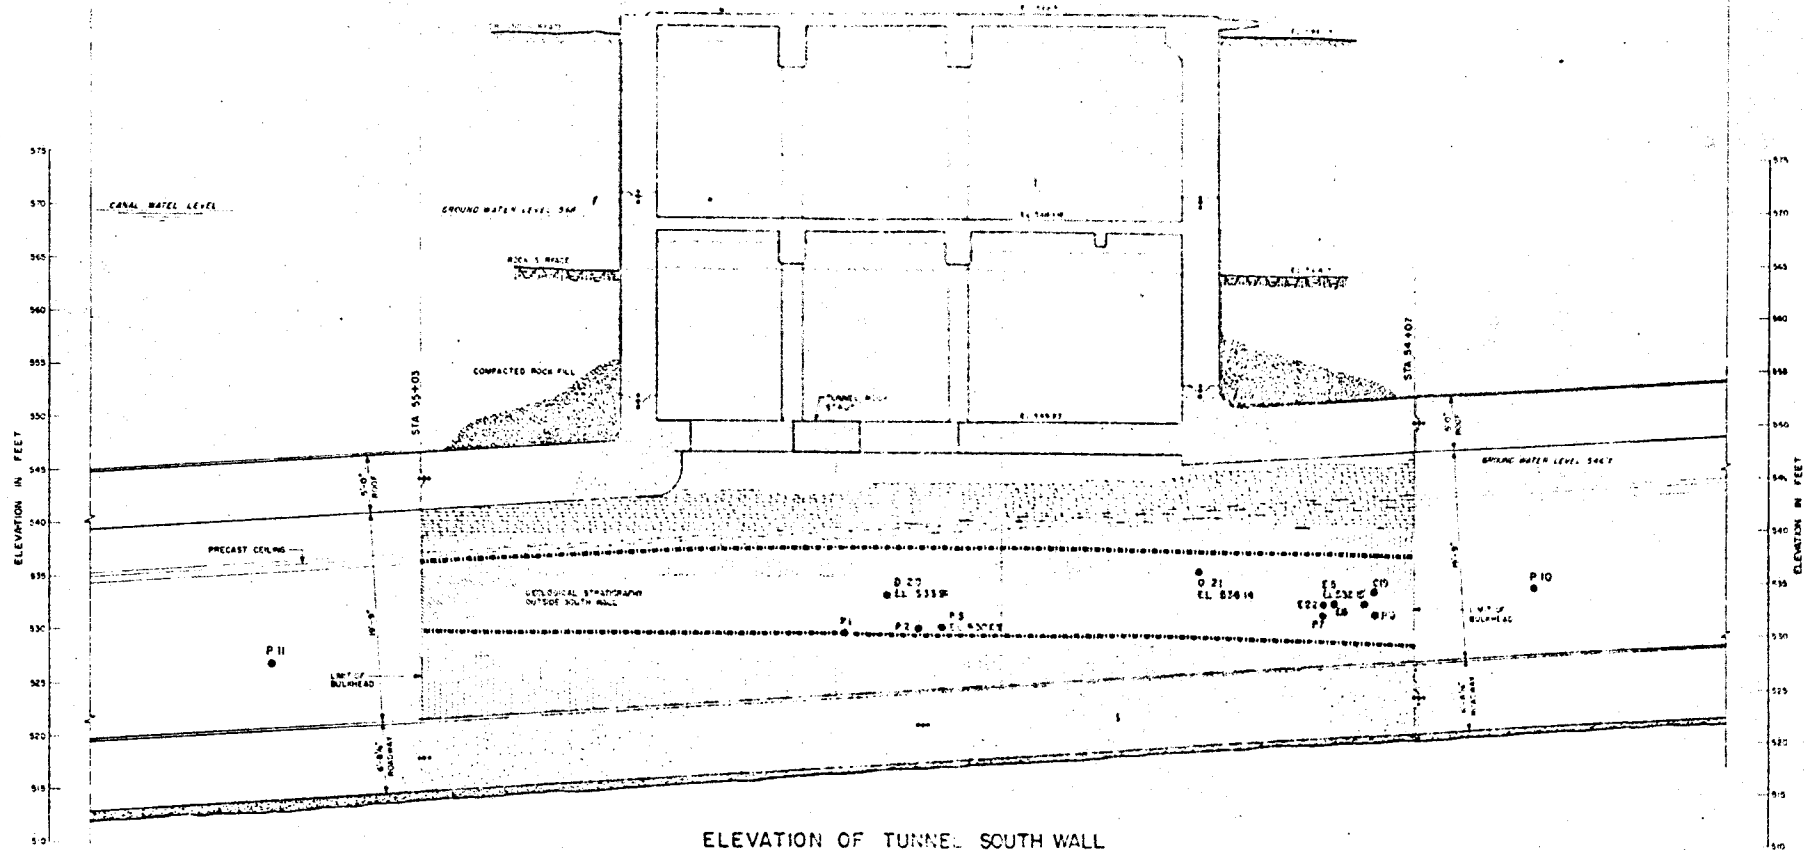
FIG. 2 W.O. 72-11096

The horizontal and/or inclined holes drilled by Canadian Longyear Co. Ltd. in 1971, showed clearly that some fracturing and jointing of the rock could be expected. These holes were drilled from inside the tunnel and holes D-20, D-21, E-5 and E-22 intersect the line of the slot at levels ranging from elevations 530 and 545 (17 to 32 feet below the bedrock surface in this area) as illustrated on Sketchs No. 3 and 4 in Appendix 2. The vertical holes (#1006 and #1009) drilled by F. E. Johnston Drilling Co. Ltd. in 1964 also revealed some minor fracturing and jointing. These borehole logs are included in Appendix 1 and the relevant data are underlined in red. It should be noted that jointing is a common feature in the bedrock

ELEVATION OF TUNNEL SOUTH WALL
LOCATIONS OF HORIZONTAL & INCLINED HOLES BY CANADIAN LONGYEAR Ltd. in 1971

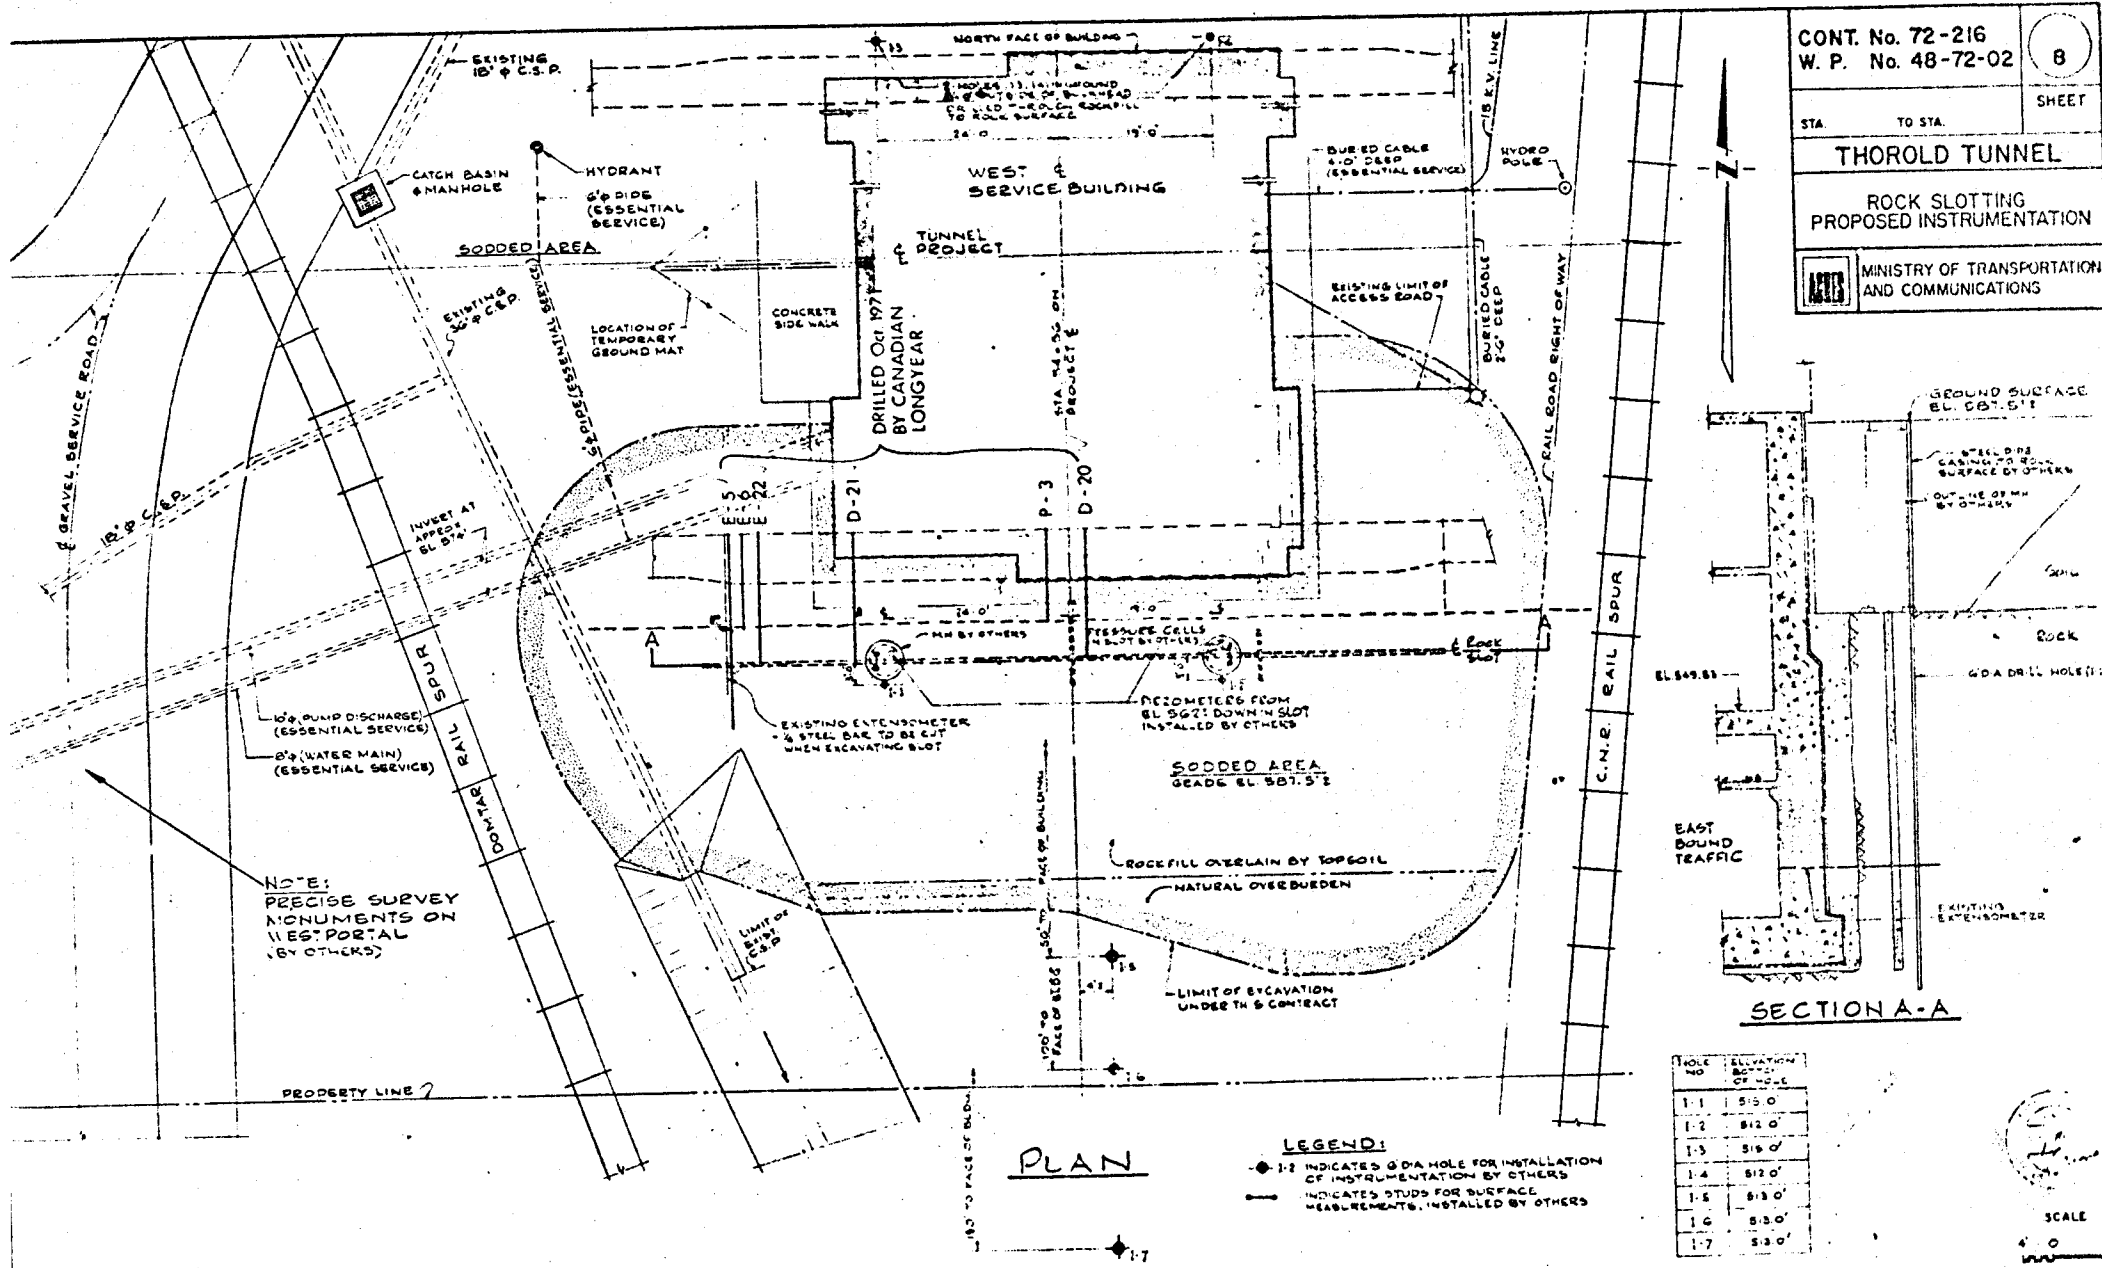
FIG. 3

- a) This Office reviewed critically the rock core samples obtained in two boreholes (#I-1 & #I-2) approximately 3 feet from the proposed slot. The locations of these two boreholes are shown on Fig. 3 in Appendix 2. These two boreholes were put down for installation of various instrumentations to monitor the rock movement. These borings were drilled after the award of this contract. The core samples (HQ size, approximately 2-1/2 inches diameter) only exhibited minor vertical jointing and fracturing in the upper 20 feet. Based on this information, it can be inferred that the bedrock is not badly shattered and cracked as claimed by the Contractor.
- b) The Contractor originally proposed to drill the slot in a continuous fashion, using overlapping 6-1/4" diameter
