THOROLD TUNNEL

INSPECTION OF ROCK SLOT  
SOUTH OF WEST SERVICE BUILDING

September 1982

Acres Consulting Services Limited  
Niagara Falls, Canada

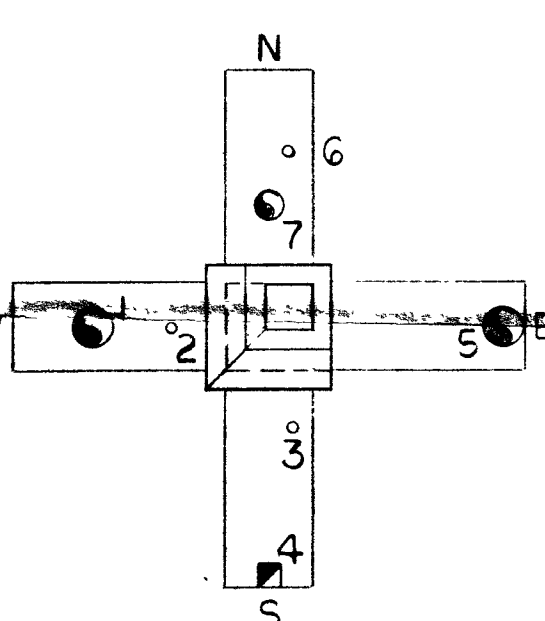
SCHEMATIC DIAGRAM  
CATCH BASIN & MANHOLE NO 118

OPENING NO	DESCRIPTION	OBSERVATIONS
1	18" STORM SEWER	A TRICKLE OF WATER
2	6" PERFORATED SURFACE DRAIN	1/2" FLOW
3	SAME AS 2	SAME AS 2
4	12"x12" INVERT KNOCK-OUT	FLOWING 1/4 FULL-CLEAR WATER
5	21" STORM DRAIN	FLOWING TO TUNNEL SUMP
6	1/2" HOLE	OPEN ONLY THROUGH WALL OF CATCH BASIN, NO CONNECTION TO OTHER PIPES, FLOWING 1/2 FULL
7	12" GUTTER SUMP AND CB189 CONNECTION	1" FLOW

NOTE  
1 THE BOTTOM OF THE CATCH BASIN WAS COVERED WITH 3" OF SAND, GRAVEL AND ROCK RUBBLE.  
2 A STRONG SULFUR/SEWER SMELL WAS NOTED.

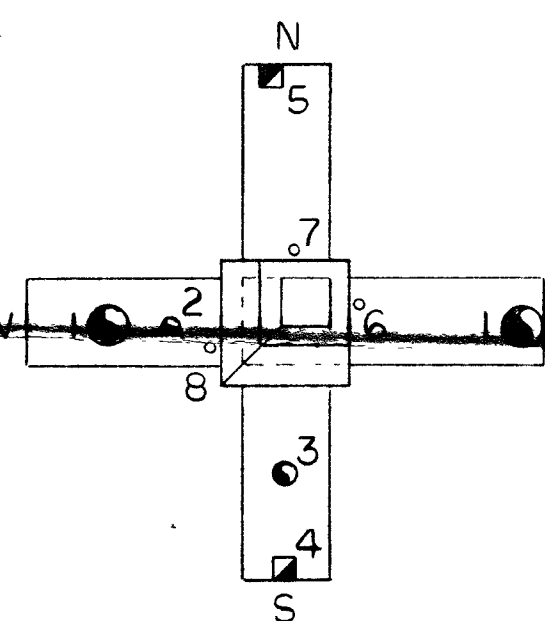
SCHEMATIC DIAGRAM  
CATCH BASIN & MANHOLE NO 119

OPENING NO	DESCRIPTION	OBSERVATIONS
1	21" STORM DRAIN FROM MH-123	A TRICKLE OF WATER FROM THE FIRST PIPE JOINT WEST OF THE MH. FLOWING 1/2 CAPACITY. OPEN FOR 5' WEST OF MANHOLE. PIPE RUNS WEST APPROX. 30' AND DOGLEGS TO THE SOUTH WEST.
2	6" PERFORATED SURFACE DRAIN	A TRICKLE OF WATER-SOURCE UNKNOWN. AS SUMP IS DRY OPENING BLOCKED ON OUTSIDE BY SEVERAL PIECES OF COARSE ROCKFILL. FLOWING 1/2 TO 3/4 FULL-CLEAR WATER
3	12" GUTTER SUMP CONNECTION	SAME AS 4
4	12"x12" INVERT KNOCK-OUT	PROBED LENGTH-3.5'. FLOWING 1/4 TO 1/2 FULL-CLEAR WATER. PROBED LENGTH-3'-0". FINES SLICED OUT FOR 2-3 MINUTES DURING PROBING. FLOW INCREASED FROM 1/4 TO 3/4 DURING PROBING.
5	SAME AS 4	PROBED LENGTH-2.5'. INCREASE IN FLOW FROM 1/4 TO 3/4.
6	1 1/2" SURFACE DRAIN	
7	SAME AS 6	
8	SAME AS 6

NOTE  
1. AFTER PROBING 6, 7 & 8, THE LEVEL OF WATER AT ROAD SURFACE WAS DRAWN DOWN APPROX. 2-2 1/2" IN 15 MINUTES.  
2. THE BOTTOM OF THE CATCH BASIN WAS COVERED WITH 3" OF SAND, GRAVEL AND ROCK RUBBLE.

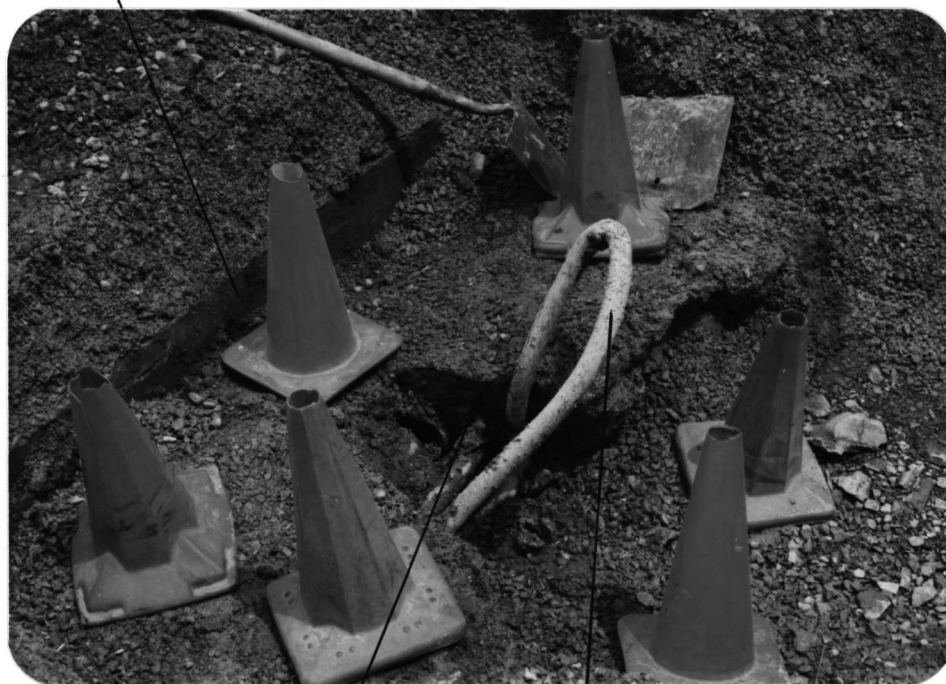
PHOTO NO. 3a

During excavation behind the curb, two 13,800-V power cables were damaged as shown in photos No. 3a and 3d. Three cable ducts were exposed during the repair work. They extend from electrical manhole No. 6 to the curb near the portal. One of the ducts carried three power cables and the other two were empty as can be seen in photo No. 3e. The two empty conduits acted as drains for the manhole. Electrical repairs were conducted on July 11 and 12 by G.A.M.S. Ltd. who spliced the two cables (photo No. 3e). Photo No. 4 shows the complete excavation and the relative positions of the portal (to the left), well standpipe and the repaired electrical cables.

Damaged power cable

Break in concrete cover over ducts

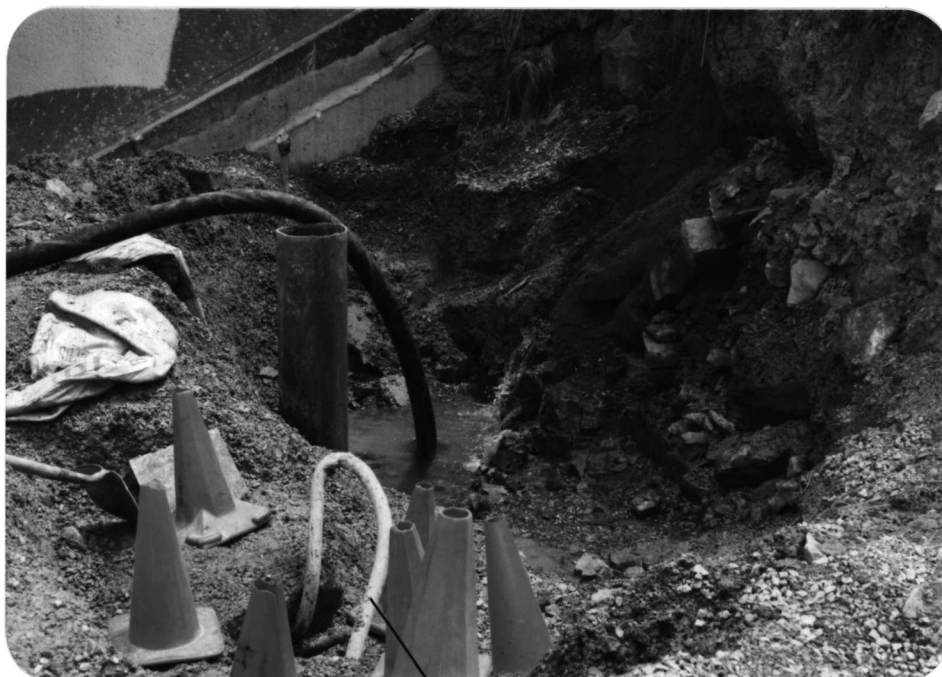
PHOTO NO. 3b

Damaged power cable

Damaged insulation and grounding

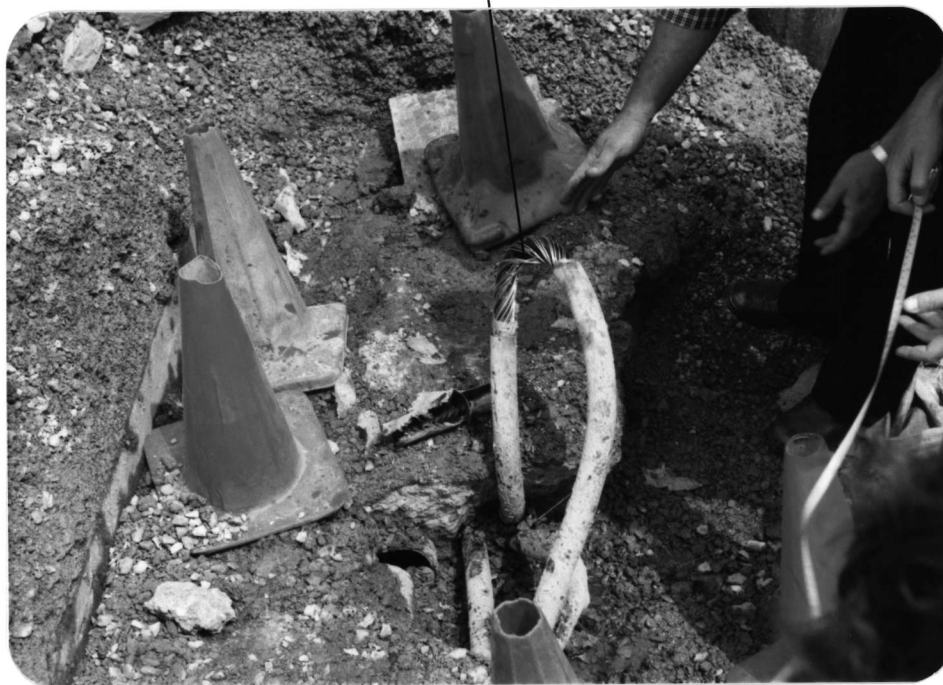
PHOTO NO. 3c

Damaged power cable

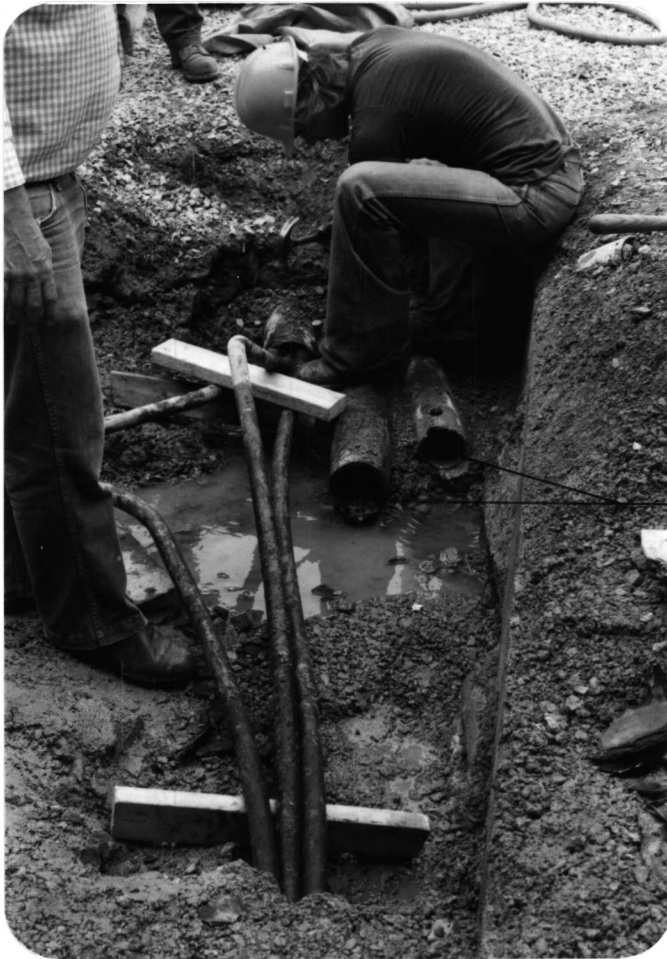
PHOTO NO. 3e

Ducts broken out

Preparing to repair  
damaged cables

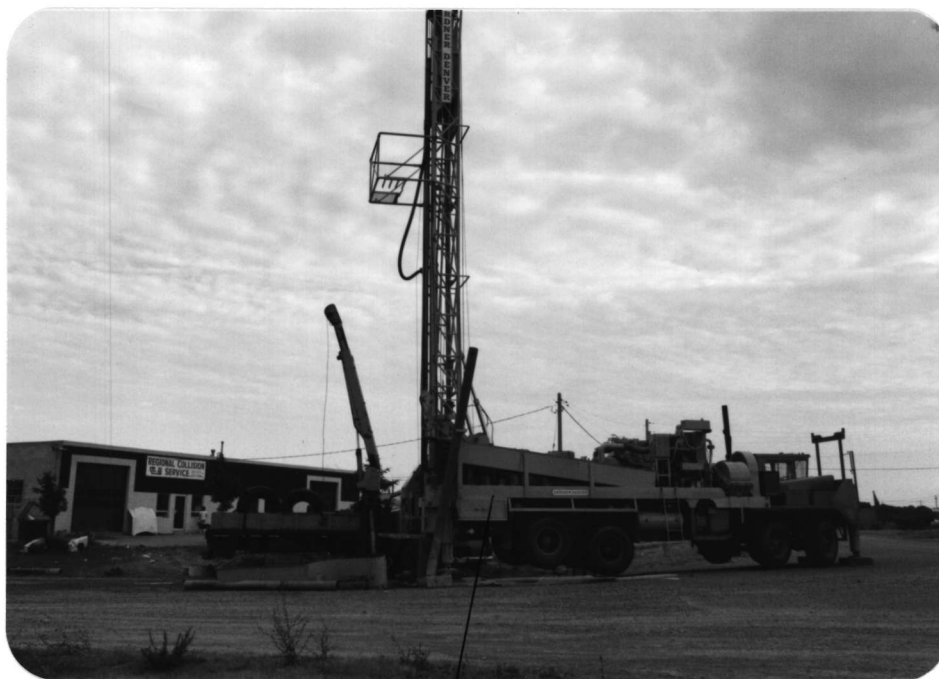
PHOTO NO. 8

A piezometer was drilled and installed off Ormond Street on July 17 to measure water levels behind the portal structure. Photo No. 8 shows the drilling rig set up over the hole location. At a depth of 24.3 ft, the drill bit contacted steel. As the depth corresponded approximately with the elevation of the tunnel roof, and the hole location was very near the wall of the tunnel, it was considered prudent to drill no deeper. A piezometer tip was placed at the 24.3-ft depth. Water level in this piezometer was found at a depth of 22.9 ft (monitored to July 23) which corresponds to an elevation approximately 3.4 ft below the Welland Canal water level.

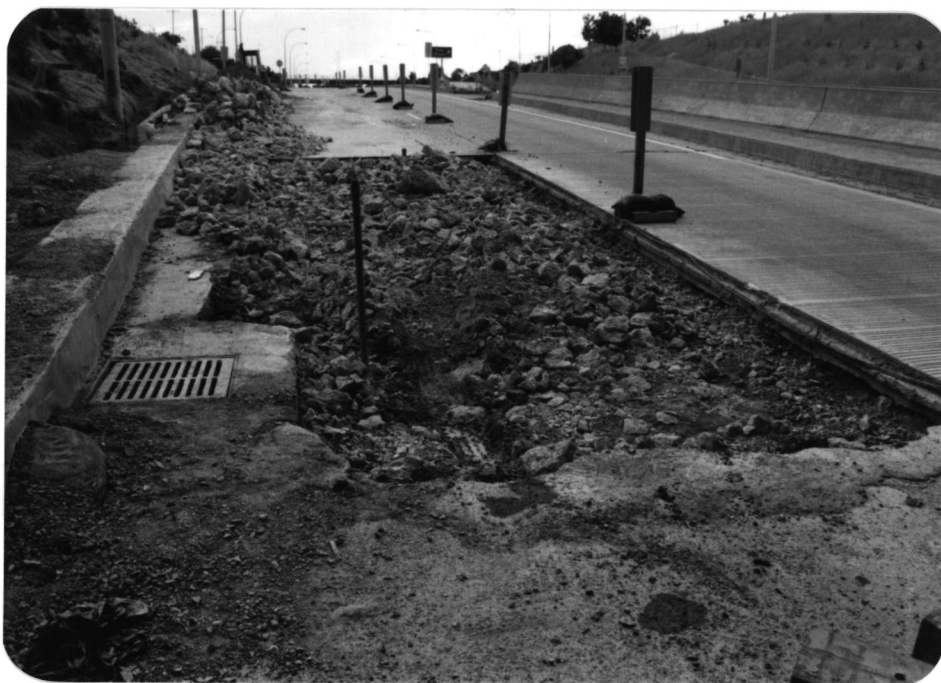
PHOTO NO. 9a

The south lane concrete slab adjacent to the portal was broken out on July 17. Photo No. 9a is a view looking west across the slab from the tunnel portal. A string line from the portal to the pavement joint 35 ft west of the portal indicated that the passing lane slab had deflected from a straight line by as much as 1-1/16 in. measured 6 ft west of the portal. In this area of maximum deflection it was also noted that a void existed under the passing lane slab as shown in photo No. 9b. The slab flexed about 1/8 in. during the passing of transport trucks. Hairline cracks across the pavement were noted in this area.

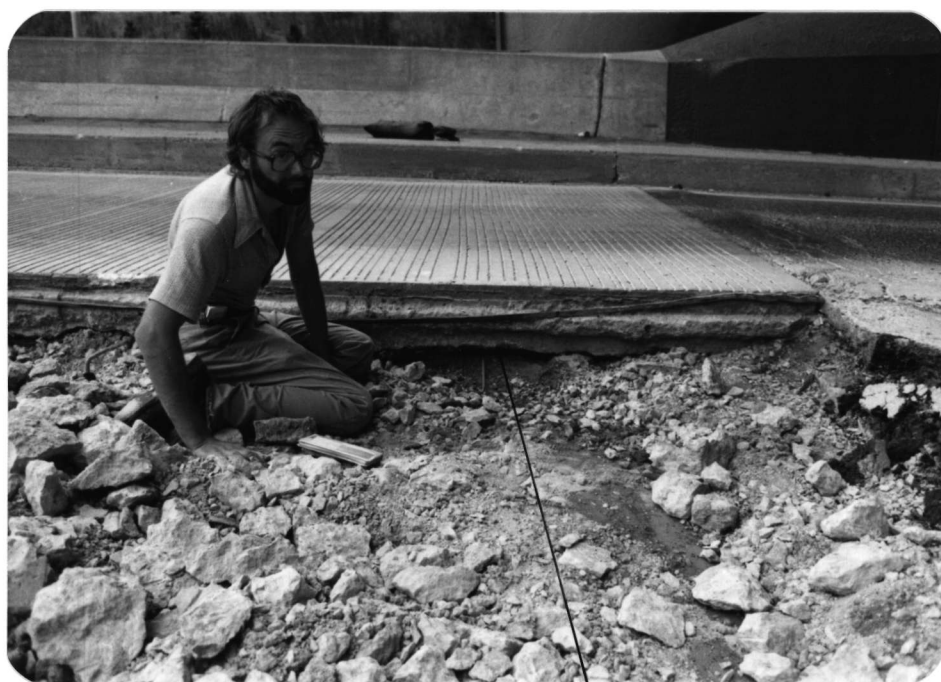
PHOTO NO. 9b

—Void under slab

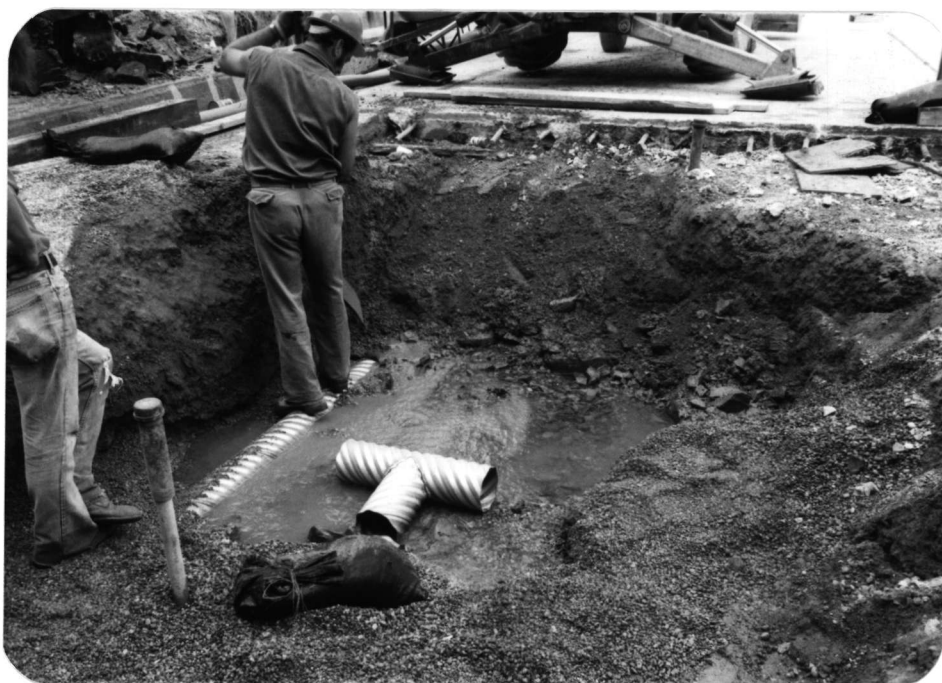
PHOTO NO. 10a

Elsewhere in the excavation, GBC "A" material was found to extend to bedrock. Slopes in the GBC "A" along the north and west walls of the excavation were cut flatter than 1:1 to prevent undermining of the roadway. It was possible to attain a near vertical cut along the south wall as shown in photos No. 10a and 10b. The portal step formed the eastern wall of the excavation.

A flow of 25 gal/min (estimated) was encountered at the western end of the excavation flowing through channels in the broken bedrock (photo No. 10a). The water, under head, boiled into the excavation as shown in photo No. 10b.

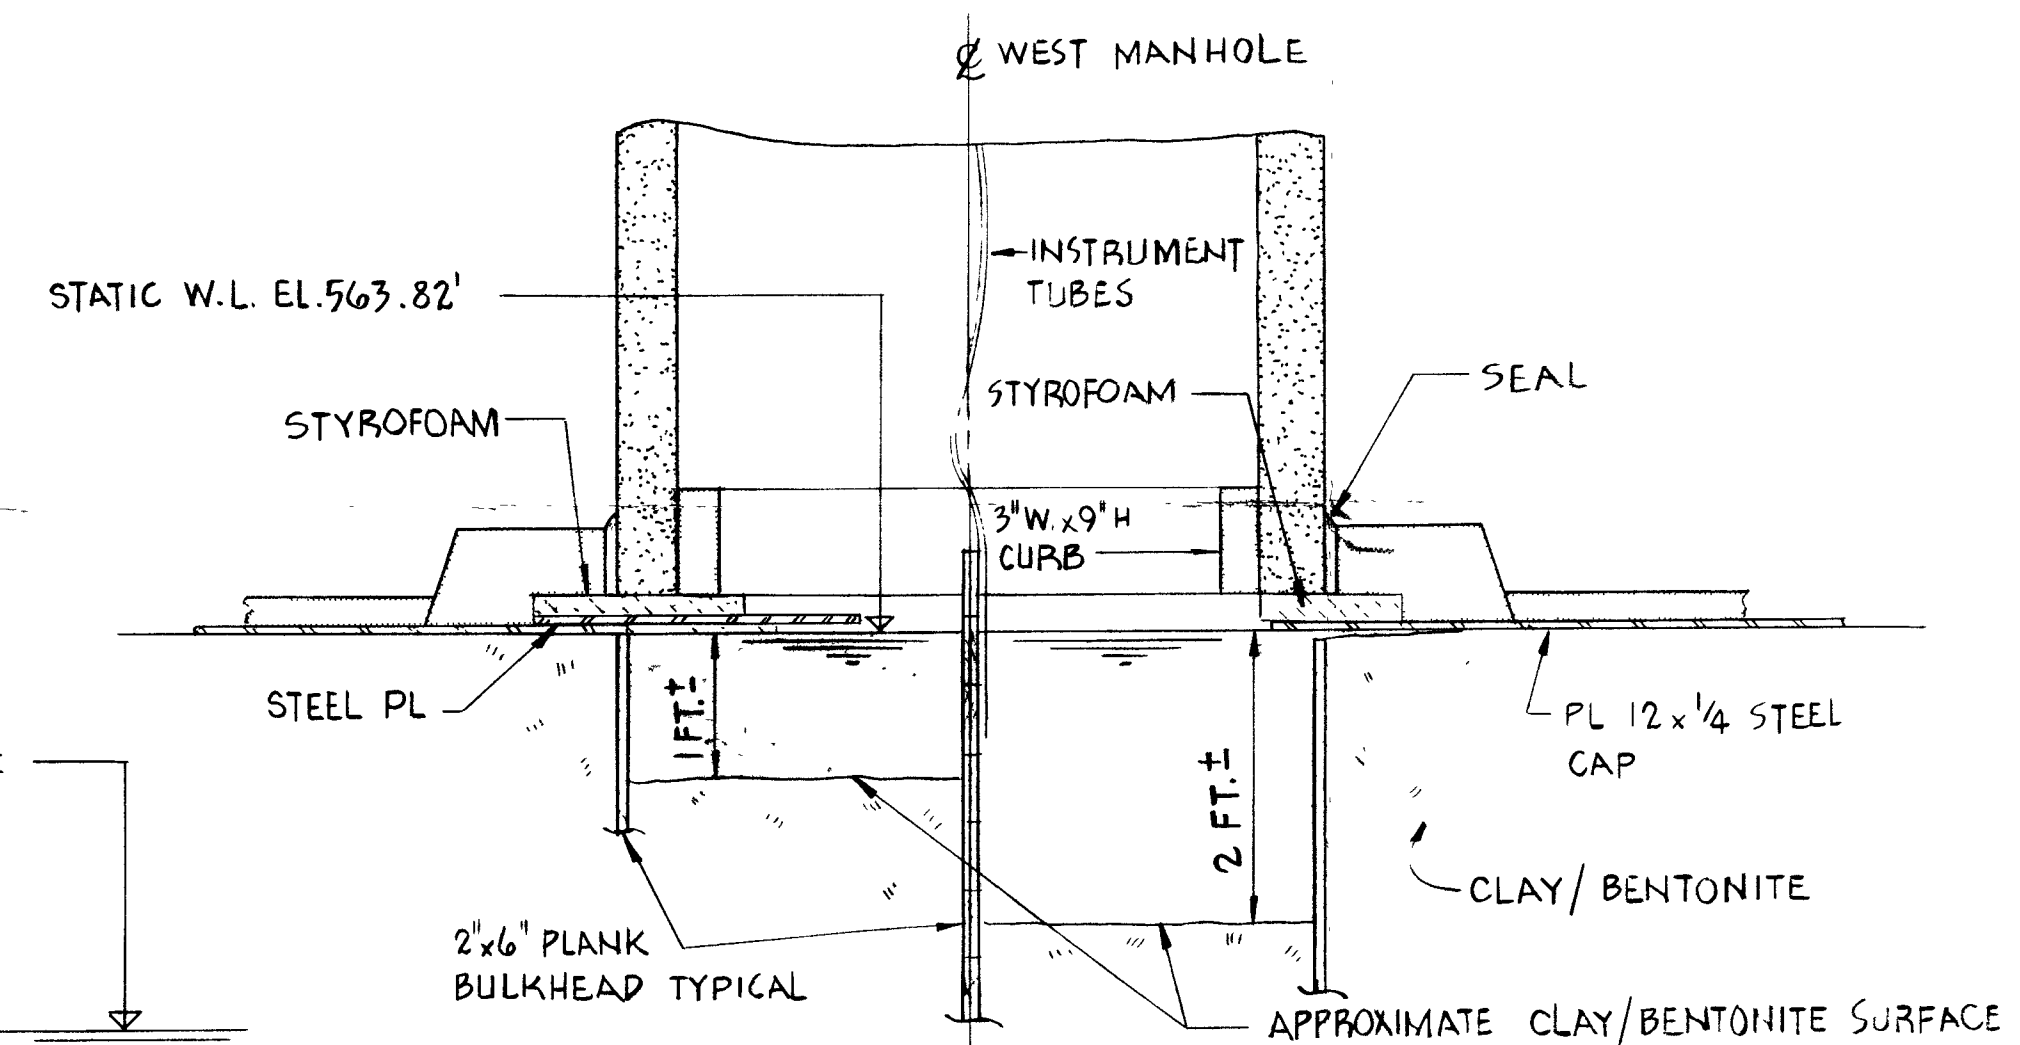
DETAIL 1  
SCALE 3/4" = 1'-0"

The probing within the slot was carried out using a metal fish wire which was pushed along the slot until an obstruction was encountered. Details of what was found in each manhole area are shown on Plate 1, Detail 1 representing the west manhole and Detail 2 the east manhole.

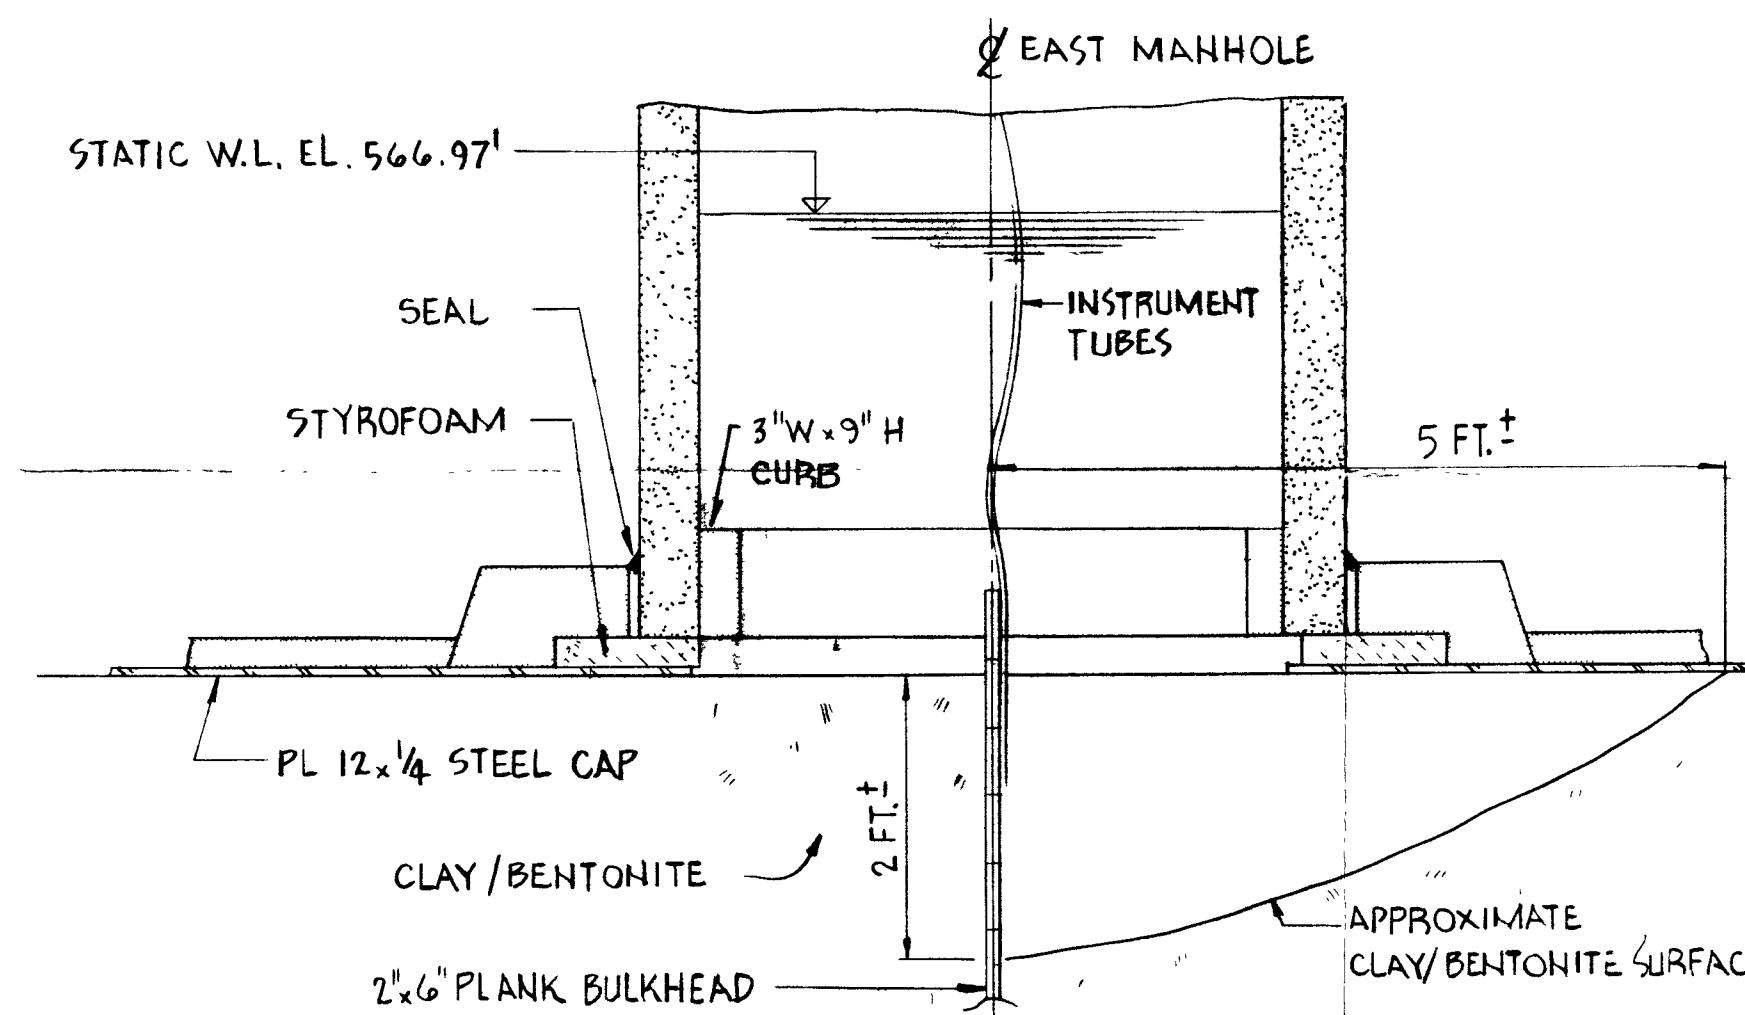
DETAIL 2  
SCALE 3/4" = 1'-0"

In the eastern manhole, only one wooden bulkhead was found near the manhole centre and it also had instrumentation tubes attached to it. The slot is full of clay/bentonite on the west side of the bulkhead, while a triangular-shaped void about 2 ft deep and 5 ft long exists on the east side (see Detail 2, Plate 1).
