THOROLD TUNNEL

INSPECTION OF ROCK SLOT
SOUTH OF WEST SERVICE BUILDING

September 1982

Acres Consulting Services Limited
Niagara Falls, Canada

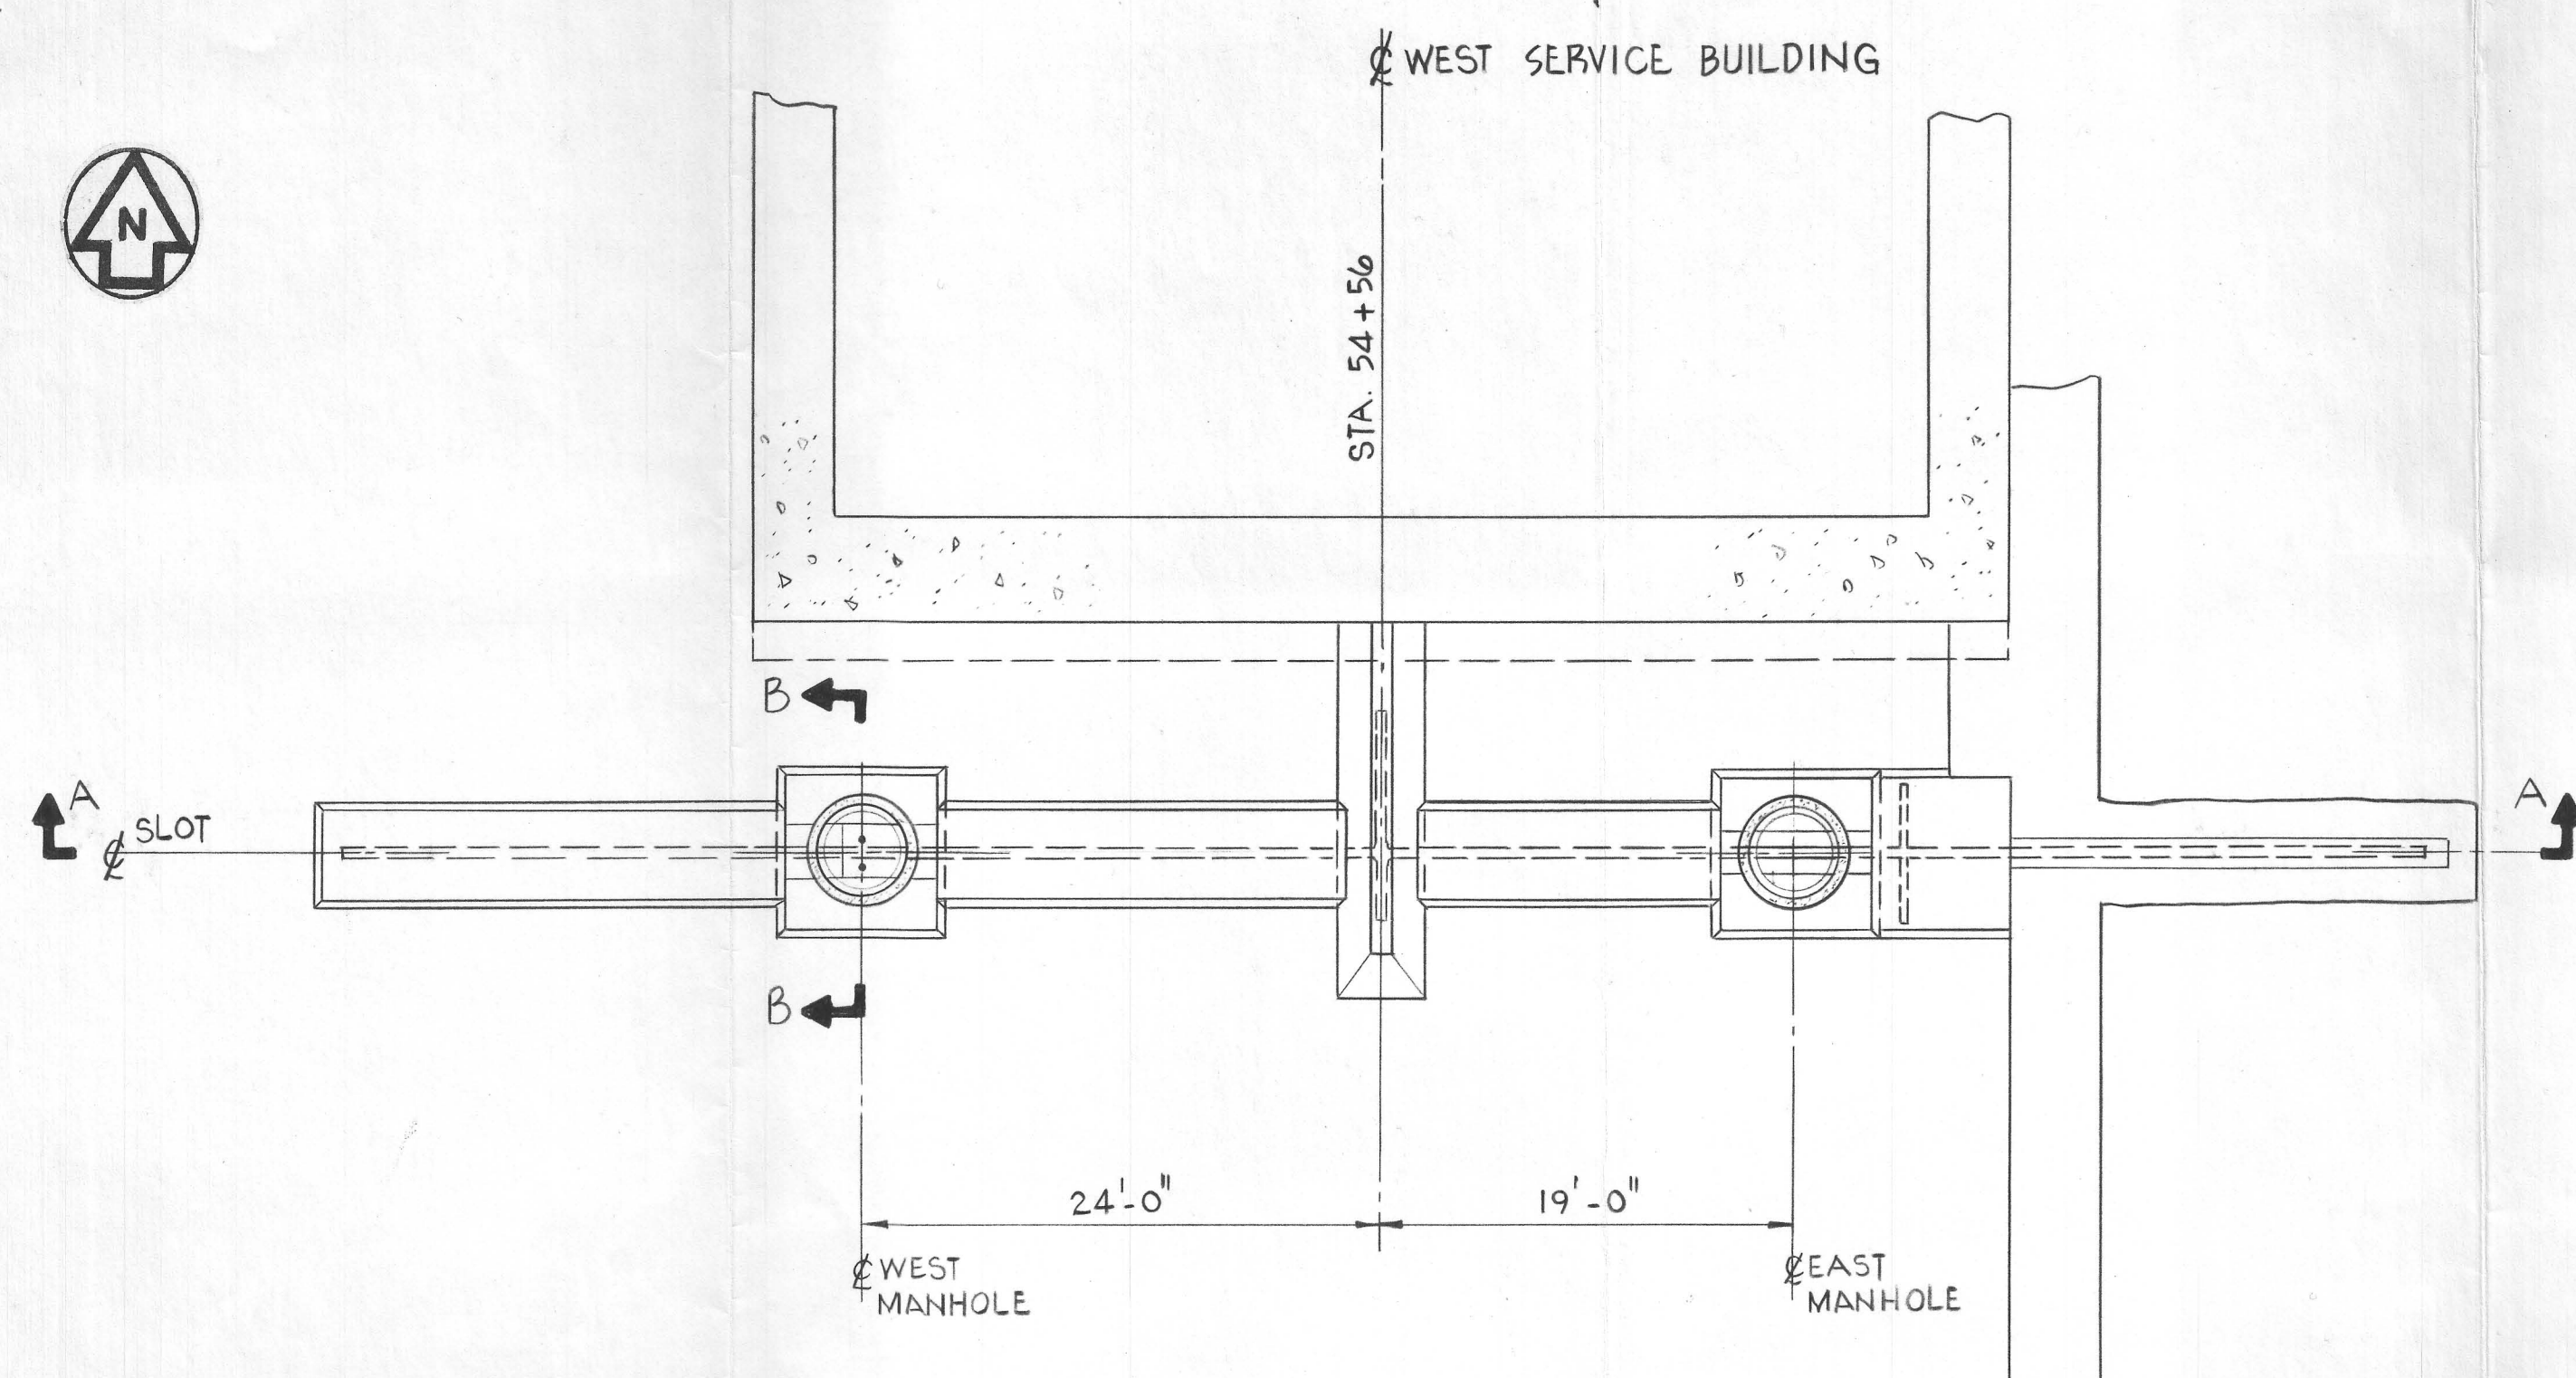
PLAN
SCALE 1/8" = 1'-0"

- (b) The lowering of the surface of the slot fill material appears to have occurred only locally at the two manholes as shown on Plate 1.
- (c) No water flow appears to be taking place along the slot indicating that the seepage control barriers across the slot and the slot fill material are performing effectively.

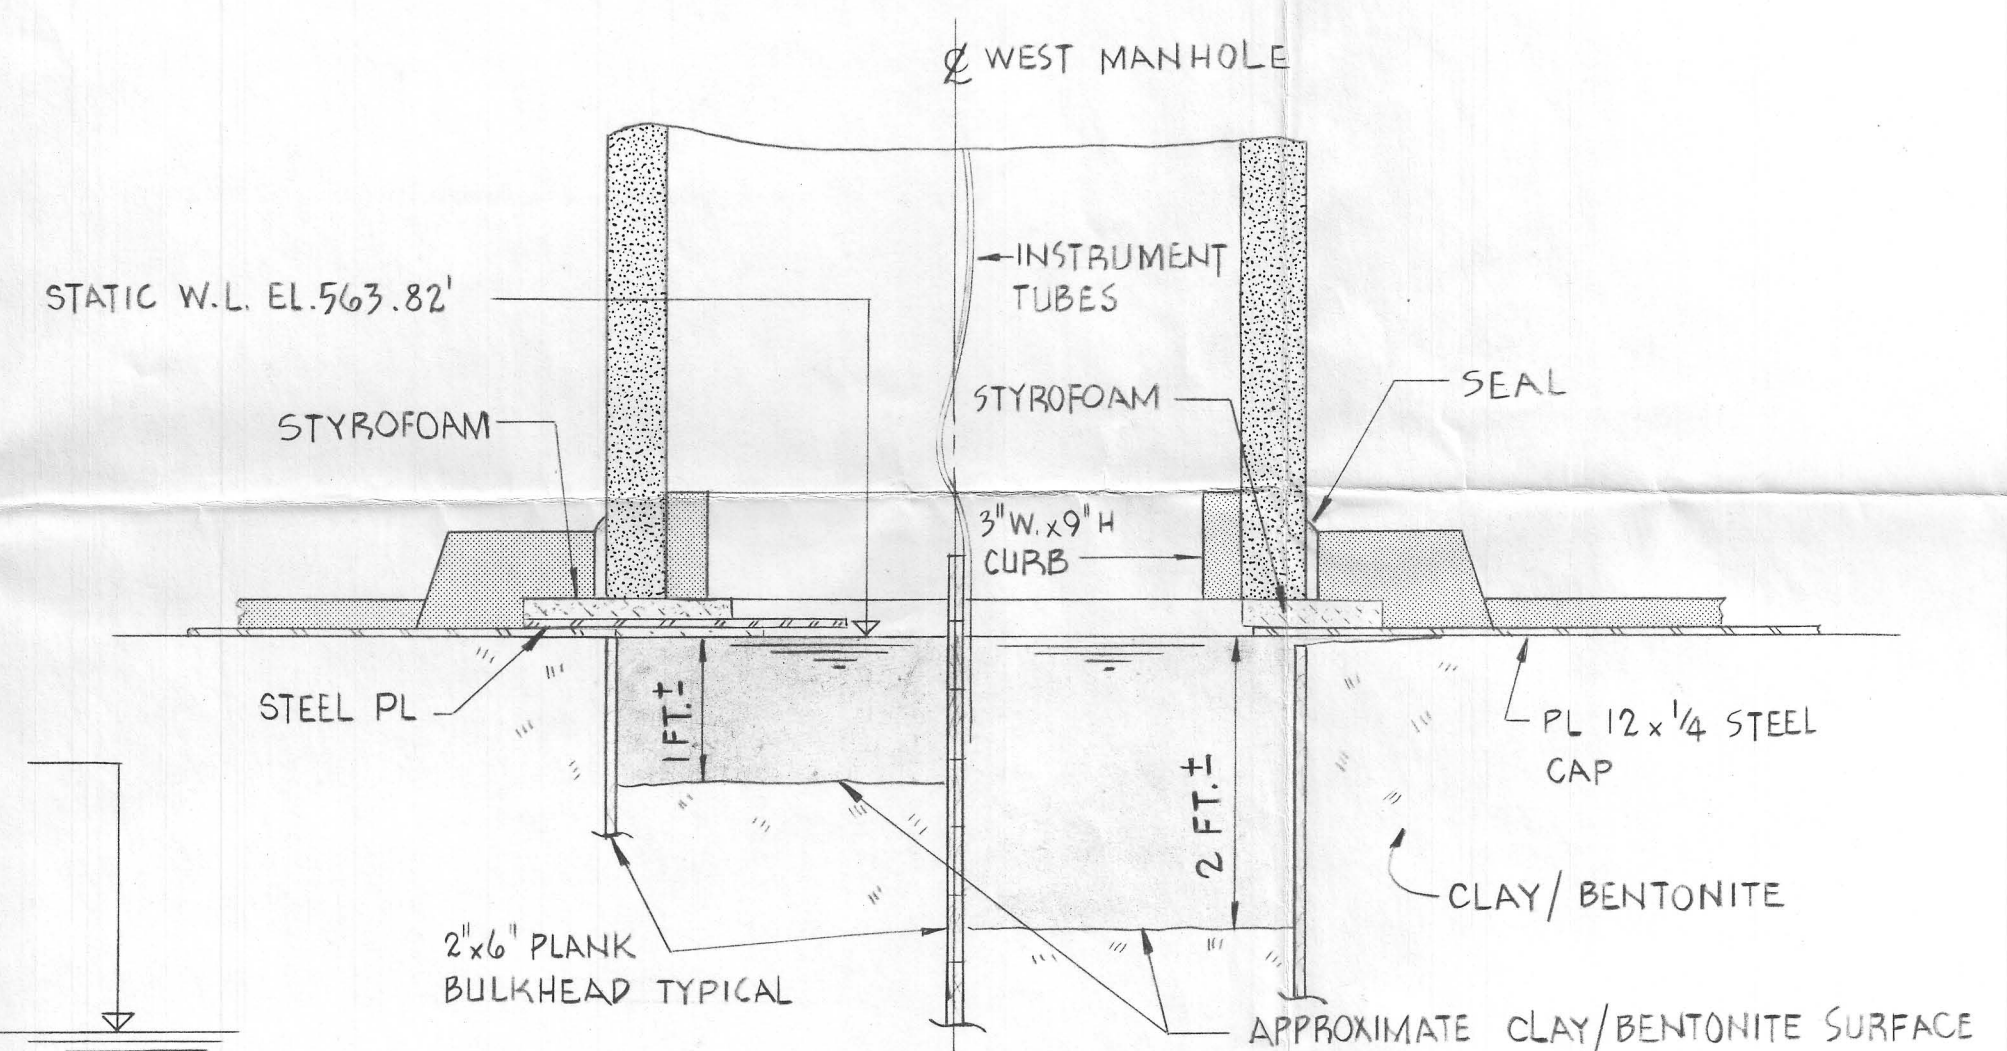
DETAIL 1
SCALE 3/4" = 1'-0"

In the west manhole, three wooden bulkheads were encountered, one in the centre, to which instrumentation tubes had been

fastened, and two others under the manhole walls. The west bulkhead prevented insertion of the fish line, however it was possible to insert the fish over the bulkhead on the east side and extend it for 13.6 ft. Clay/bentonite adhering to the fish indicated that the slot was full on the east side. Within the manhole area, the slot fill was about 1 ft below the bedrock surface in the western half and about 2 ft down in the eastern half.

Since the portion of the slot without fill material is relatively small and no flow appears to be occurring along the slot, it is not considered necessary to proceed with filling the voids at this time. It is recommended that the slot be inspected in the future, say 5 years from now, to assess whether any changes have occurred.

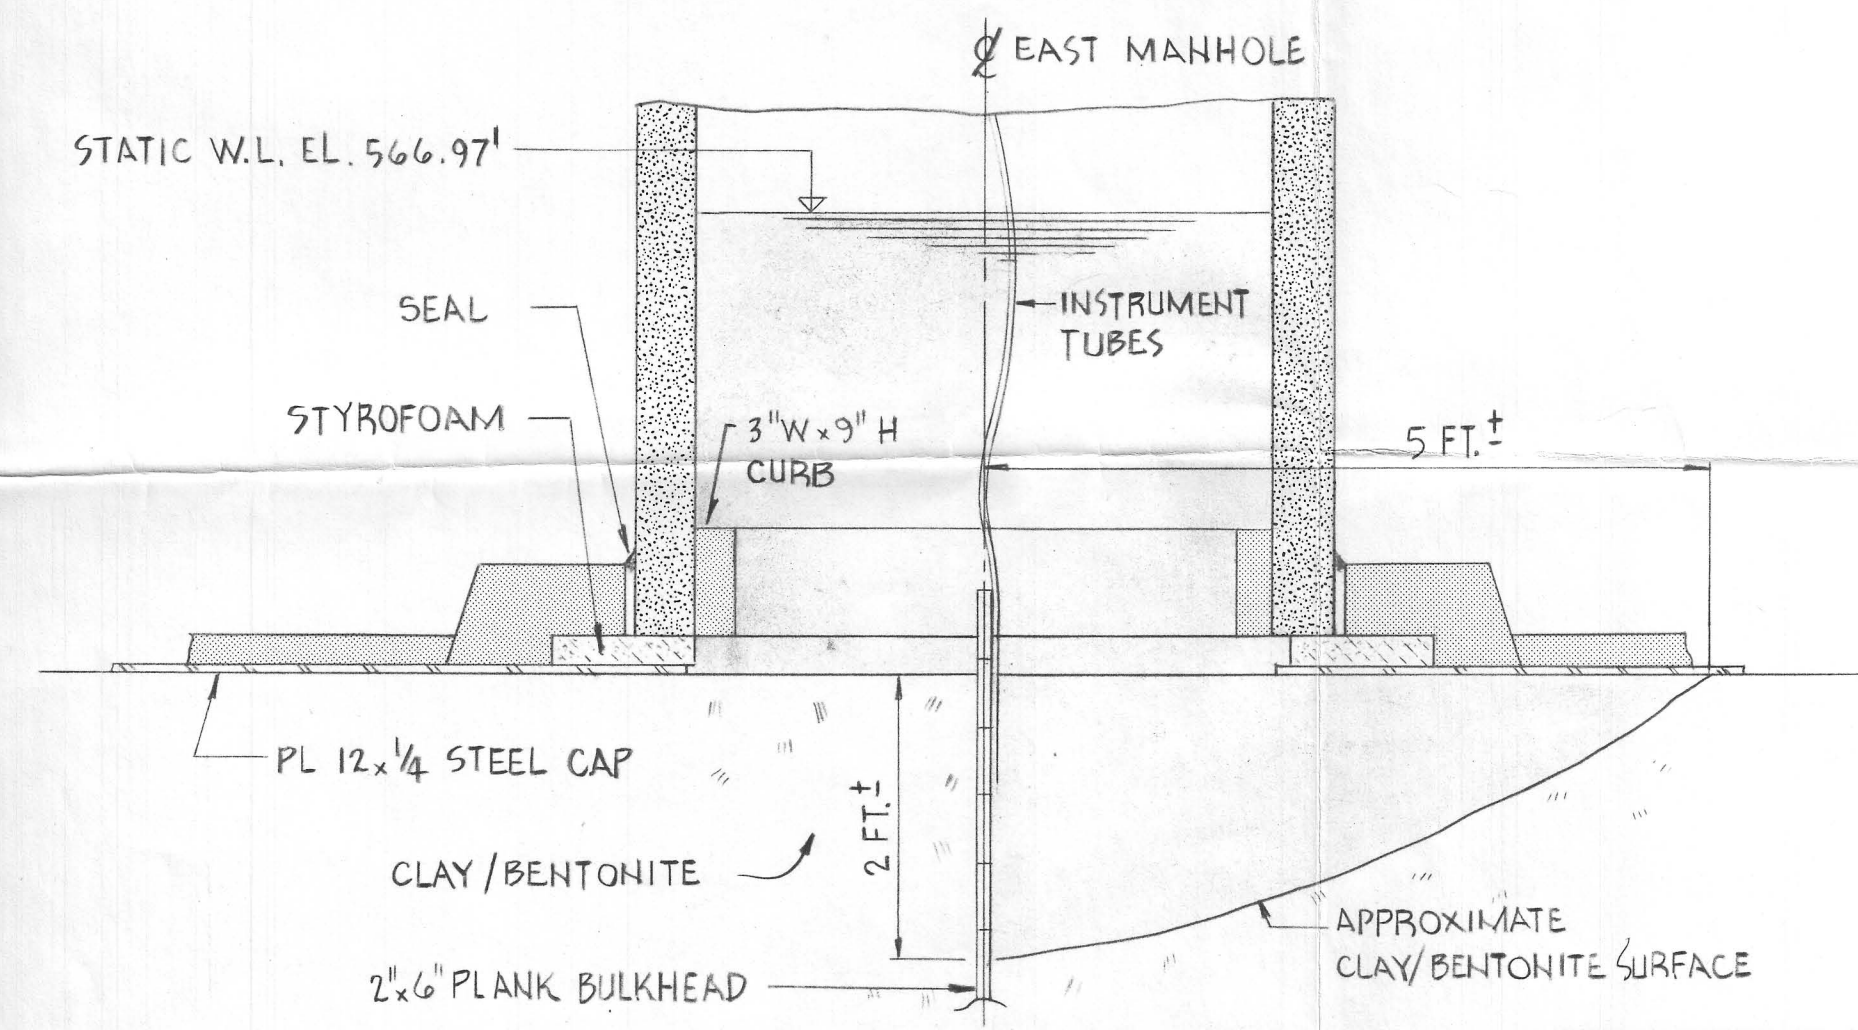
DETAIL 2
SCALE 3/4" = 1'-0"

In the eastern manhole, only one wooden bulkhead was found near the manhole centre and it also had instrumentation tubes attached to it. The slot is full of clay/bentonite on the west side of the bulkhead, while a triangular-shaped void about 2 ft deep and 5 ft long exists on the east side (see Detail 2, Plate 1).
