THOROLD TUNNEL

Investigations to Determine the  
Cause of Cracking in the Structure

Supplementary Report No. 3  
West Service Building  
Review of Observed Structural  
Behavior 1971 to 1972

December 1972

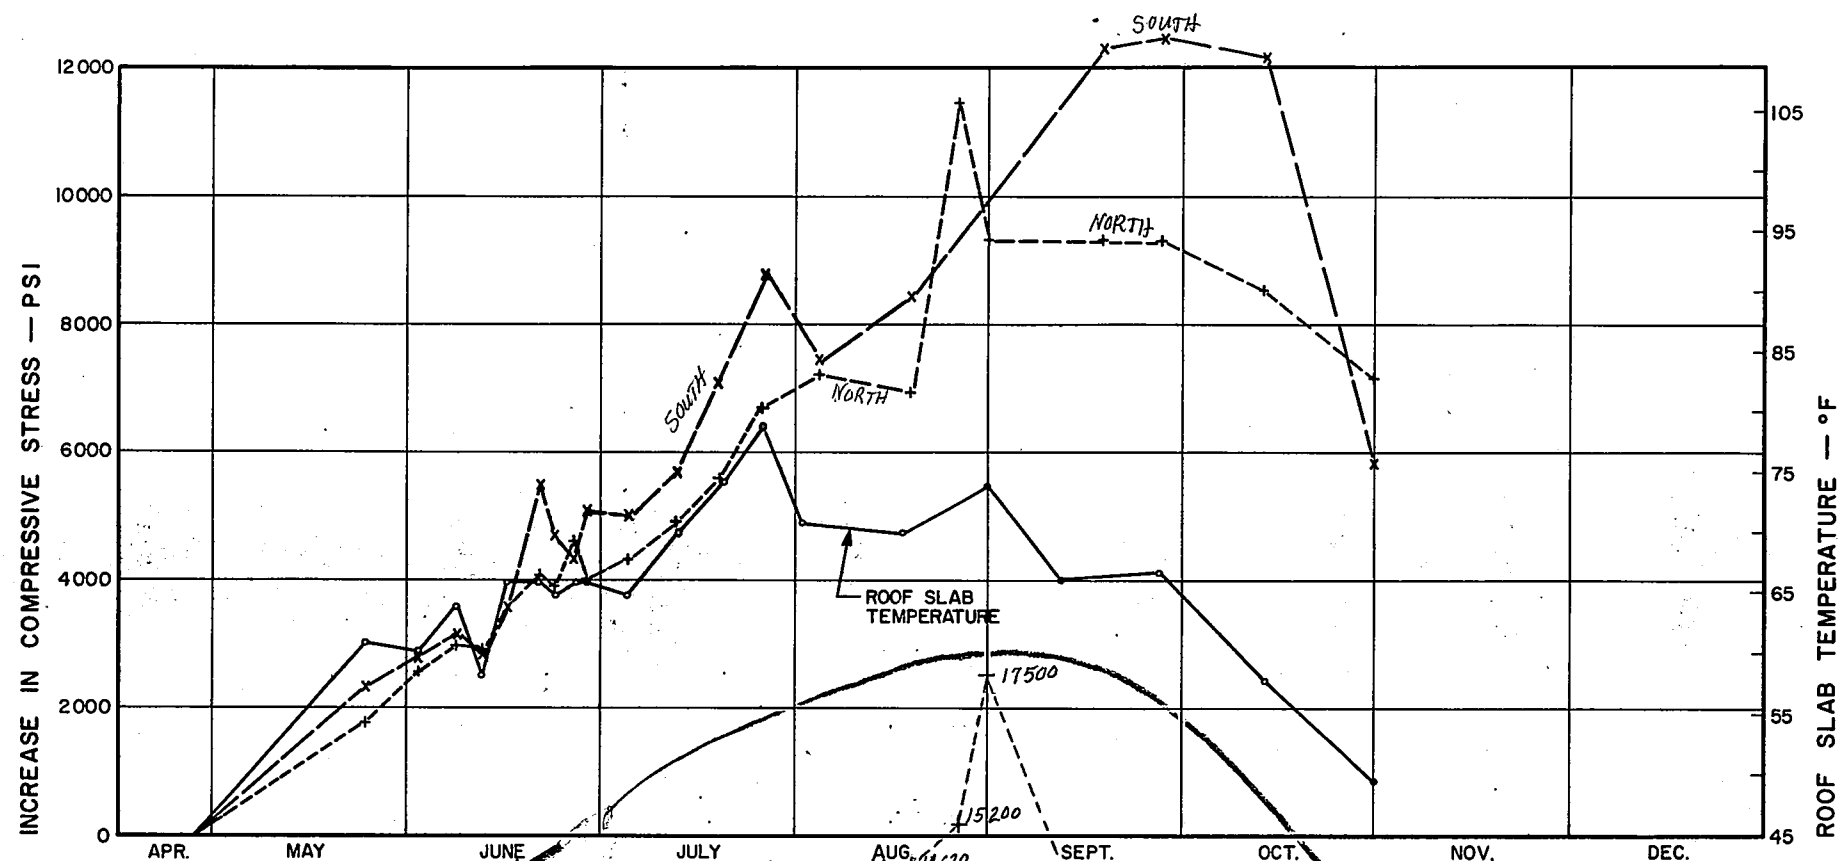
STEEL STRESS CHANGES IN TUNNEL ROOF SLAB

By superposition of the components of the deformation and stress changes in the structure the stress fluctuations for 1971 to 1972 have been derived, and are shown on Plate 3. Peak stress occurred in September, while the peak deformation occurred in November. By integrating the stress fluctuations occurring in September 1972 with the in situ stresses observed in March 1972, peak steel stresses were derived for north and south roof struts, and they were of the order of 32,300 and 44,900 psi respectively, see Table 3.

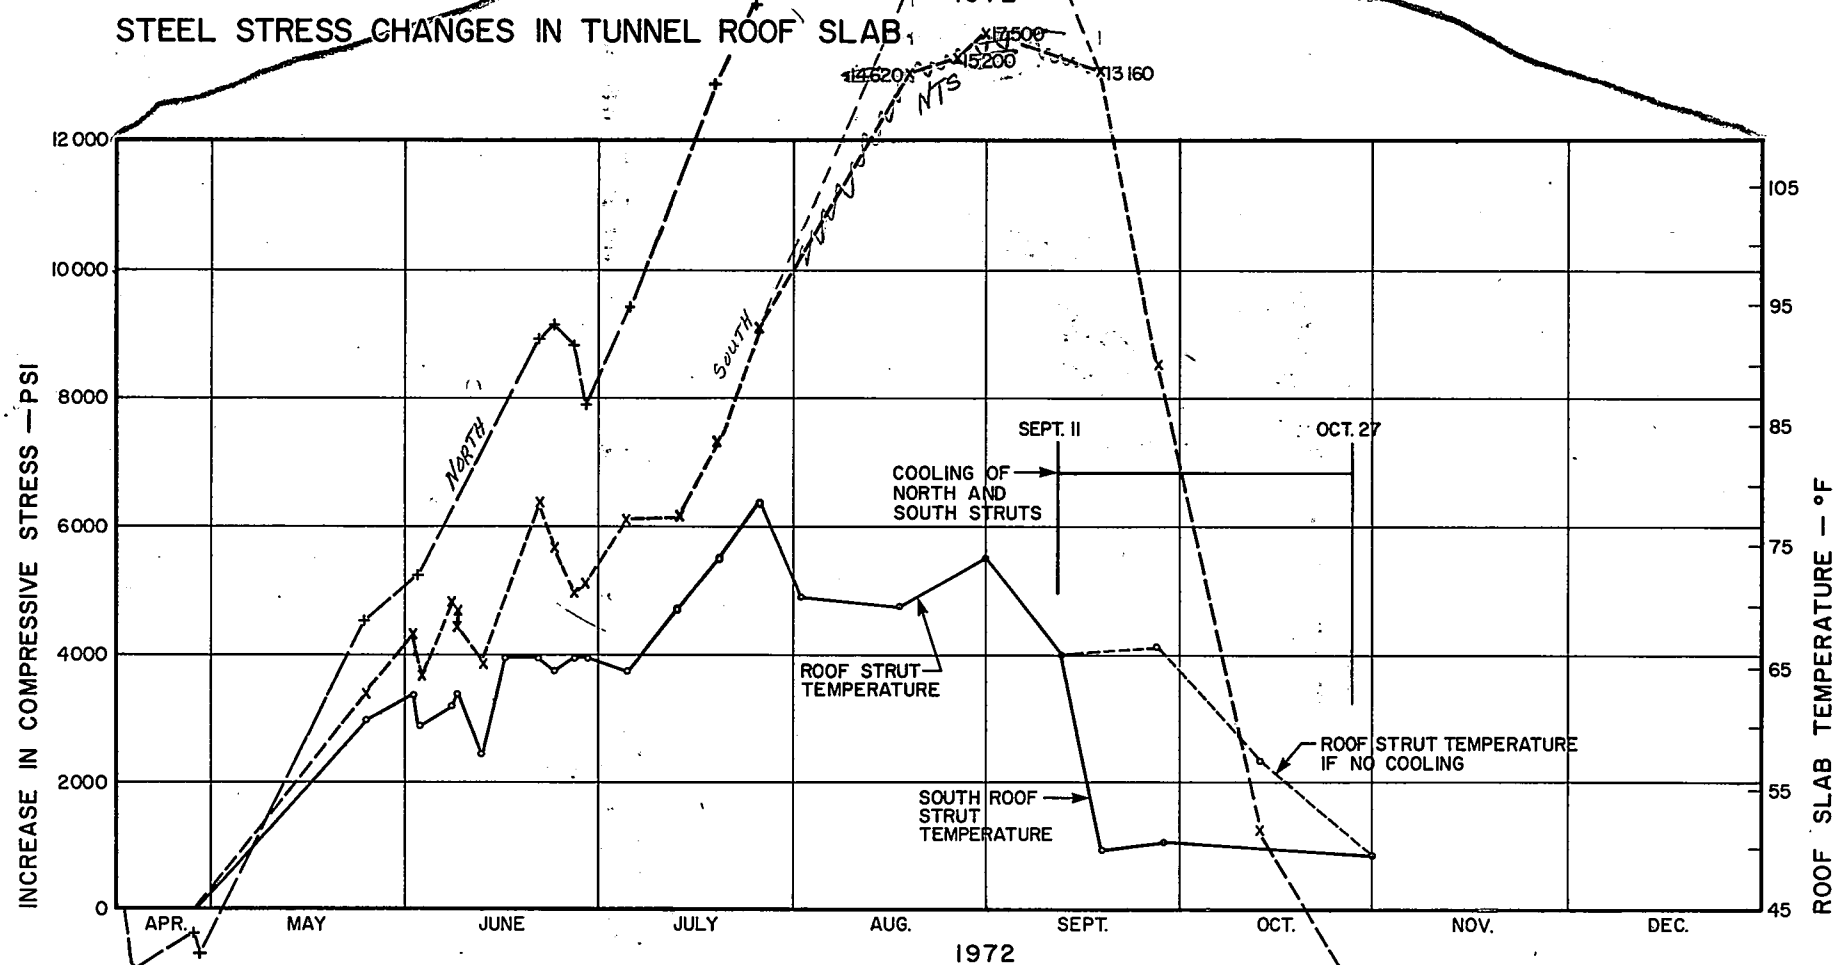
STEEL STRESS CHANGES IN TUNNEL ROOF STRUTS

- (f) Areas of stress concentration have been delineated in the struts between the air exhaust holes in the tunnel roof at the west service building. Peak stresses in 1972 in the reinforcing steel, due to rock squeeze and thermal changes, have been estimated to be 32,300 psi and 44,900 psi in the north and south roof struts respectively (nominal yield stress of steel is 50,000 psi).

It was necessary in September and October 1972 to cool the north and south tunnel roof struts artificially to maintain stress levels approximately equal to those of 1971. In September 1972 the slab was generally at 70 degrees F, while the struts were maintained at approximately 50 degrees F, and this caused a stress reduction of approximately 3,000 psi in the reinforcing steel.

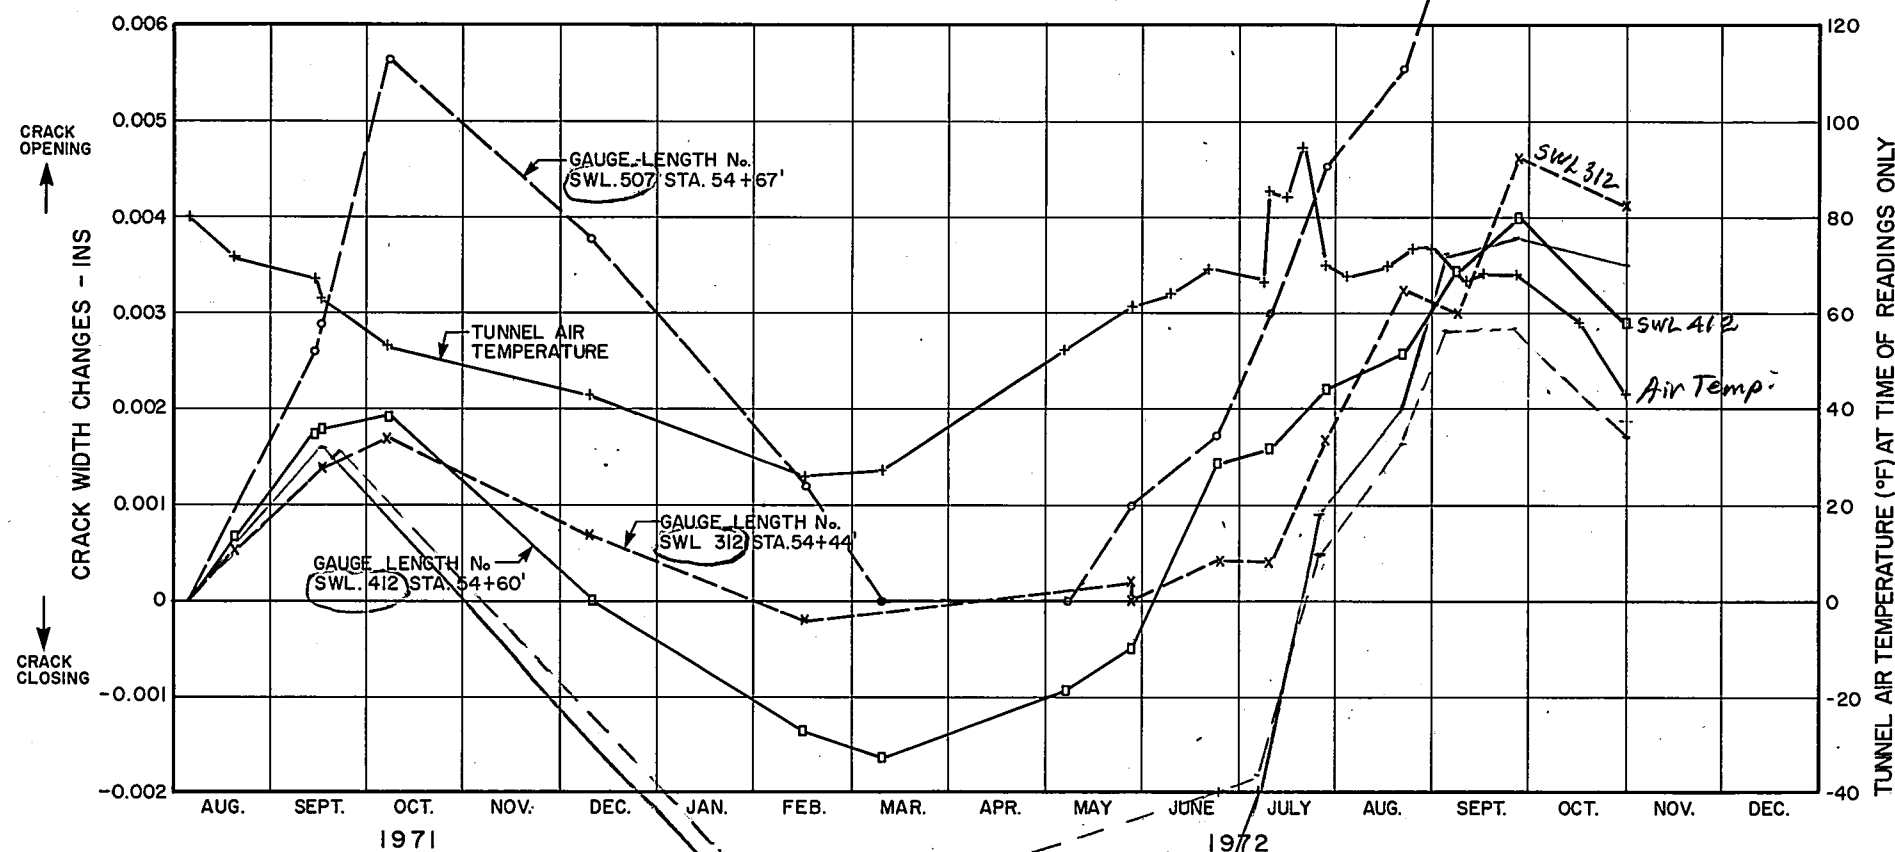
CRACK WIDTH AND TUNNEL TEMPERATURE CHANGES WITH TIME

Crack widths in the south tunnel wall, shown on Plates 5, 8 and 9, have changed significantly, reducing in the winter, with a minimum in March, and widening in the summer and fall. The crack widths measured in September 1971 were exceeded by August 1972, and have continued to enlarge since that date.

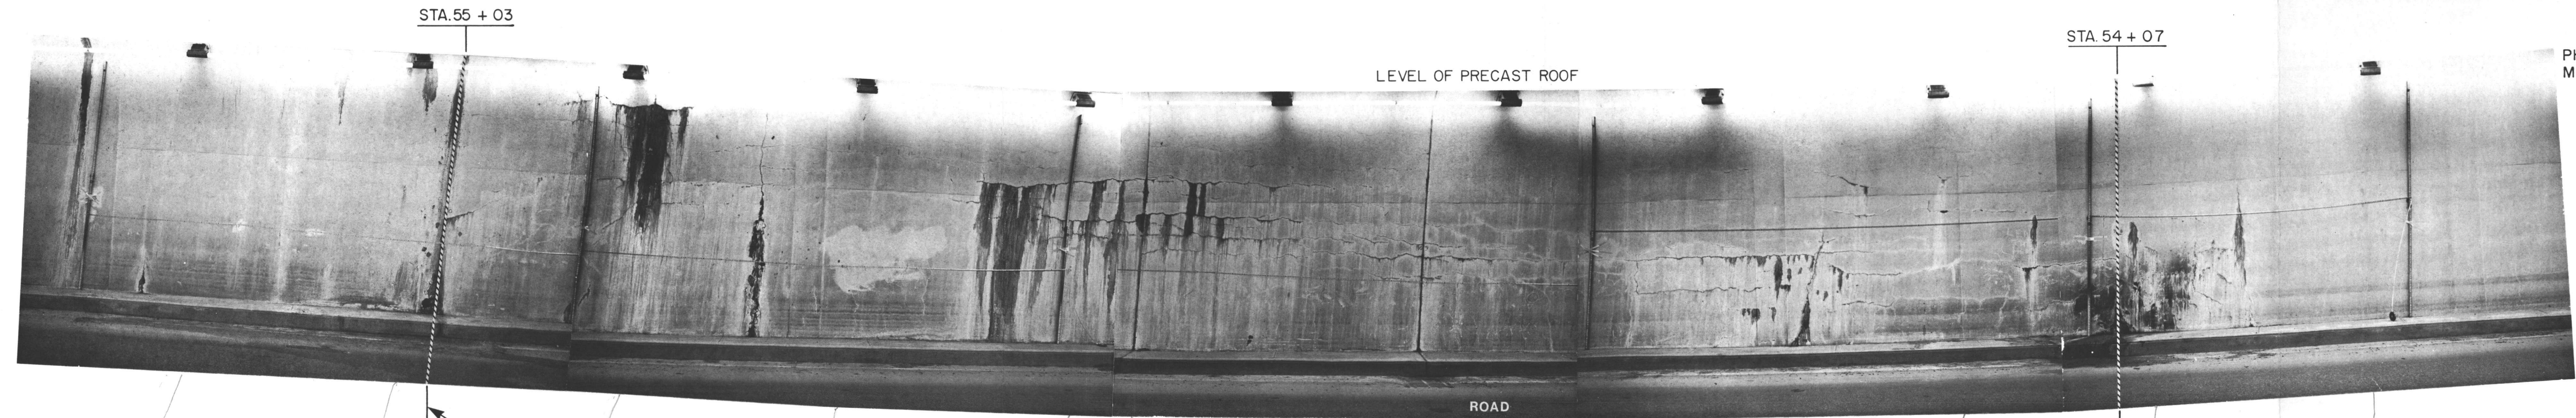
PHOTOGRAPHED  
MAY 1971

The pattern of cracking in the tunnel wall is essentially the same as that previously surveyed in May 1971, but the cracks have propagated slightly and become more evident. Fresh cracks have occurred in the north and south walls of the west service building above tunnel roof level, as shown on Plate 8. The largest crack in this area was approximately 0.030 inch wide in February 1972, and has increased by 0.012 inch between June and October 1972.

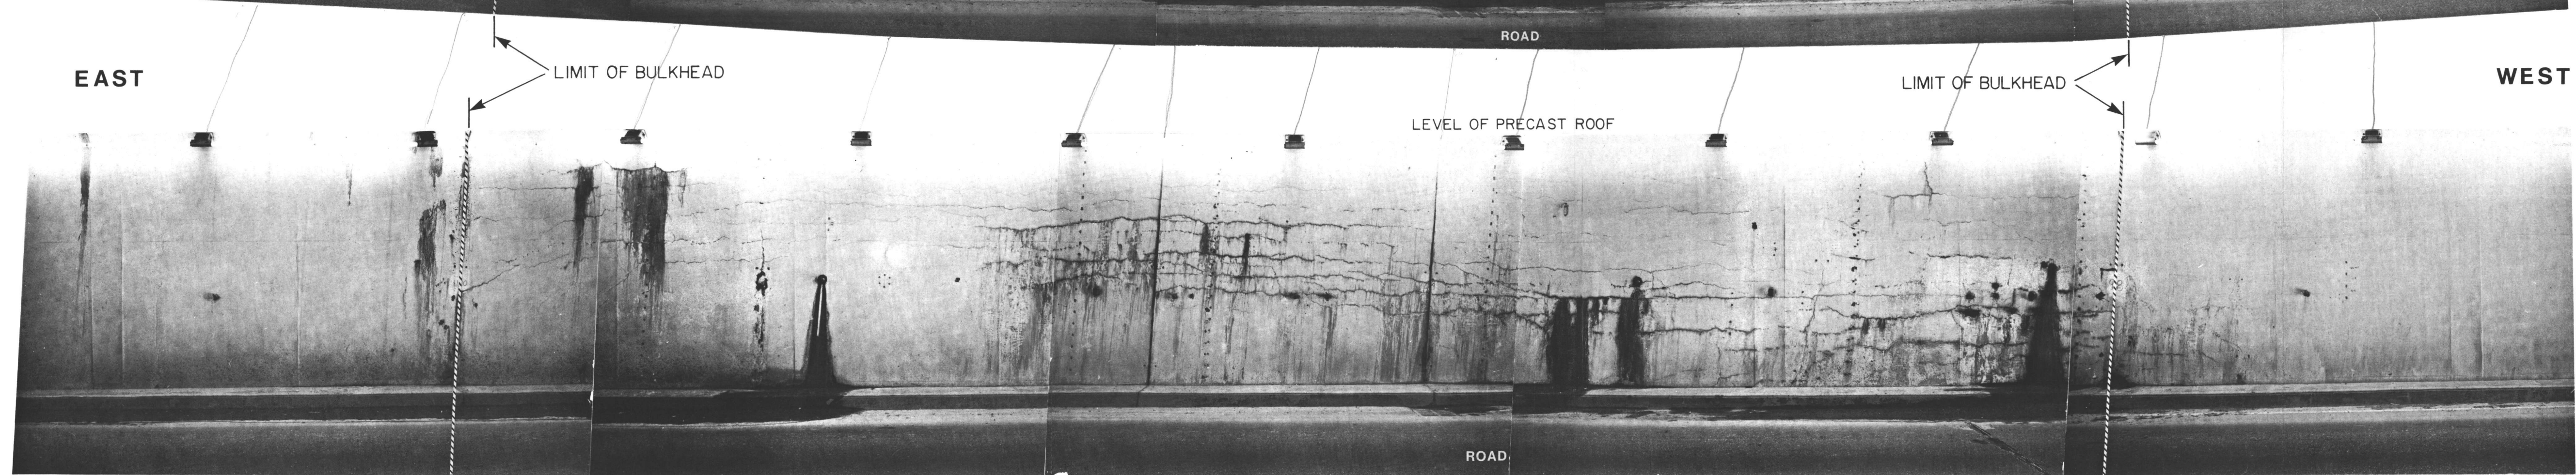
PHOTOGRAPHED  
NOV. 1972

The cracking pattern observed in the south tunnel wall at the west service building in November 1972 is shown on Plates 8 and 9. The width of the cracks in the tunnel wall have varied significantly over the past year. These variations have been symptomatic of flexure of the wall, with a peak width occurring in November. Generally, the crack widths of 1972 have exceeded those measured in 1971, indicating that the cracks have penetrated deeper into the wall than the 3 feet 6 inches observed in October 1971. As noted in May 1972 the wall is already well advanced into a Phase 2 condition. It is estimated from changes observed in 1971-1972 that areas of the wall will reach Phase 3 within 8 years or so, if no remedial work is done. At this stage progressive collapse of the structure will be considered to have commenced and be evidenced initially by minor spalling.

Above tunnel roof level on the west service building new cracking has occurred in the north and south walls, as shown on Plate 8. Also, cracks have continued to enlarge at a significant rate. The major crack in this area was approximately 0.030 inch wide in October 1971, with an increase of about 0.012 inch measured between June and October 1972. It is considered that corrosion of the steel exposed at the cracks may reduce the time required to reach the Phase 3 condition.

It is assumed that, following completion of the remedial work as described, it will be necessary to seal the cracks to prevent further corrosion of the reinforcing steel, and to allow restoration of the structural surface in the tunnel.

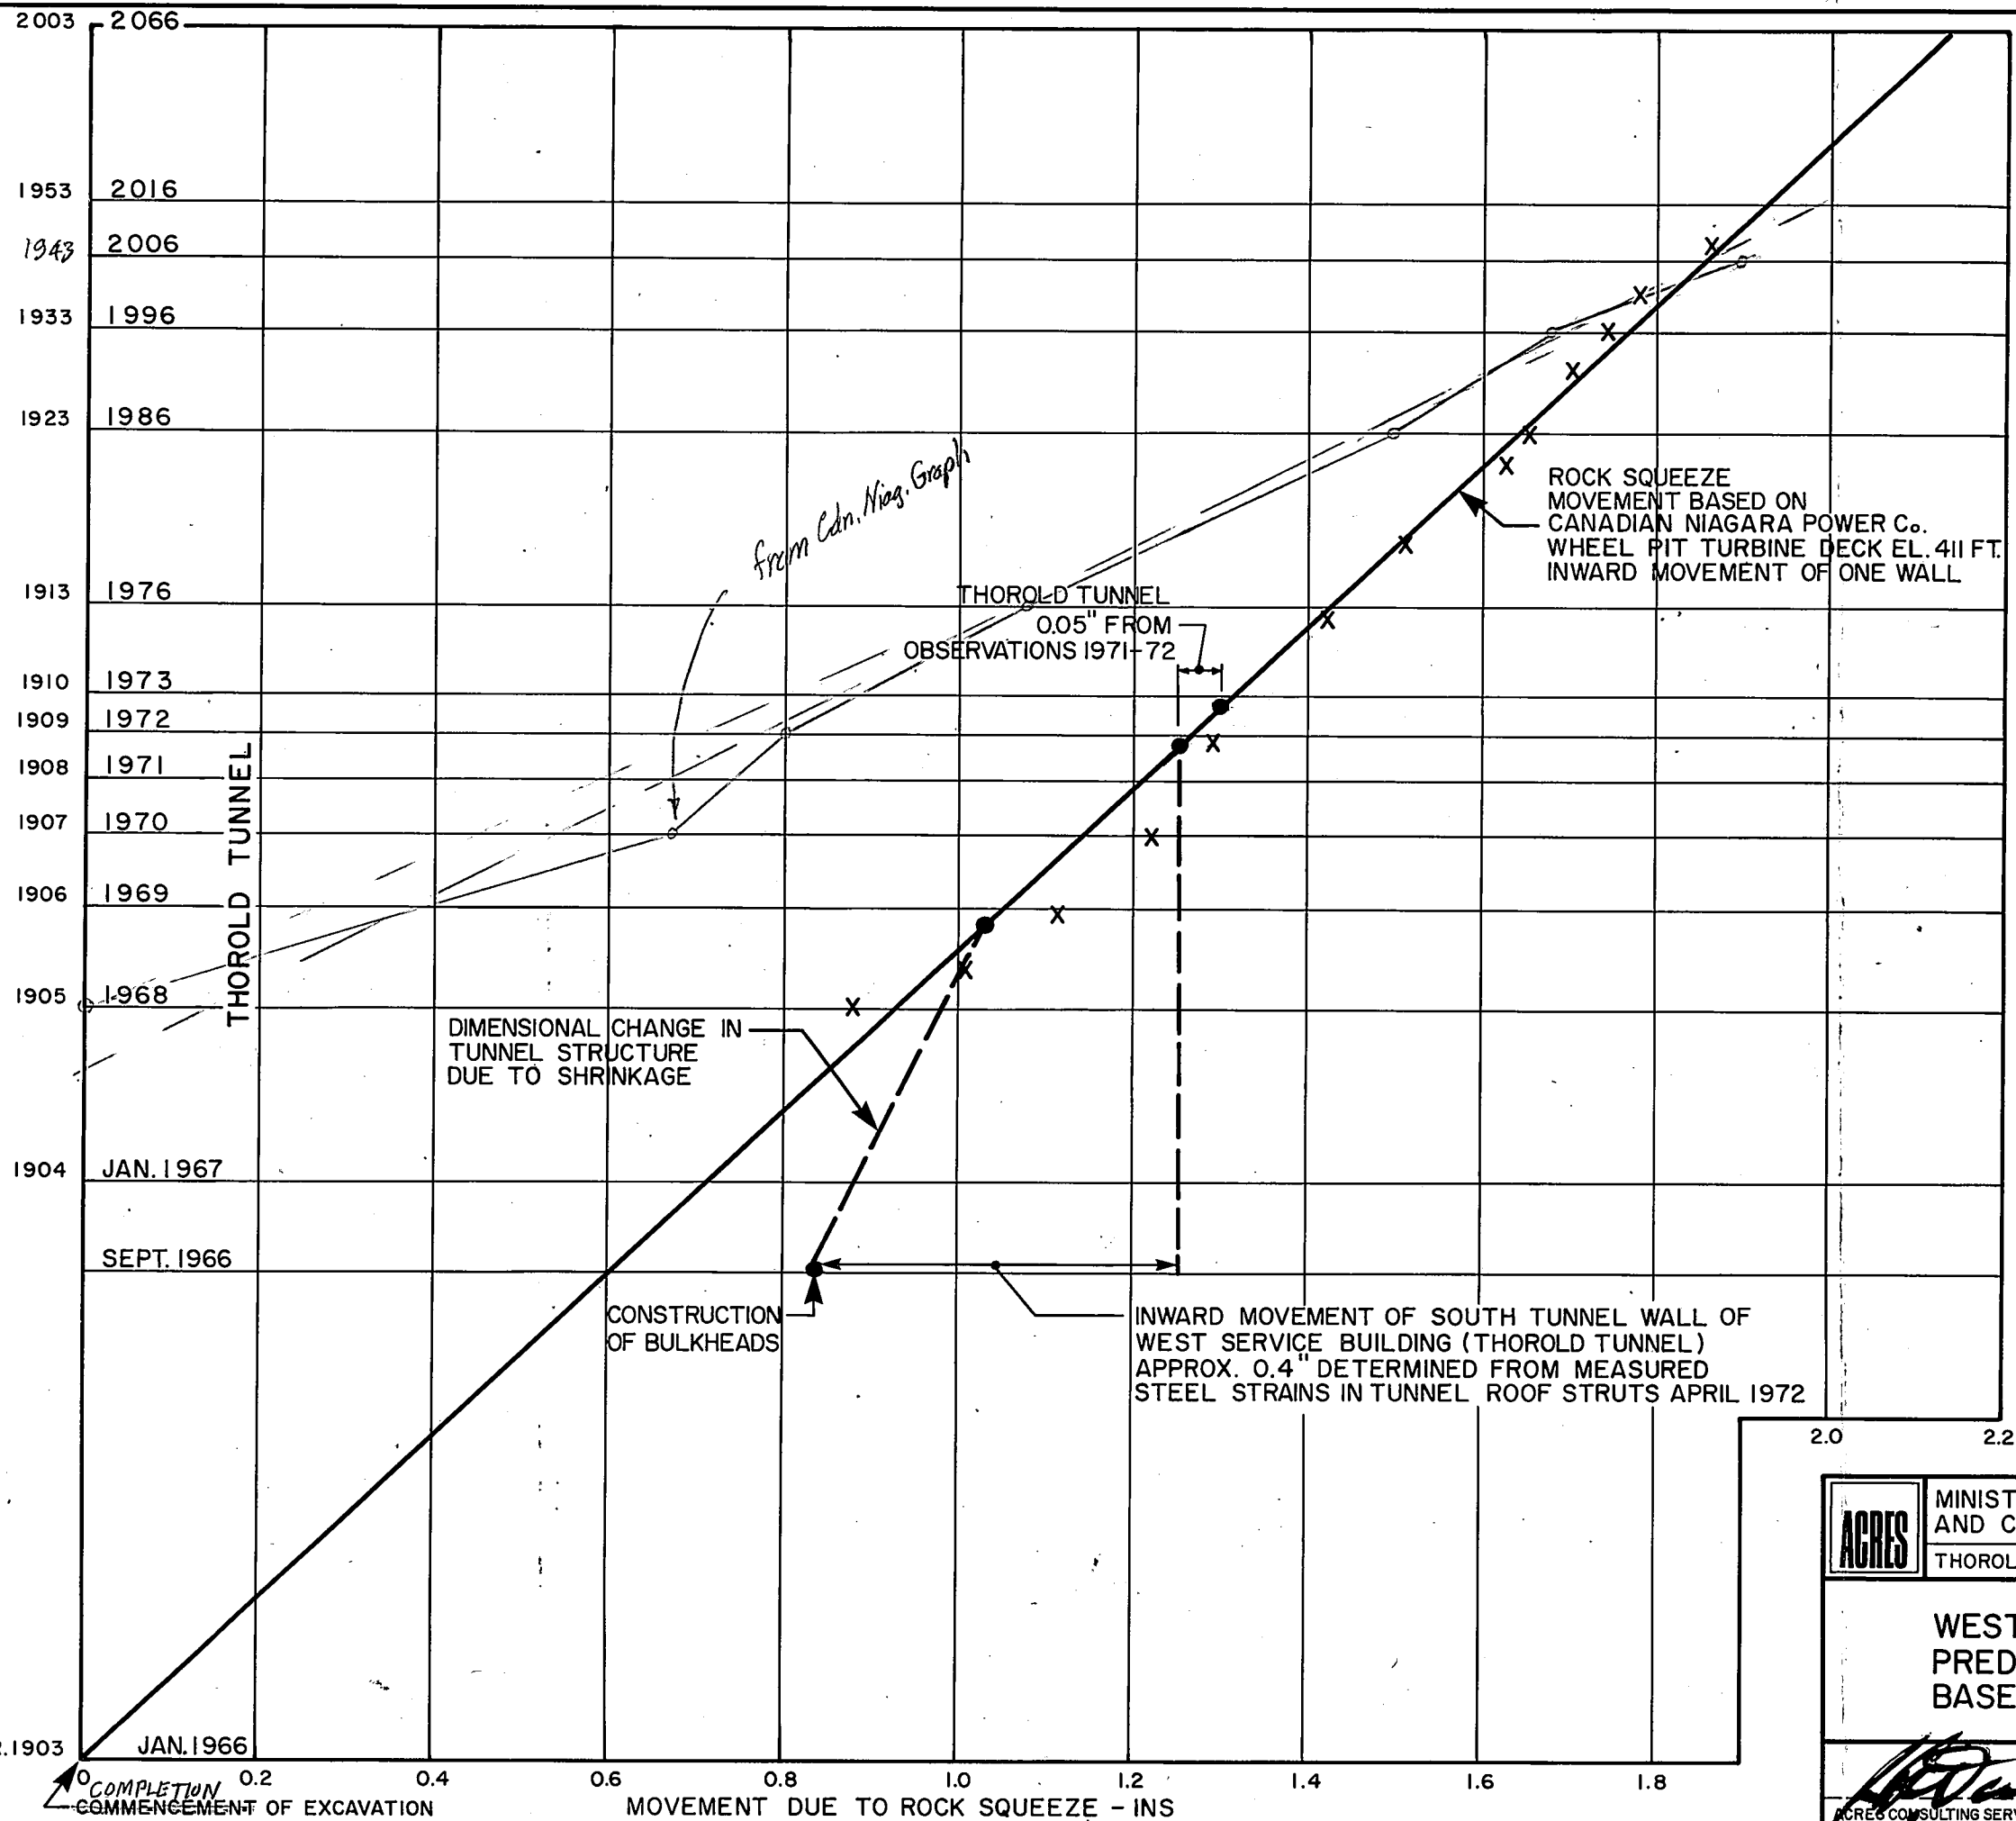
- (k) It is predicted, see Plate 12, that over the next 70 years the inward movement of each wall of the tunnel will be of the order of 0.7 inch. This figure is based on data from the Canadian Niagara Power Company's wheel pit, with which the 1 year's observations in the tunnel are in agreement. Due to the short duration of observations at Thorold, this prediction must be used with considerable caution.

The observed deformations at the Canadian Niagara Power Company wheel pit and at Thorold have been used to develop a hypothetical curve for imposed deformation due to rock squeeze, as shown on Plate 11. This curve has been adjusted to take into account the natural shrinkage of the concrete structure. Extrapolation of the deformation curve into the future has been based on observations in the Canadian Niagara Power Company's wheel pit, as given in the original report of March 1972. These observations correlate well with the tunnel measurements when plotted on a semilog scale, with the time scale adjusted with respect to initial excavation, see Plate 12. Based on this curve, for the period November 1972 to November 2022, the north and south tunnel walls will each have an estimated inward closure of the order of 0.7 inch. This figure is based on extremely limited knowledge of the actual mechanism of rock squeeze at Thorold, and hence, its use in predicting future behavior of the west service building must be treated with caution.

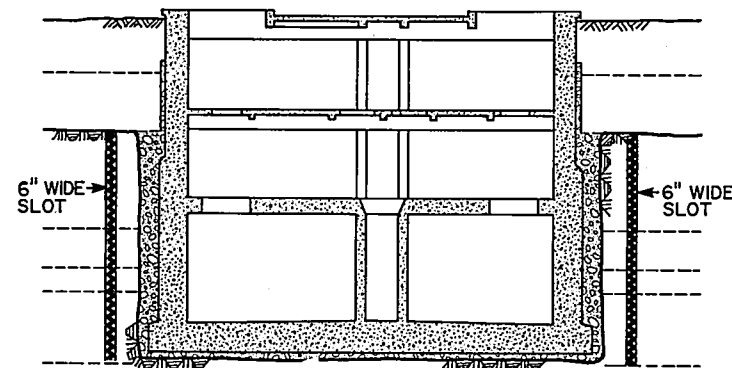
### 1. REMOVE ROCK DEFORMATION FROM STRUCTURE

THIS MEETS THE TWO OBJECTIVES OF REDUCING PRESENT HIGH STRESSED CONDITION AND ELIMINATING FUTURE HIGH STRESSES

THIS WORK CAN BE CARRIED OUT FROM GROUND SURFACE AND WILL NOT INTERFERE WITH TRAFFIC IN THE TUNNEL

CUT SLOTS IN THE ROCK BOTH SIDES OF THE STRUCTURE

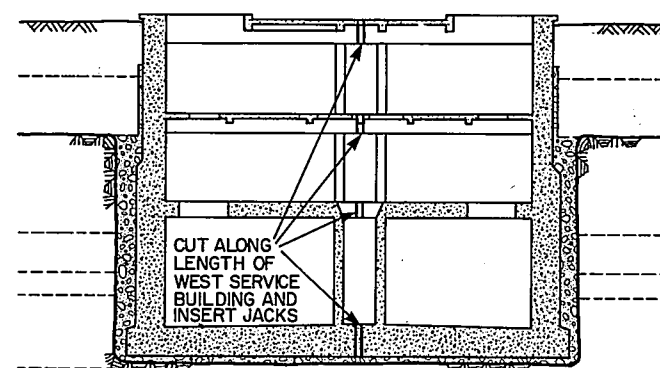
### 2. MODIFY STRUCTURE TO REDUCE INTERNAL STRAIN TO ACCEPTABLE LEVEL

WILL REMOVE PRESENT DEFORMATIONS ON STRUCTURE BY ROCK SQUEEZE AND COULD ELIMINATE FUTURE IMPOSED DEFORMATIONS

IT IS IMPRACTICABLE TO CUT THE MORE RIGID MEMBERS WITHOUT ENDANGERING THE SAFETY OF THE STRUCTURE OR ENGAGING IN MAJOR ALTERATIONS

CUT STRUCTURAL MEMBERS ACTING AS STRUTS BETWEEN ROCK FACES

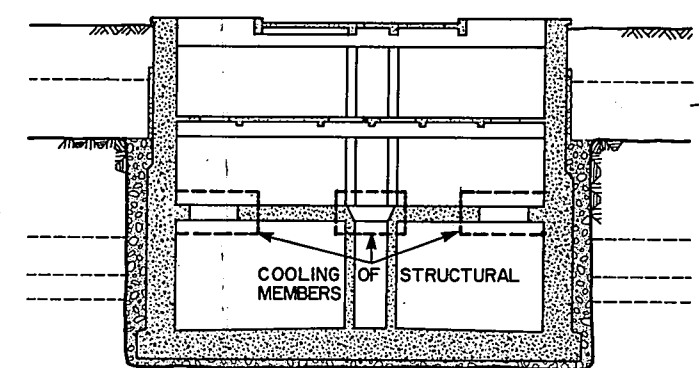
### 3. COOLING OF STRUCTURAL MEMBERS

CANNOT BE REGARDED AS A PERMANENT SOLUTION AS TEMPERATURES REQUIRED ARE EXCESSIVELY LOW AND NOT PRACTICABLE TO APPLY TO ALL MEMBERS

APPLY REFRIGERATION TO MEMBERS ACTING AS STRUTS TO REDUCE THEIR LENGTH AND PERMIT ROCK SQUEEZE TO CONTINUE

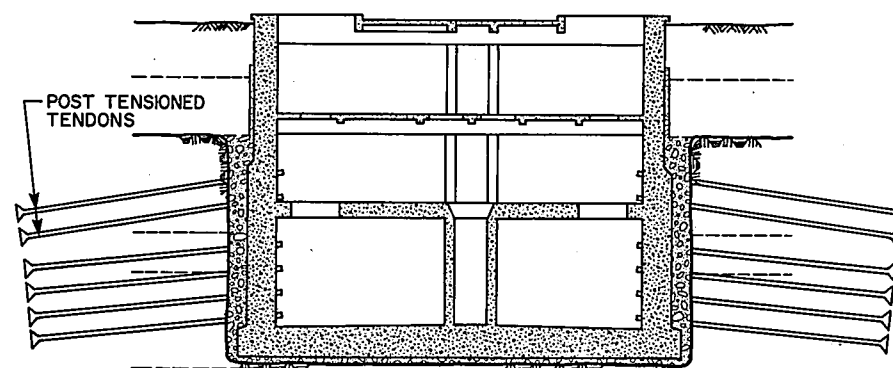
### 1. POST-TENSIONED TENDONS IN ROCK

TO EITHER a. MAINTAIN STRUCTURE IN PRESENT CONDITION OF STRAIN, THIS MAY BE PRACTICAL BUT WILL NOT REDUCE PRESENT UNACCEPTABLY HIGH STRESS LEVELS IN THE STRUCTURE

OR b. RELIEVE STRAINS IN STRUCTURE, THIS IS NOT PRACTICABLE

ALSO INVOLVES CLOSING ONE TUBE OF TUNNEL FOR PROTRACTED PERIOD

LARGE DIAMETER TENDONS AT CLOSE SPACING INSTALLED FROM INSIDE TUNNEL

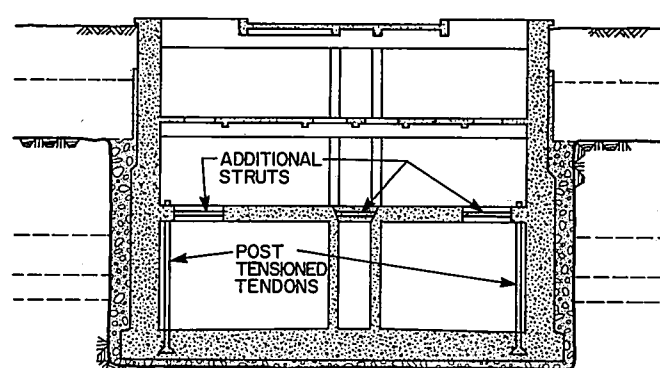
### 2. STIFFENING THE STRUCTURE

WILL NOT PREVENT FURTHER DEFORMATION DUE TO ROCK SQUEEZE

REQUIRES CLOSING ONE LANE AT LEAST TO IMPLEMENT AND WILL REDUCE TUNNEL CLEARANCES

POST-TENSIONING THE WALLS AND PROVIDING ADDITIONAL STRUTTING AT TUNNEL ROOF LEVEL

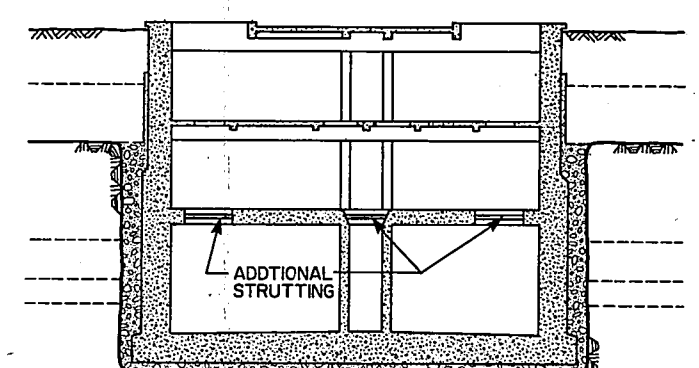
### 3. STRUTTING ACROSS STRUCTURE

WALLS WOULD CONTINUE TO DEFORM LEADING EVENTUALLY TO FAILURE

PROVIDING ADDITIONAL STRUTTING IN VENTILATION OPENINGS AT TUNNEL ROOF LEVEL
