THOROLD TUNNEL

Investigations to Determine the
Cause of Cracking in the Structure

Supplementary Report No.2
East Service Building

December 1972

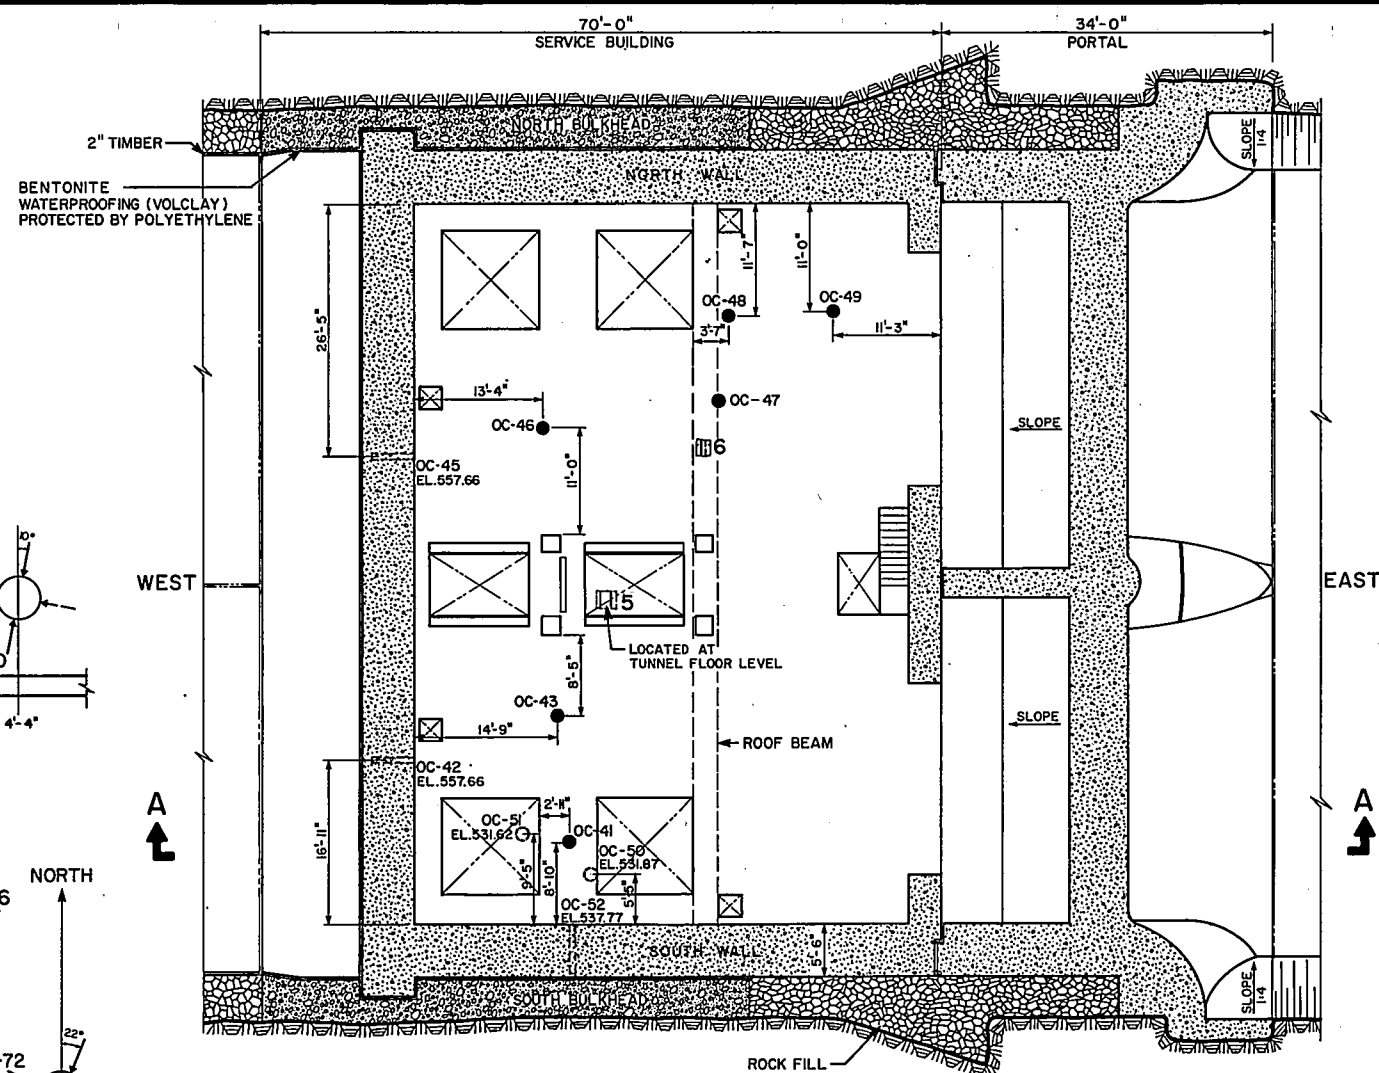
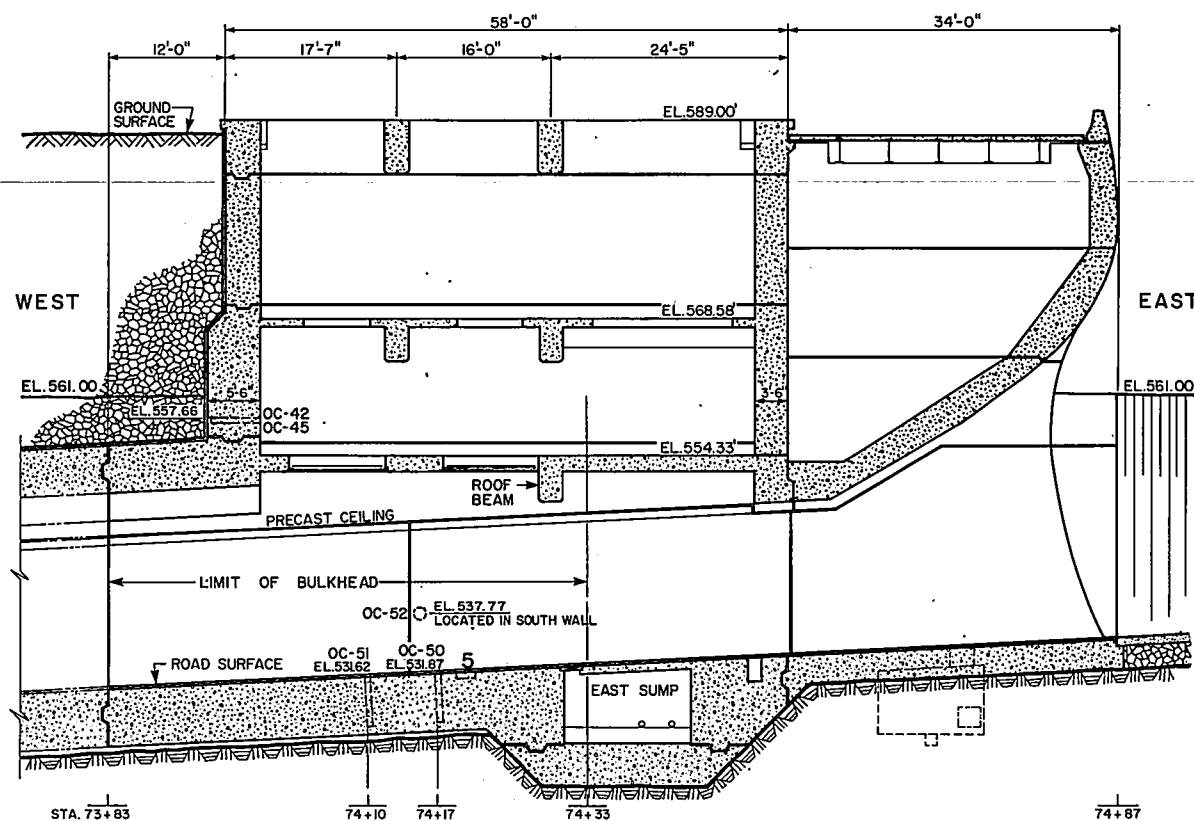
PLATE 1

The stresses determined from strain measurements in both the concrete and reinforcing steel at all locations were considerably lower than design stress levels.

The distribution of compressive concrete stresses in the tunnel roof slab, elevation 554.33 feet, was consistent with that anticipated, with the highest stresses in the area of roof spanning between the north and south bulkheads. Highest concrete stress levels were measured in the area of slab between the ventilation holes, but the readings were not of sufficient magnitude to indicate clearly a stress concentration in this area compared with the adjacent slab. Lower concrete stress levels in the north-south direction were measured in Holes OC-48 and OC-49, located elsewhere in the roof slab.

The stresses in the concrete of the road slab in Hole OC-51 were compressive and significantly higher than those at roof level, but were considerably below design values, the orientation being predominantly in a north-south direction.

Steel stresses indicated a compressive stress in the major north-south roof beam, elevation 554.33 feet, with a stress level lower than the design limits.

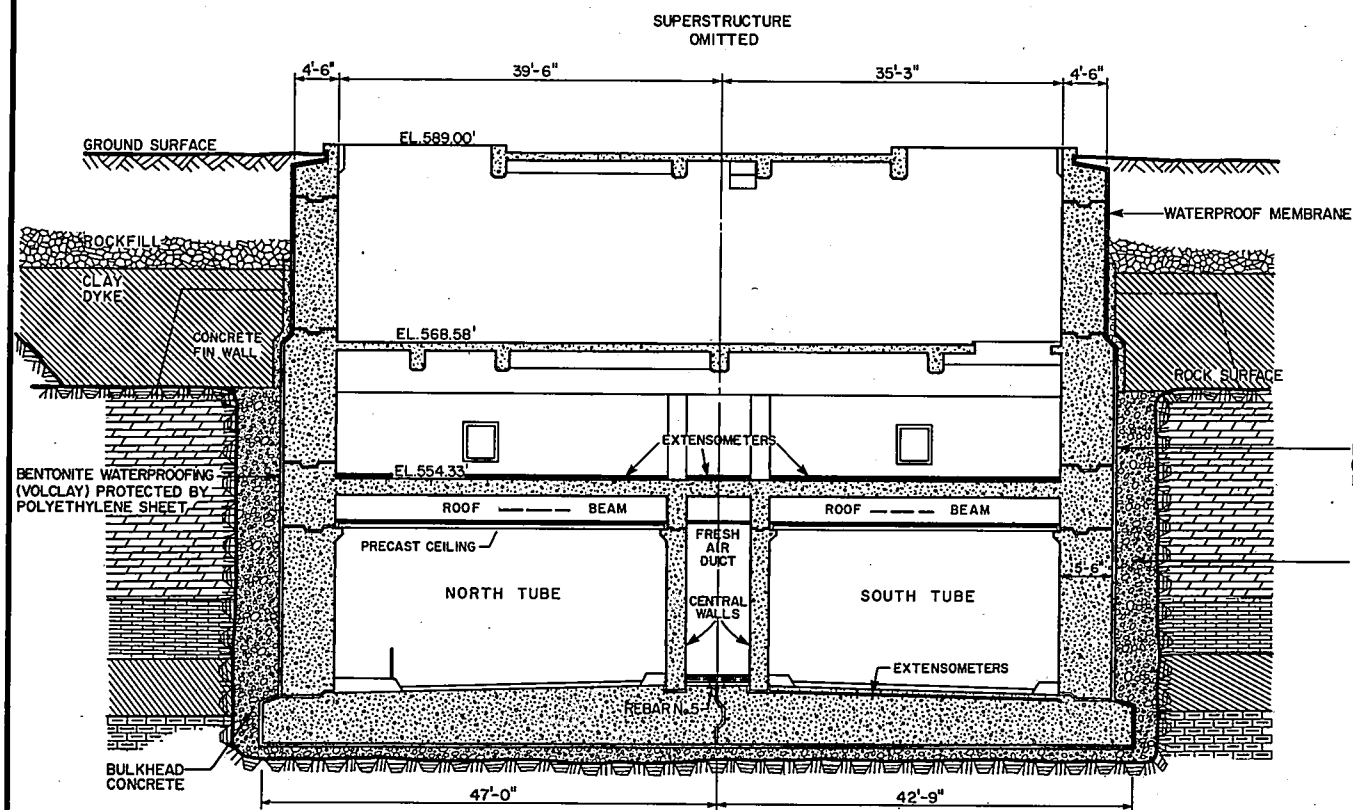
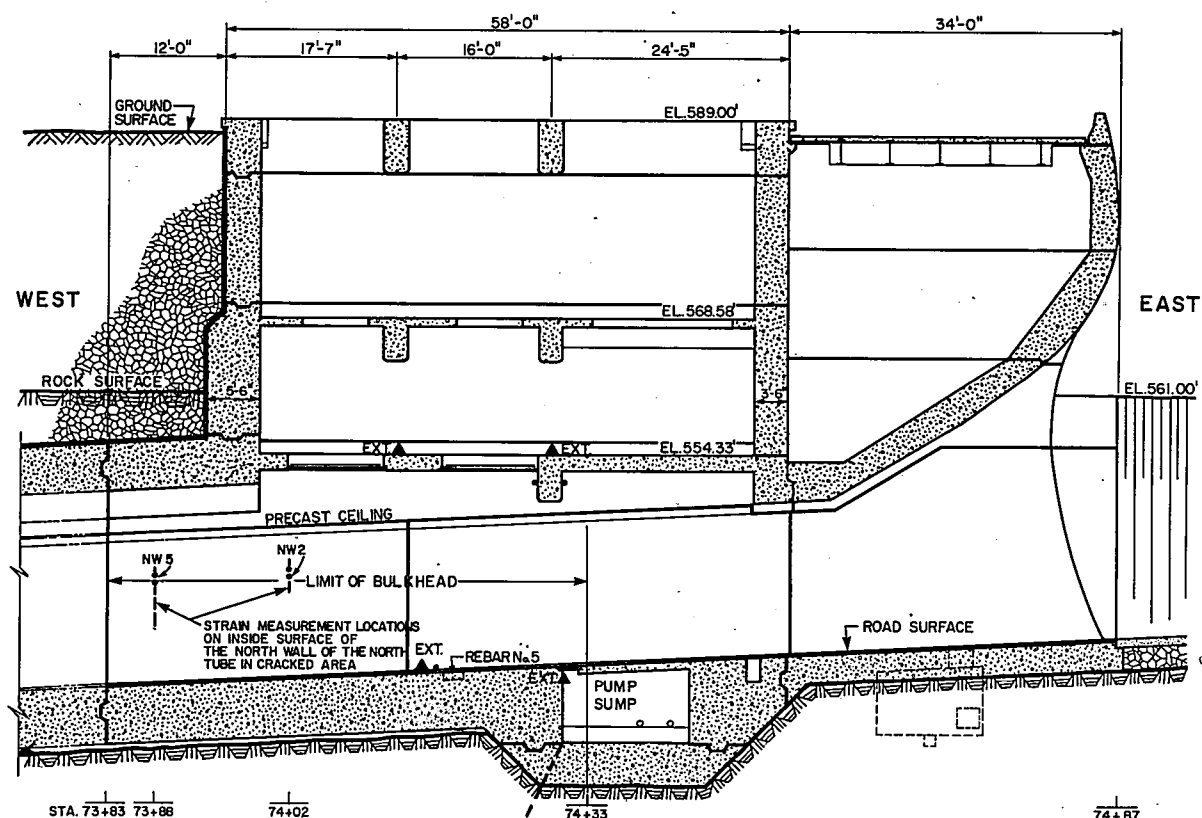
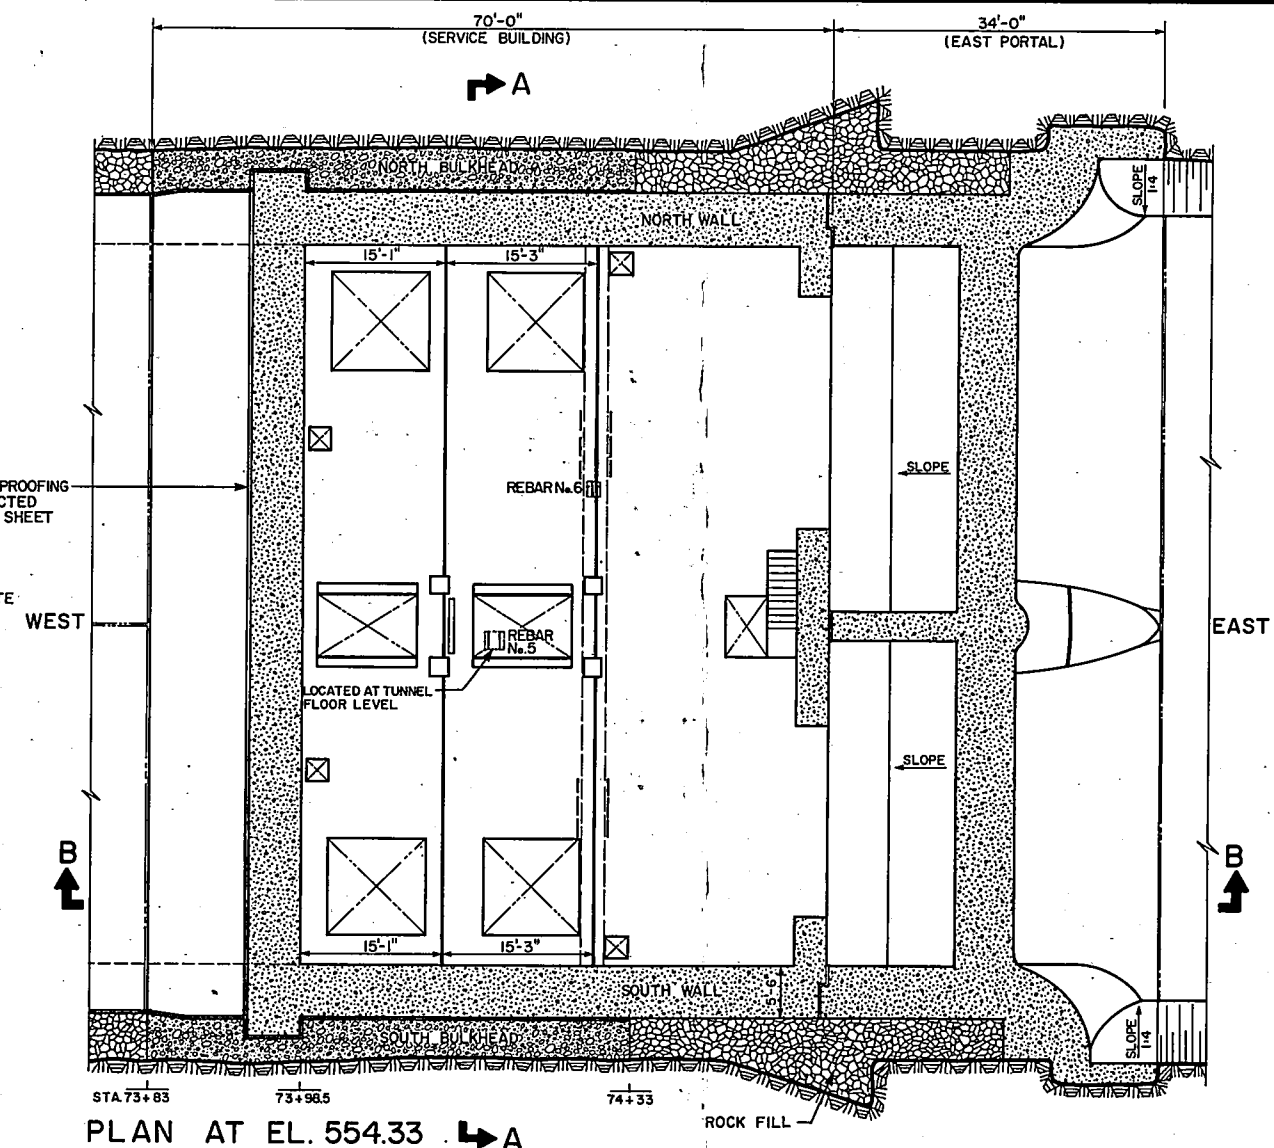
The steel stress determined in the top of the tunnel floor slab in the fresh air duct, as shown on Plate 2, was lower than that in the roof beam. Subsequent strain observations in this area have indicated that restraint by the adjacent internal walls has a significant effect on the observed strains, so that due to unreliability of the in situ steel strain measurements, a meaningful comparison with the concrete stress measurements (OC-50 and OC-51) is not possible.

The instrumentation for long-term monitoring of the structural behavior shown on Plate 2, was installed in May 1972. There have been insufficient readings yet to confirm any long-term trends with accuracy.

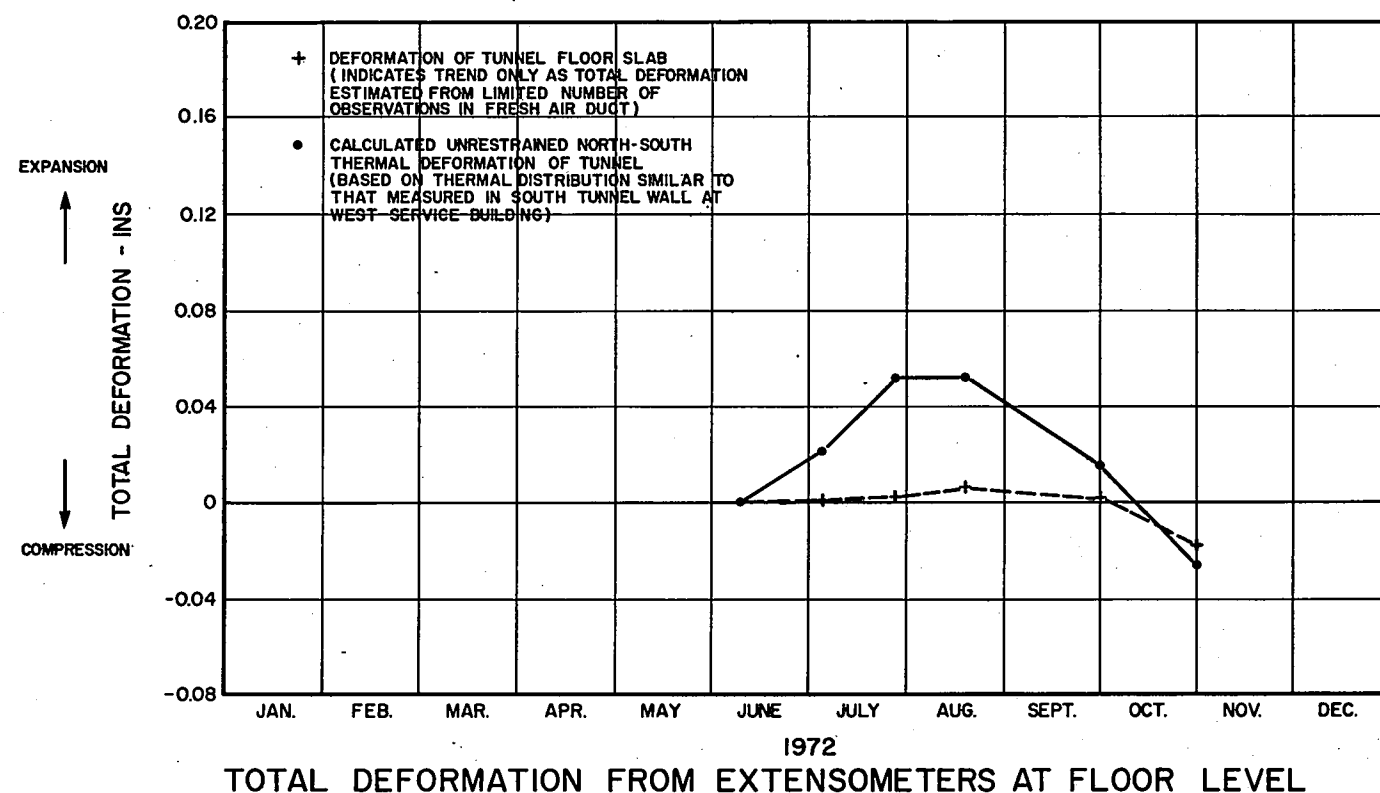
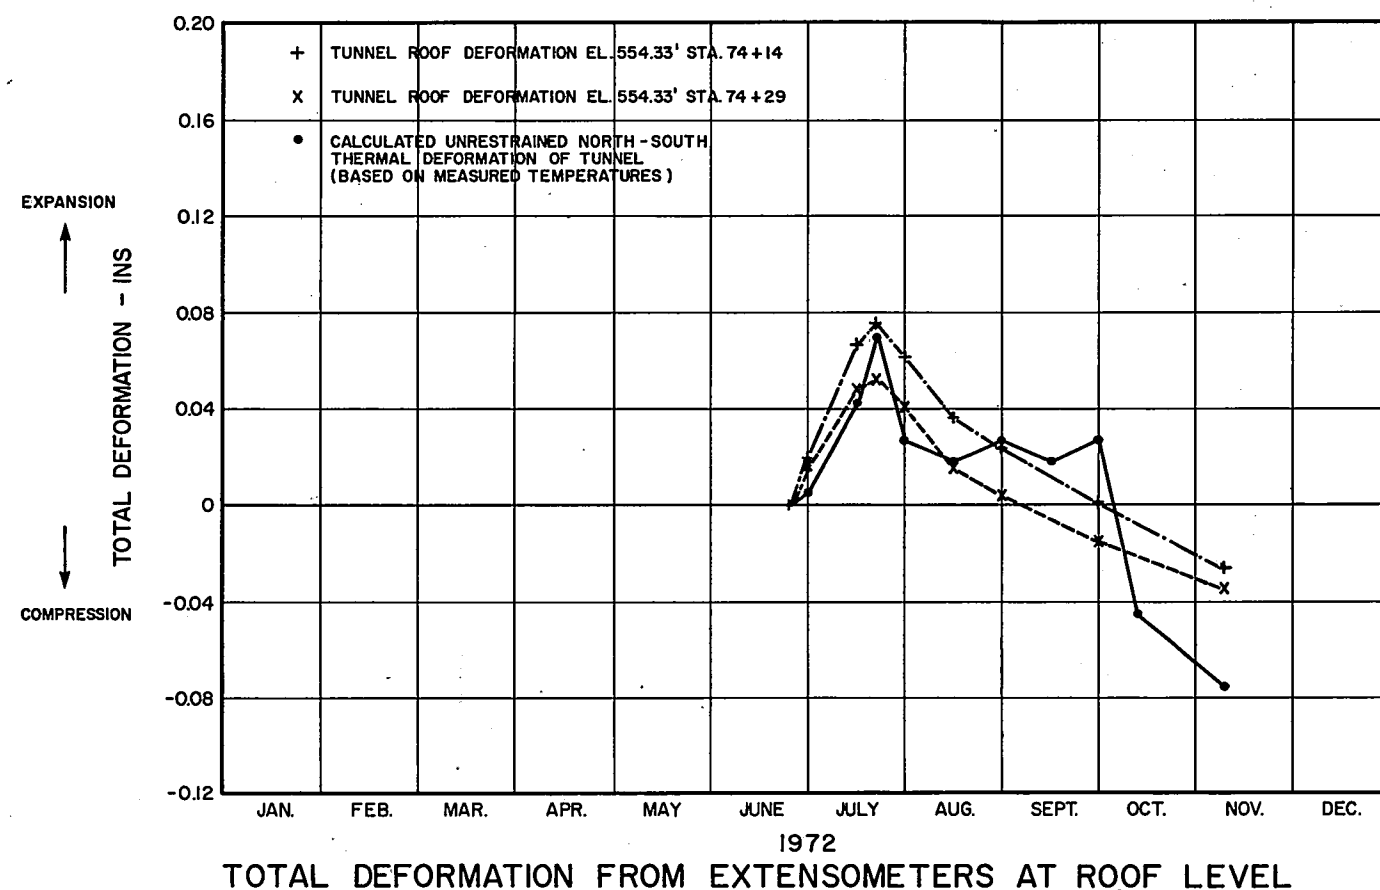
The indications up to November 1972 are that the total deformation of the tunnel at roof level, elevation 554.33 feet, shown on Plate 3, can be correlated well with changes in atmospheric temperature. From the beginning of September onward, however, it appears that the building is being subjected to an increasing compressive deformation in excess of that predicted due to changes in the temperature of the roof slab.

From continued strain observations it has been deduced that an imposed compression of approximately 0.020 inch has been applied at tunnel roof level, during September 1972, as shown in Table 1. It is estimated that this caused an increase in compressive stress in the reinforcing steel of 670 psi. During this period the temperature in the structure did not vary significantly.

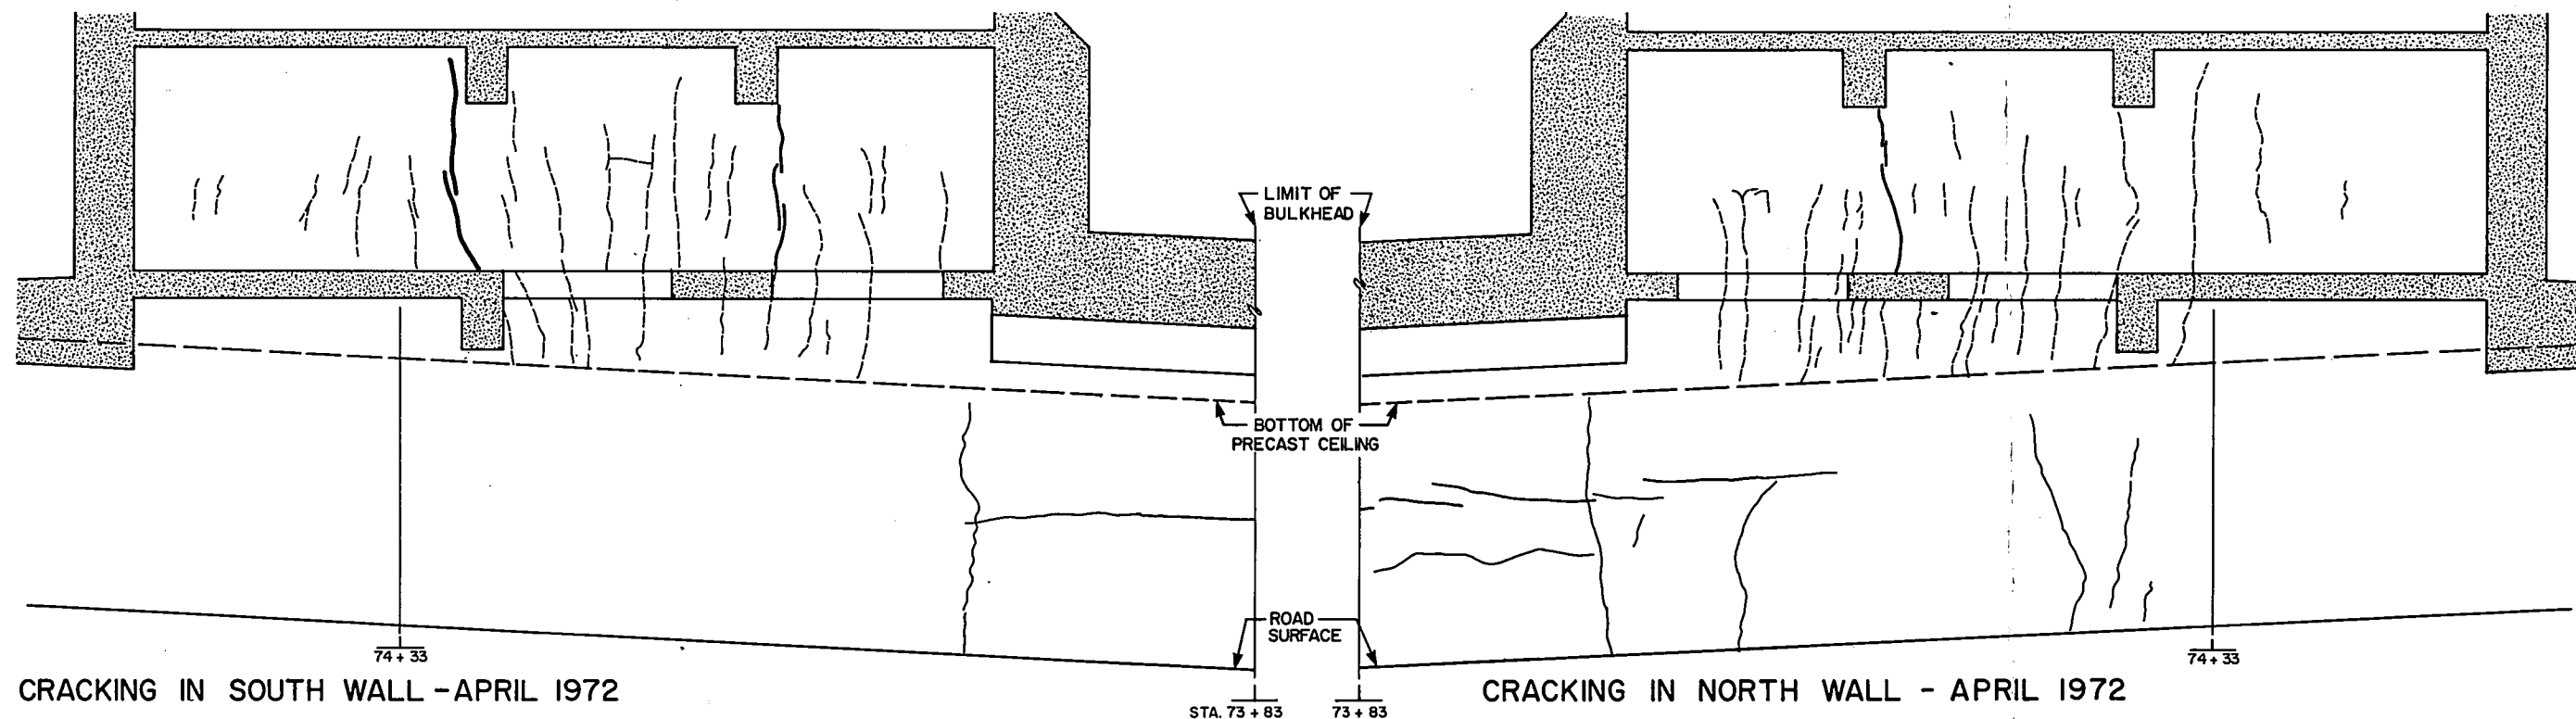
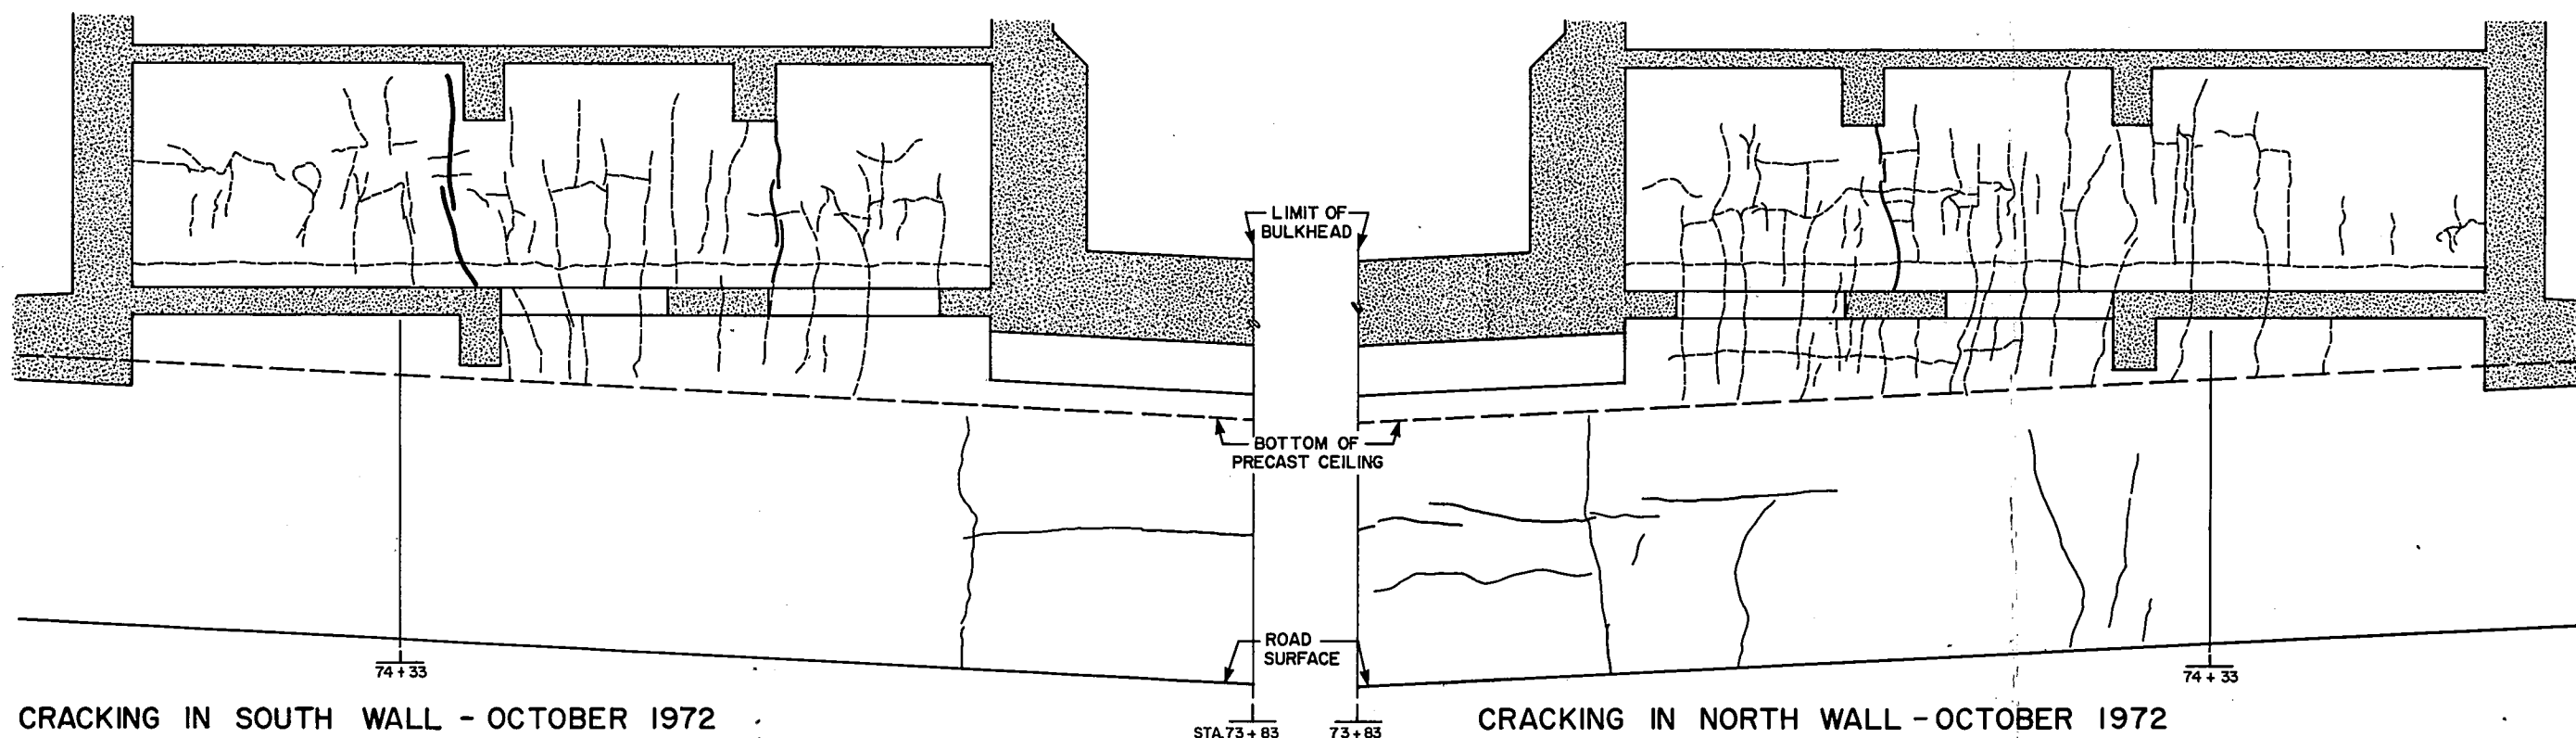
AGRES	MINISTRY OF TRANSPORTATION AND COMMUNICATIONS	
	THOROLD TUNNEL STRUCTURAL INVESTIGATIONS	
EAST SERVICE BUILDING PATTERN OF CRACKING NORTH AND SOUTH WALLS		
<i>[Signature]</i> AGRES CONSULTING SERVICES LIMITED	DECEMBER 1972	PLATE 4

- (f) Cracking in the outer tunnel walls between Stations 73 + 83 and 74 + 33, and below precast ceiling level, elevation 546 feet approximately, is minor, consisting essentially of one or two discontinuous horizontal cracks. This is not considered indicative of a serious structural problem at present. Cracking is more extensive in the outer walls between precast ceiling level, elevation 546 feet approximately, and second floor level, elevation 568 feet. These cracks are vertical and predominantly concentrated in the length of the service building adjacent to the bulkhead, that is, between Stations 73 + 83 and 74 + 33. Inspection of these walls has indicated that further cracking has become evident between May and November 1972.

Crack patterns in the north and south outer wall of the east service building and adjacent tunnel walls have been mapped as shown on Plate 4. No significant changes in the crack pattern have been observed, although a further propagation of cracking above roof level has become evident in the period between April 1972 and November 1972.

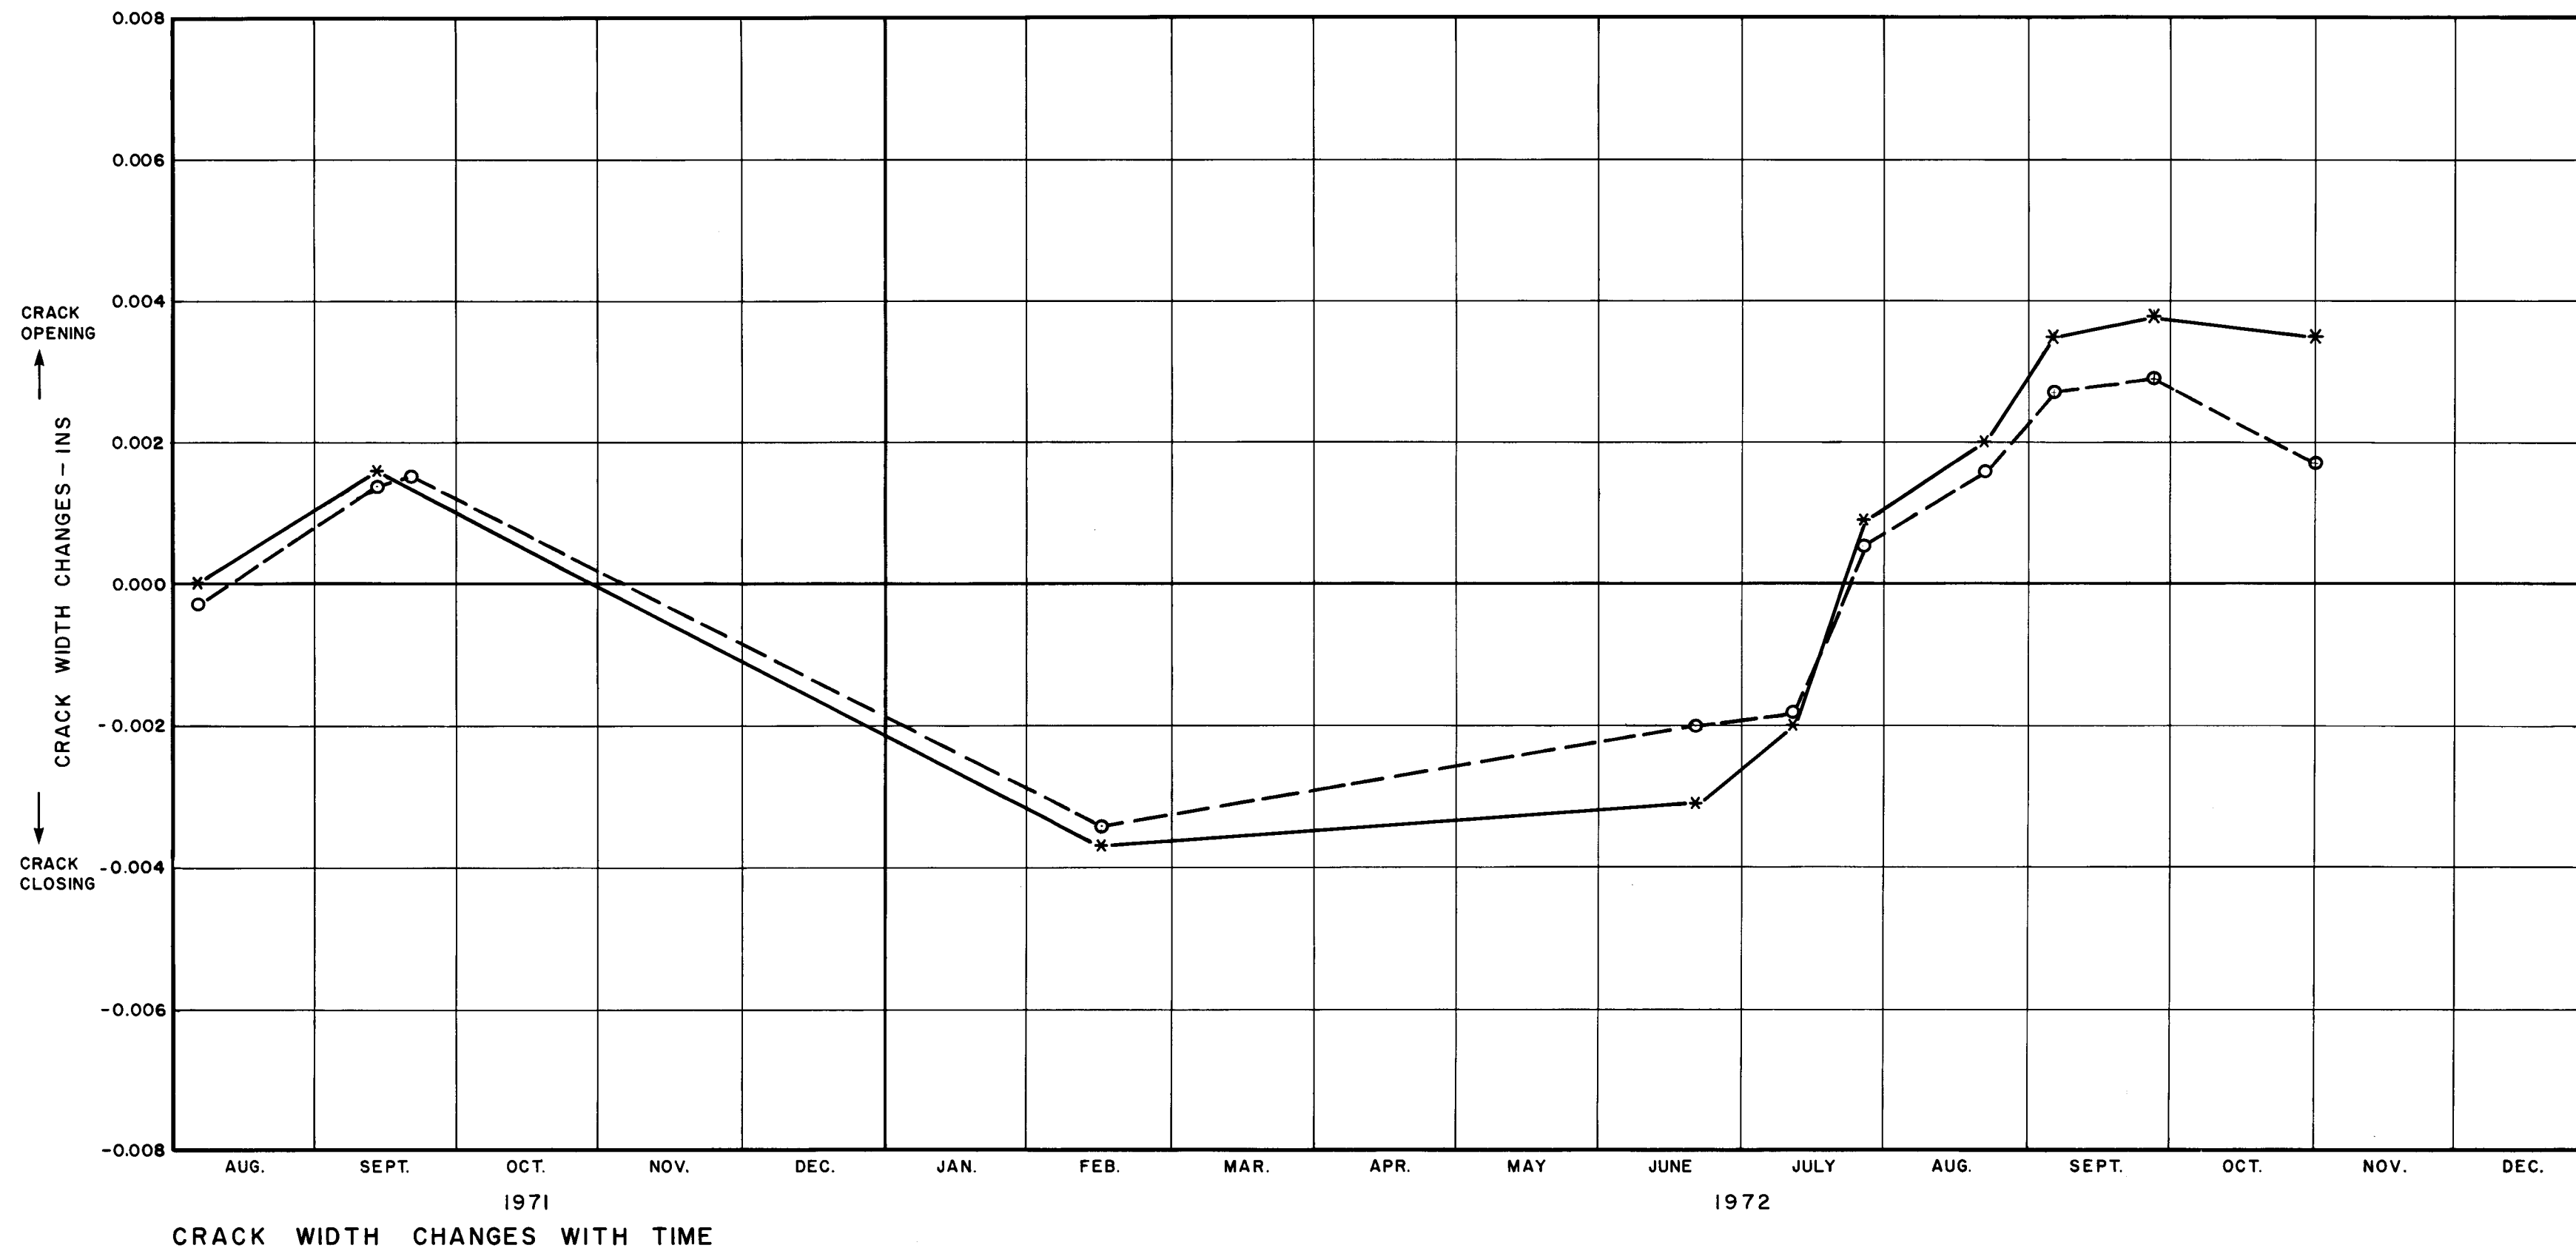
Crack widths in the north tunnel wall decreased during the winter and have continued to increase from about April 1972 to September 1972, as shown on Plate 5. The magnitudes observed in September 1971 have been exceeded in September 1972; the maximum increase being of the order of 0.002 inch.

Although the crack widths in the outer tunnel walls have exceeded the magnitudes of those of September 1971, the observed increase of about 0.002 inch is not considered large enough to indicate a definite trend.

The crack widths in the outer tunnel walls have increased in 1972, but the magnitudes are small and are not considered significant with respect to structural safety.

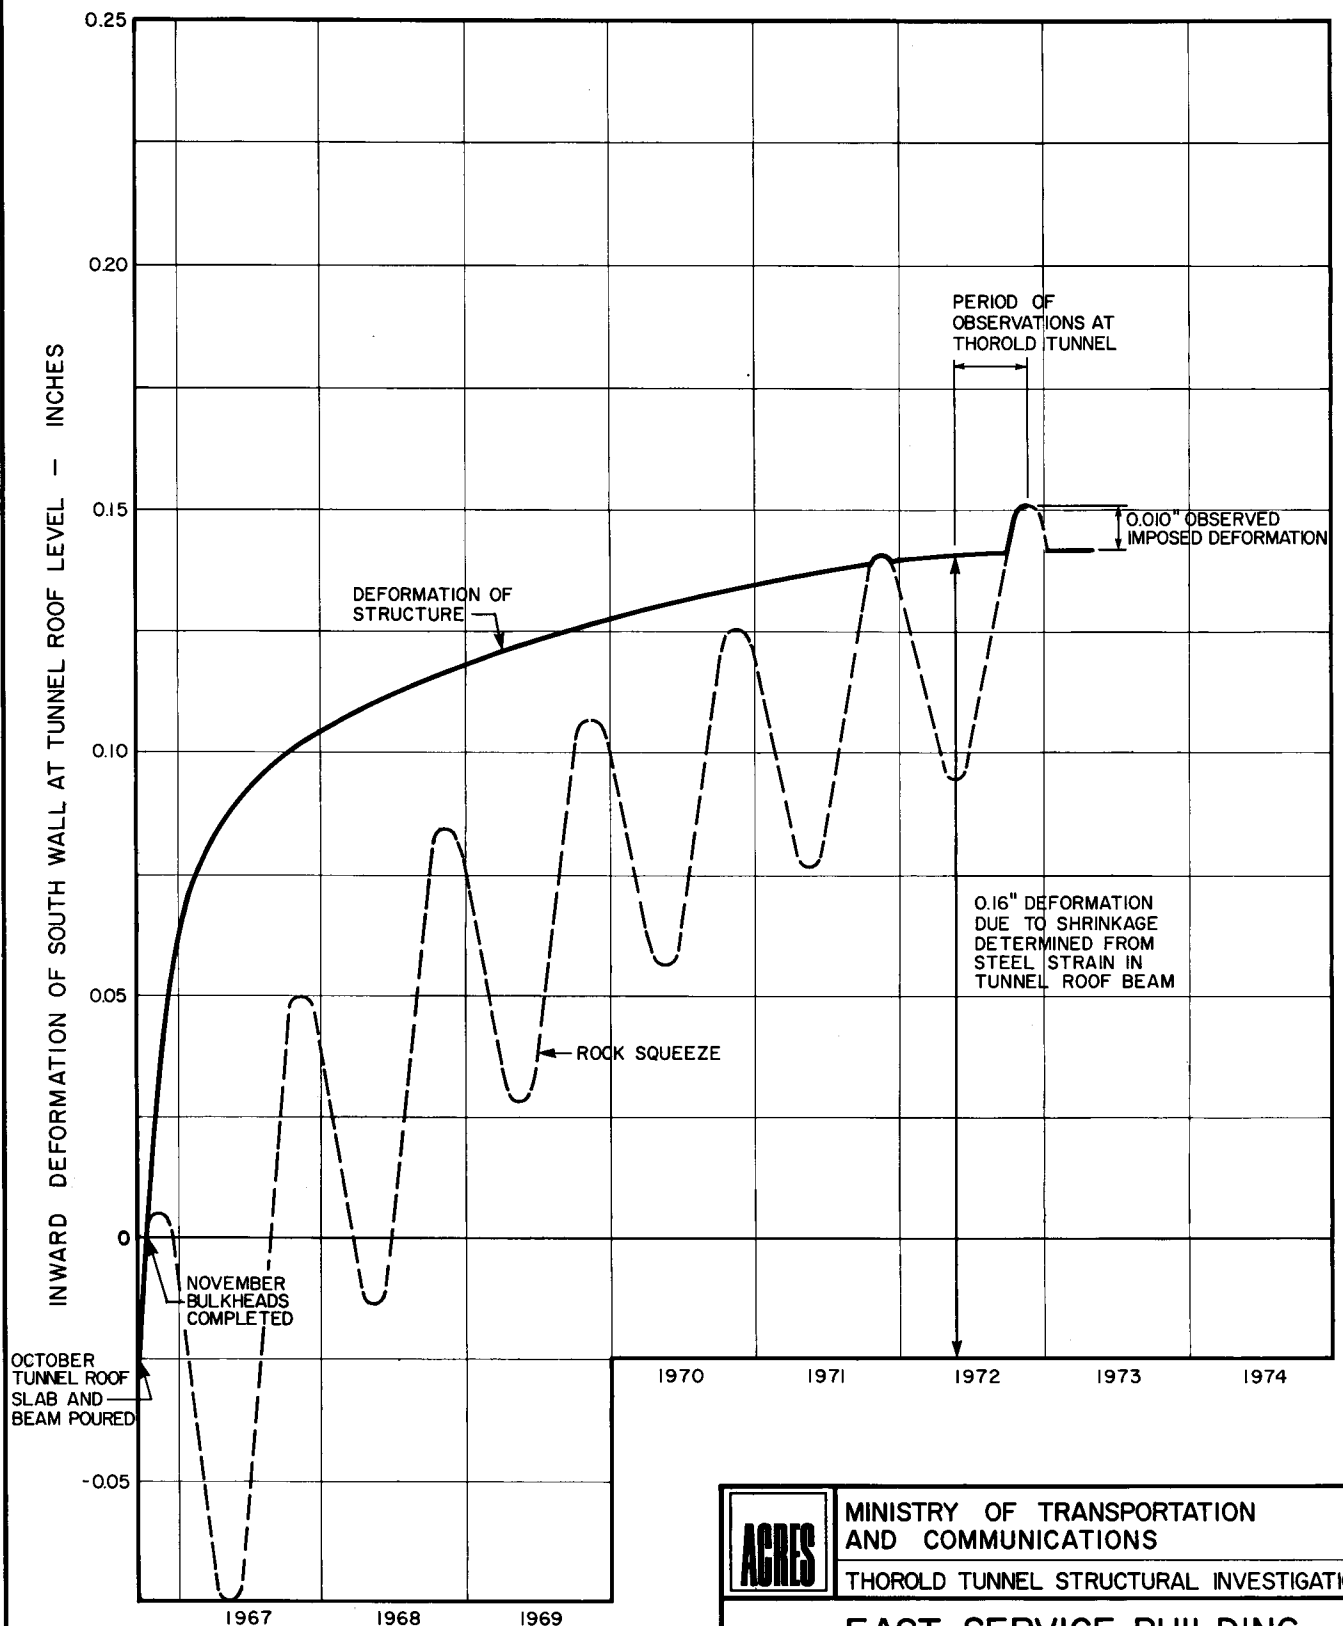
PLATE
6

- (d) Since June 1972 continuing observations have indicated that the structure has responded to thermal changes as though unrestrained, except for September 1972. During this time an estimated additional compressive stress of 670 psi was developed in the reinforcing steel of the roof beam. This change has been tentatively attributed to limited partial restraint due to rock squeeze, as shown on Plate 6.

It is not possible at this stage to predict the probable rate of increase in rock squeeze on the structure, but it is deduced that the imposed deformations to date are of a smaller magnitude than those at the west service building. The pattern of restraint is similar to that at the west service building, but at a stage which lags behind that of the west service building by approximately 4 years. This difference may be partly due to the initial rock cut having remained open for approximately 10 months, compared with 7 months at the west service building. The construction sequence for the east service building is detailed in Table 2.

- (a) Observations on the performance of the structure be continued for at least 2 years.
- (b) Results of the continuing observations be reviewed in the fall of each year to determine if any significant increase in stress levels is occurring.
