## THOROLD TUNNEL

Investigations to Determine the  
Cause of Cracking in the Structure

Supplementary Report No.1  
West Service Building

May 1972

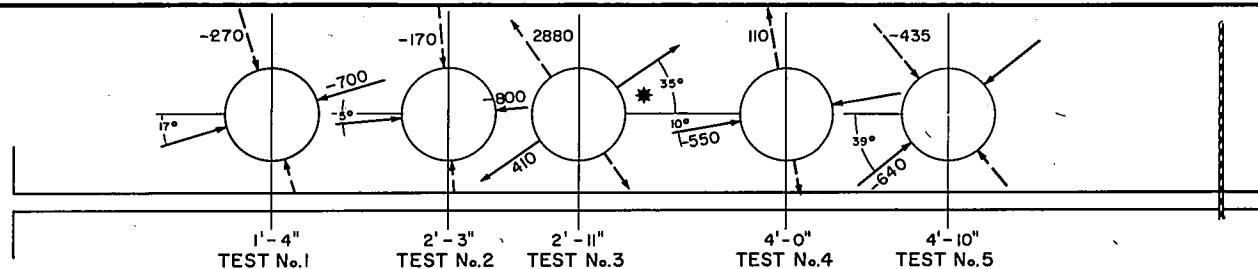
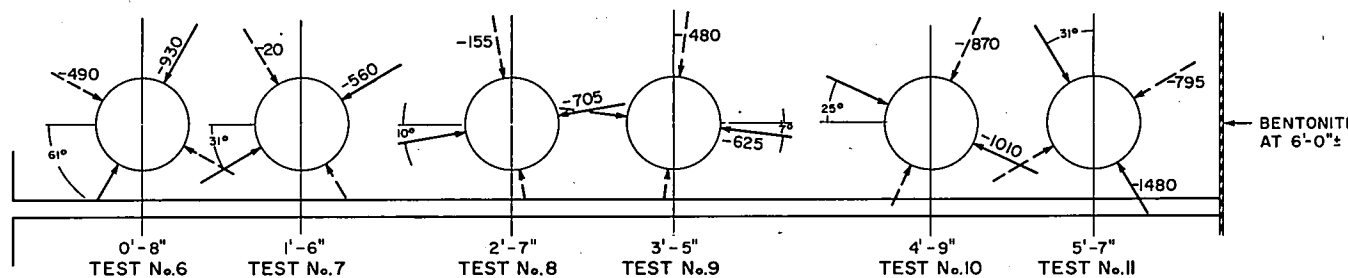
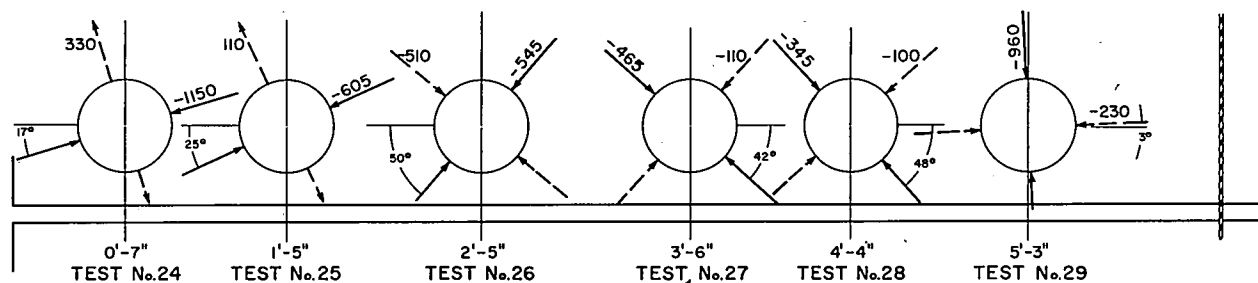
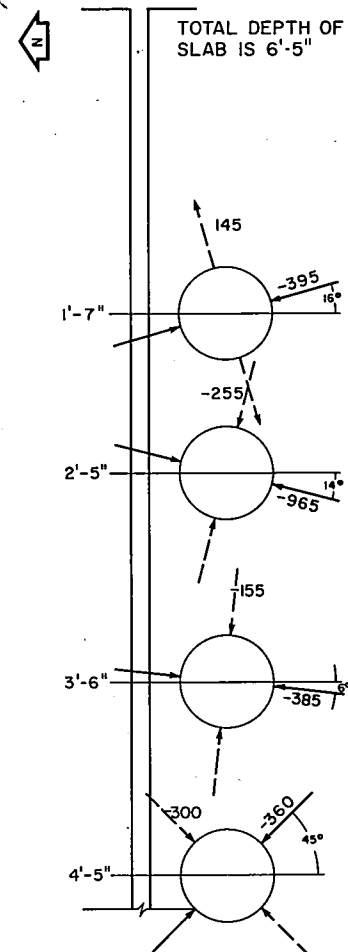
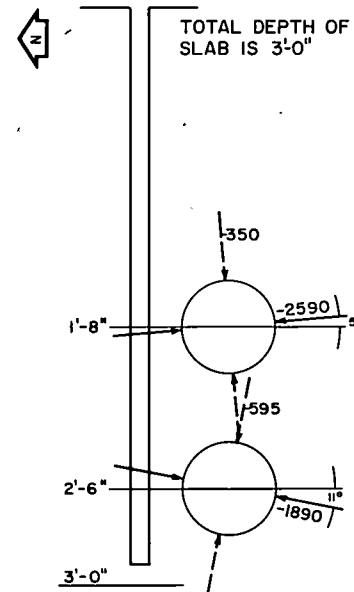
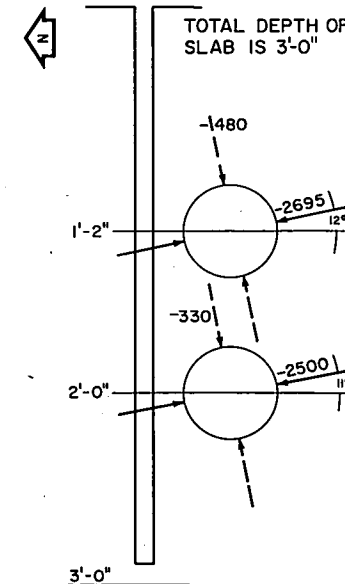
PLATE  
2

The results of additional stress measurements carried out in April 1972 are shown on Plate 1. Stress measurements made in October 1971 are shown on Plate 2. Continuing observations on deformations of the west service building and temperature are given on Plates 3 and 4.

As stated in the report of March 1972, the south tunnel wall at the West Service Building has already been subjected to considerable strain, causing extensive cracking. The concept of behavioural phases, as outlined previously for compressive members, can also be applied to flexural members with certain adjustments to the defined limits.

WEST SERVICE BUILDING  
OVERCORING TESTS  
RESULTS - OCTOBER 1971

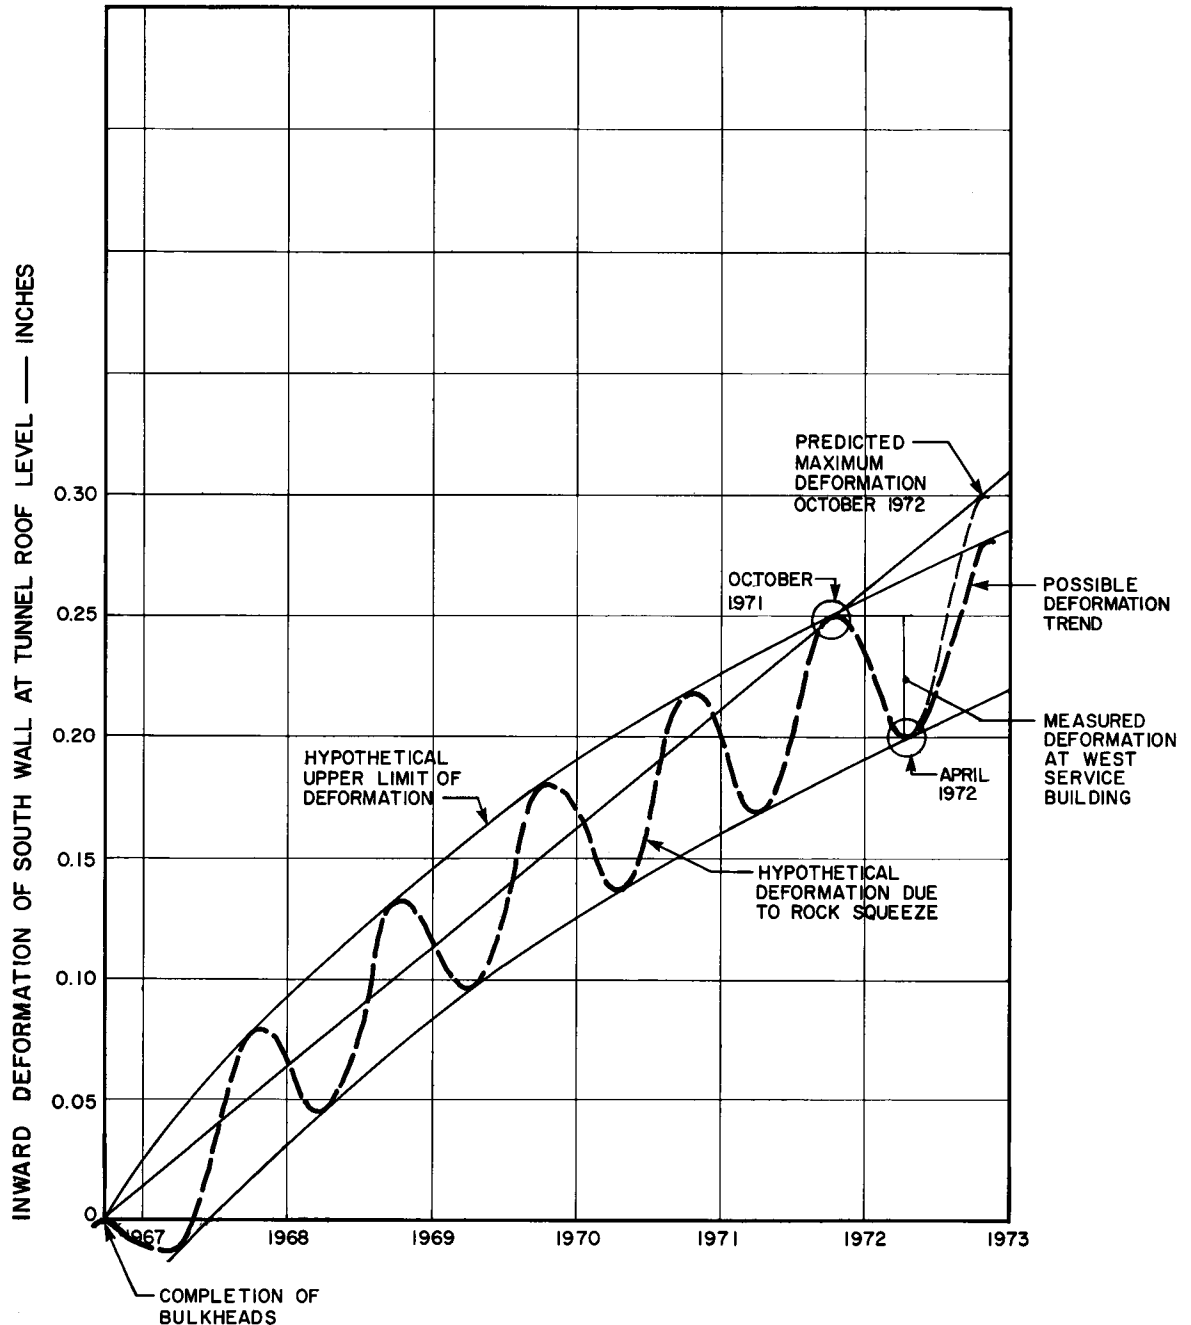
ACRES	MINISTRY OF TRANSPORTATION AND COMMUNICATIONS	
	THOROLD TUNNEL STRUCTURAL INVESTIGATIONS	
WEST SERVICE BUILDING IMPOSED DEFORMATION DUE TO ROCK SQUEEZE HYPOTHETICAL CURVE		
 ACRES CONSULTING SERVICES LIMITED		MAY 1972 PLATE <b>5</b>

- (c) - Deformations due to rock squeeze are subject to annual cyclical fluctuations, with peak values occurring in the autumn of each year, apparently following the peak atmospheric temperatures by a time lag of up to 1 or 2 months.

From Table 1 it can be seen that the stress in the reinforcing steel in the tunnel roof strut in October 1971 is estimated to have been of the order of 28,000 psi, and, based on an effective modular ratio of 15, this is equivalent to a stress of 1,900 psi in the concrete. This is at the low end of the range actually measured - between 1,900 and 2,700 psi, suggesting that possibly the effective modular ratio may be as low as 11. The seasonal reduction in rock squeeze which appears to have occurred, and has been allowed for in calculating the change in stress, is assumed to be as illustrated on Plate 5.

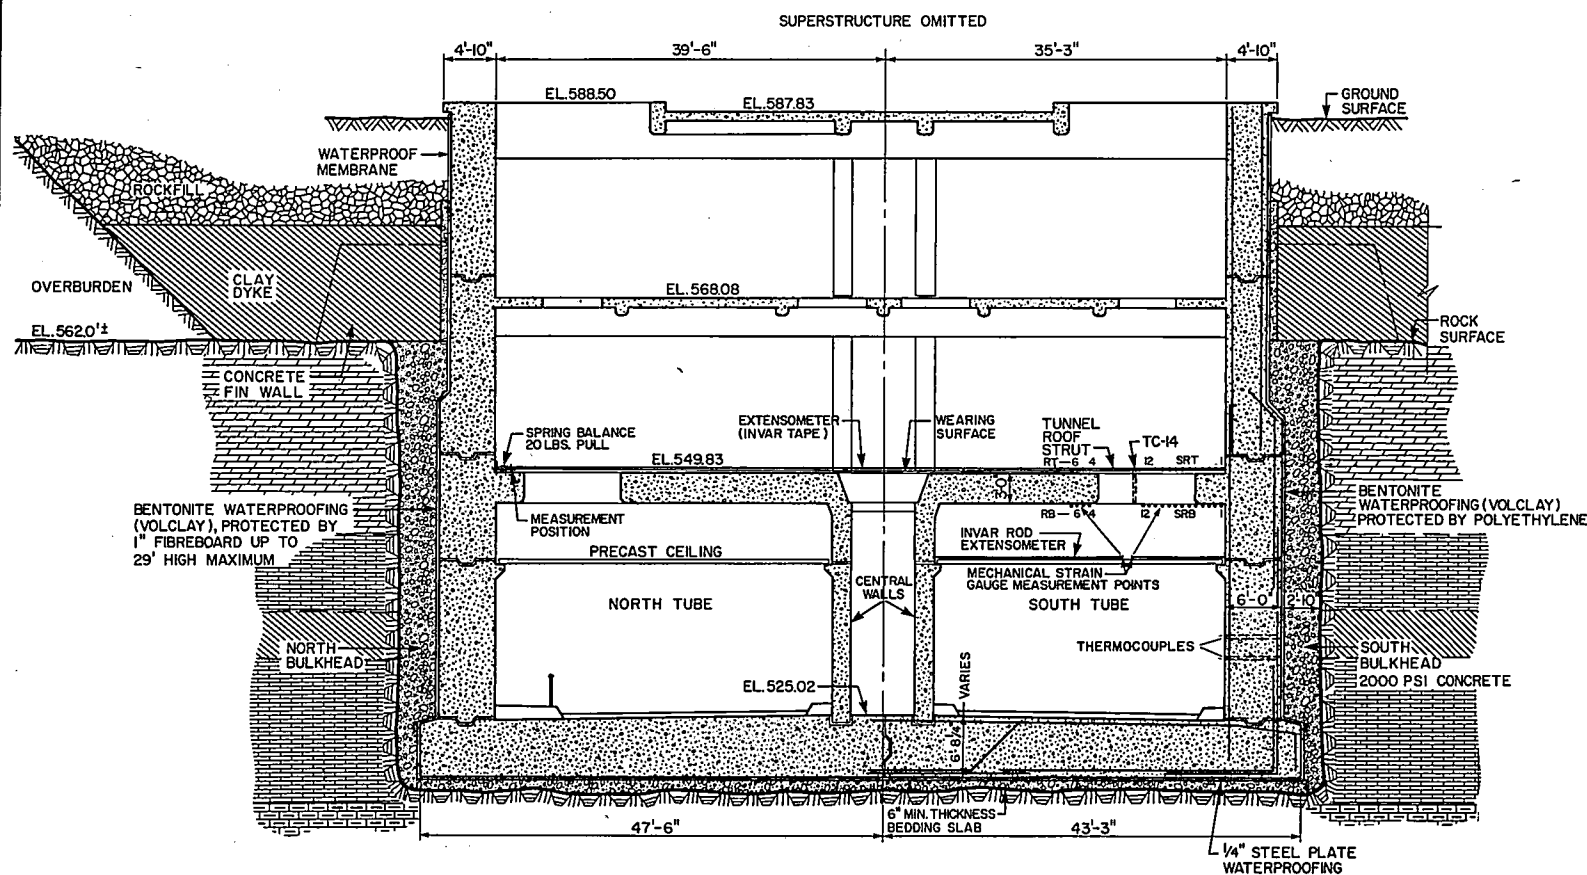
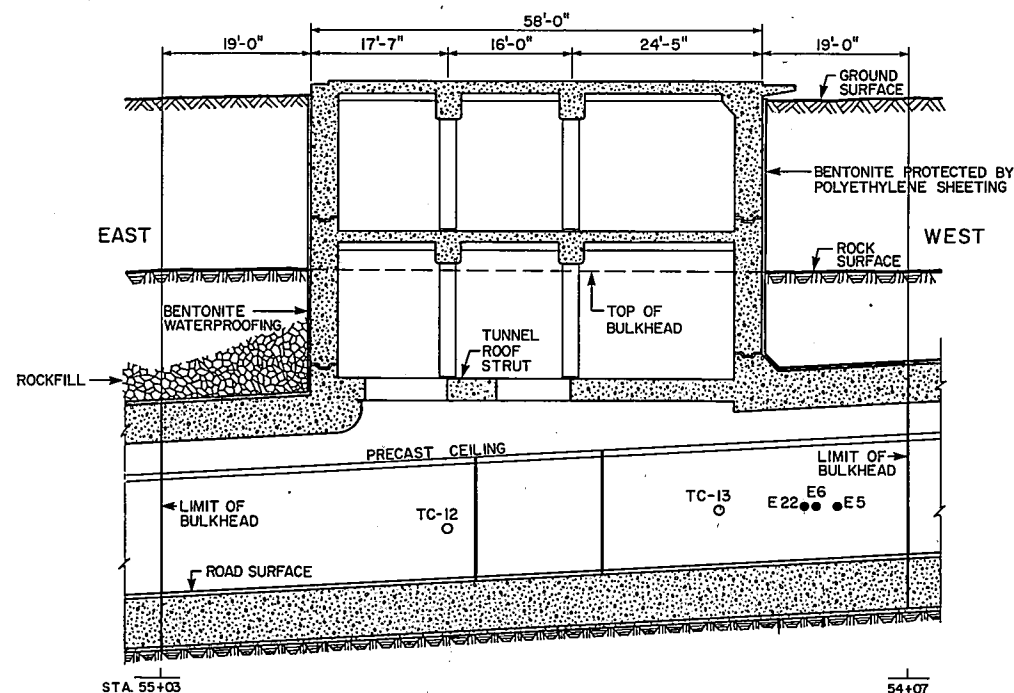
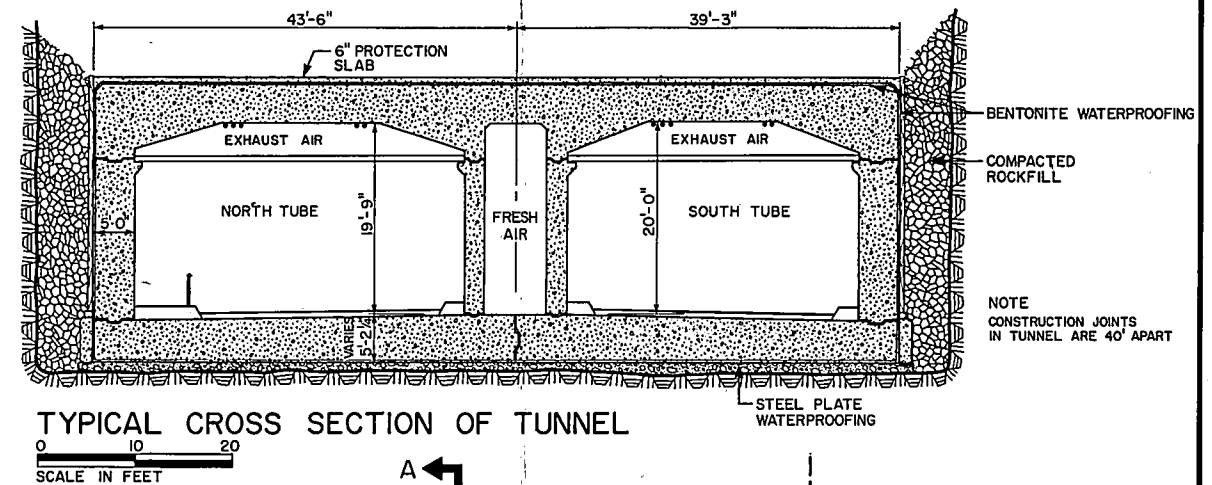
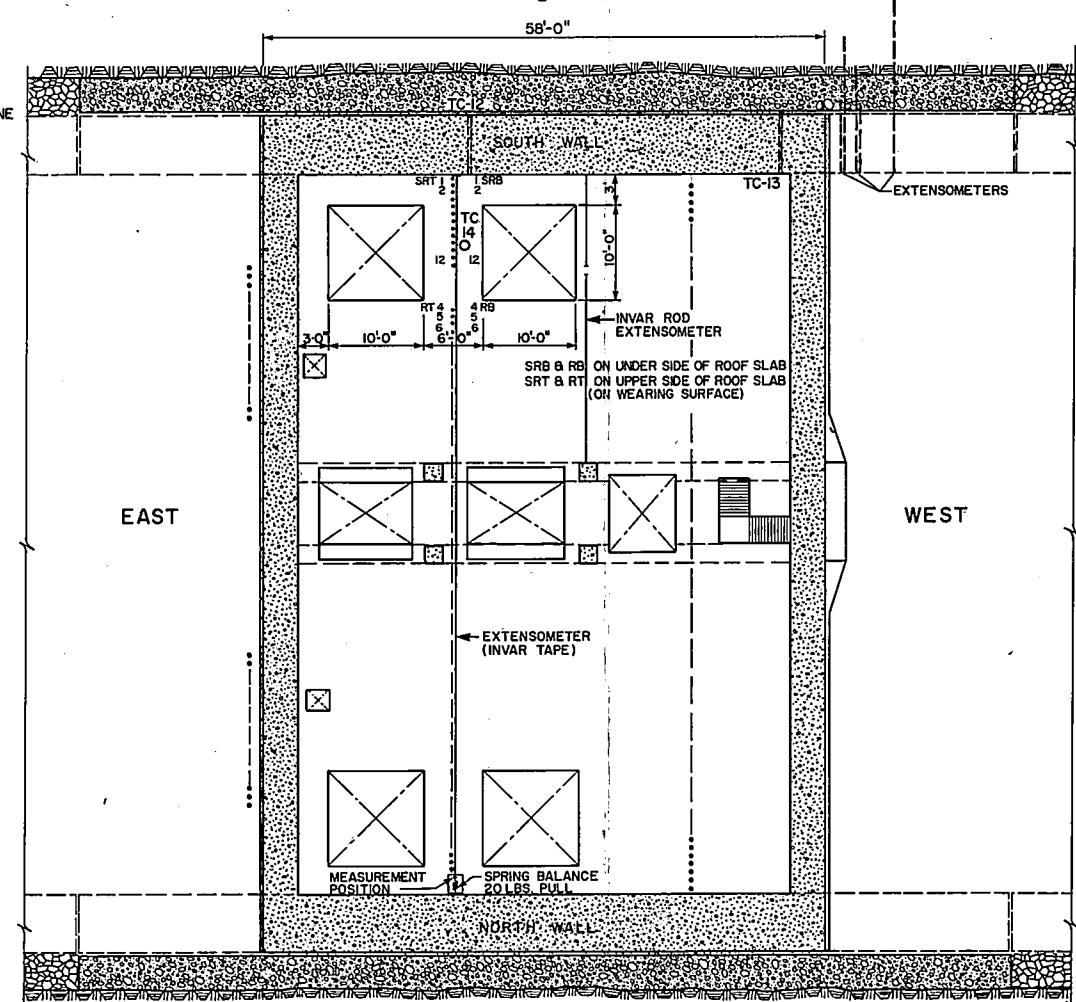
- E 5, 6, AND 22 EXTENSOMETER POSITIONS
- TC 12, 13 AND 14 THERMOCOUPLE INSTALLATIONS
- ..... ADDITIONAL MEASUREMENT POSITIONS INSTALLED MAY 1972

Before remedial work to unload the west service building is commenced, it is considered desirable that certain additional instrumentation be installed to facilitate accurate monitoring of the results of the remedial work. Such instrumentation could take the form of slope indicator devices installed in boreholes in the rock near the structure, and use of a tiltmeter to determine changes in face angle in the outside walls of the tunnel.
