TECHNICAL MEMORANDUM

TO: Mr Chris McShane
(McIntosh Perry Consulting Engineers Ltd.)
FR: Phil de Graaf/Mark Telesnicki
RE: **ROCK CUT STABILITY ASSESSMENT**
1000 ISLAND PARKWAY BRIDGE OVER HWY 137
W.P. 254-98-00

DATE: February 12, 2004
JOB NO: 041-117-016

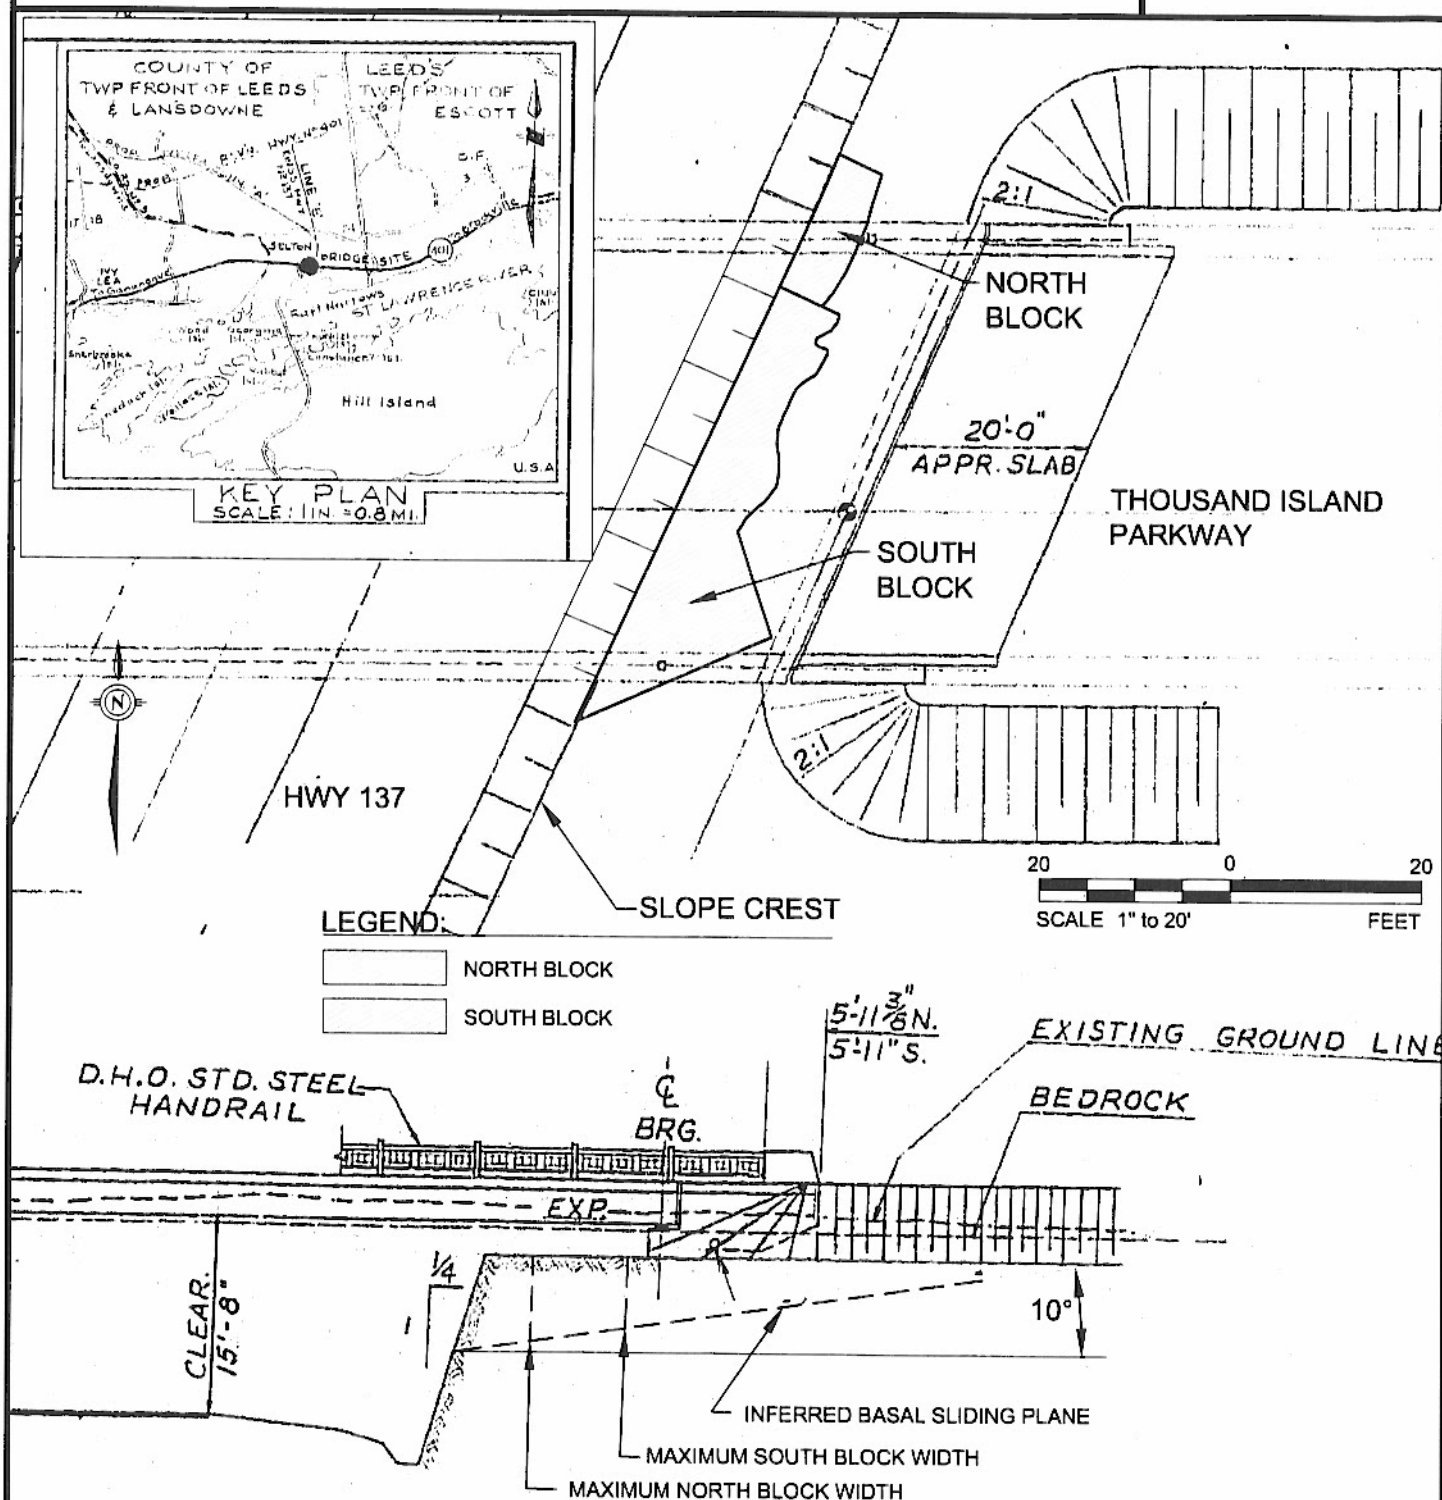
FIGURE 1

Highway 137 runs north south and links Highway 401 with the 1000 Islands Bridge to the USA. Highway 137 passes below the 1000 Islands Parkway at an overpass bridge at marker chainage 12+542 (Ref. Figure 1). The east bridge abutment comprises a steep (75° dip angle) rock cut ranging in height from less than 1 m to the south, up to more than 10 m to the north of the bridge. In the immediate vicinity of the bridge, the rock cut height is approximately 4.6 m high, except for a localised area near the southern end of the bridge deck which is about 5.4 m high. The clear zone, measured from the edge of pavement to the toe of the rock cut (at road elevation) is at least 10 m.

1000 ISLAND PARKWAY BRIDGE AND HWY 137 LOCATION PLAN & SKETCH OF POTENTIAL SLIDING BLOCKS FOR EAST BRIDGE ABUTMENT

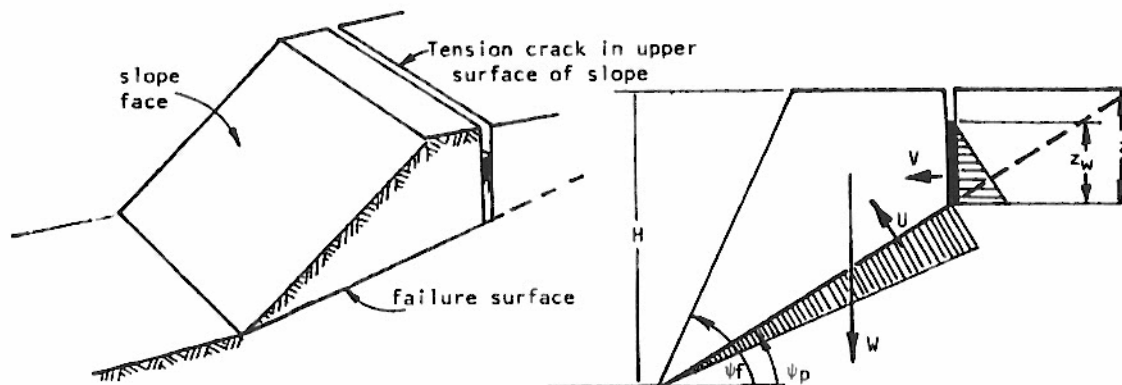
FIGURE 2

The occurrence of sub-vertical tension cracks, basal plane joints roughly parallel to the slope crest, and sub-vertical end joints, define classic planar type potential sliding blocks (Ref. Figure 2). The plane failure mechanism involves sliding on a planar discontinuity which strikes sub-parallel to and is undercut by the slope face (i.e.: the failure plane “daylights” in the slope face). For sliding to occur, the shear strength along the failure surface must be exceeded and release surfaces must exist normal to or at a steep angle to the failure plane. This usually means that the dip of the failure plane for the ‘dry’ slope must be steeper than the angle of friction (ϕ) applicable to that plane, however; where water-filled tension crack and sliding plane conditions exist, water pressure and /or ice jacking induced failure may occur even where the sliding plane angle is lower than the friction angle.

The stability of the identified blocks has been evaluated by limit equilibrium techniques such as those described by Hoek and Bray (1977). Refer to Figure 2 for a graphical representation of the plane failure mechanism, and explanation of the limit equilibrium stability assessment methodology. Results of the plane failure analysis are summarized on Figure 2. Three typical cross-sectional block geometries were used to evaluate the stability of the blocks (refer to Plate 2a for locations of these sections). Due to variations in block height and tension crack location two sections (Sections A & B) were taken to represent the south block, and a single section (Section C) for the north block. Most input parameters can be fairly well defined through actual field measurements, however, some uncertainty remains as to the quantification of key parameters such as:

As summarised in the tables on Figure 2, the stability assessment for the average and best case block conditions indicates that the blocks are stable (Factor of safety, $FOS > 1.5$). This analysis suggests that planar block failure could occur should worst case conditions for both sliding plane angle and tension crack water condition occur simultaneously. Although this scenario is considered somewhat conservative, the limit equilibrium analysis indicates that by installing a

Plane Failure Mechanism Limit Equilibrium Stability Assessment Summary

Section A (South Block)	Basal Sliding Plane Angle ϕ_p	Tension Crack Water Condition (Z_w/Z)	FOS	No. Shear Dowels for FOS>2*	No. 100kN Rock Bolts for FOS>2*
Best Case	10	0 (Dry)	3.28	NA	NA
Average	15	0.5 (half full)	1.86	2	1
Worst Case	20	1 (full tension crack)	1.21	12	5

Section B (South Block)	Basal Sliding Plane Angle ϕ_p	Tension Crack Water Condition (Z_w/Z)	FOS	No. Shear Dowels for FOS>2*	No. 100kN Rock Bolts for FOS>2*
Best Case	10	0 (Dry)	3.28	NA	NA
Average	15	0.5 (half full)	1.70	2	1
Worst Case	20	1 (full tension crack)	0.93	9	4

Section C (North Block)	Basal Sliding Plane Angle ϕ_p	Tension Crack Water Condition (Z_w/Z)	FOS	No. Shear Dowels for FOS>2*	No. 100kN Rock Bolts for FOS>2*
Best Case	10	0 (Dry)	2.44	NA	NA
Average	15	0.5 (half full)	1.67	1	1
Worst Case	20	1 (full tension crack)	0.88	6	1

total of 27 (twenty seven) 25 mm diameter untensioned shear dowels, or a total of 10 (ten) tensioned (100 kN) rock bolts, would provide sufficient reinforcement to achieve a FOS of at least 2 for the worst case scenario for both the south and north blocks.

Although safety factors in excess of 1.5 are considered acceptable for many civil engineering applications, in some instances slightly higher factors of safety are necessary, in particular where repercussions of failure will be severe or where some uncertainty exists over in-put parameter values. In these cases a safety factor in excess of 2 are usually used. For the average case scenario a total of 5 (five) untensioned shear dowels or a total of 3 (three) tensioned (100 kN) rock bolts will provide an FOS of 2 for both the south and north blocks.

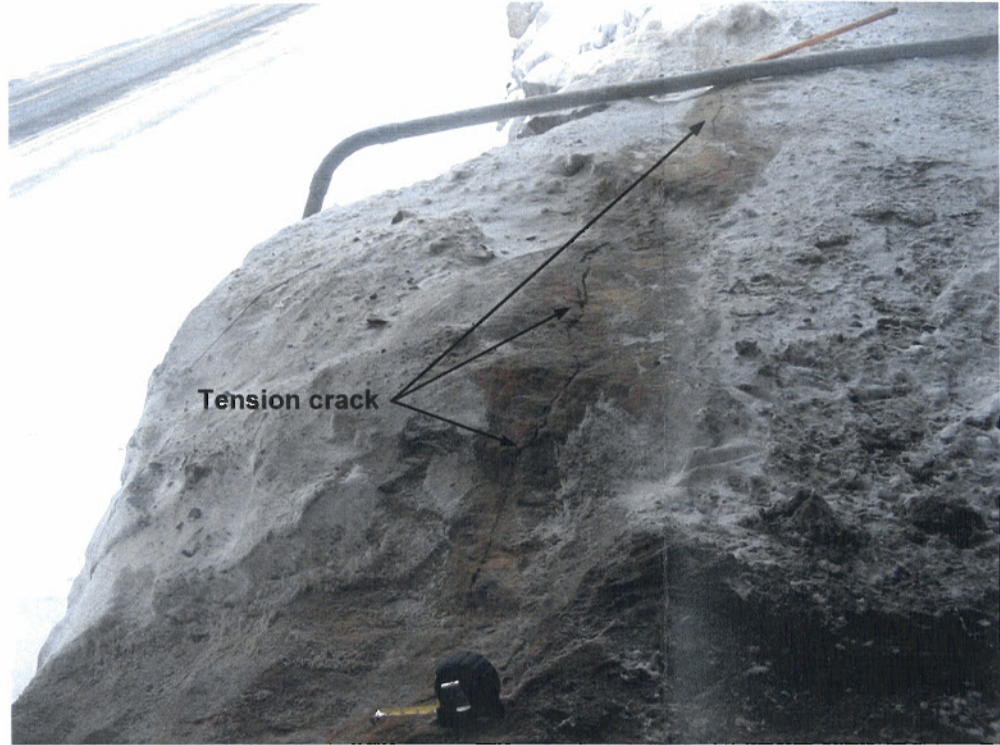
A) Slope crest looking north

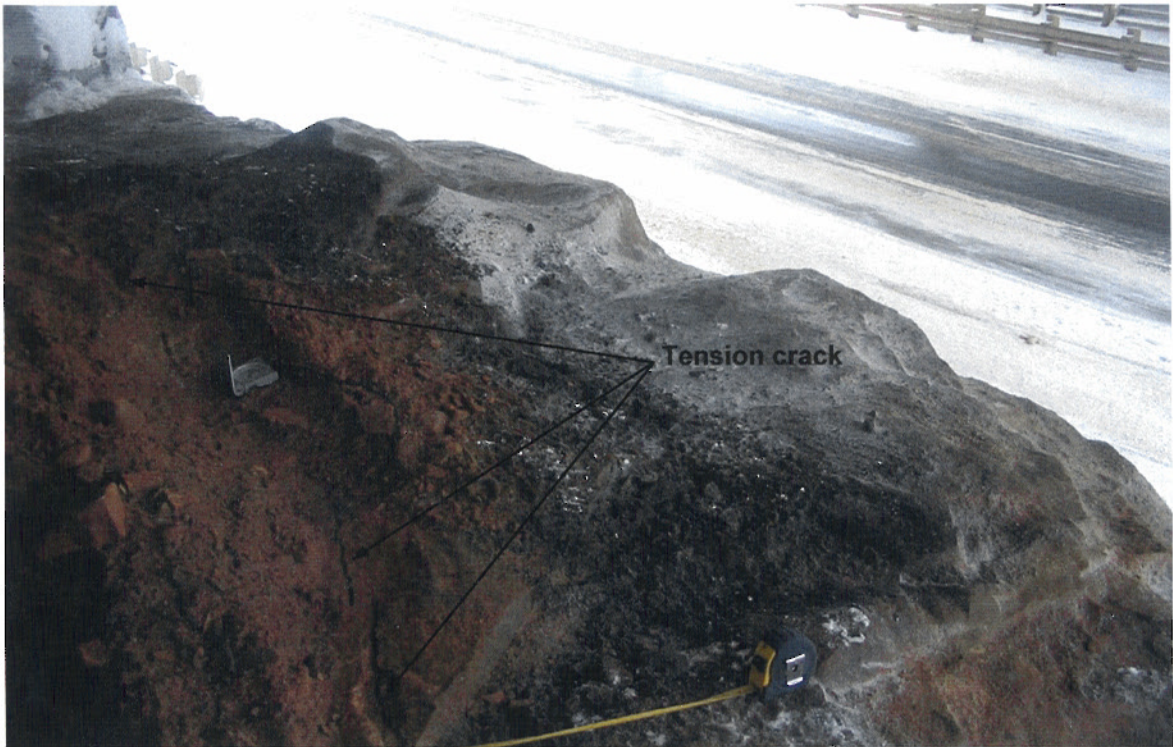
B) Slope crest looking south

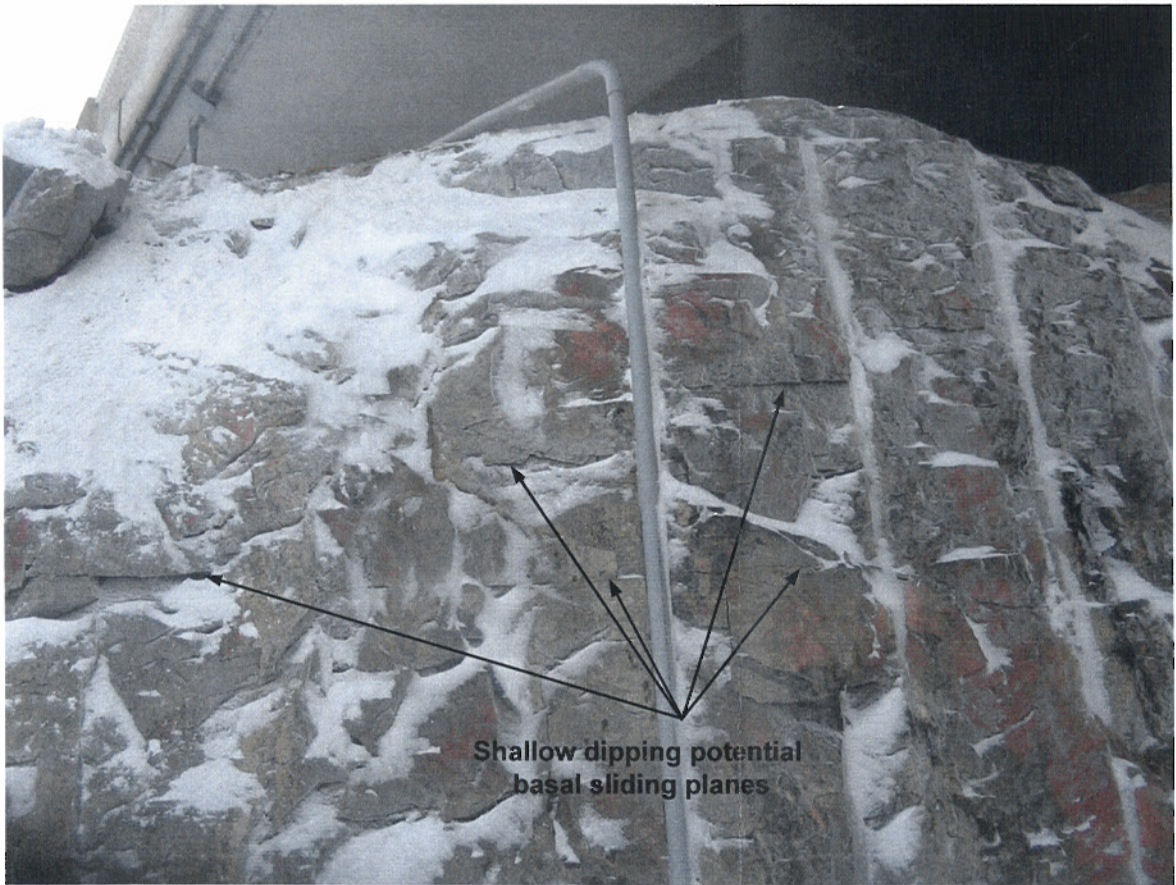
C) Slope face north side of bridge

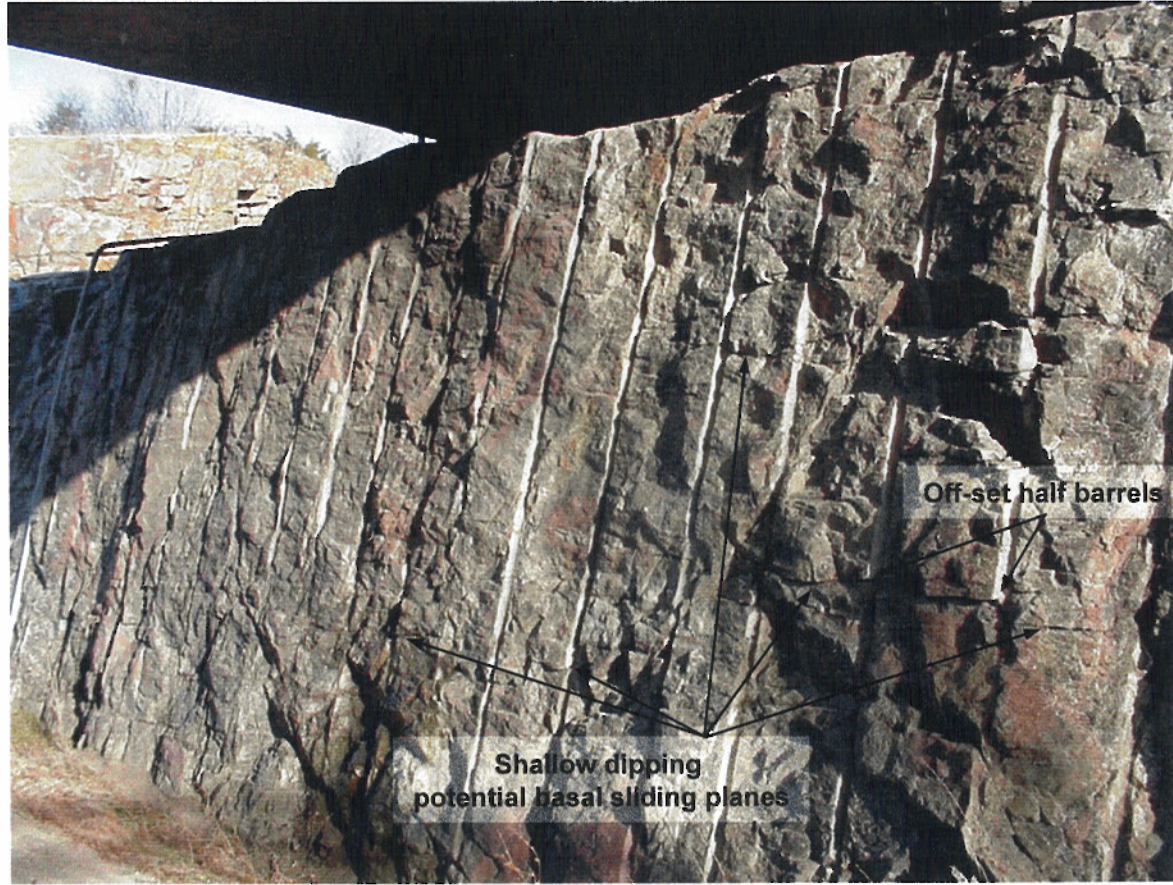
D) Slope face south side of bridge (photo provided by Tony Sangiuliano)

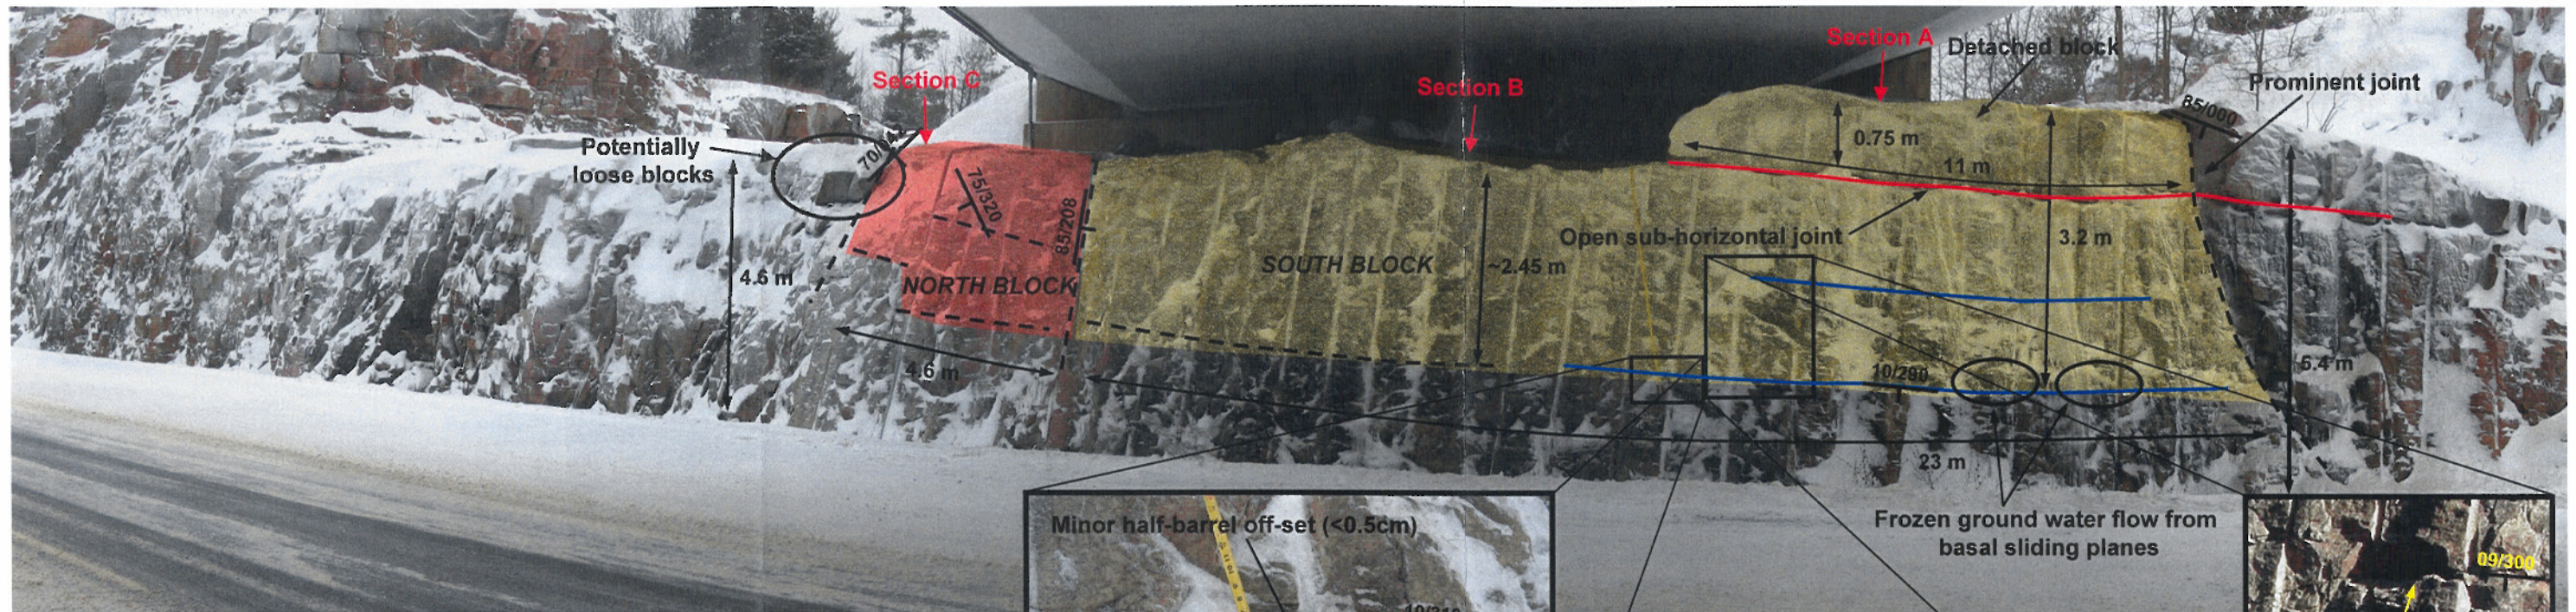
Two separate tension cracks were observed along the slope crest, directly below the bridge deck. These tension cracks run sub-parallel to the slope crest and daylight along the top of the cut, the full width of the bridge deck. Based on observed (and inferred) discontinuity intersections of at least three sub-vertical joints (providing lateral 'release' planes) and a series of shallow dipping basal sliding planes, two kinematically feasible sliding blocks were identified (Ref. Plate 2).

A small zone of blocky, potentially unstable material was identified to the north of the north block (Ref. Section A on Plate 2). This zone comprises about 2 to 3 m³ and would probably be contained by the roadside catch ditch should it become dislodged. This material is not considered a significant hazard to the roadway nor to the bridge structure. The rock could be removed using a back-hoe to minimize future ditch maintenance requirements.

A) Overall View of East Bridge Abutment Rock Cut Face

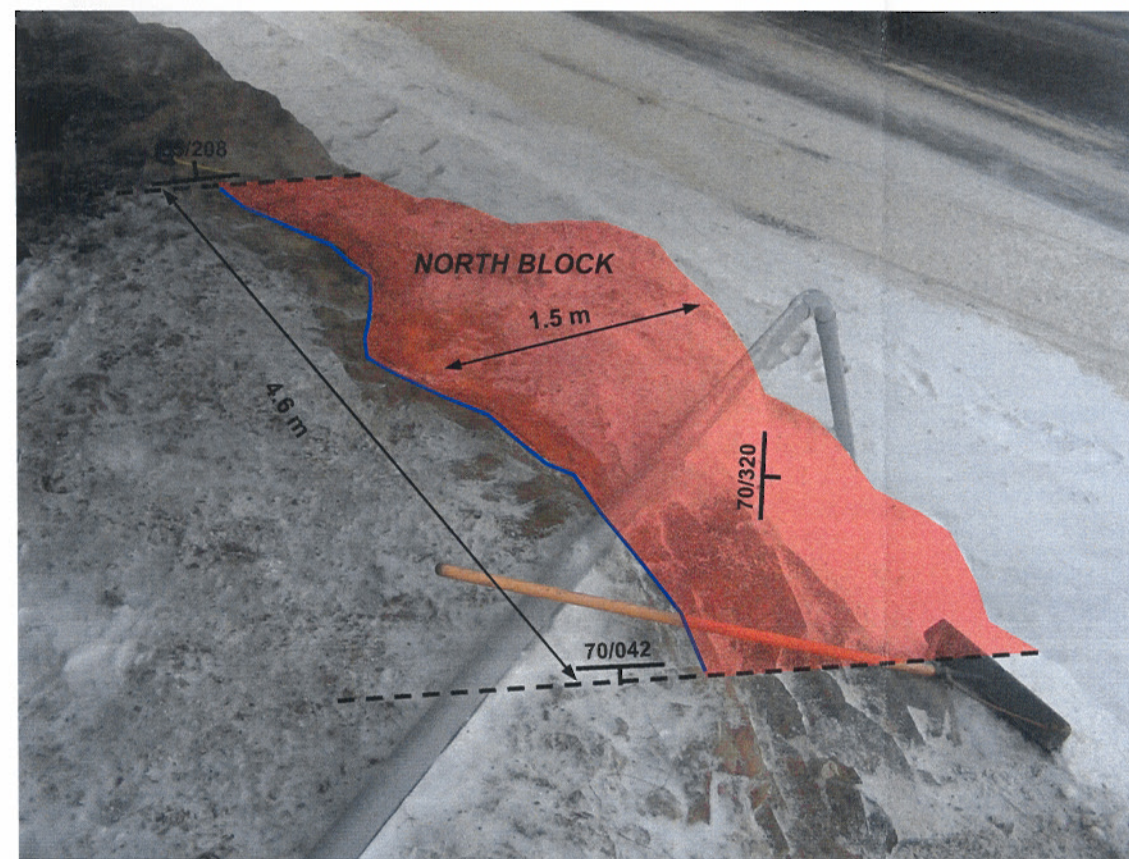
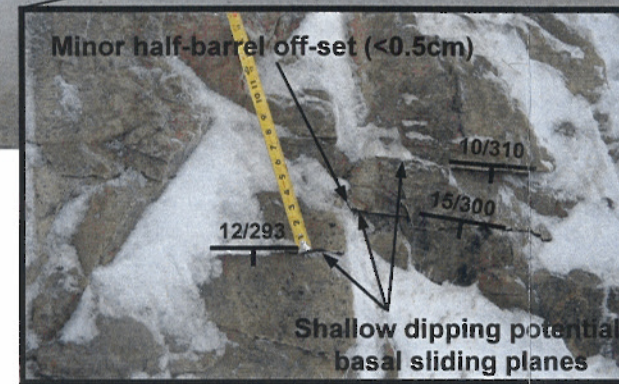
The tension crack at the rear of the larger of the two blocks; the south block; has an aperture (crack opening) ranging between 0.25 to 0.75 cm. For the north block, the aperture is less than 0.5 cm. Portions of these tension cracks appear to have preferentially developed along pre-existing joints, however, there is also evidence of tensile failure through intact rock. Although it is difficult to ascertain, for certain, whether these tension cracks developed during construction or are a post-construction phenomenon (i.e. due to weathering such as ice jacking), it is likely they were at least partly developed during initial construction (i.e. during blasting).

B) North Block Crest

Basal plane zone

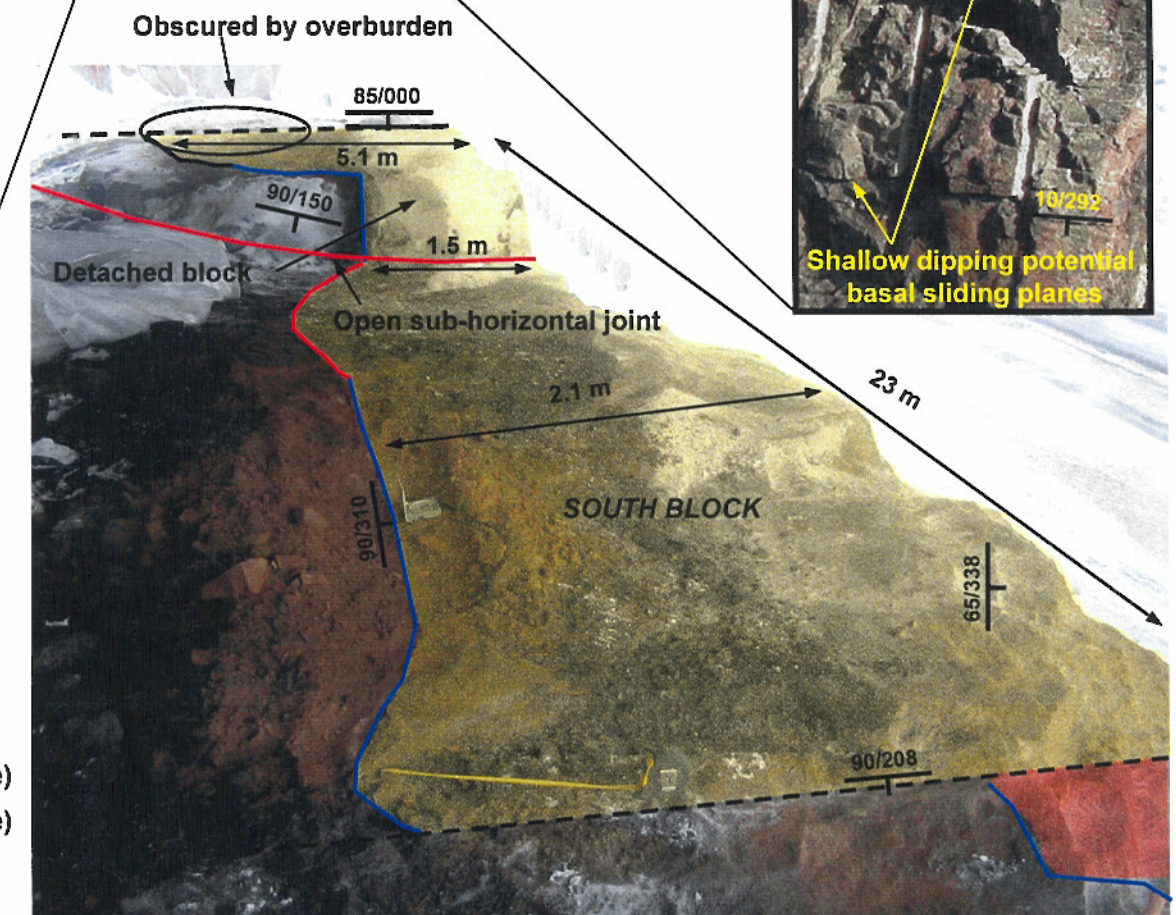
The south block has an inferred calculated volume of about 190 m³ with a weight of just over 500 tonnes. The volume of the north block is about 15 m³ with a weight of less than 40 tonnes. Measured and calculated block geometrical information for both blocks are summarized below:

C) South Block Crest
