COLLINS BAY

FAILURE AREA

Re: Collins Bay Failure Area,
Hwy. #33, near Kingston,
Cont. 60-129 - Dist. #8.

COLLINS BAY FAILURE AREA
HWY. #33, NEAR KINGSTON,
CONT. 60-129, DISTRICT #8.

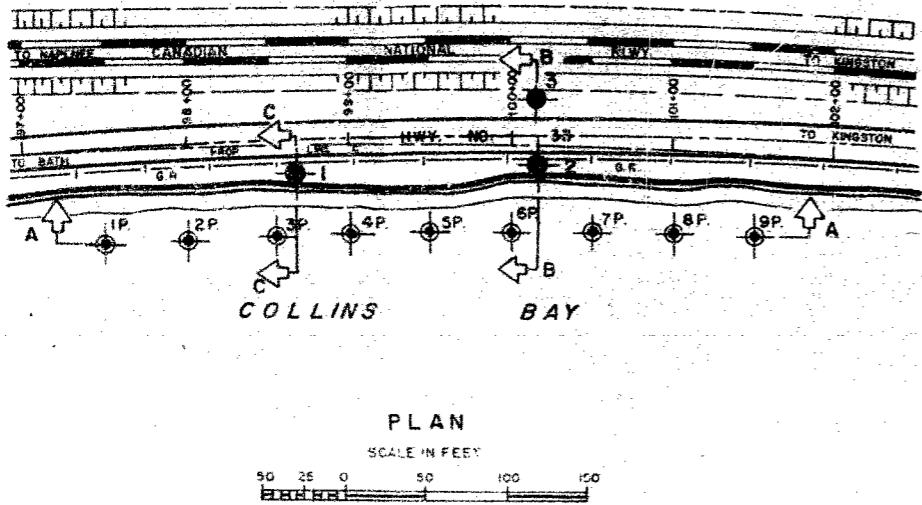
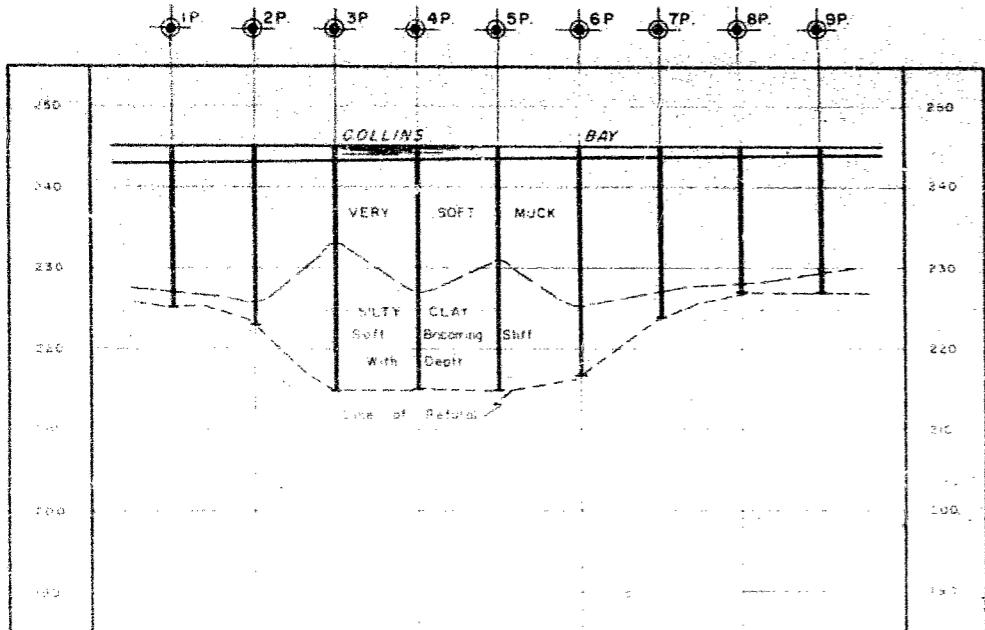
A - A

Cross section A shows the rough subsoil stratification parallel to the road centre line. None of these power auger borings has encountered any rock fill, only very soft tuck underlain by silty clay, soft in the upper portion and becoming stiffer

with depth. The contact between the muck and the silty clay is very irregular. The borings were carried down to refusal, but the cause of refusal was not established.

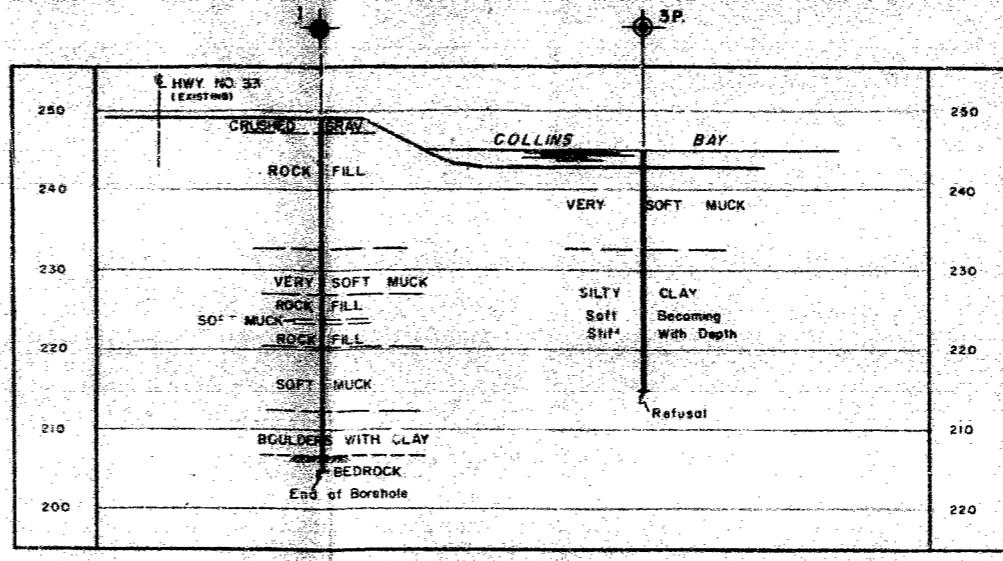
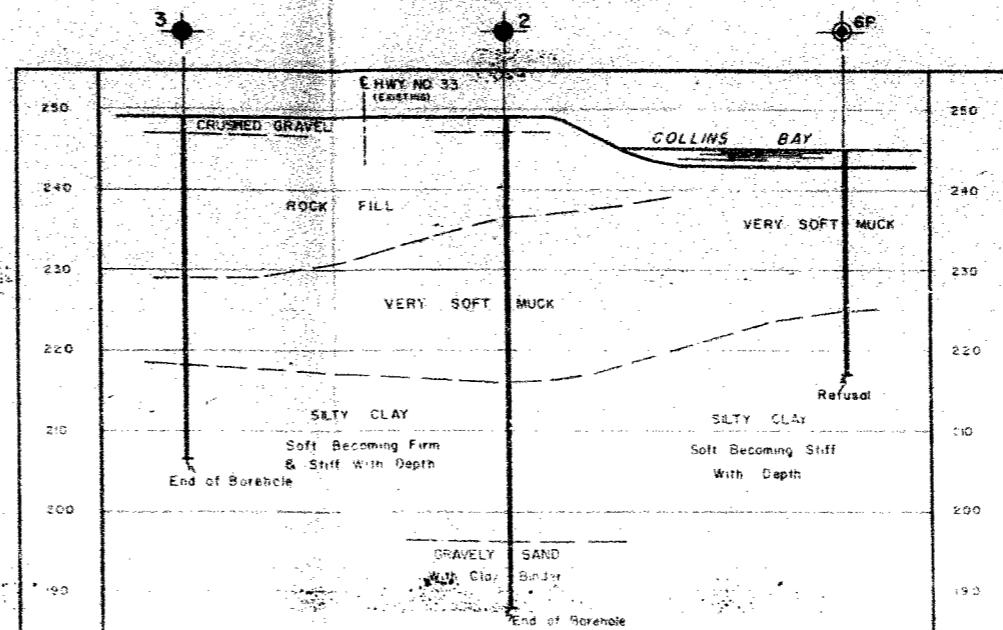
B - B

Cross section B-B is perpendicular to the road's centre line and encompasses two diamond drill boreholes - No. 3 and 2) and one power auger borehole (No. 6P). There the difference in thickness of rock fill and very soft compressible muck is obvious. A more equalized condition is to be expected under the area of borehole 3 than 2. Apart from that, the very soft muck in the area of borehole 6P provides only little lateral support and therefore, movements in this direction are explainable.
