BLESSINGTON CREEK

REPORT NO. S-500-501/55/T-77-1

Toronto, Ontario,
May 2nd, 1955.

RE: FOUNDATION INVESTIGATION
THURLOW TWP. BRIDGE NO. 8
(BLESSINGTON CREEK)

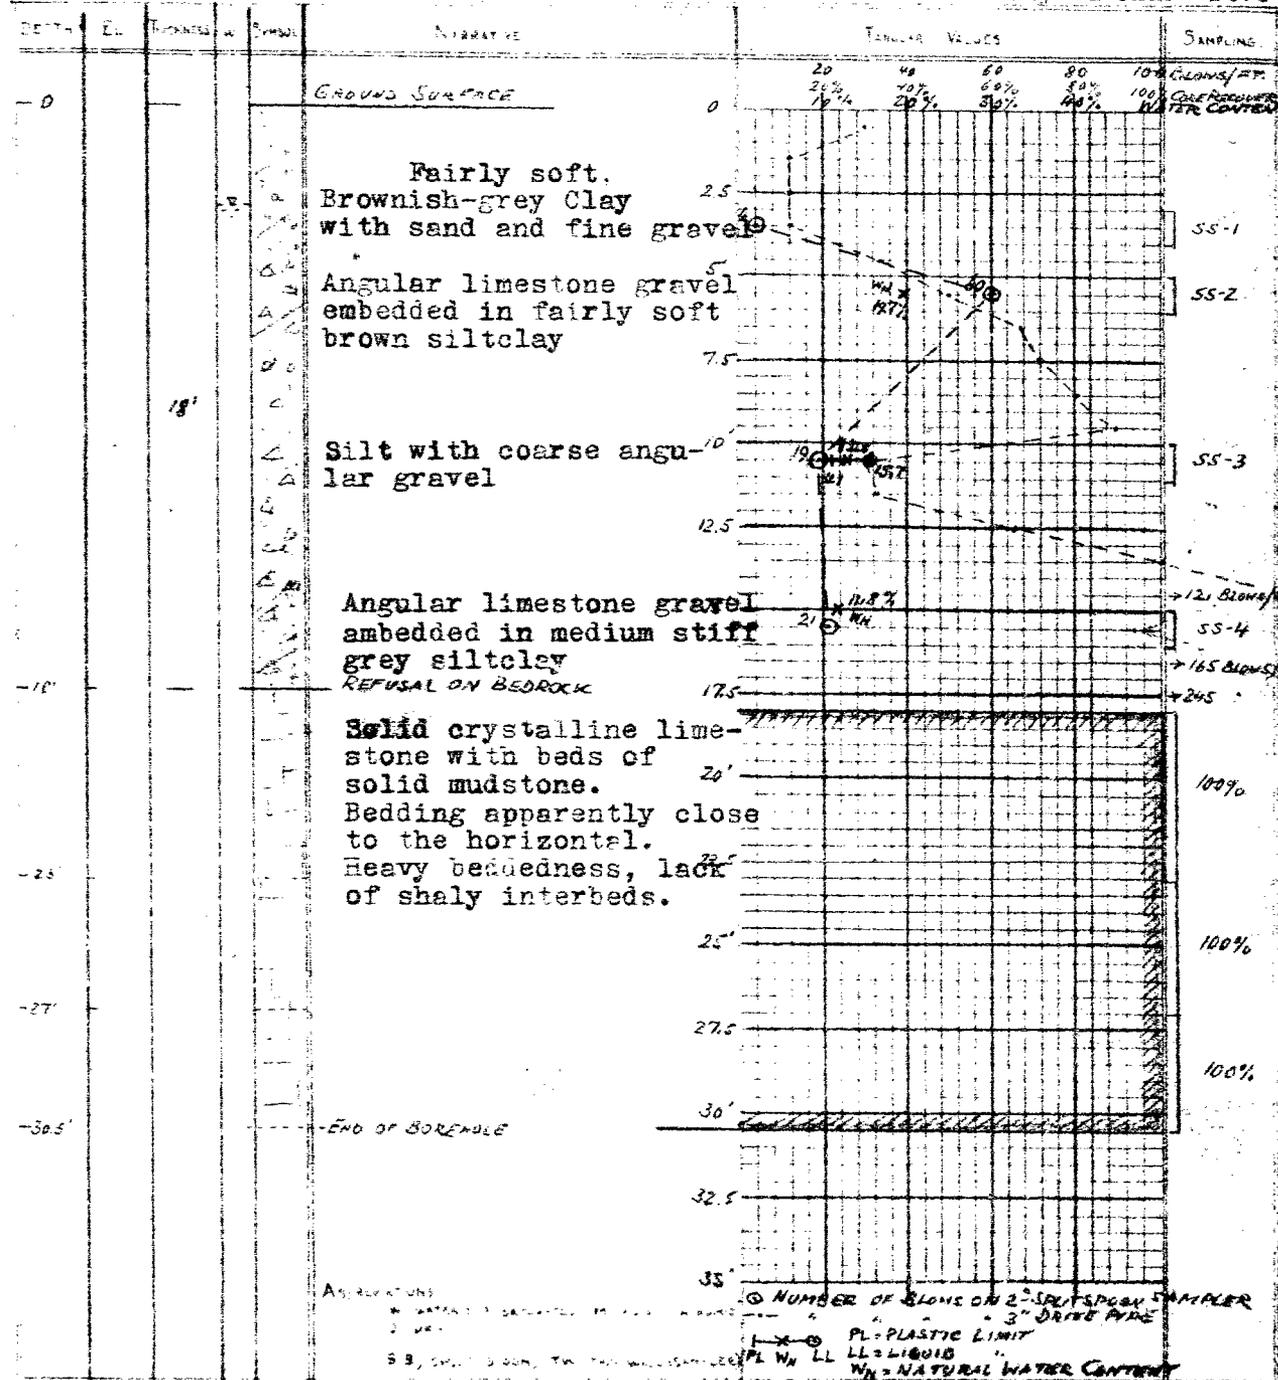
Hole Begun 8/3/55 Hole Ended 10/3/55 Engineering Dist: Sheet for Corehole: 1

Bedrock was met in Boreholes Nos. 1 and 3 in 18 feet depth, in Borehole No. 2 in 19 feet depth. The surface of bedrock appears to be fairly horizontal, and we do not believe that the difference in depth shown in Borehole No. 2 can be of use to determine a slope of the rock surface. Such unevenness is quite usual for natural surfaces.

The rock consists of very sound and solid crystalline limestone with some solid mudstone interbeds. Bedding appears to be nearly horizontal. Heavy beddedness and the lack of shales characterize this rock. The core recovery in all three boreholes was 100%.

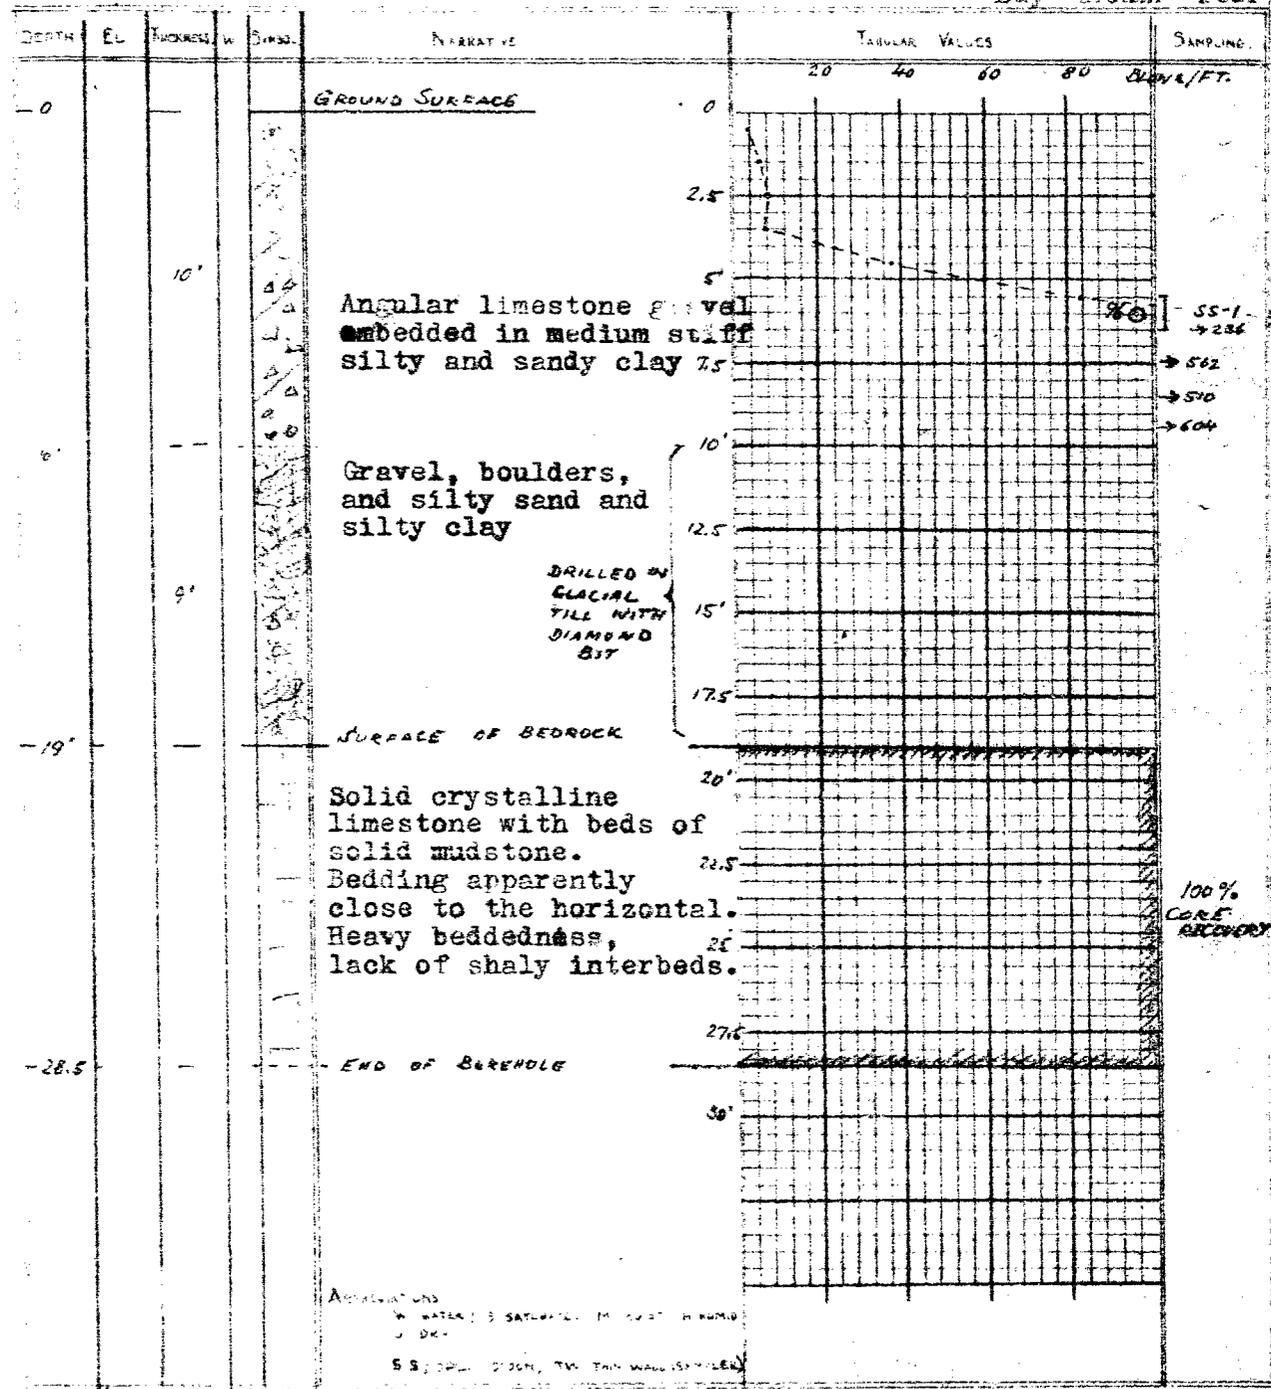
Hole Ended 22/4/55 Engineering Data Sheet for Borehole: 2

The soils on this site represent a river deposited mixture of clay, silt, and angular limestone gravel of any size up to boulders of more than a foot thickness (Borehole No. 2). The topmost layer of about five feet depth is fairly soft, the penetration value being four (4) blows per foot on the split spoon sampler.

Below five feet depth the soil contains gravel to such an extent that the penetration of the split spoon sampler can no more be considered indicative for the state of compaction or stiffness of the surrounding soils body. Soft pockets may occur as well as aggregates of hard to penetrate gravel and boulders. The latter were encountered in Borehole No. 2 and forced the drillers to discontinue the driving of pipe and proceed by drilling with the diamond bit through coarse gravel and boulders.

The river deposits of this site being quite erratic, we feel that a bridge foundation should not be based on them. The surface of bedrock offers a very sound base for a pile foundation. It may be noted that difficulties to drive the piles may be encountered where the gravel and boulder zone (Borehole No. 2) occurs: the number of blows on the three-inch inside diameter drive pipe exceeded 100 at 6 feet, 200 at 7 feet, 500 from 7 to 9, and 600 from 9 to 10 feet, where diamond core drilling was begun. We consider this material dense enough to carry the pile load as well as the rock surface will do, without the danger of any noticeable differential settlement.
