FOUNDATION INVESTIGATION REPORT

Re: Bedford Mills Diversion,  
Dev. Road 170, Bedford Mills,  
Ontario. (W.O. 51-70129)

**BEDFORD MILLS DIVERSION**

**DEV. ROAD 170, DIST. #3**

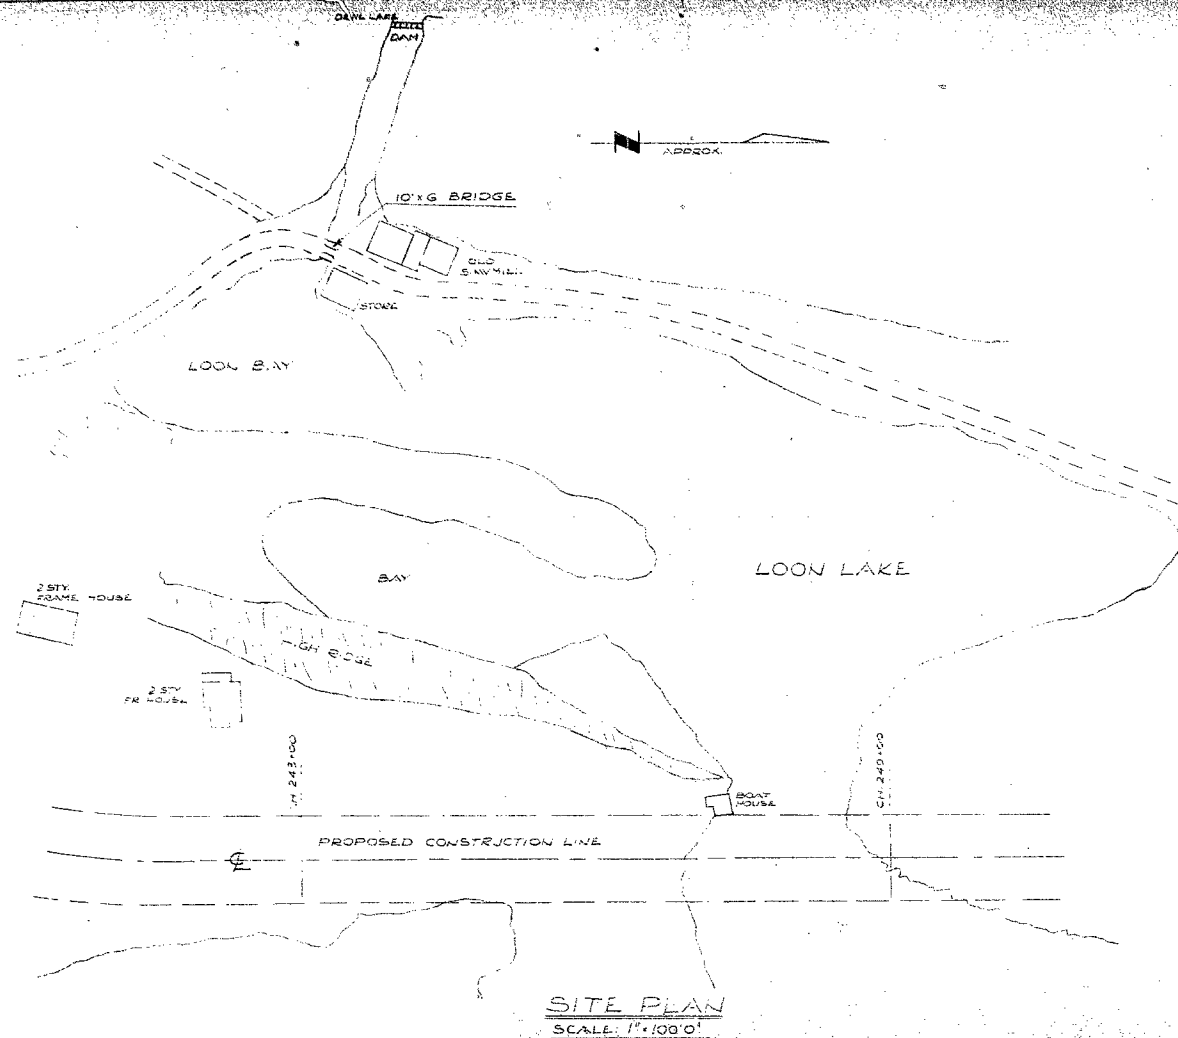
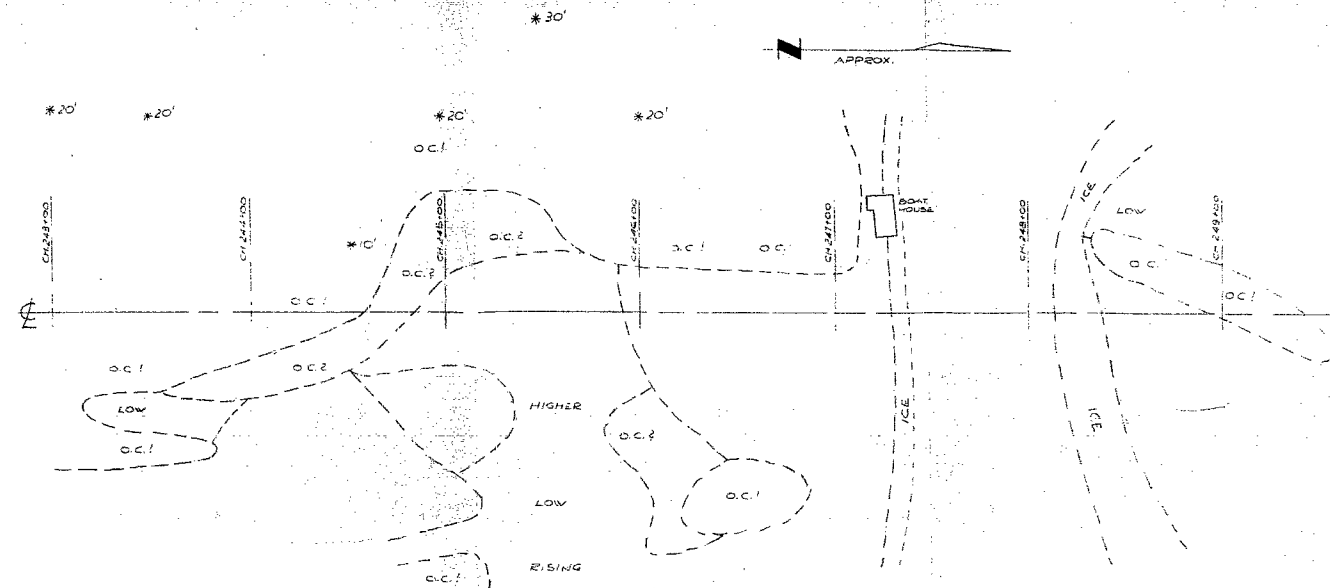
DWG. # 1  
JOB # 6223  
em peto associates ltd.  
FEB. 1962 K.K.

A key plan of the site is included on Drawing No. 1, on which a sketch showing approximately the topographical features of the site, has also been plotted.

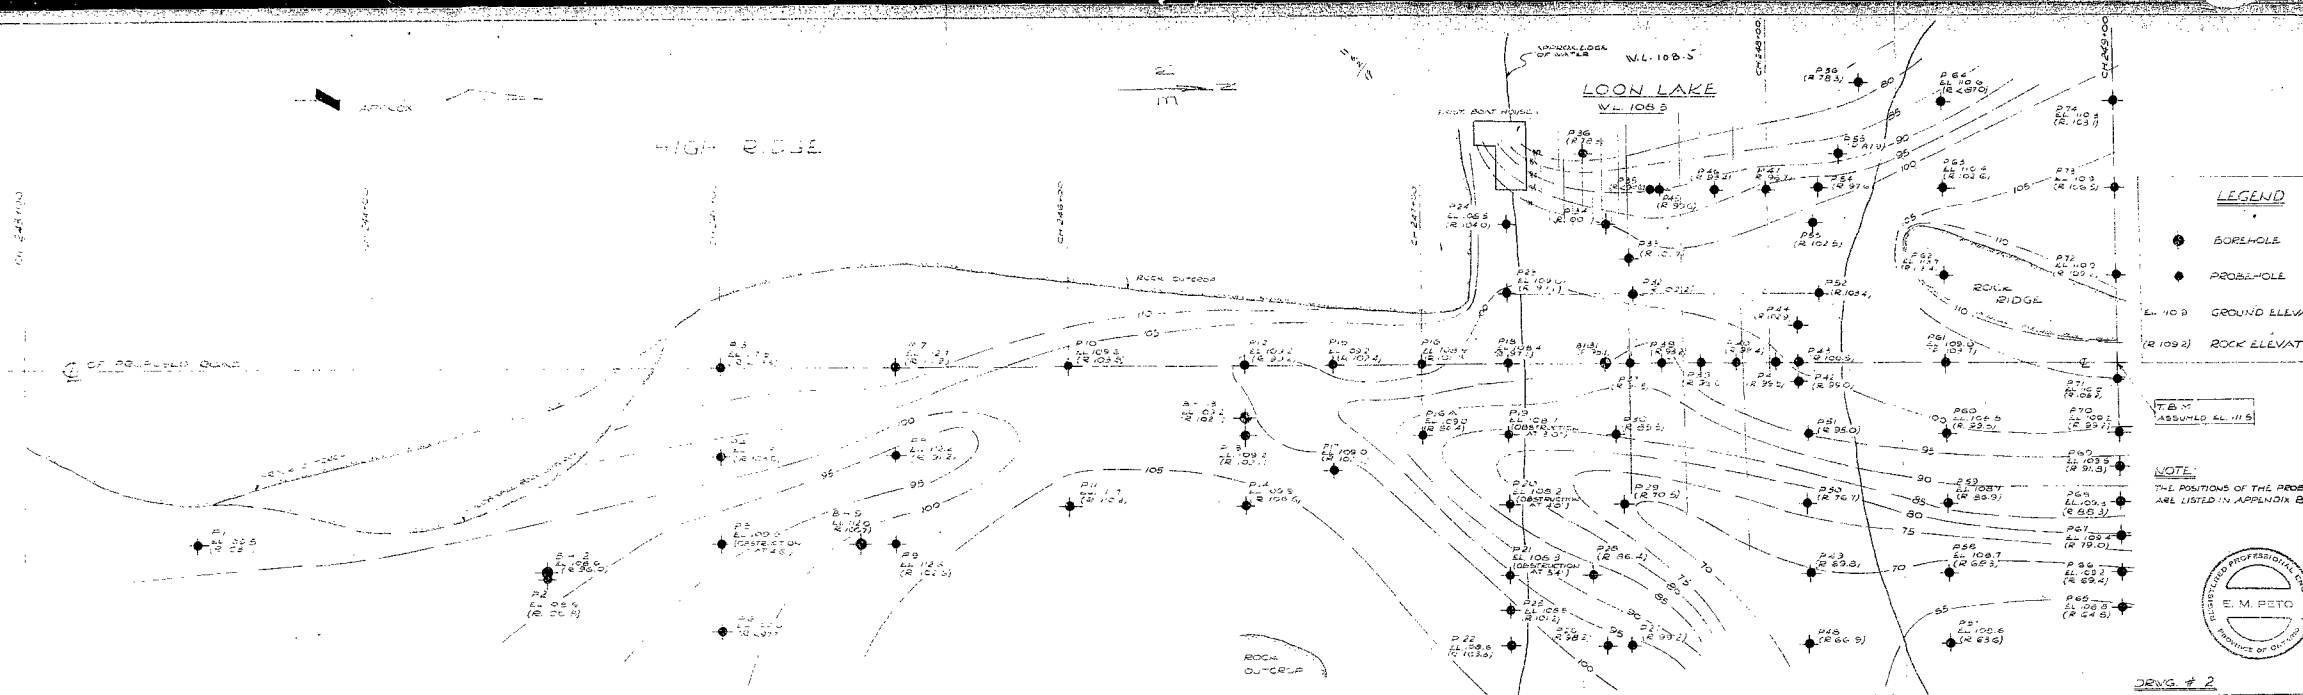
CONTOUR MAP OF ROCK SURFACE  
SCALE: 1" = 20'0"

As will be observed from the bedrock surface contours, a saddle in the granite bedrock exists at the water gap between the rock exposures on both sides of the channel. The centre of this saddle is located some 25 ft to 30 ft west of the presently proposed centre line of the highway. The rock surface drops steeply on both sides of this saddle.

The surface of the bedrock was found to rise again at the south-eastern part of the water gap, in the direction of a bedrock outcrop ridge which was observed some 75 ft east of Ch. 246 + 50. This rise in surface of the bedrock is illustrated by the bedrock contours on Drawing No. 2.

To the east of the centre line, the surface of the bedrock dropped in a north-easterly direction, as indicated by contours on Drawing No. 2. The bedrock was covered mainly by very soft organic debris and sawdust, apart from the area east of Ch. 247 + 25, where hard obstructions, probably caused by sunken barges and timber, were encountered in probes P 19, P 20, and P 21. The elevation of bedrock could not be determined in these three probes, so that the contours in the corresponding area are only approximate.

In order to take advantage of the local higher elevation of bedrock, it appears advisable to relocate the centre line of the proposed highway in the vicinity of the channel crossing by moving it 20 ft, or, preferably, 25 ft to the west. In this way, construction problems for the bridge foundations will be greatly simplified, and a considerably lesser quantity of fill will be required on the east side of the bridge approach embankments. However, the volume of necessary excavation through the rock ridge west of the centre line south of the water gap will be greater.

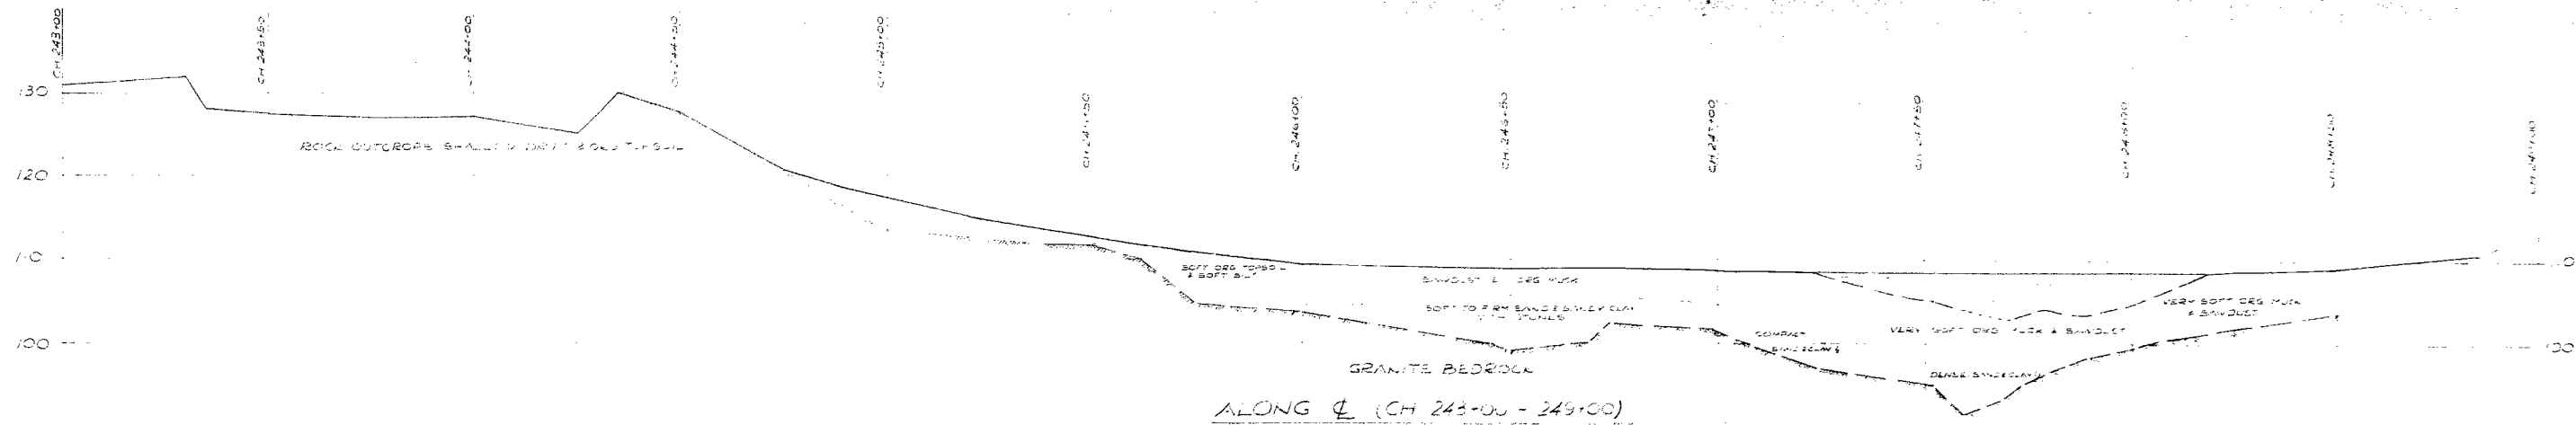
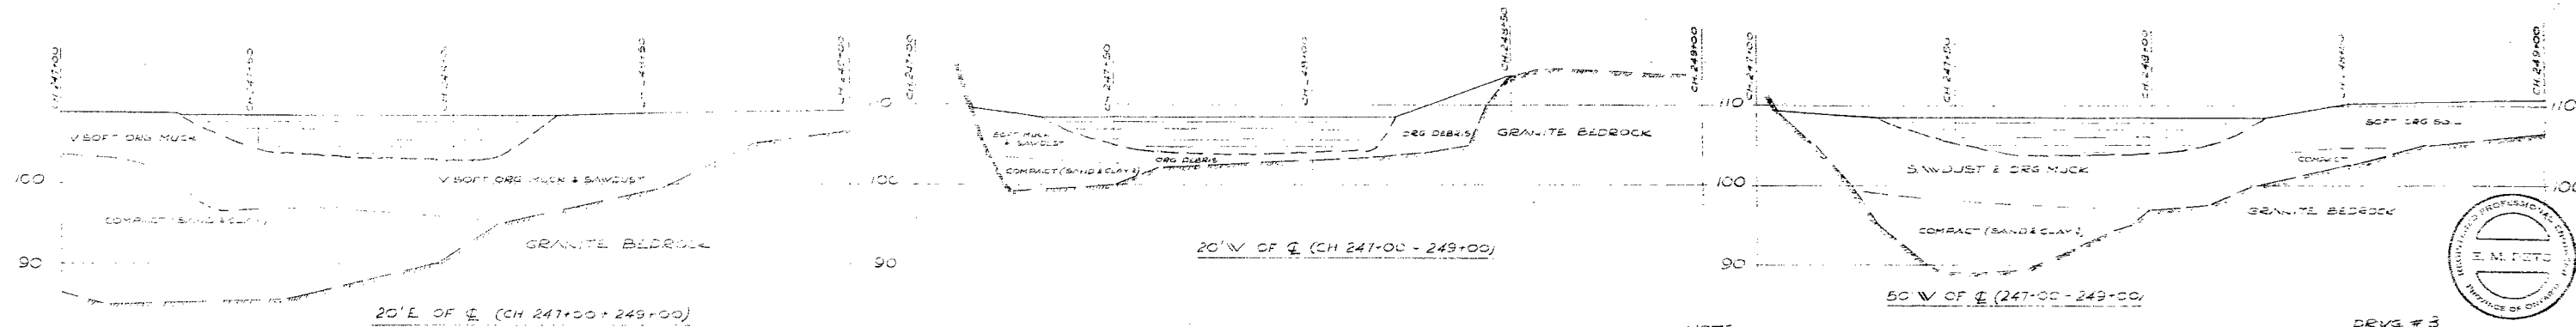
**LONGITUDINAL SECTIONS**  
 SCALES: HOR. 1" = 20' 0", VERT. 1" = 10' 0"

In addition, longitudinal sections and cross sections of the bedrock surface are presented on Drawings 3 and 4.
