62-F-264M  
BEDFORD MILLS  
DIVERSION  
DEVELOPMENT  
ROAD 170

<b>e.m. peto &amp; associates ltd.</b>	
SOIL SITE INVESTIGATION	
AT	
BEDFORD MILLS DIVERSION	
W.O. 51 - 70129	
FOR	
THE DEPARTMENT OF HIGHWAYS OF ONTARIO	
OUR JOB No. 6223	DATE FEB. 1962
CLIENTS PLAN No.	PER. K.K.

FOUNDATION INVESTIGATION REPORT  
By: E. M. Peto Associates, Ltd.

**Re: Site Investigation,  
Bedford Mills Diversion,  
Dev. Road 170,  
Bedford Mills, Ontario.**

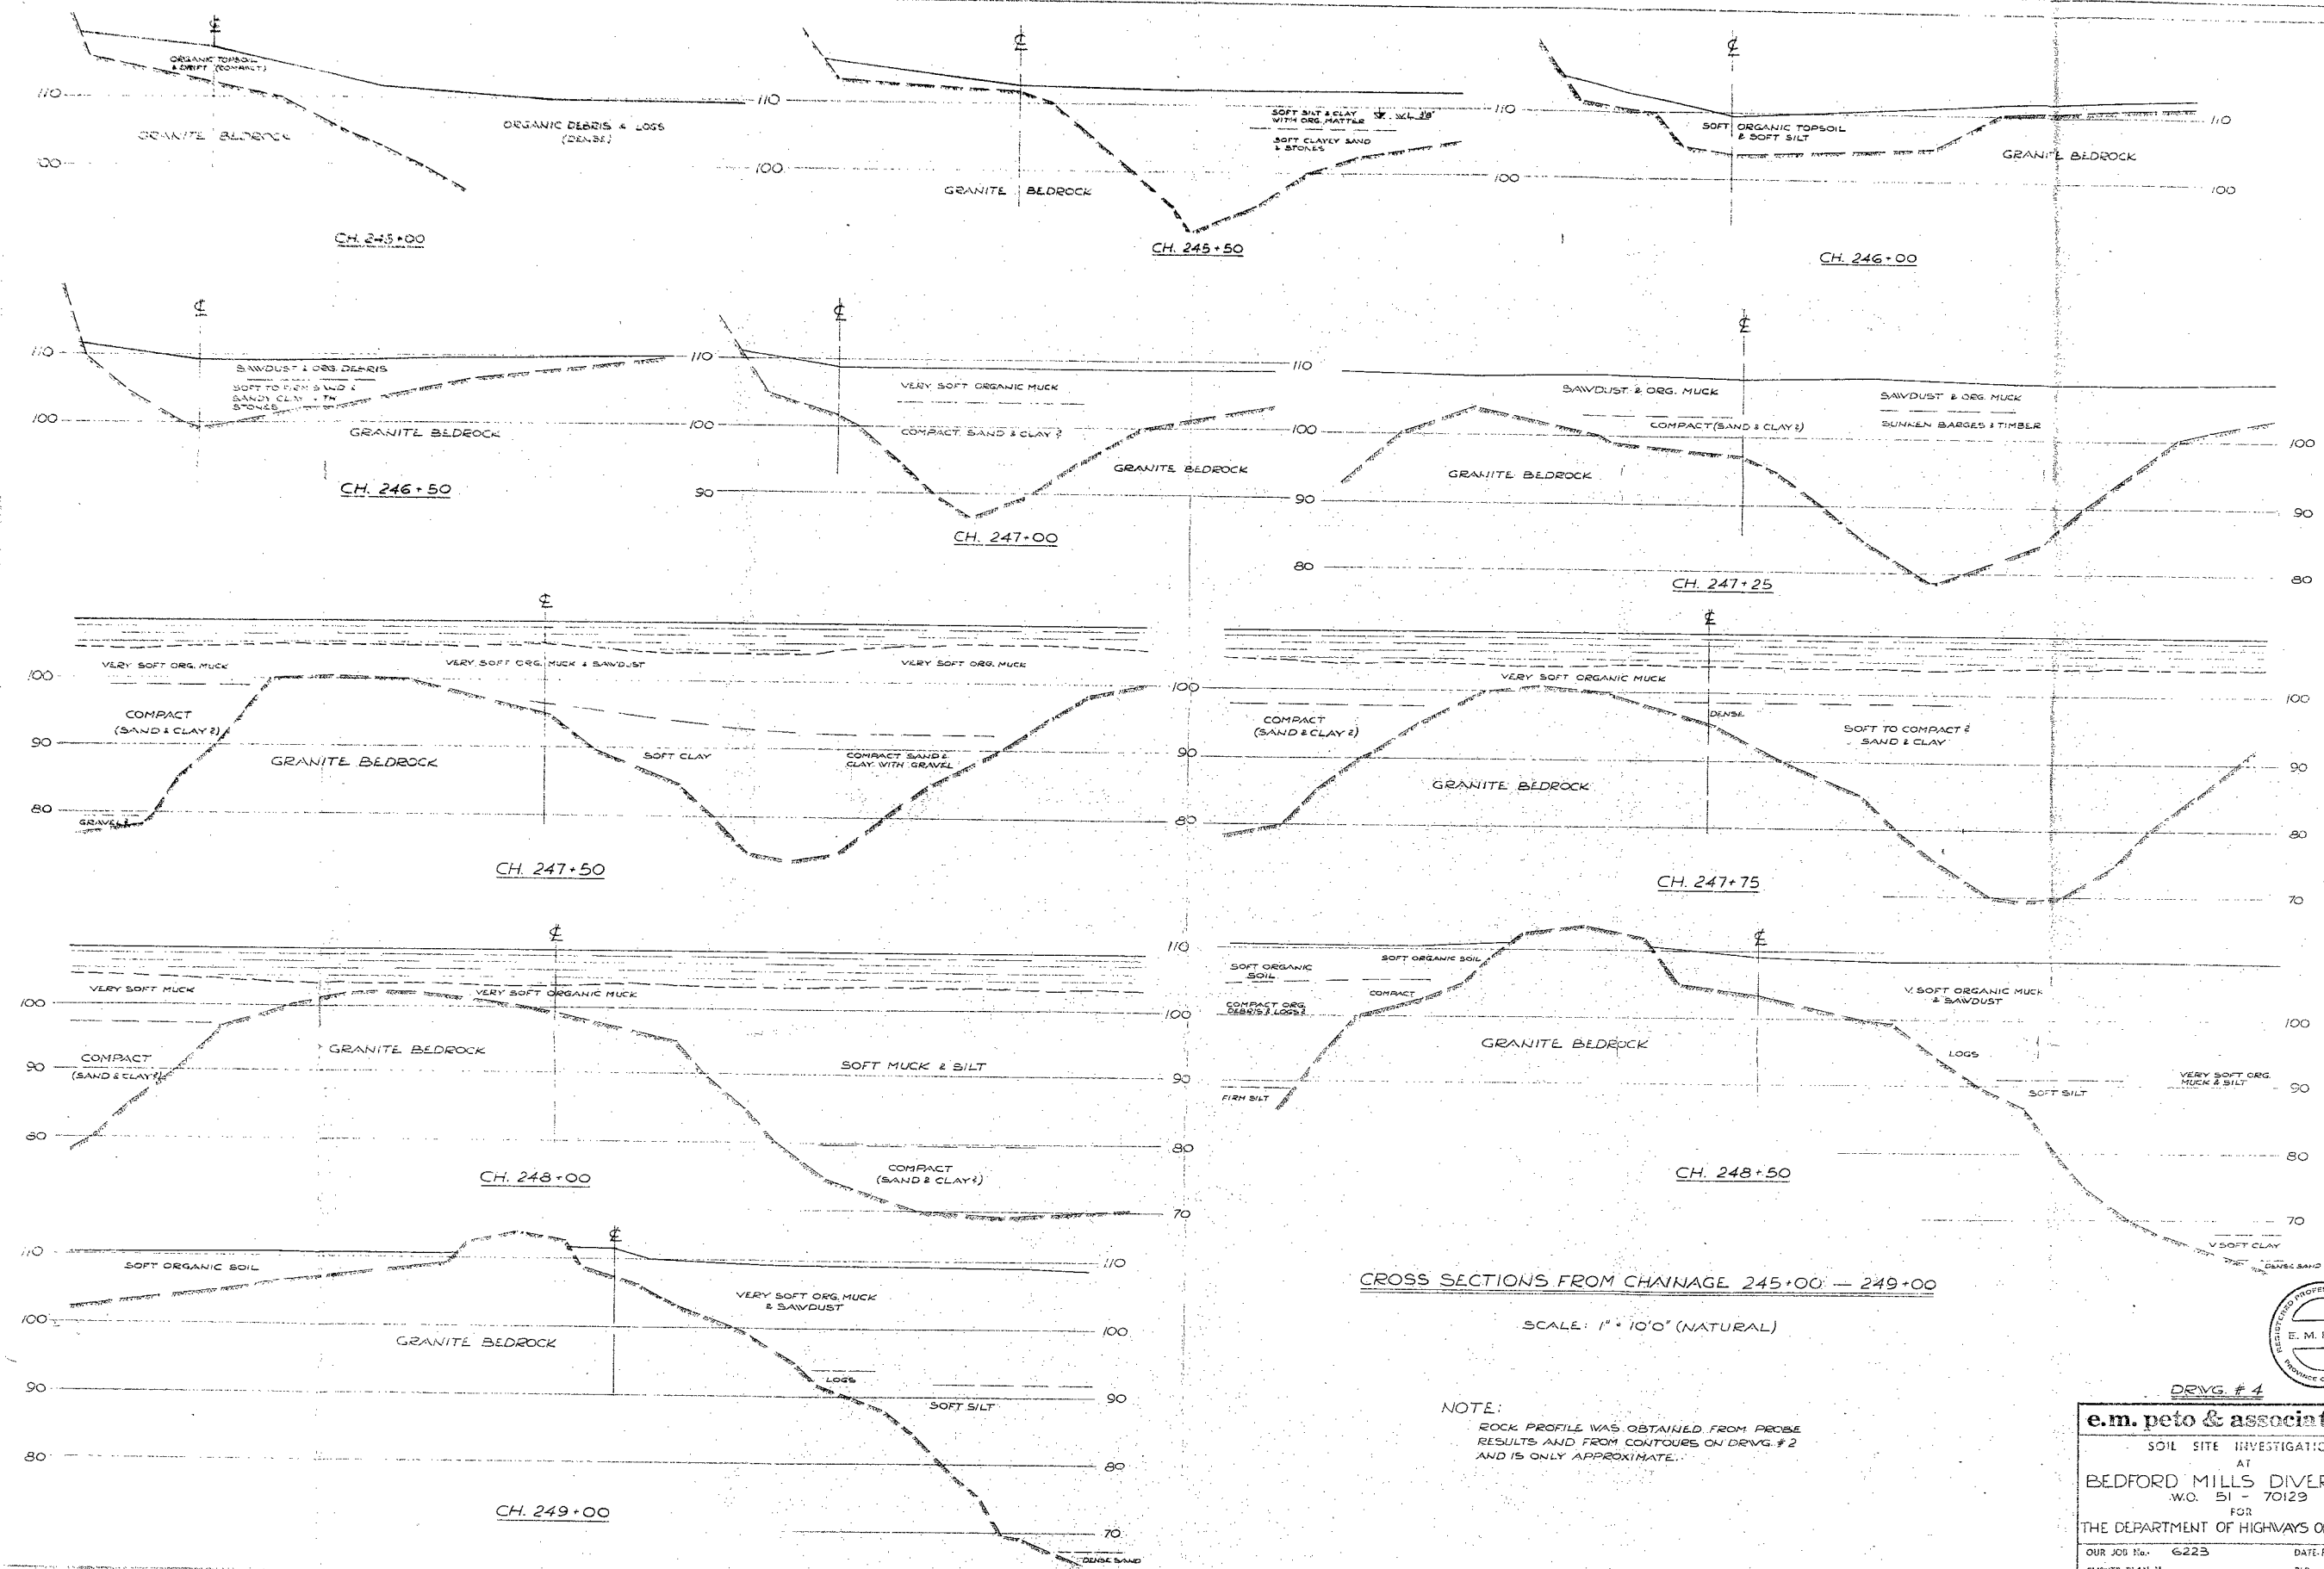
DRWG. # 4

In addition, longitudinal sections and cross sections of the bedrock surface are presented on Drawings 3 and 4.

The soil conditions in this section are illustrated on Drawing No. 4 on which cross sections at the Ch. 248 + 50 and 249 + 00 have been plotted.

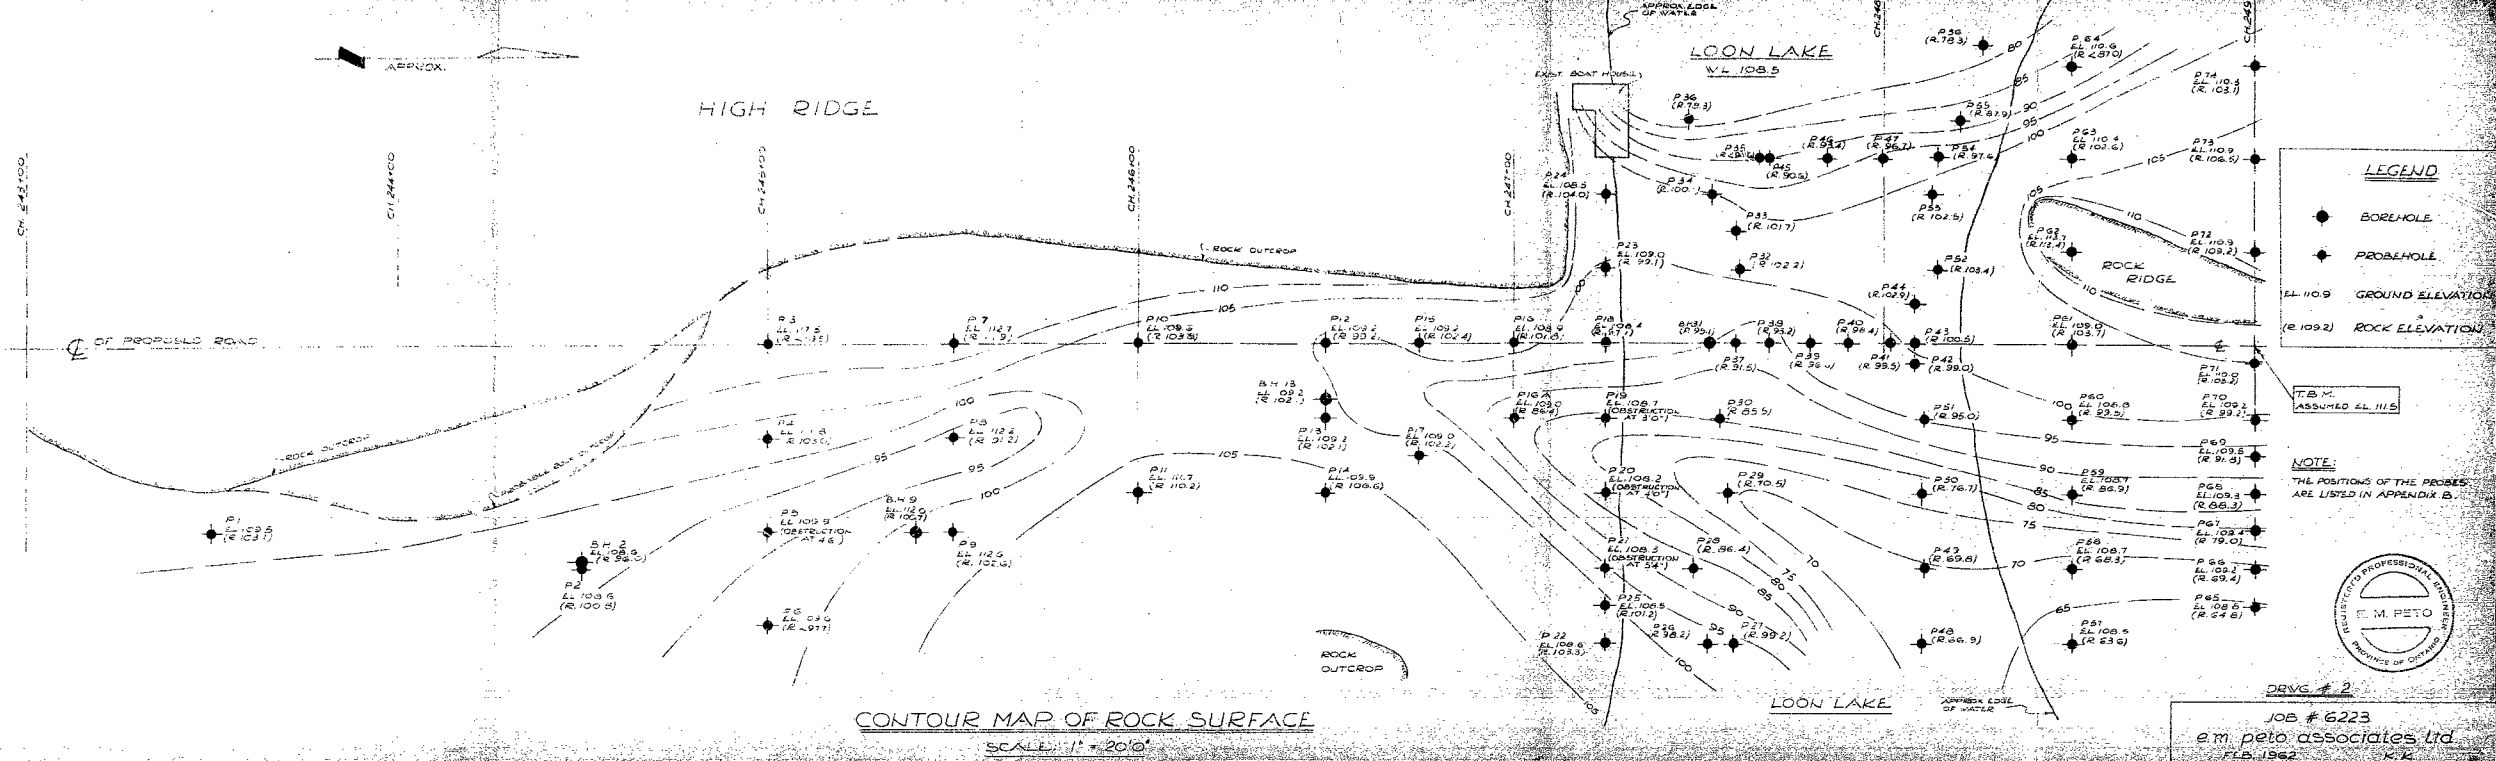
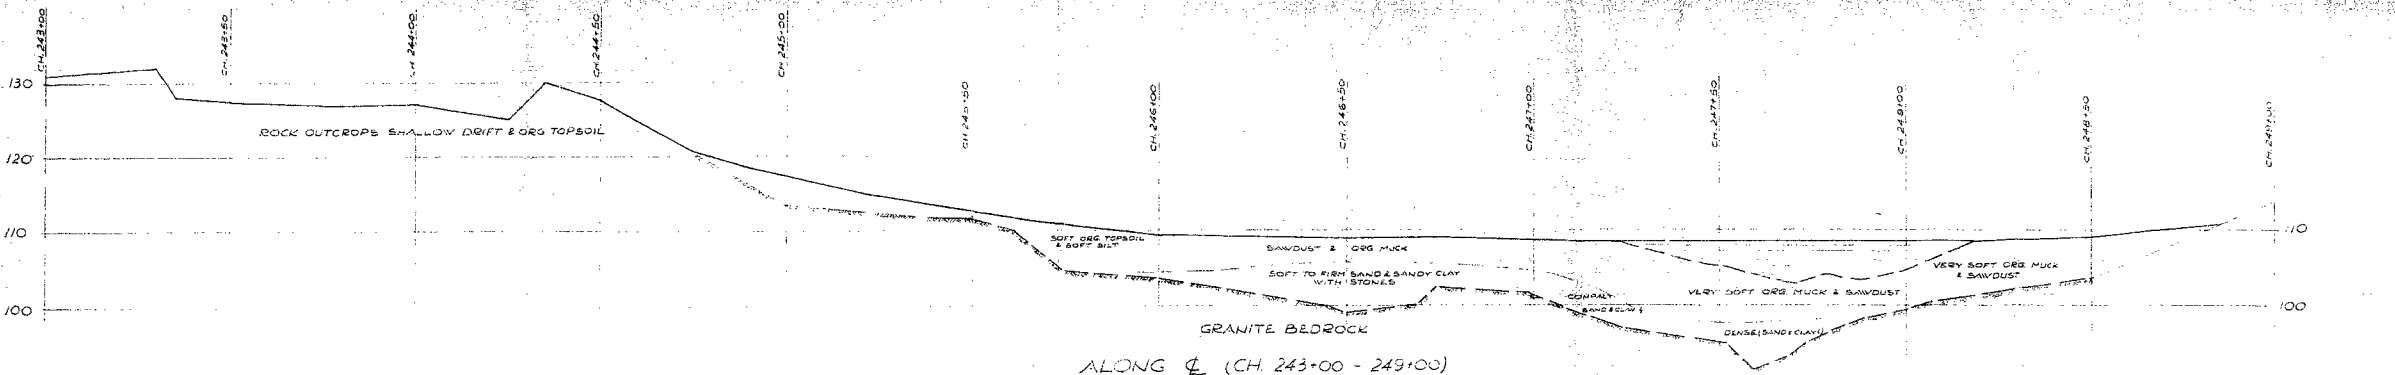
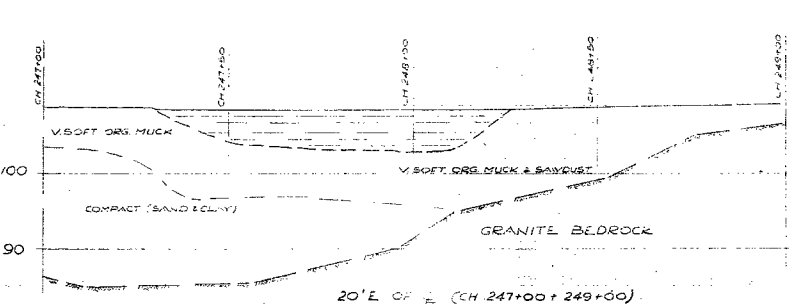
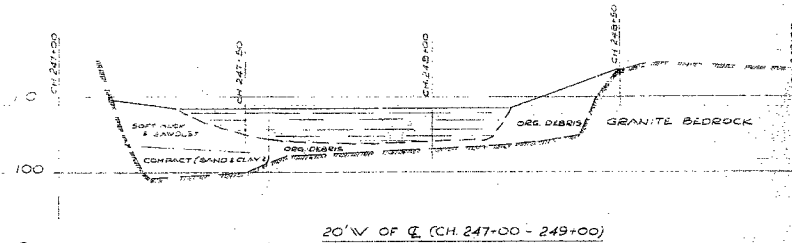
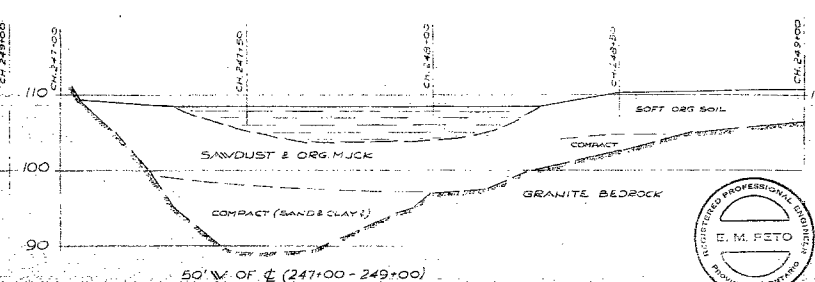
**LONGITUDINAL SECTIONS**  
 SCALES: HOR. 1" = 20' 0", VERT. 1" = 10' 0"

As will be observed from the bedrock surface contours, a saddle in the granite bedrock exists at the water gap between the rock exposures on both sides of the channel. The centre of this saddle is located some 25 ft to 30 ft west of the presently proposed centre line of the highway. The rock surface drops steeply on both sides of this saddle.

In order to take advantage of the local higher elevation of bedrock, it appears advisable to relocate the centre line of the proposed highway in the vicinity of the channel crossing by moving it 20 ft, or, preferably, 25 ft to the west. In this way, construction problems for the bridge foundations will be greatly simplified, and a considerably lesser quantity of fill will be required on the east side of the bridge approach embankments. However, the volume of necessary excavation through the rock ridge west of the centre line south of the water gap will be greater.
