(PIERS 'D' & 'E' SWING BRIDGE)

HIGHWAY NO. 14 (South Bridge) DIST. NO. 7
CO. PRINCE EDWARD

BORE HOLE LOCATIONS & SOIL STRATA

FOUNDATION INVESTIGATION
For
Piers 'D' & 'E', Swing Bridge
Hwy. #14 and Bay of Quinte
District #7 (Port Hope)
W.O. 72-11112 -- W.P. 83-71-01

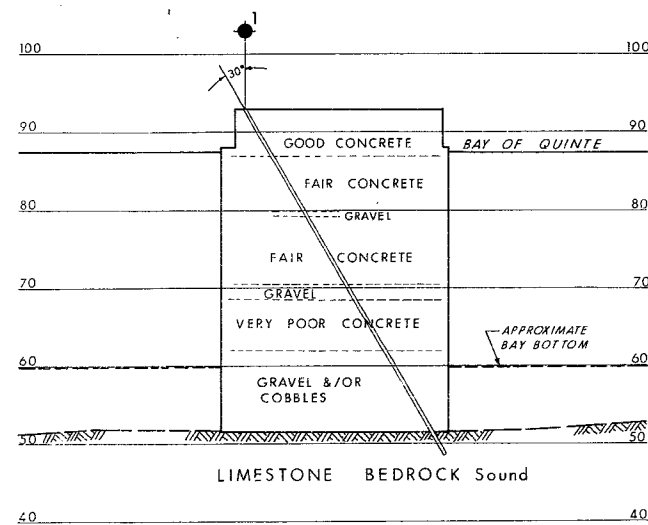
SECTION A-A PIER 'D'

Pier 'D' (Refer to B.H. #1)

<u>Depth</u> (from top of pier)	<u>Description</u>
0.0' - 6.0'	Good concrete
6.0' - 22.5'	Fair concrete with gravel layers up to 6" thick throughout
22.5' - 24.5'	Gravel
24.5' - 31.0'	Very poor concrete with gravel layers up to 15" thick throughout
31.0' - 41.5'	Gravel and/or cobbles with occasional small pieces of concrete
41.5' - 44.2'	Limestone bedrock

The Bay of Quinte water level, during the field investigation, was at elevation 87.5, which is 5.5 and 7.5 feet below the top of piers 'D' and 'E', respectively. It is, therefore, interpreted that both pier 'D' and pier 'E' were concrete-filled and that the concrete above the bay water level is good. However, the concrete below the bay water level varies progressively with depth from fair to very poor with numerous layers of gravel and/or cobbles. It is believed that the piers were poured under water which

resulted in aggregate segregation.

It is our opinion that pressure grouting techniques be employed to strengthen the bottom portion of both pier 'D' and pier 'E'

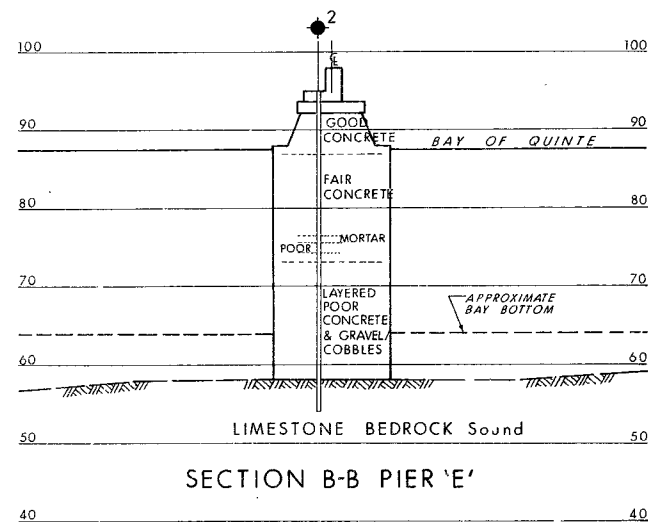
SECTION B-B PIER 'E'

Pier 'E' (Refer to B.H. #2)

<u>Depth</u> (from top of pier)	<u>Description</u>
0' - 8.0'	Good concrete
8.0' - 21.7'	Fair concrete with minor gravel layers throughout
21.7' - 36.9'	Layered poor concrete and gravels/cobbles
36.9' - 41.0'	Limestone bedrock

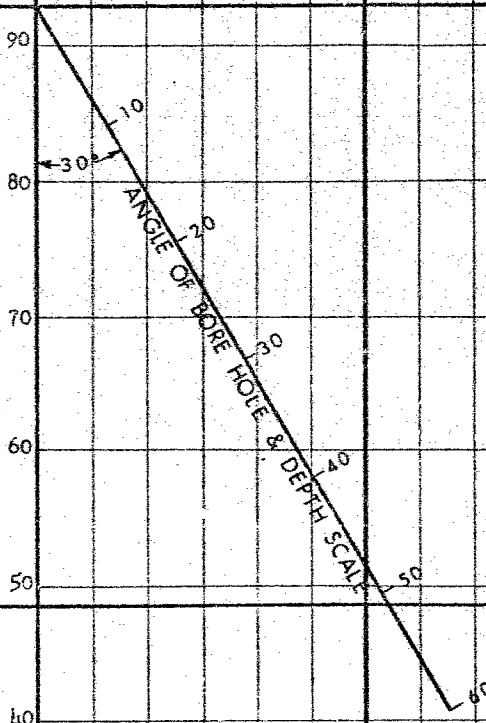
RECORD OF BOREHOLE NO 1

93.0	Top of Pier 'D'									
0.0	Good Concrete		1	NXL	100%	90				
87.0			2	NXL	95%					
7.0	Fair Concrete		3	NXL	90%					
	gravel		4	NXL	70%					
	(with gravel layers up to 6" thick throughout)		5	NXL	95%					
			6	NXL	95%

70.5			7	NXL	83%					
26.0	Gravel		8	NXL	50%					
28.3	Very poor concrete (with gravel layers up to 15" thick throughout)		9	BXL	71%					
			10	BXL	67%

62.0			11	BXL	70%					
			12	BXL	76%					
35.7	Gravel, and/or cobbles with occ. small pieces of concrete.		13	BXL	20%					
			14	BXL	35%					
51.5			15	AXT	20%

48.0	Bedrock Limestone									
48.8	Sound		16	AXT	100%					
51.3	End of Borehole
