GEOCRES No. 31C-154DIST. 41 REGION W.P. No. 48-94-01CONT. No. W. O. No. STR. SITE No. 17-16HWY. No. 41LOCATION Hwy 41 & CLARE RIVERNo of PAGES -OVERSIZE DRAWINGS TO BE INCLUDED WITH THIS REPORT.REMARKS:

**FOUNDATION INVESTIGATION AND DESIGN REPORT
FOR
CLARE RIVER BRIDGE REHABILITATION
WP 48-94-01, SITE 17-16
HIGHWAY 41, DISTRICT 41, KINGSTON**

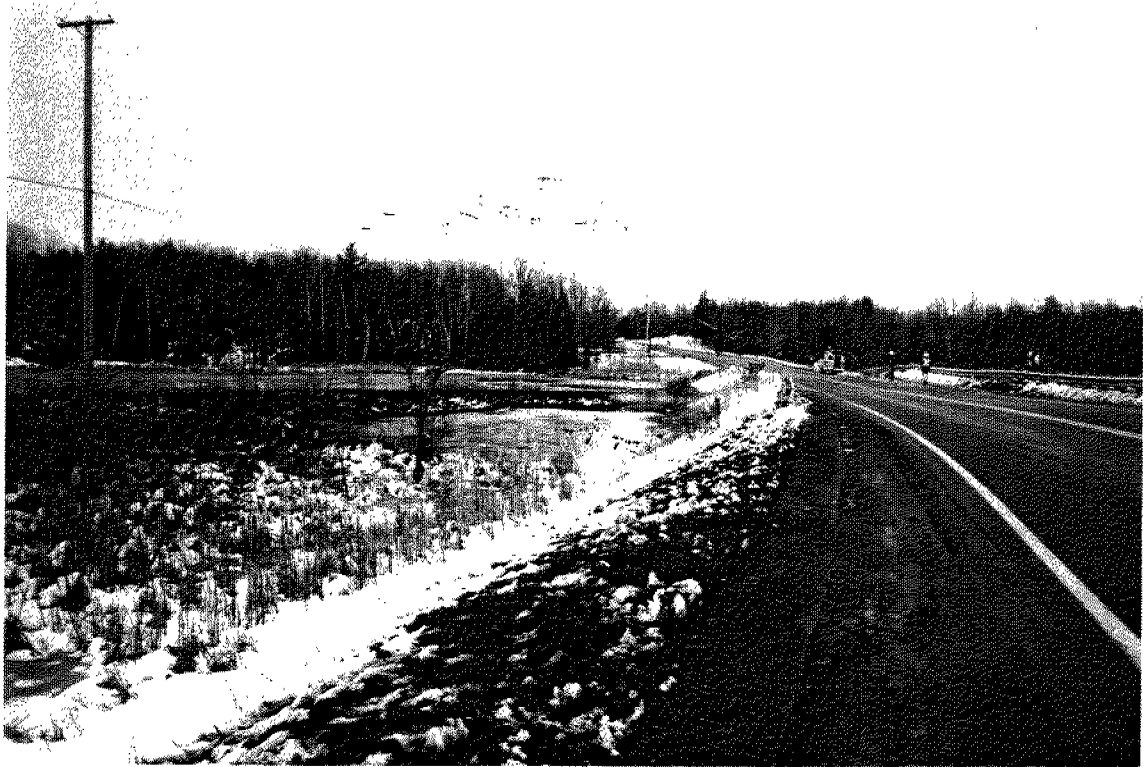
May 41 - Looking South
East
~~East~~ Approach

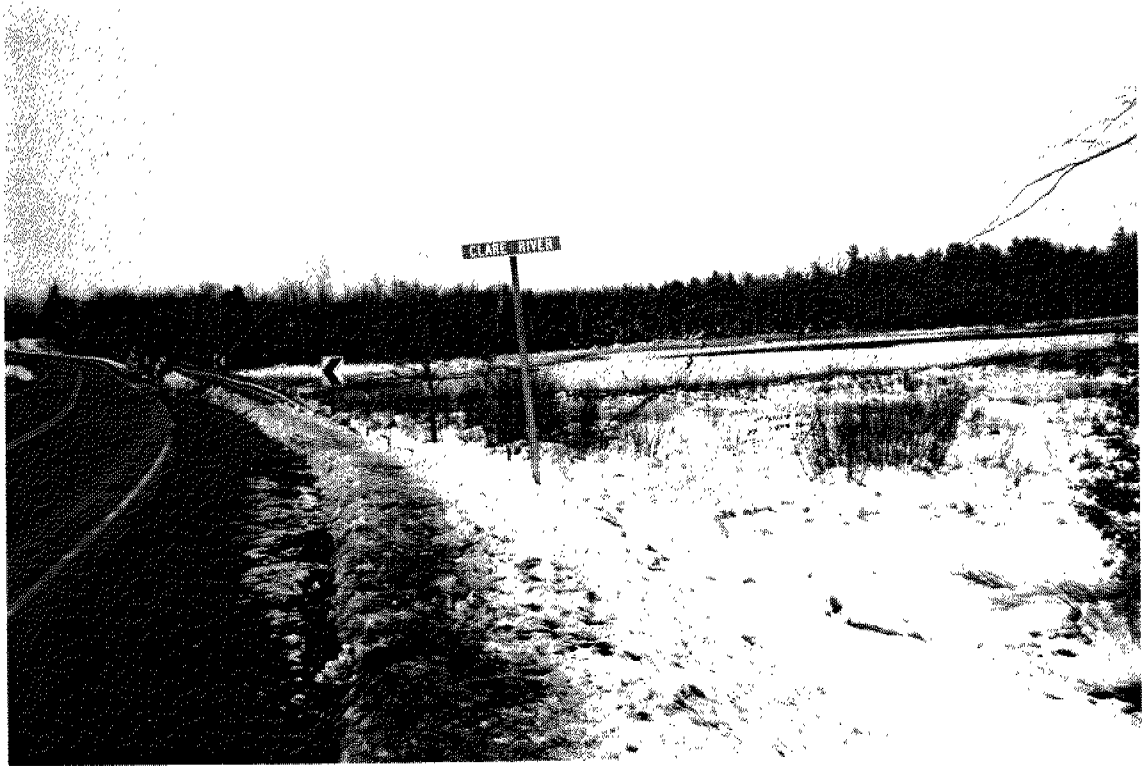
Looking ~~North~~ South,

West Side

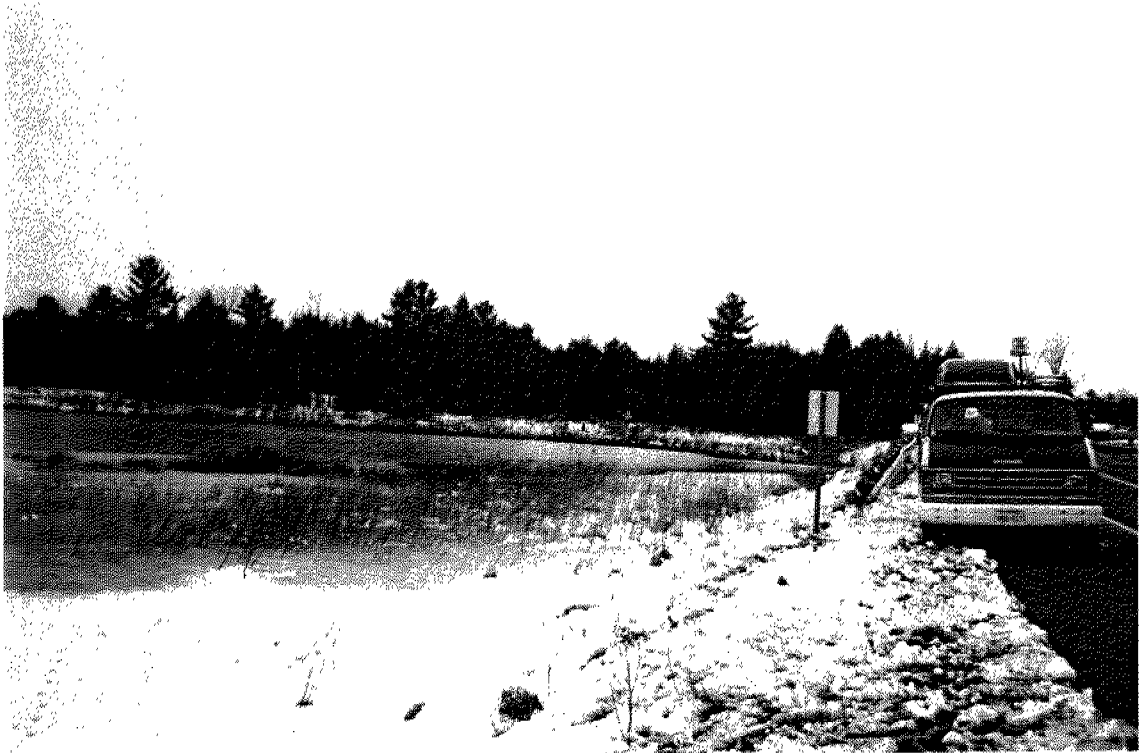
Looky North
West Side

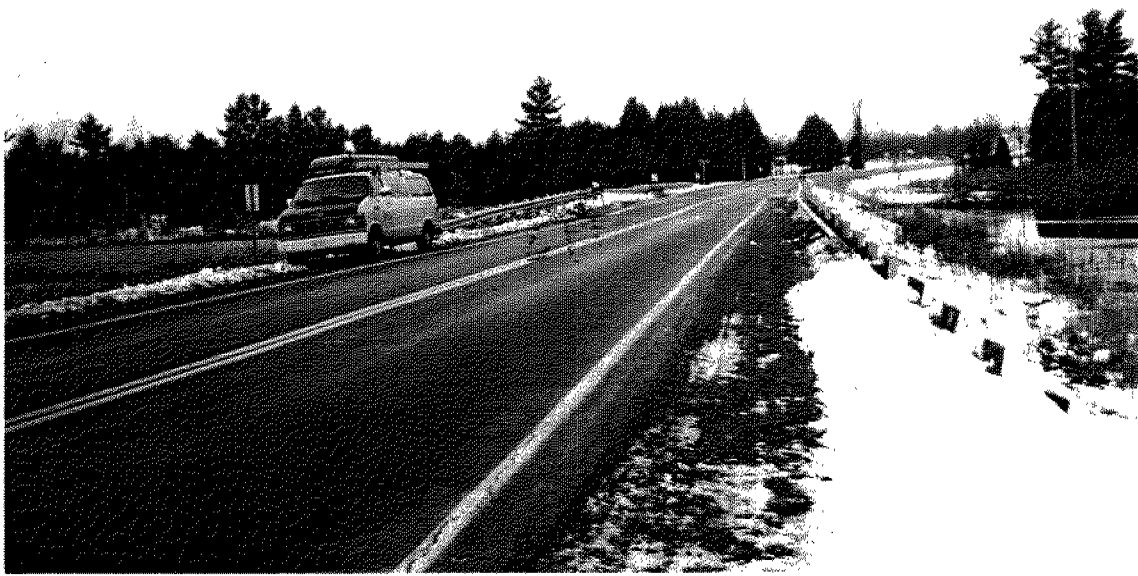
Looking North
East Side

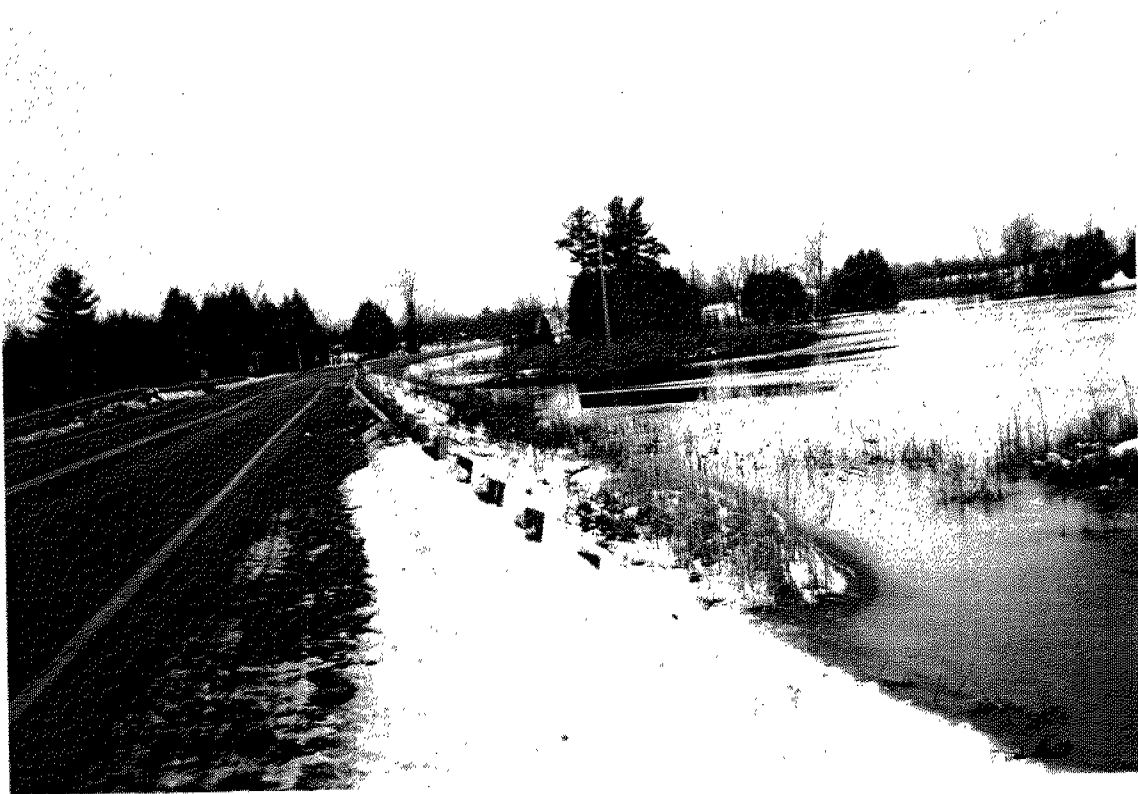
Loddy South East Side

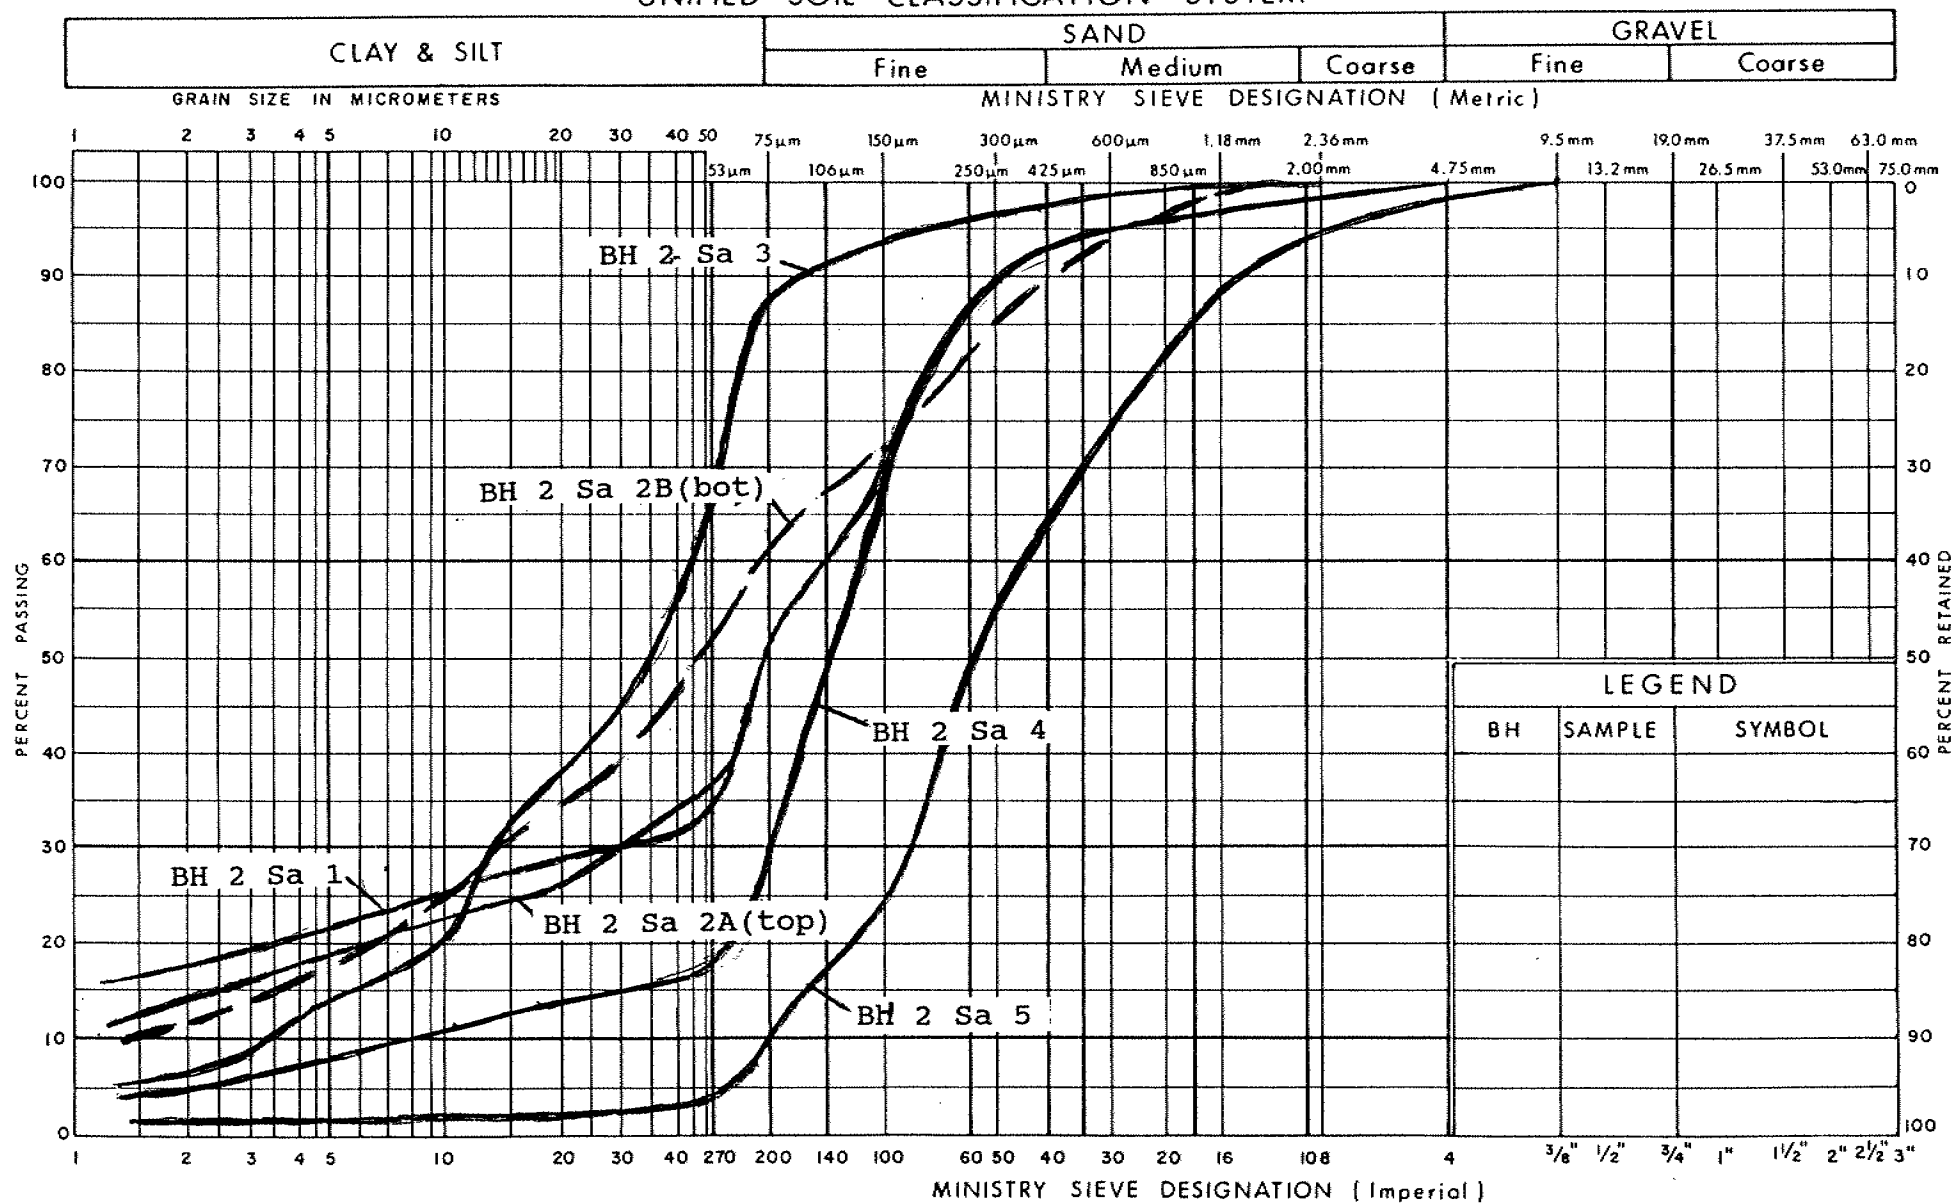
FIG No 2

The organic silt extended down to a depth of 8.6 m and was underlain by a layer of sandy silt with a trace of clay. This layer was non plastic, grey in colour, loose to compact and wet and it extended down to a depth of 9.75 m. Below this sandy silt was a layer of fine to medium sand, with some silt and boulders and a trace of clay. It was grey, loose to compact, wet and extended down to 13.00 m below ground surface. Below this was a layer of boulders or possibly weathered bedrock. No recovery was obtained as the core barrel could not be retrieved. The borehole was terminated at 14.7 m. Detailed soil profiles are shown on the borehole logs and grain size analyses are shown on figures 1 and 2. Plasticity index properties for the organic silt are shown on figure number 3.

GRAIN SIZE DISTRIBUTION ORGANIC SILT TO SAND

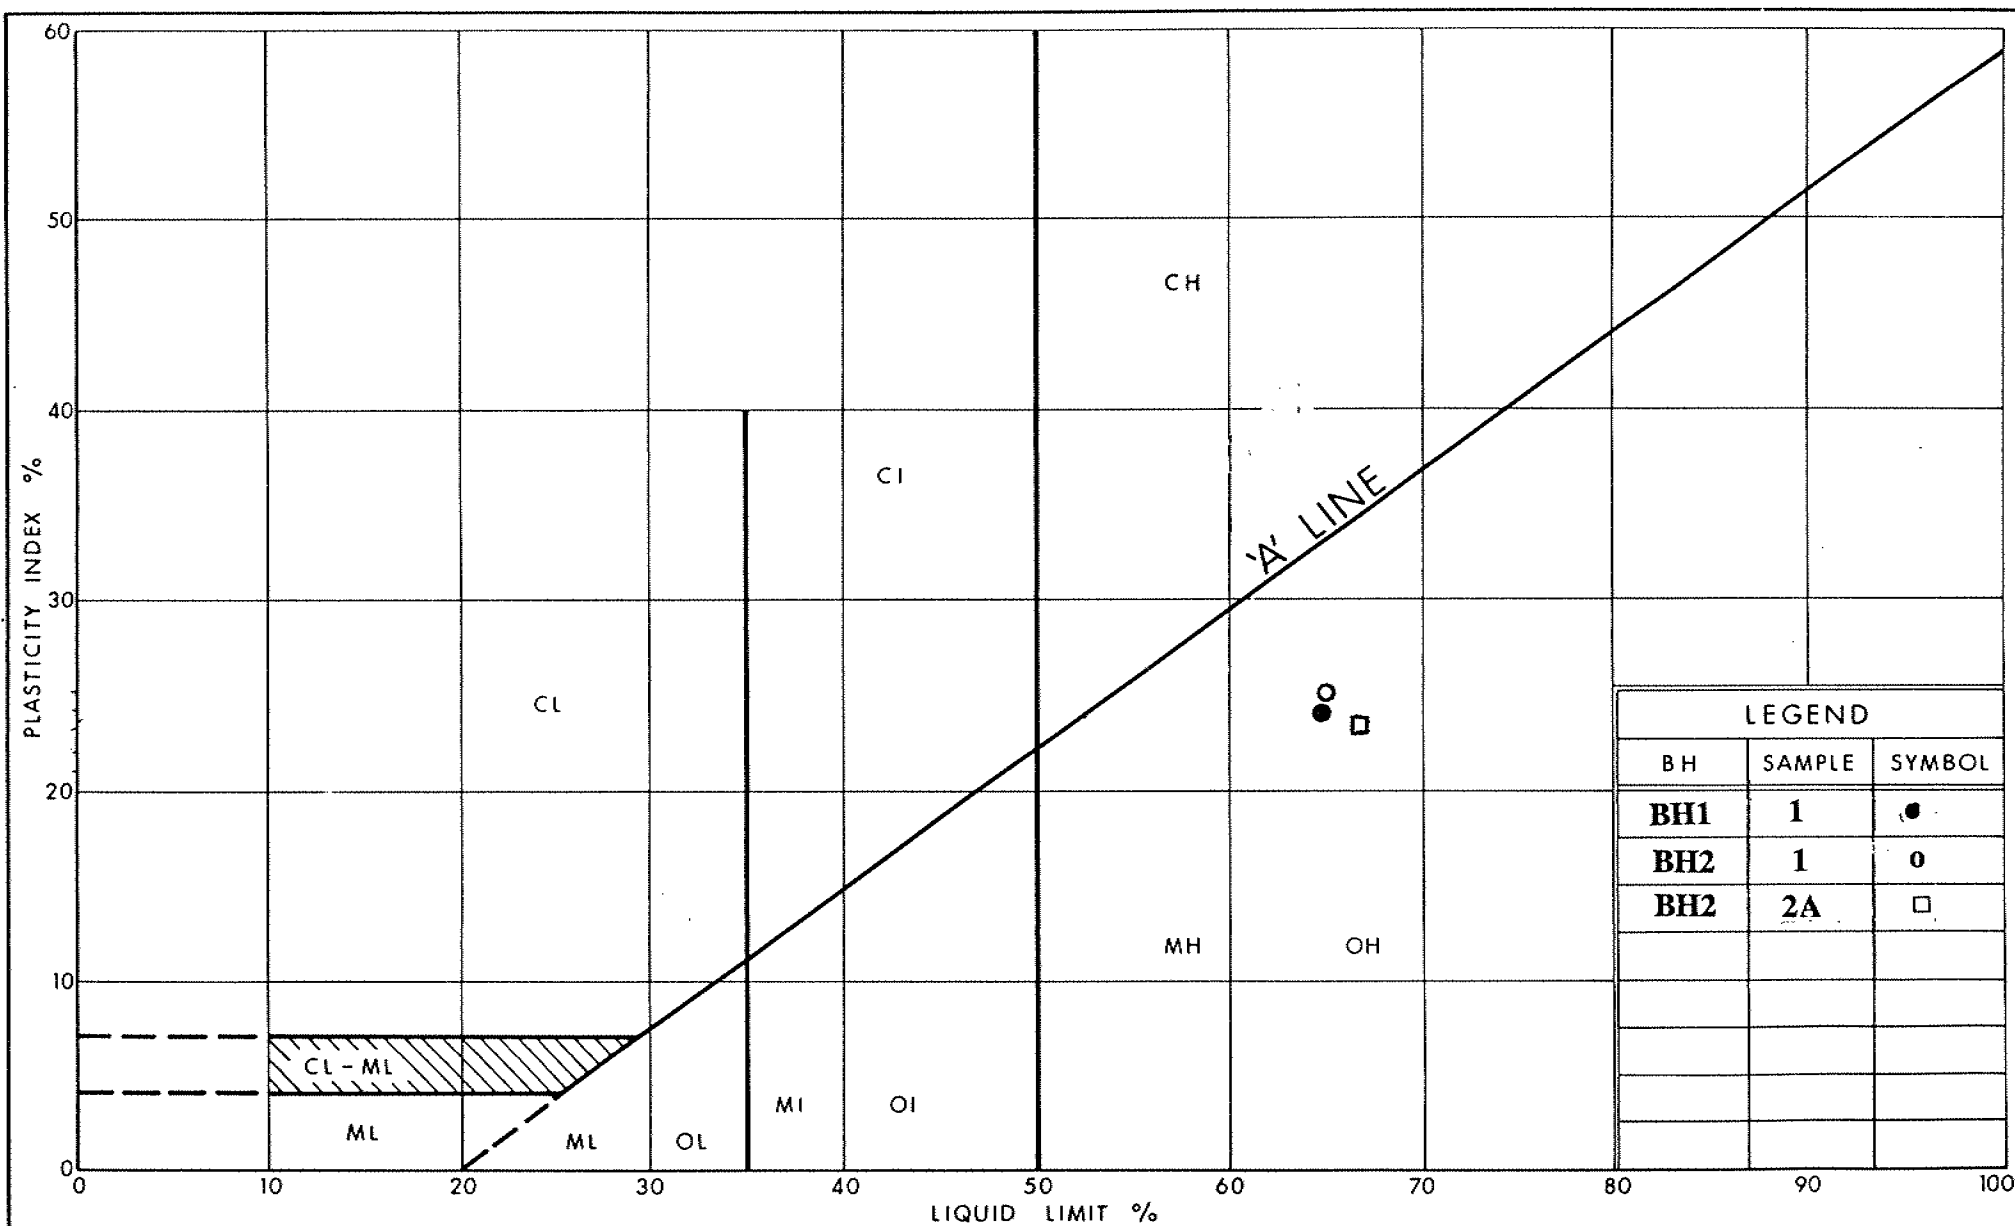
PLASTICITY CHART ORGANIC SILT sandy, clayey
