**CONDITION SURVEY REPORT  
3892 HIGHWAY 26 - DRAINAGE DITCH IMPROVEMENT  
AGREEMENT NO. 2013-E-0039  
TOWN OF EDENVALE, ONTARIO  
FOR  
MINISTRY OF TRANSPORTATION**

PML Ref.: 14TF007  
Index No.: 017CSR  
GEOCRES No.: 31D-579  
September 16, 2014

**Condition Survey Report**  
**Highway 26 – Edenvale, 3892 Highway 26,**  
**Personal Residence and Detached Structures**  
**Agreement No. 2013-E-0039**  
**Edenvale, Ontario**

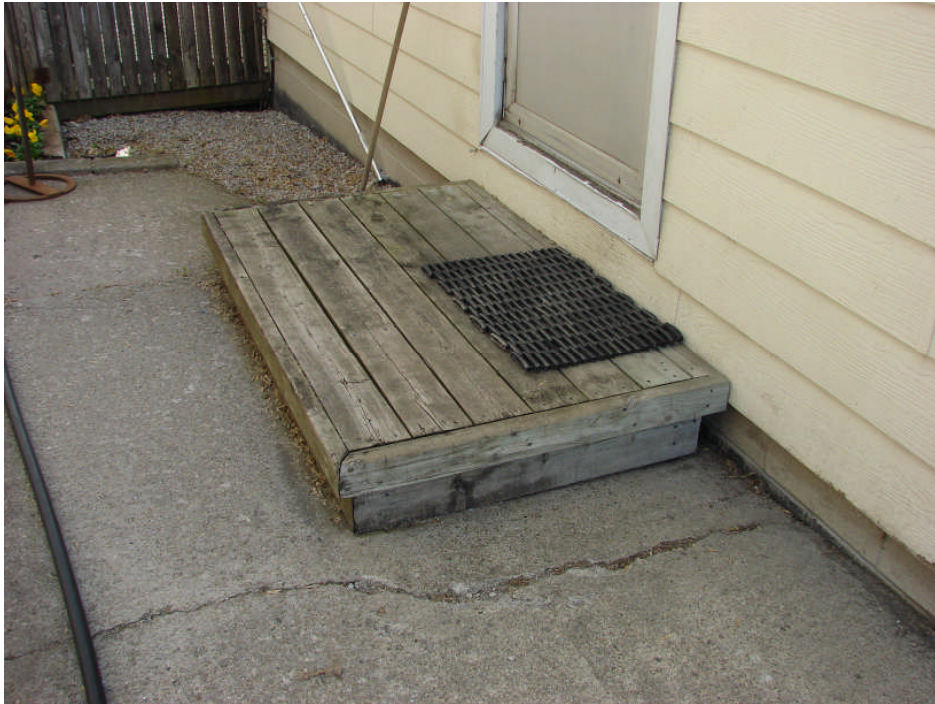
**Photograph 10:** Residence West elevation – severely deteriorated slab-on-grade concrete with extensive cracking, typical.

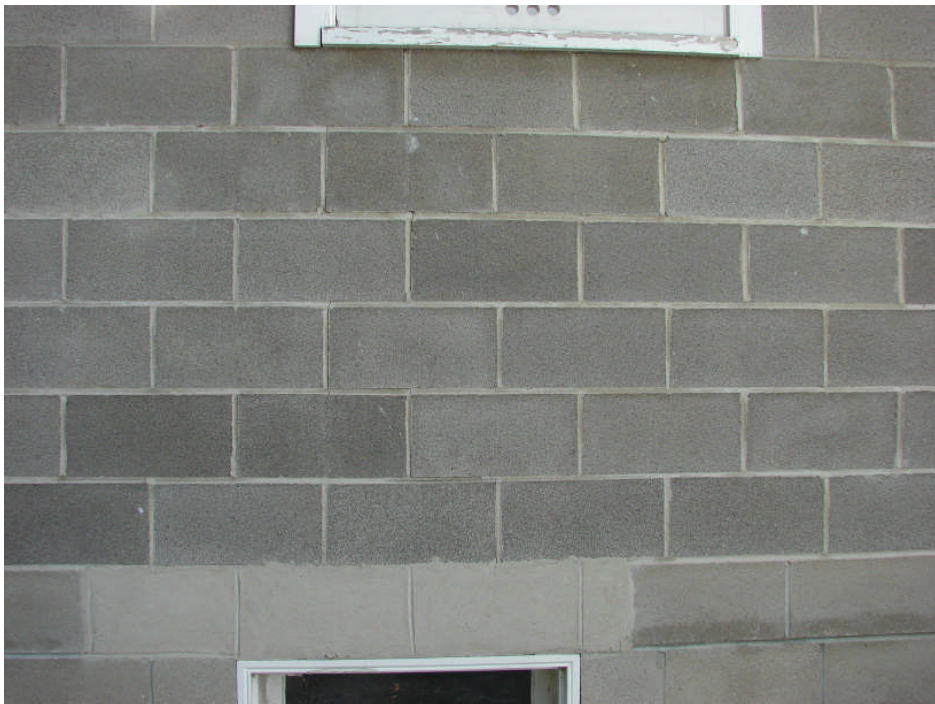
**Photograph 13:** Residence north elevation – Basement window paint peeling/blistering, also repaired window lintel and wall cracks near west end, typical.

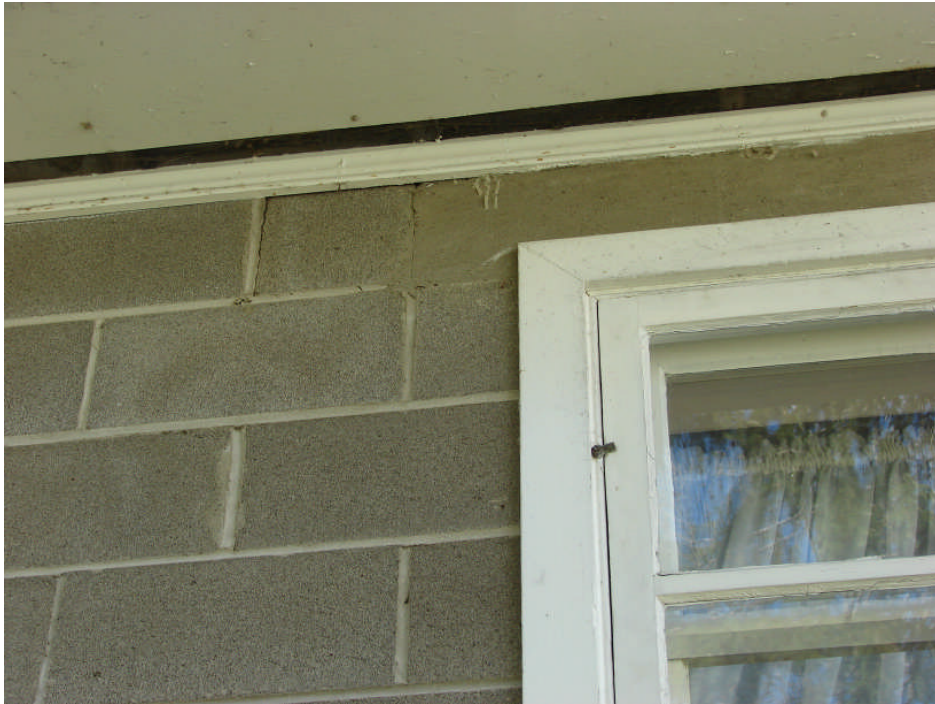
**Photograph 18:** Residence north elevation – repaired wall step cracks at east end.

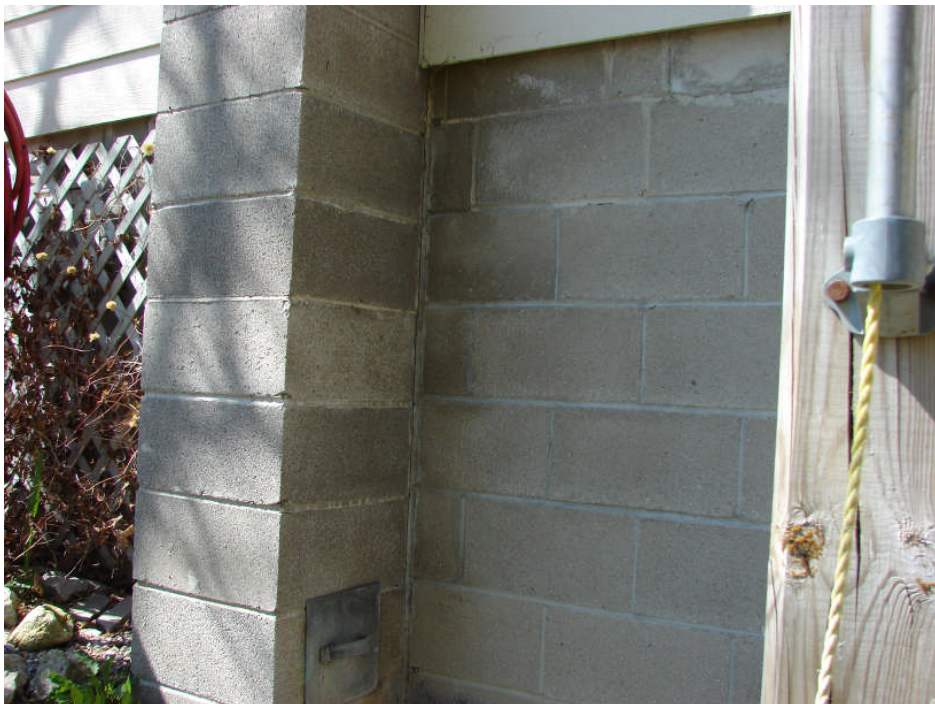
**Photograph 21:** Residence east elevation – concrete block wall step cracking at north end of basement lintel door frame.

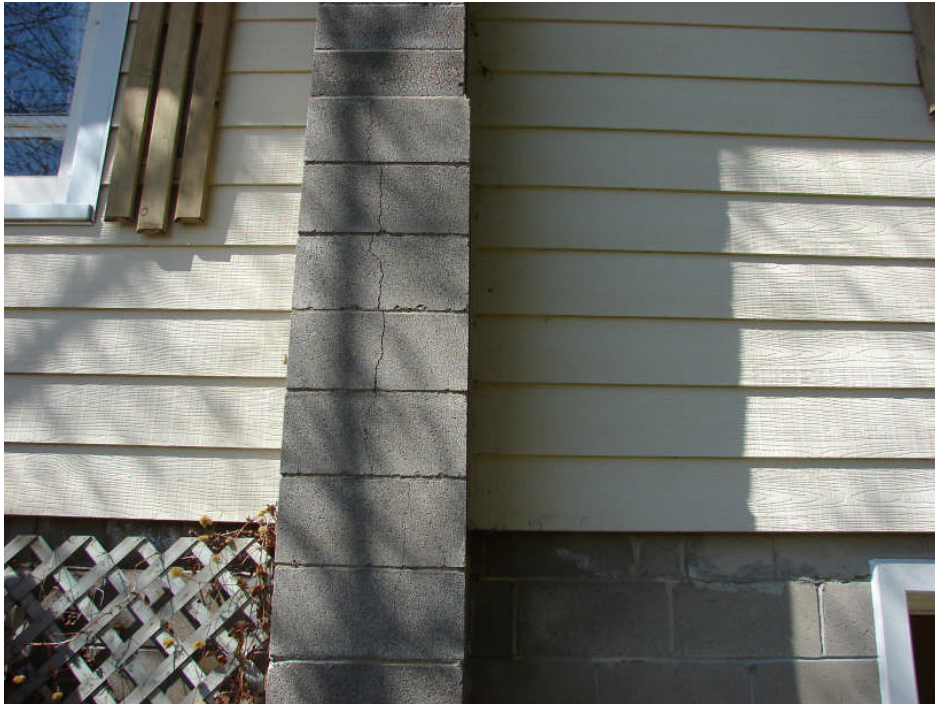
**Photograph 22:** Residence east elevation – concrete block wall joint cracking at chimney at basement level, typical.

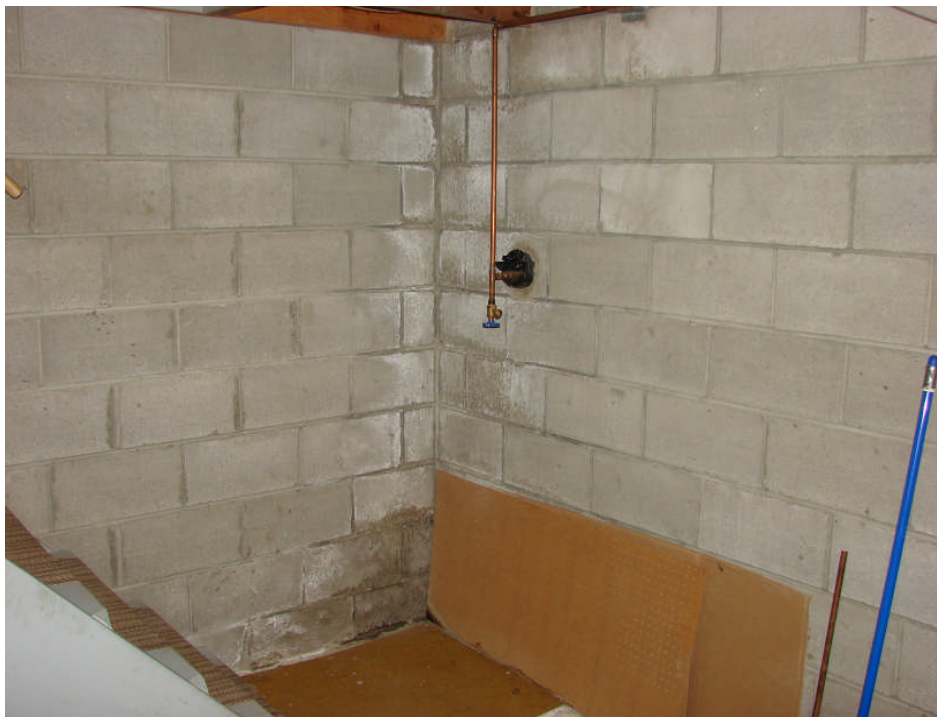
**Photograph 25:** Residence east elevation – concrete block wall step cracks near south end of the basement level, typical.

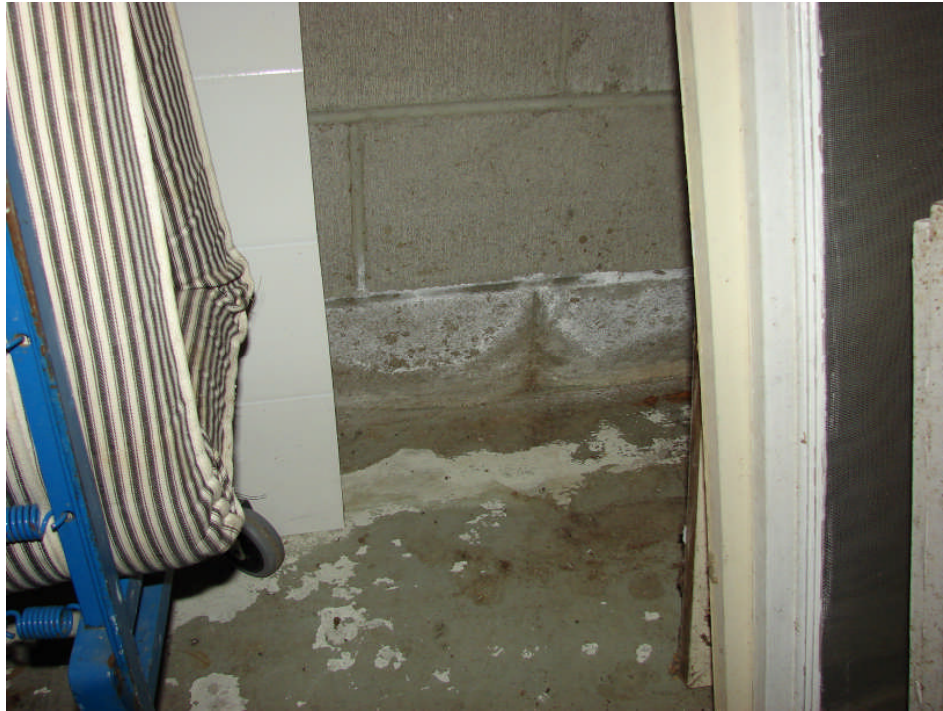
**Photograph 26:** Residence basement level north wall – moisture stain and efflorescence at the concrete block wall at west corner.

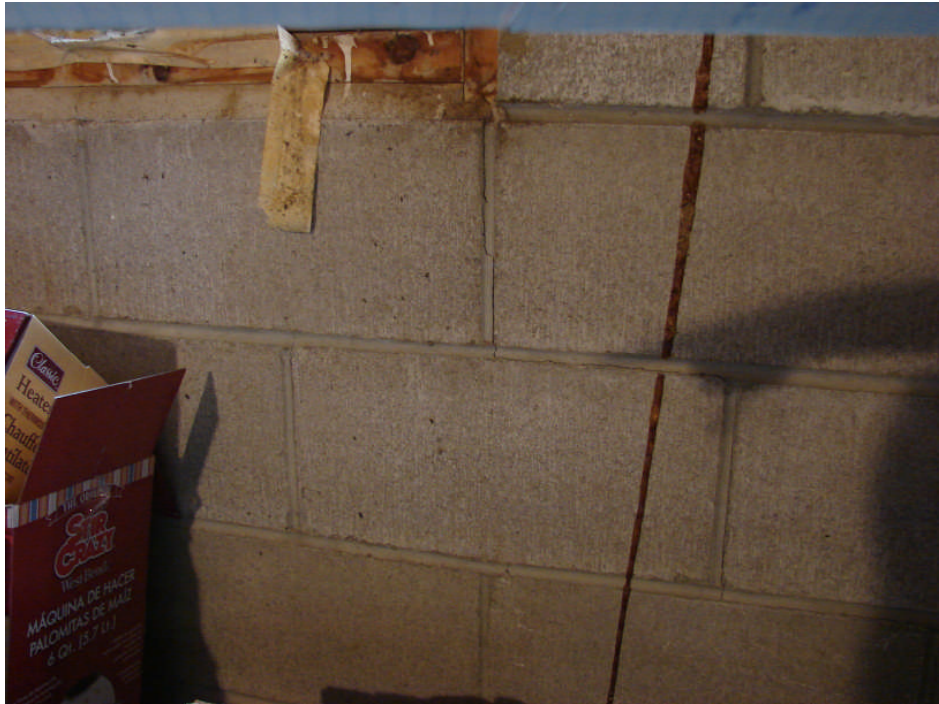
**Photograph 28:** Residence basement level north wall – concrete block step cracking and taped window perimeter, typical.

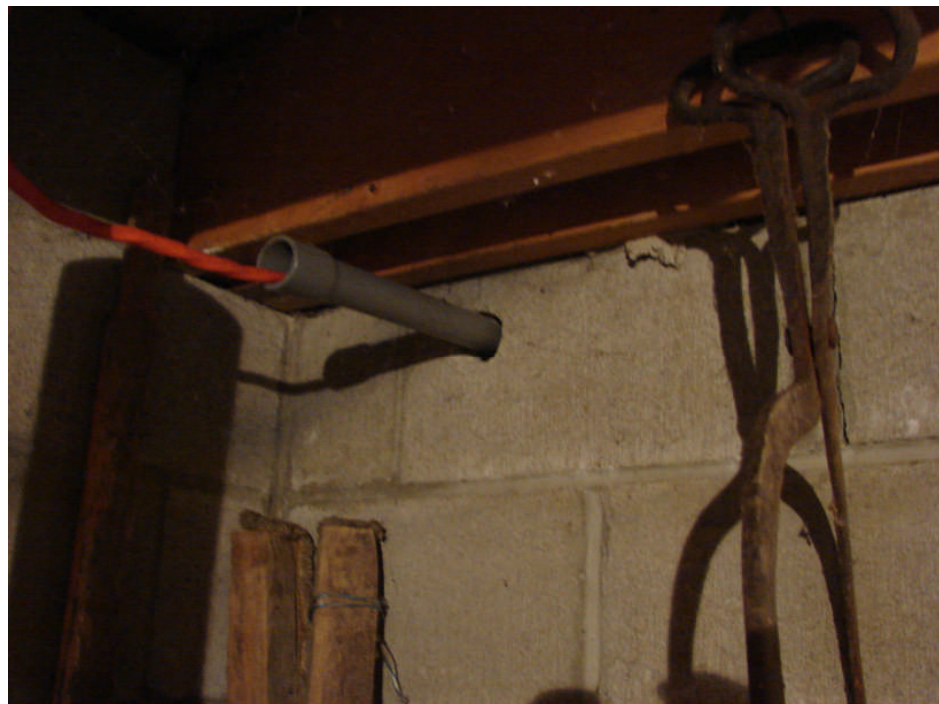
**Photograph 29:** Residence basement level north wall – concrete block step cracking west window, typical.

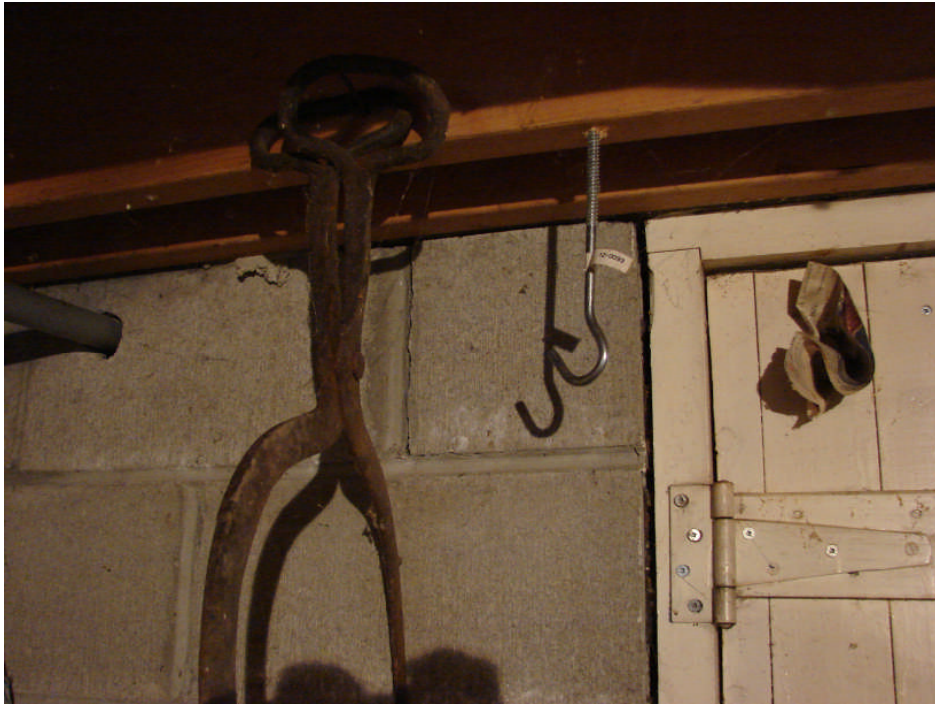
- Residence basement level east wall – unsealed wall penetration through concrete block
- Residence basement level west wall – concrete block wall joint cracking at beam pocket

**Photograph 30:** Residence basement level east wall – unsealed wall penetration through concrete block.

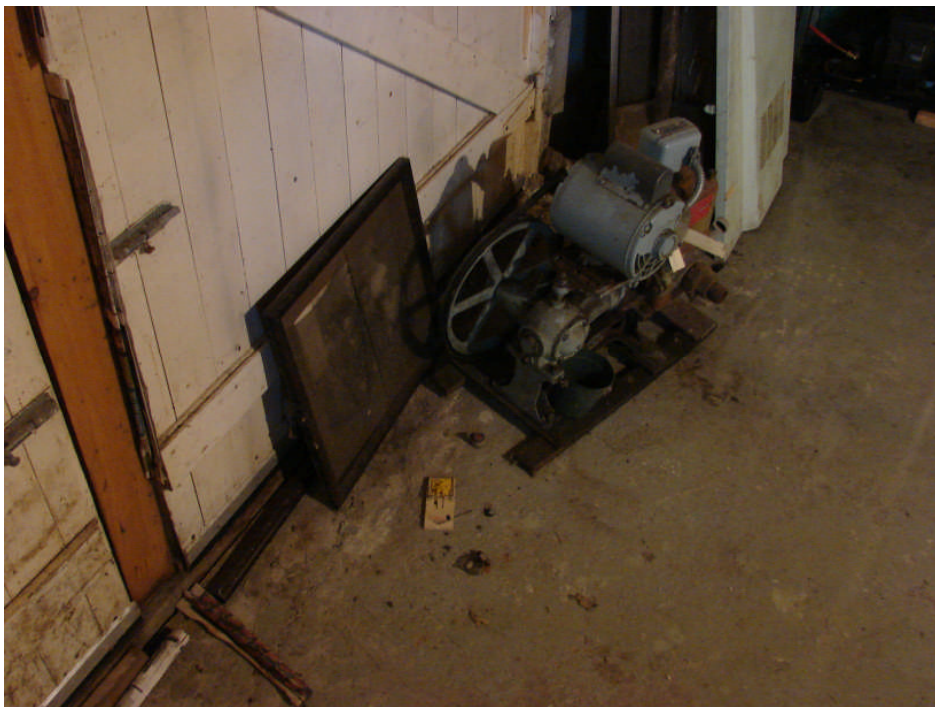
**Photograph 31:** Residence basement level east wall – concrete block step cracking on north side of external door.

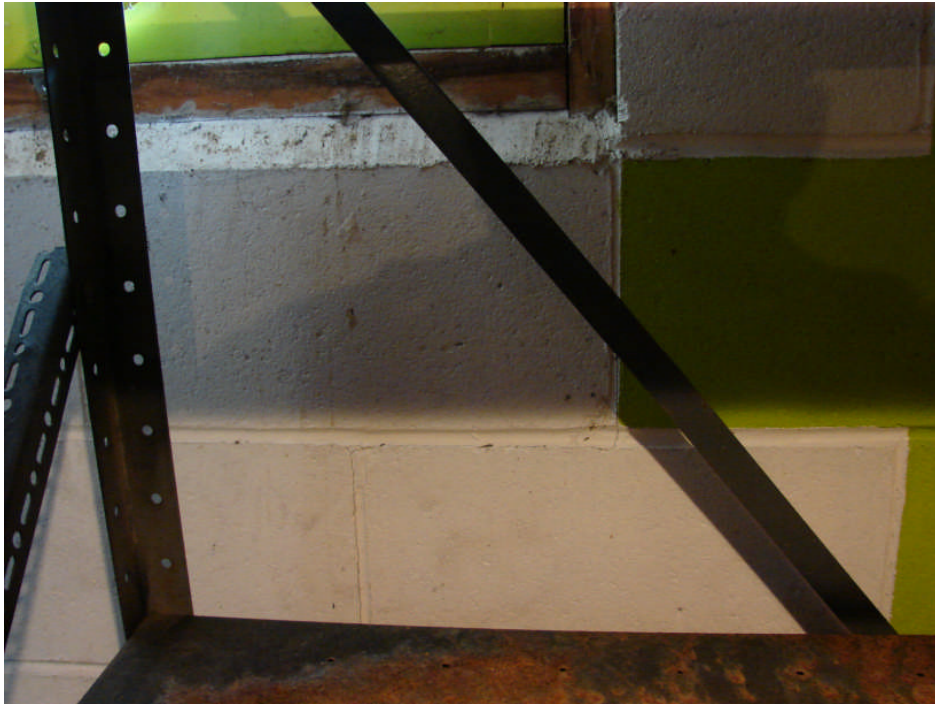
**Photograph 34:** Residence basement level east wall – moisture staining and efflorescence behind heating system.

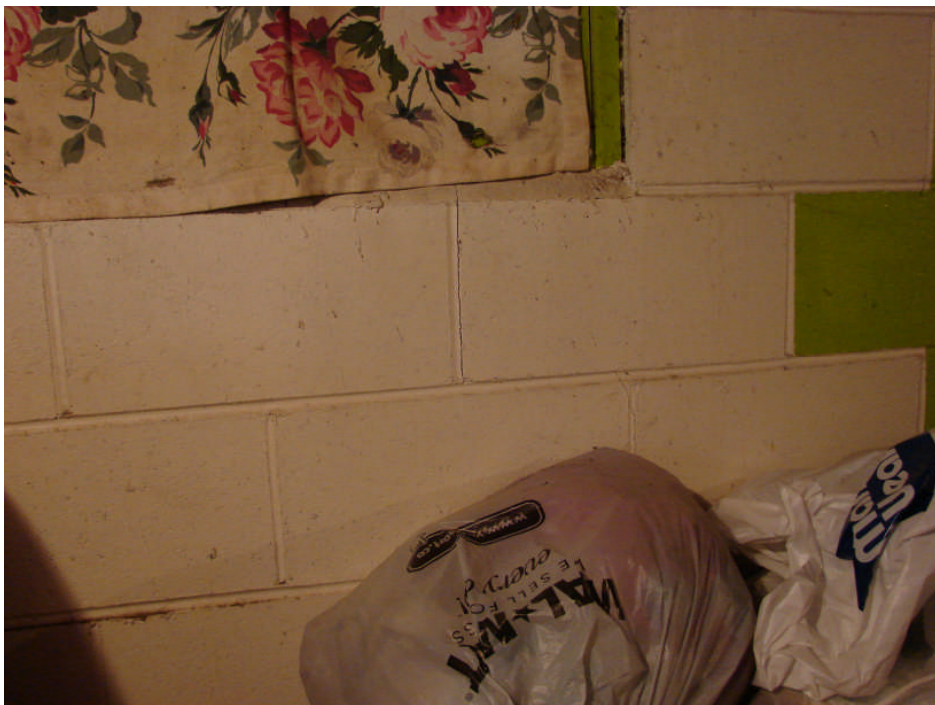
**Photograph 35:** Residence basement level east wall – concrete block wall step cracking under north window, typical.

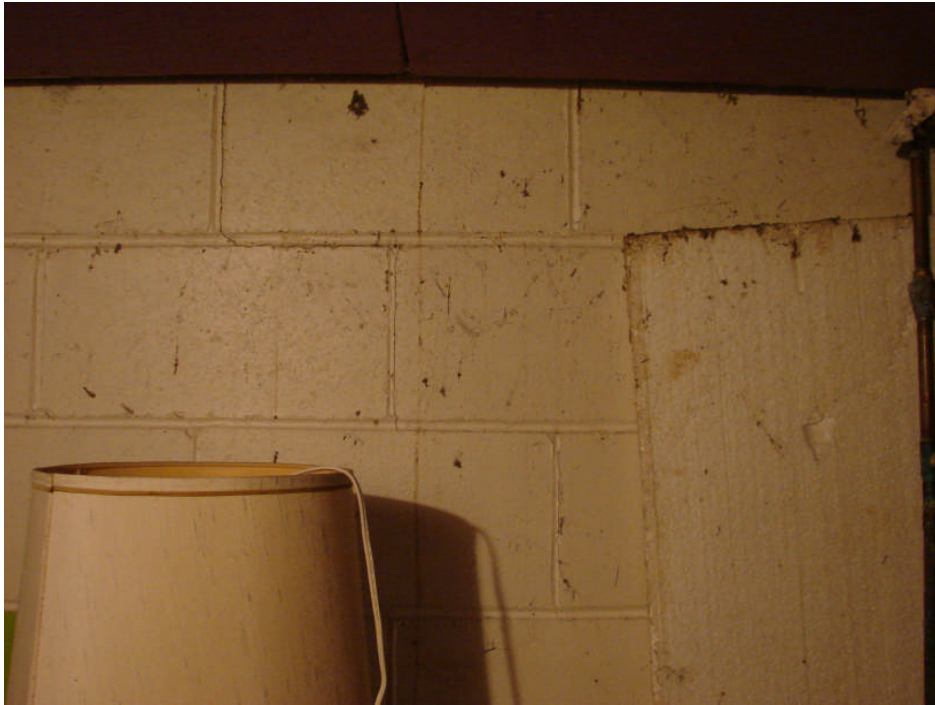
**Photograph 36:** Residence basement level east wall – concrete block wall step cracking under south window, typical.

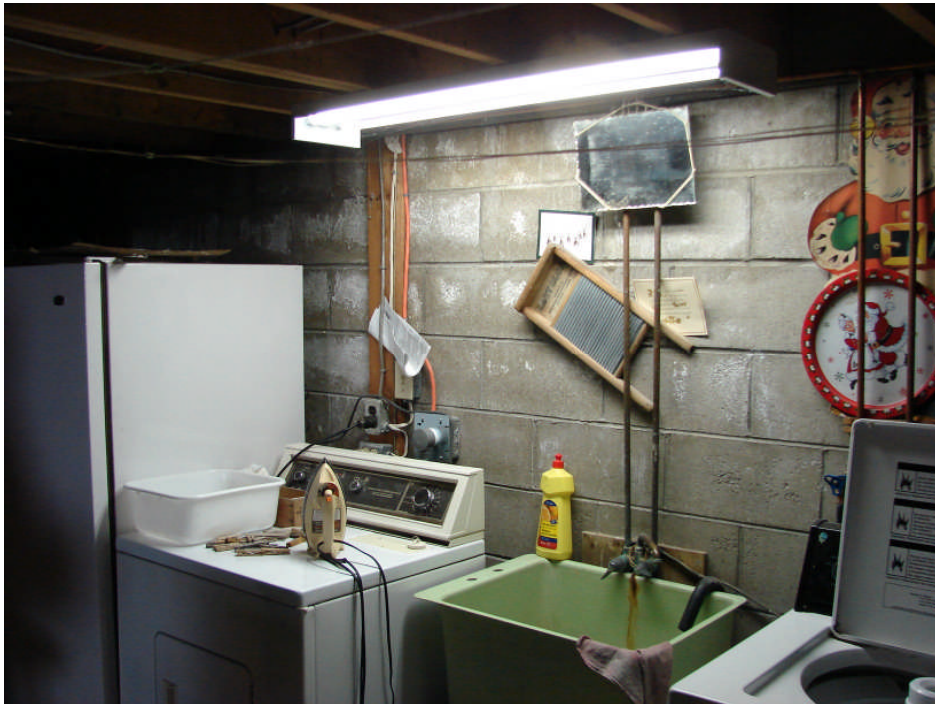
**Photograph 37:** Residence basement level south wall – concrete block wall step cracking near east end, typical.

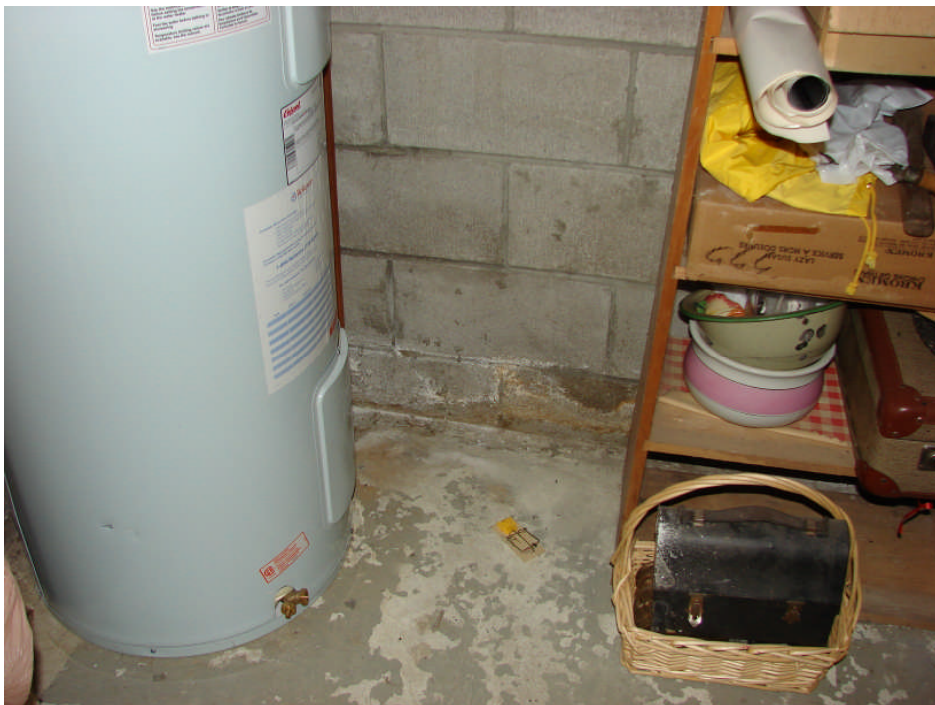
**Photograph 39:** Residence basement level south wall – extensive efflorescence and wall pitting of concrete block, typical.

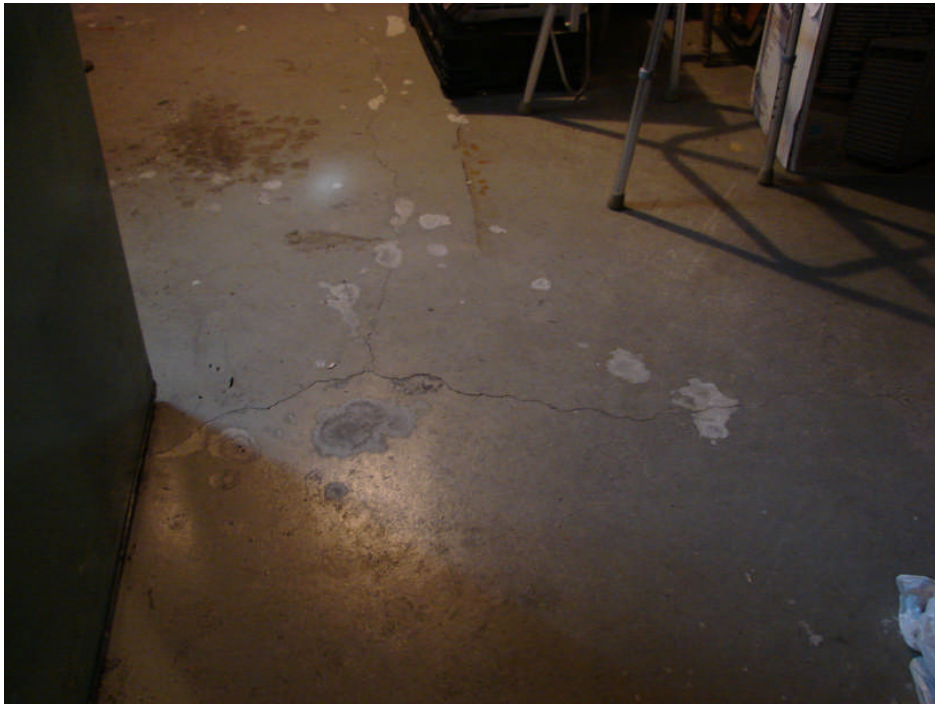
**Photograph 43:** Residence basement level – painted concrete slab-on-grade cracks, typical.

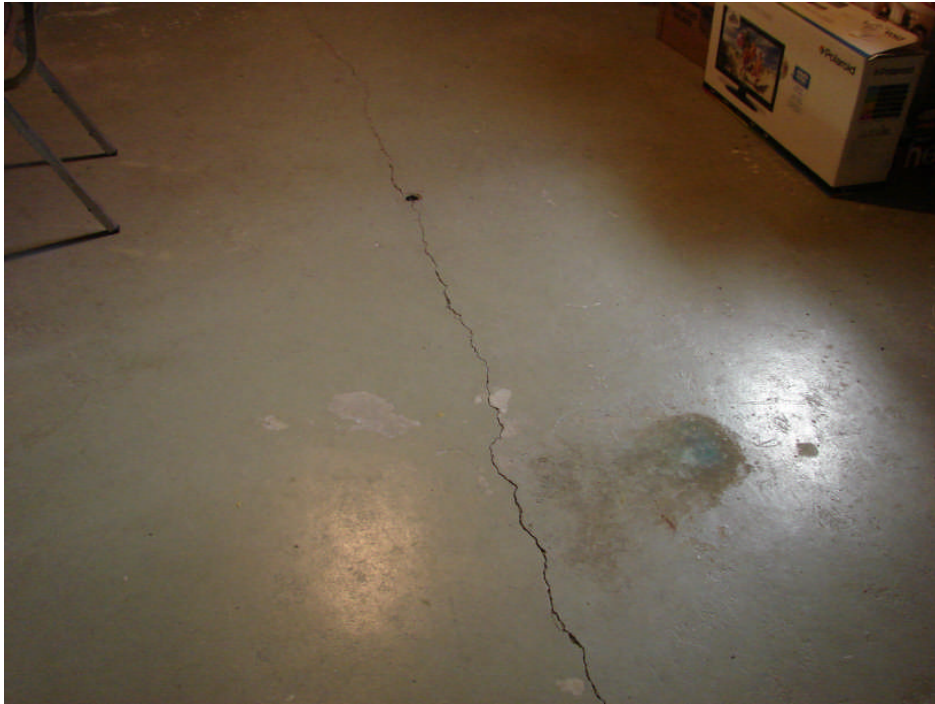
**Photograph 44:** Residence basement level – painted concrete slab-on-grade cracks, typical.

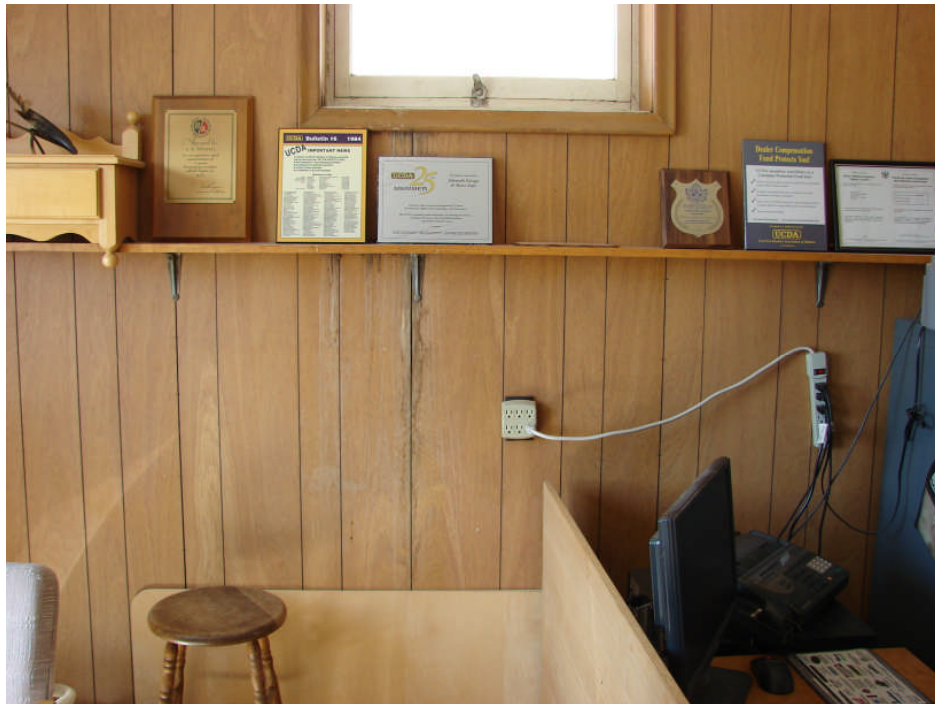
**Photograph 54:** Residence main floor level – moisture staining at window at west wall at office.

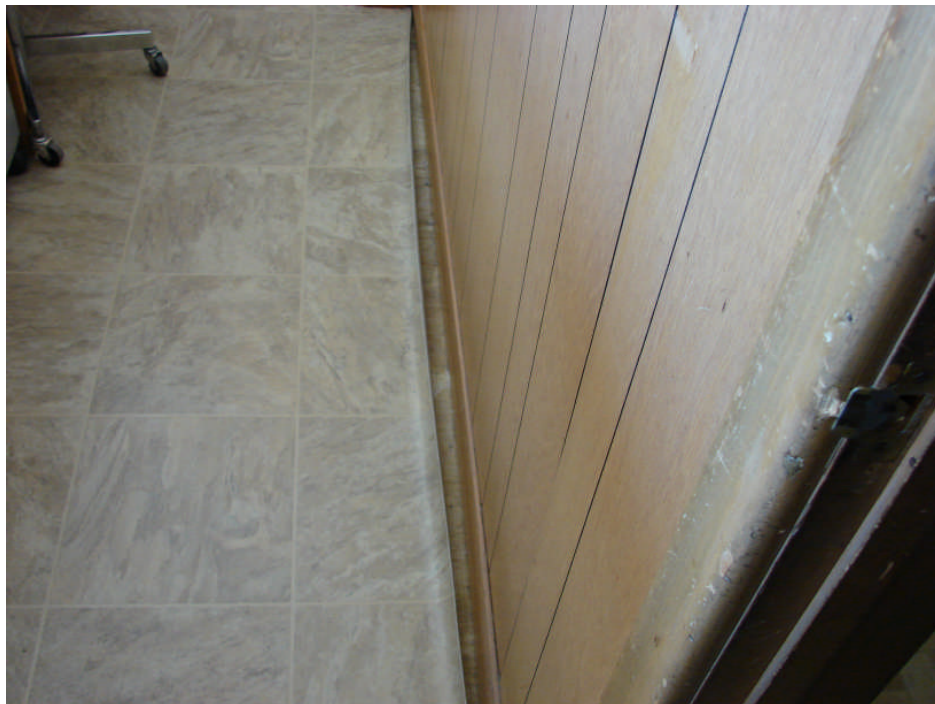
**Photograph 55:** Residence main floor level – moisture staining of wood panelling below west window at office.

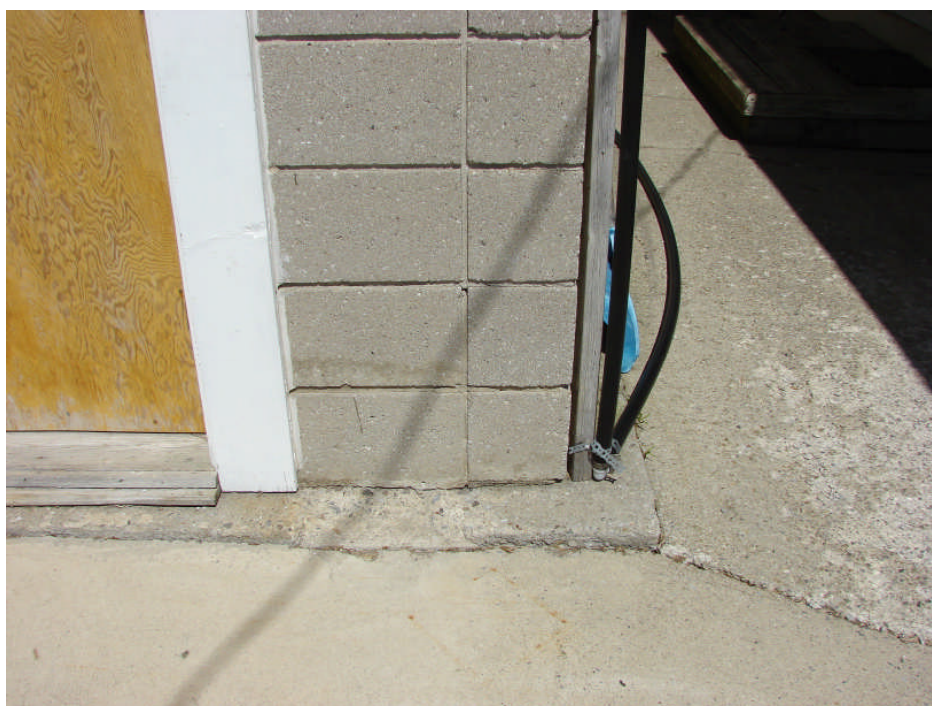
**Photograph 7:** Garage Building south elevation –concrete block wall step cracking between overhead doors, typical.

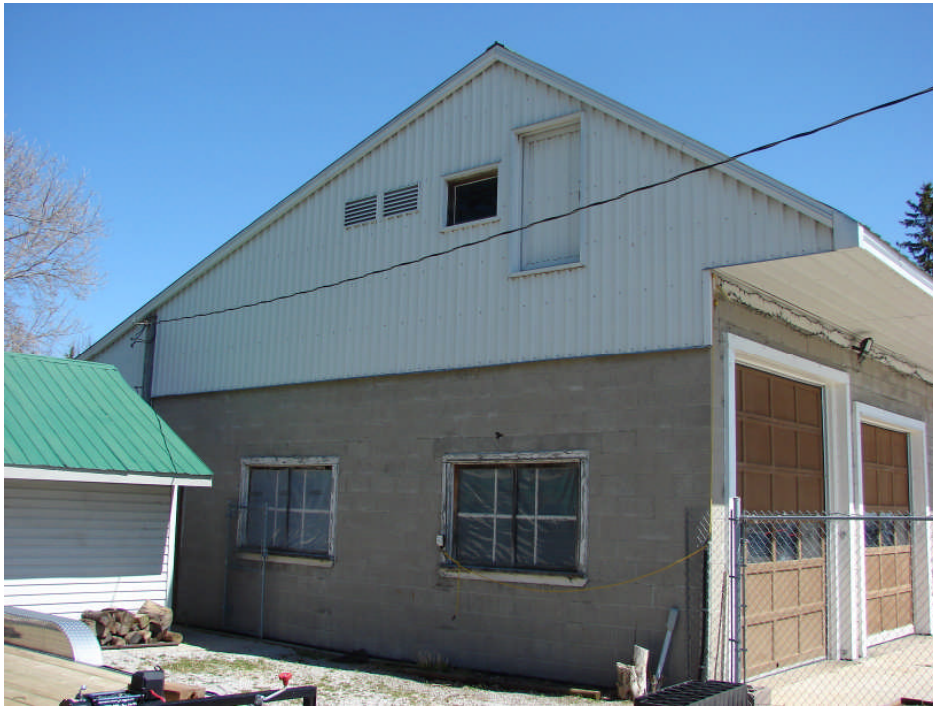
**Photograph 8:** Garage Building south elevation – concrete block wall step cracking at east end, typical.

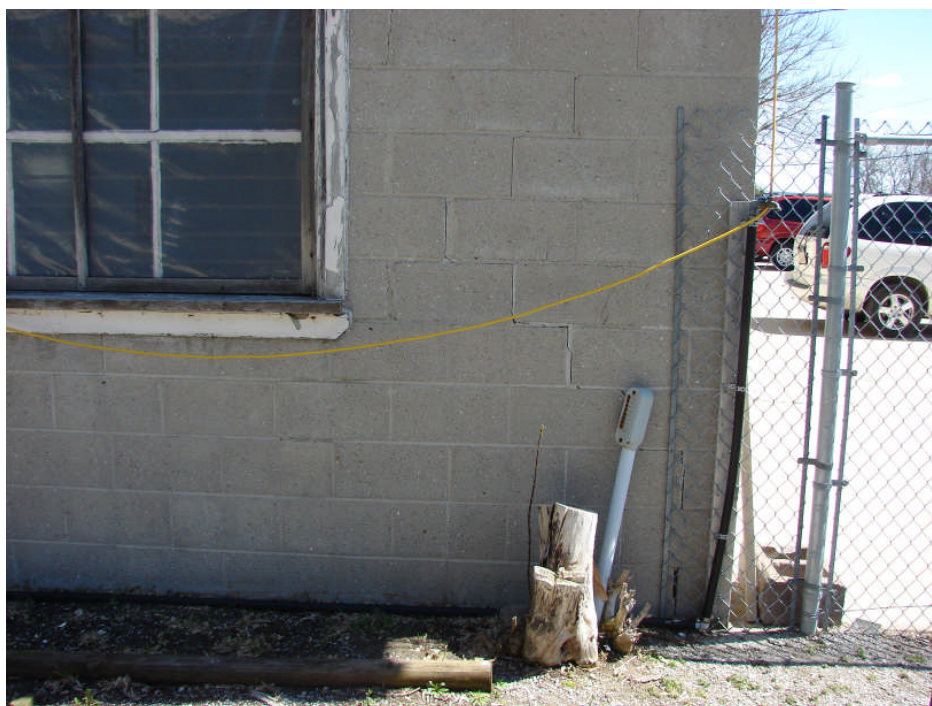
**Photograph 10:** Garage Building west elevation – missing ridge end cover at west side of metal roof, typical.

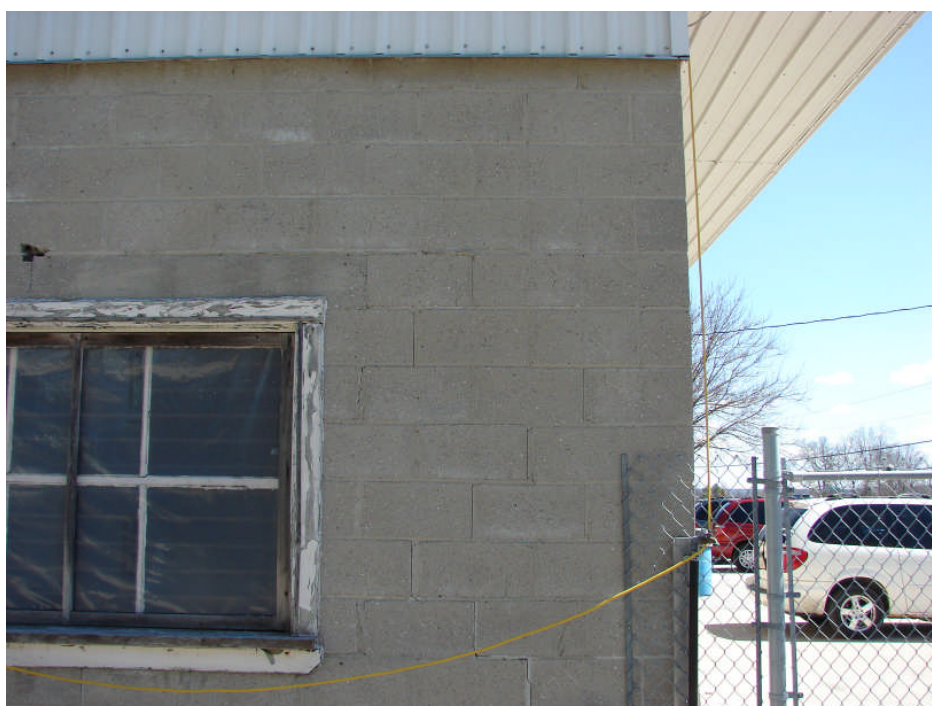
**Photograph 11:** Garage Building west elevation – concrete block wall step cracking at south end, typical.

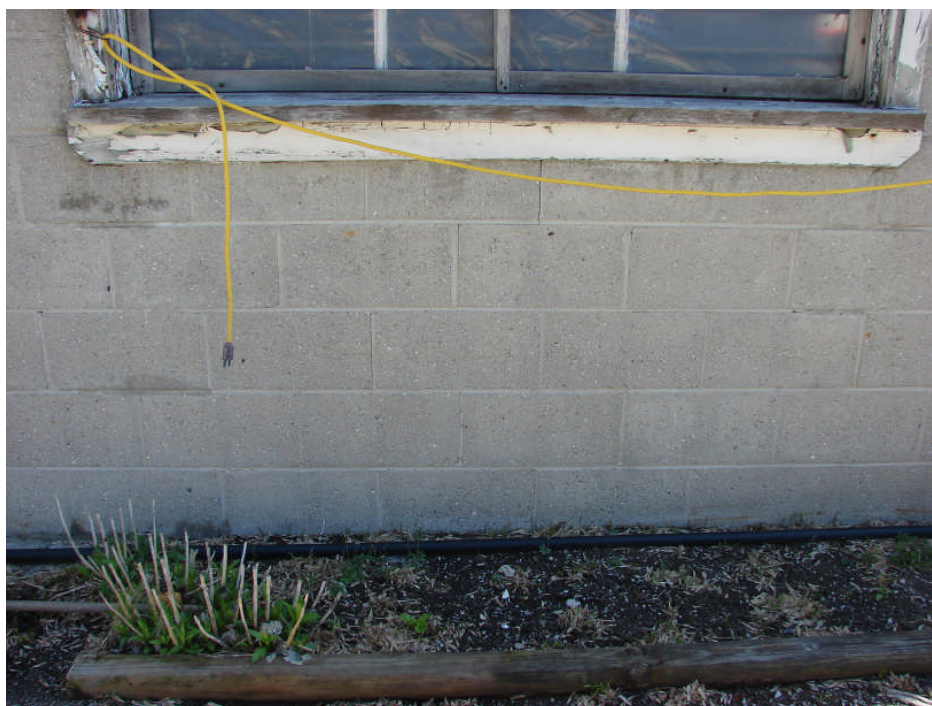
**Photograph 12:** Garage Building west elevation – concrete block wall step cracking above south window at south end, typical.

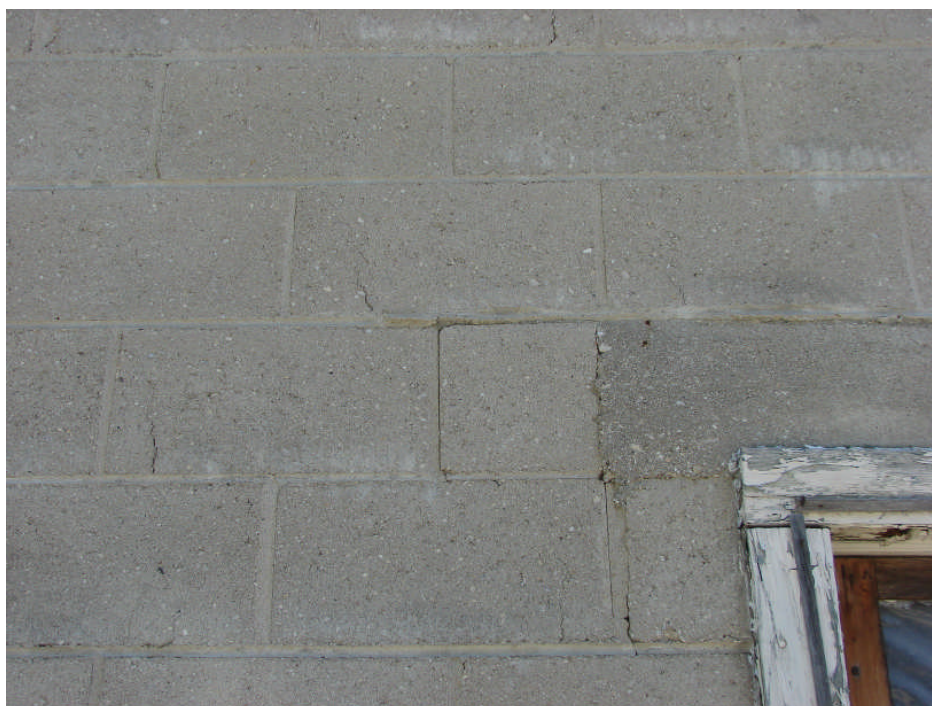
**Photograph 13:** Garage Building west elevation – concrete block wall step cracking below south window, typical.

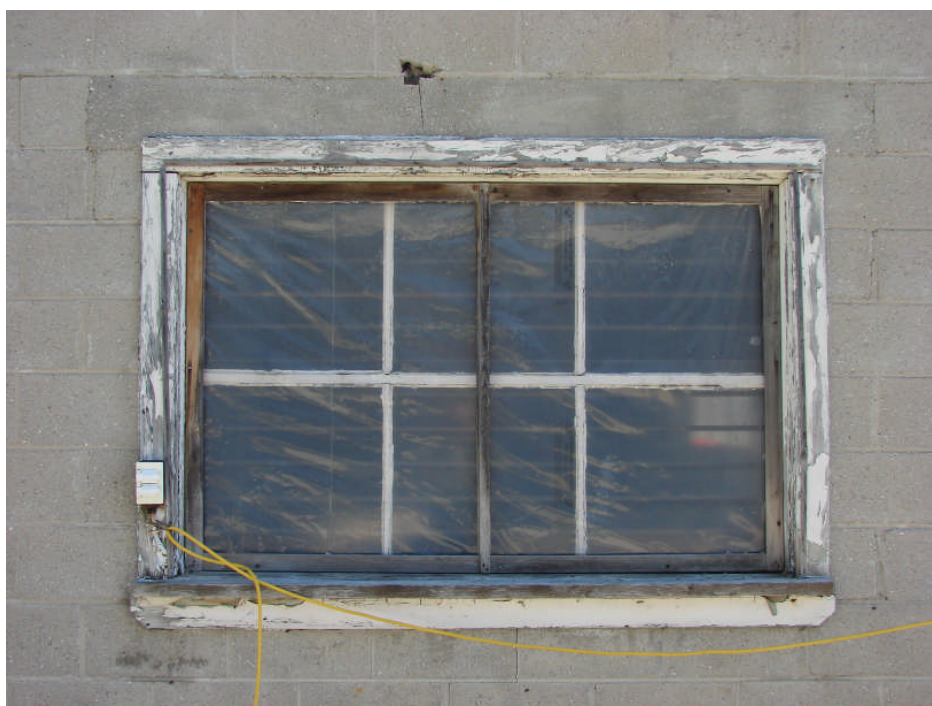
**Photograph 17:** Garage Building west elevation – concrete block wall step cracking near door on north side, typical.

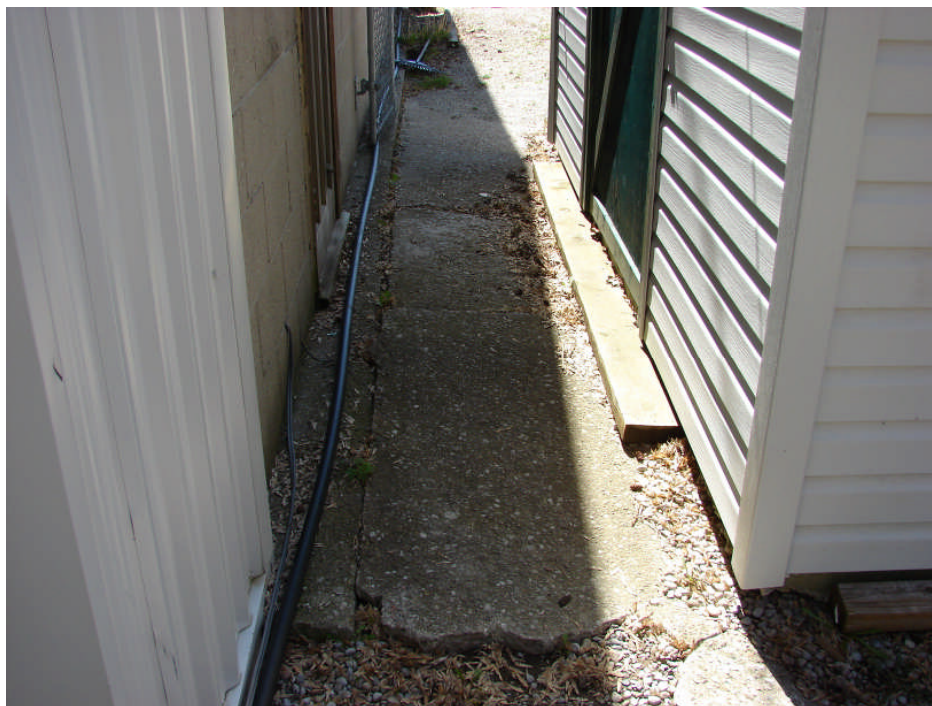
**Photograph 20:** Garage Building west elevation – extensive deterioration of concrete slab-on-grade with severe surface spalling, typical.

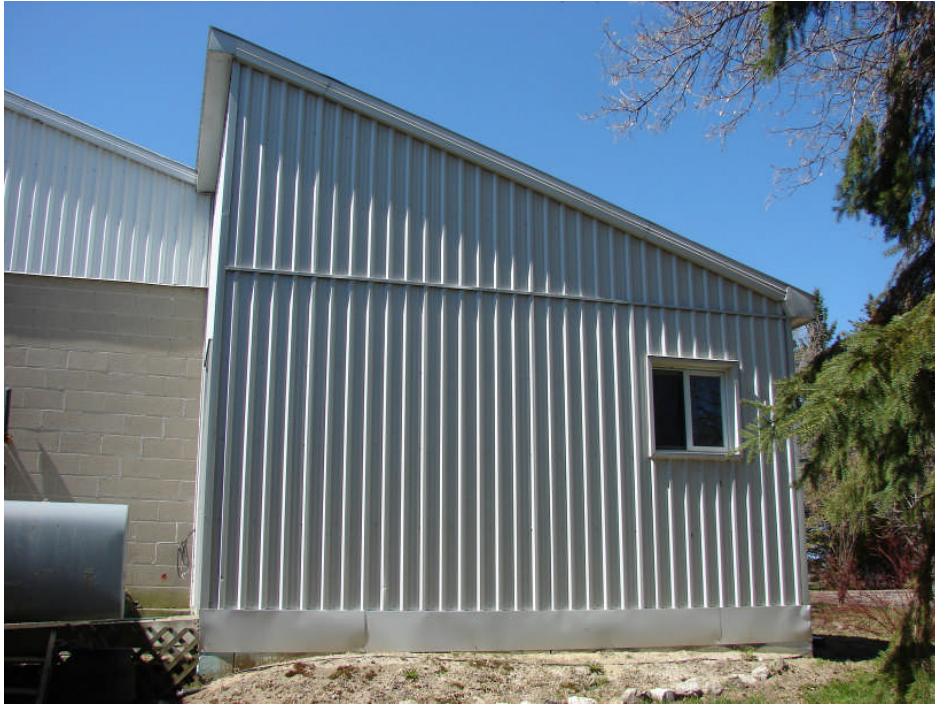
**Photograph 24:** Garage Building north elevation – missing rainwater gutter.

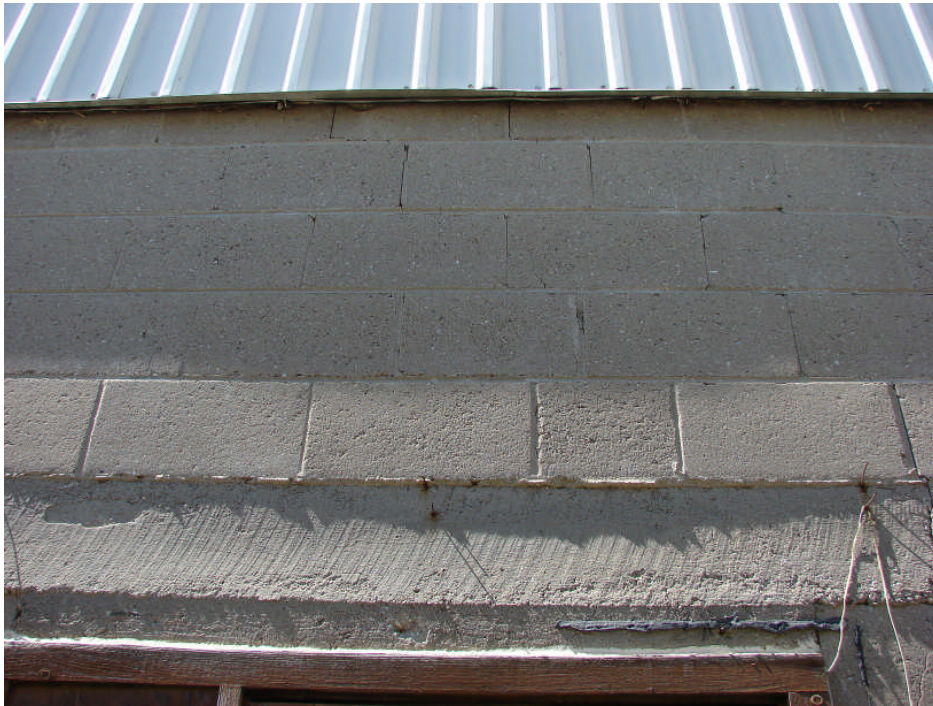
**Photograph 32:** Garage Building east elevation (south part) – concrete block wall step cracking at door lintel, typical.

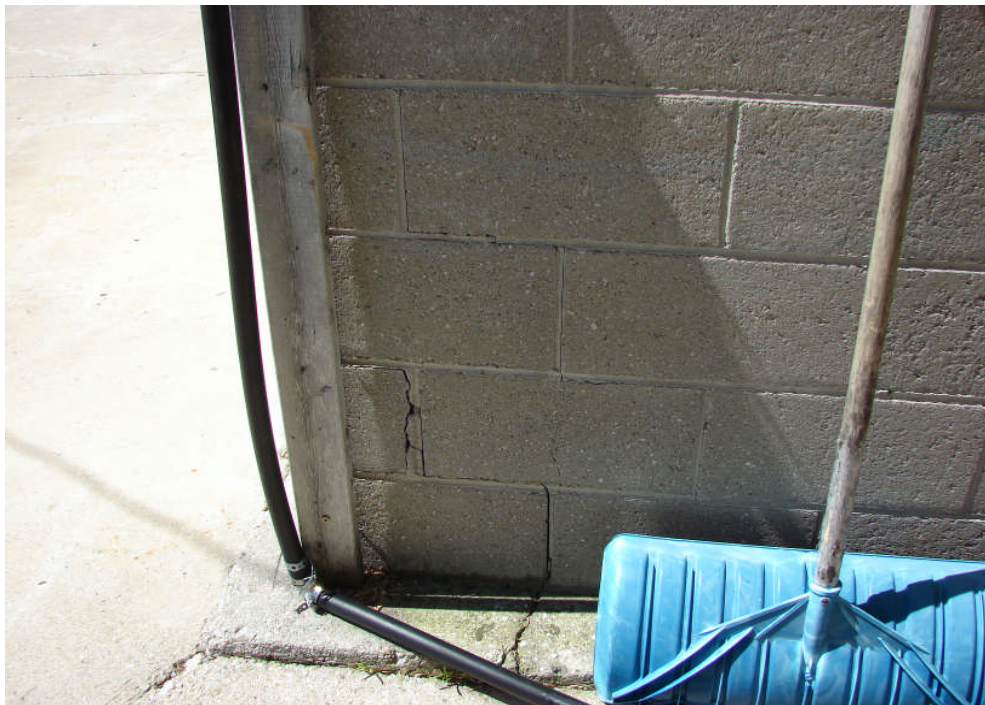
**Photograph 33:** Garage Building east elevation (south part) – concrete block wall step cracking above door, typical.

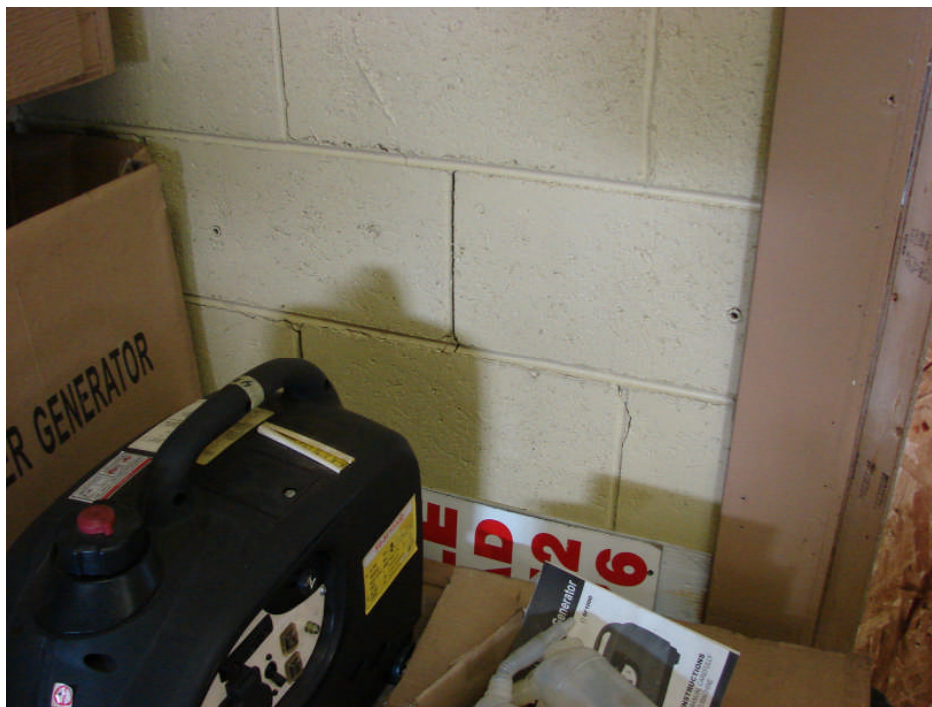
**Photograph 35:** Garage Building – unpainted concrete slab-on-grade cracking, typical.

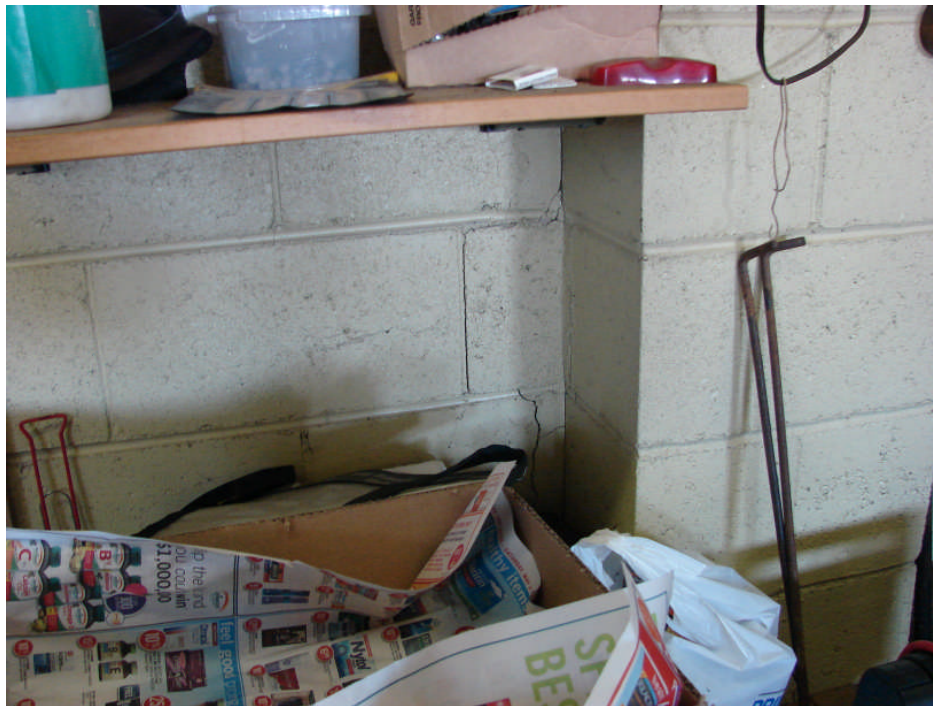
**Photograph 38:** Garage Building north wall – concrete block wall step cracking on east side of door, typical.
