**CONDITION SURVEY REPORT  
3892 HIGHWAY 26 - DRAINAGE DITCH IMPROVEMENT  
AGREEMENT NO. 2013-E-0039  
TOWN OF EDENVALE, ONTARIO  
FOR  
MINISTRY OF TRANSPORTATION**

PML Ref.: 14TF007  
Index No.: 017CSR  
GEOCRES No.: 31D-579  
September 16, 2014

**Condition Survey Report**  
**Highway 26 – Edenvale, 3892 Highway 26,**  
**Personal Residence and Detached Structures**  
**Agreement No. 2013-E-0039**  
**Edenvale, Ontario**

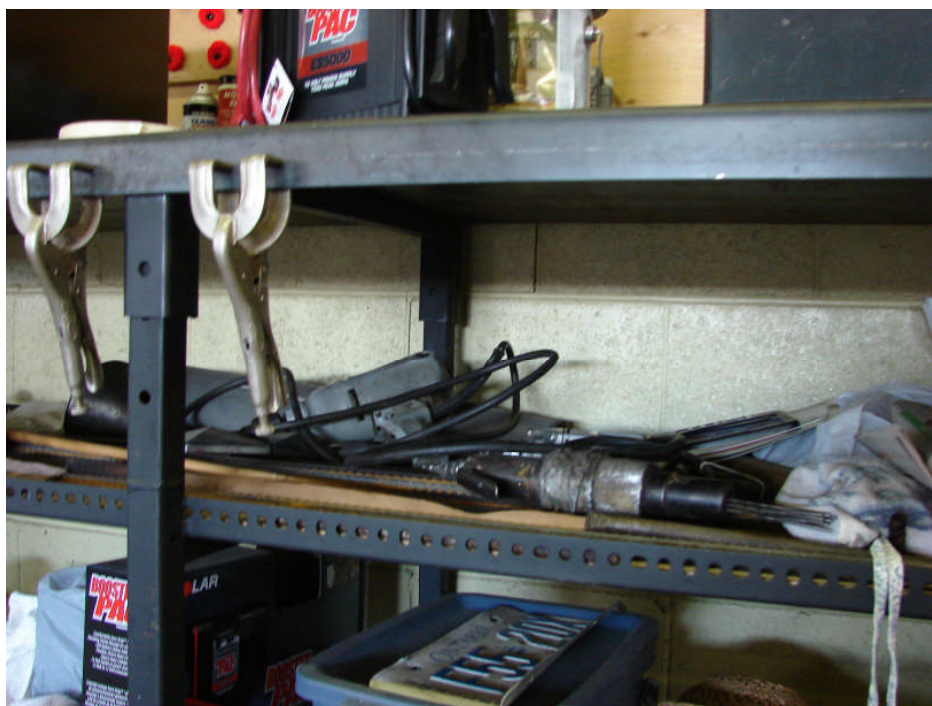
**Photograph 40:** Garage Building north wall – continued wall and slab cracks at east concrete block pier, typical.

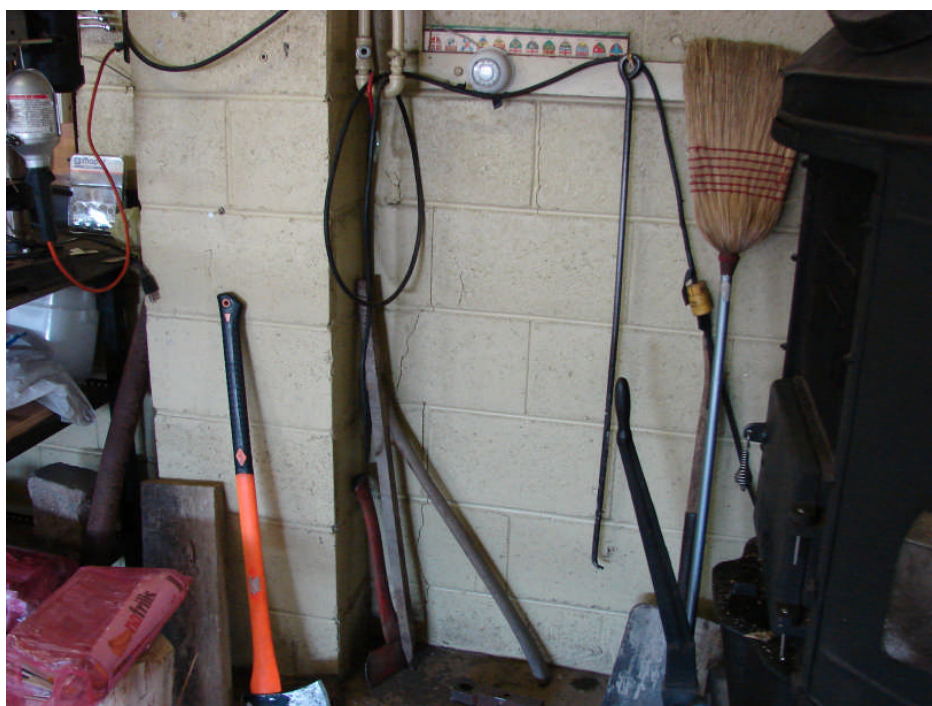
**Photograph 41:** Garage Building north wall – concrete block wall step cracking near east end, typical.

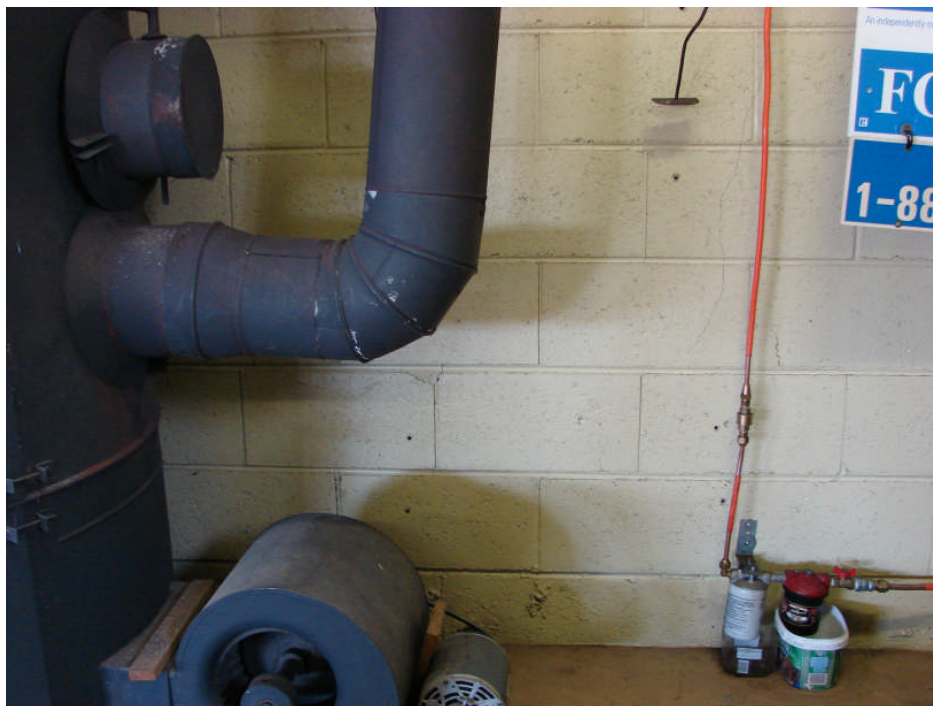
**Photograph 42:** Garage Building north wall – concrete block wall step cracking near east end adjacent wood stove, typical.

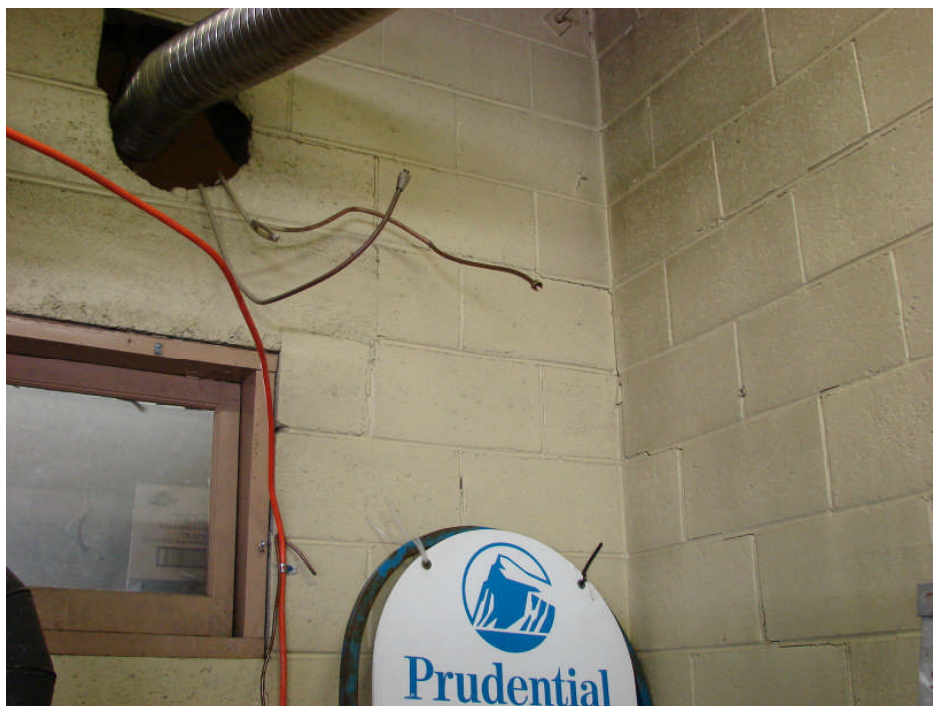
**Photograph 43:** Garage Building north wall – concrete block wall step cracking near east end adjacent wood stove, typical.

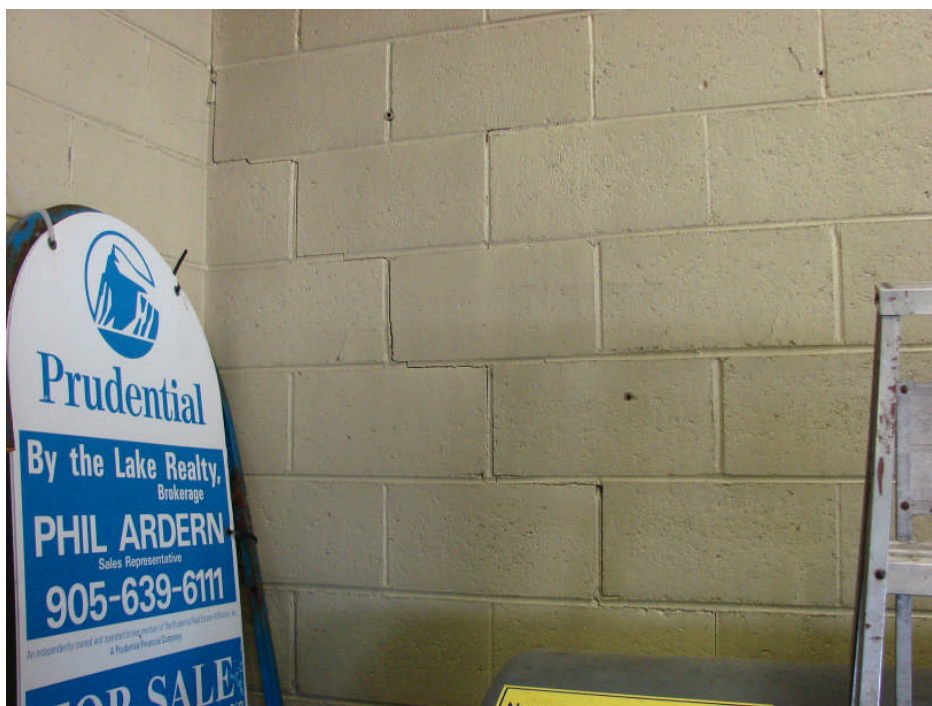
**Photograph 44:** Garage Building north wall – concrete block wall step cracking at east end, typical.

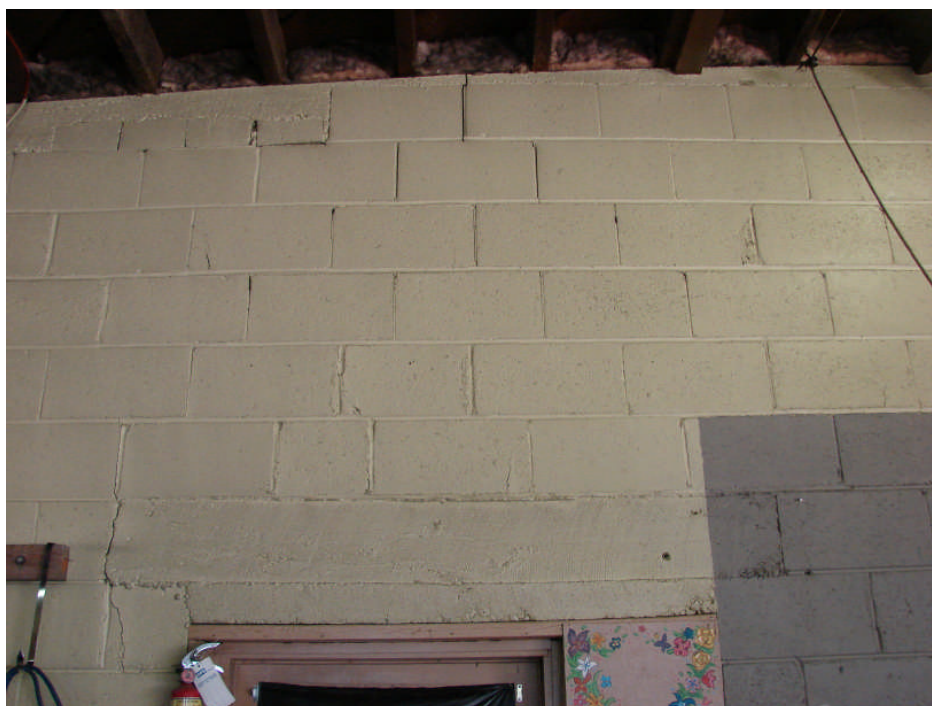
**Photograph 45:** Garage Building east wall – concrete block wall step cracking at north end, typical.

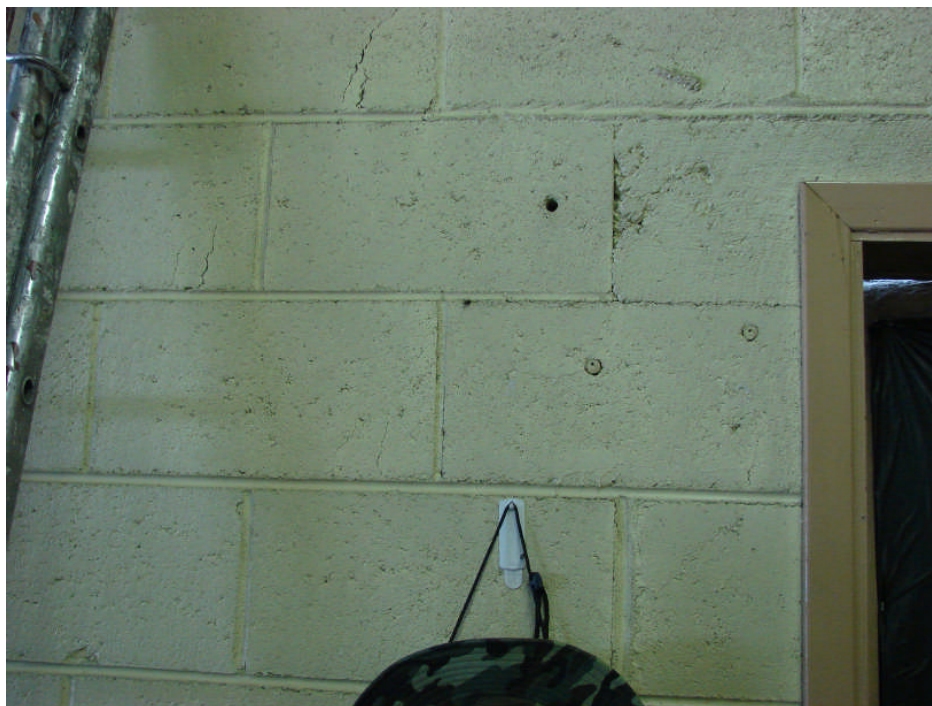
**Photograph 50:** Garage Building west wall – concrete block wall step cracking at south end of north window, typical.

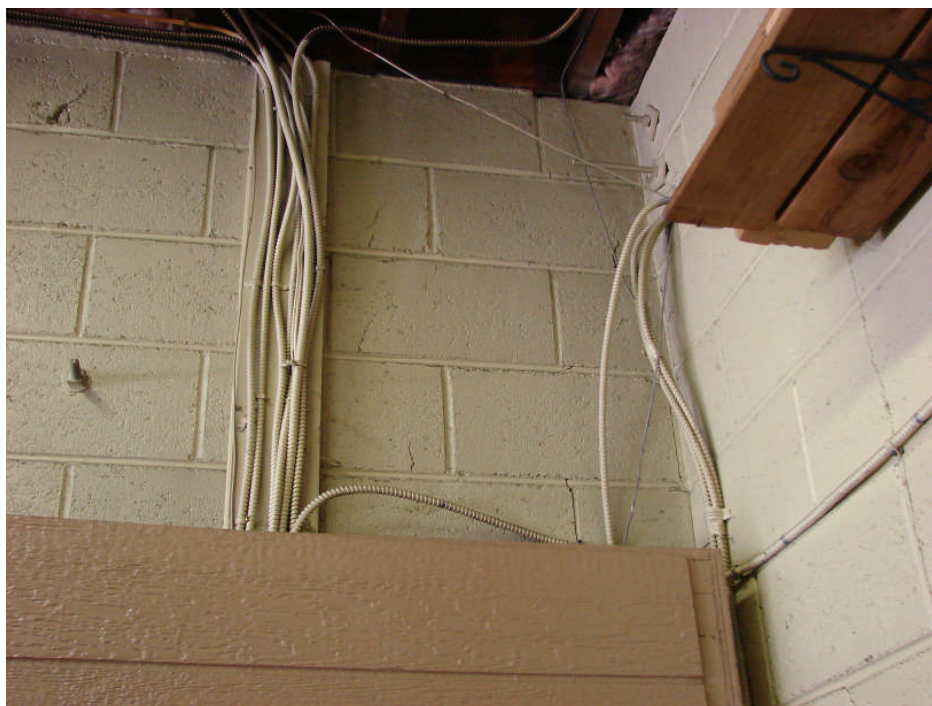
**Photograph 51:** Garage Building west wall – concrete block wall step cracking at door near north end, typical.

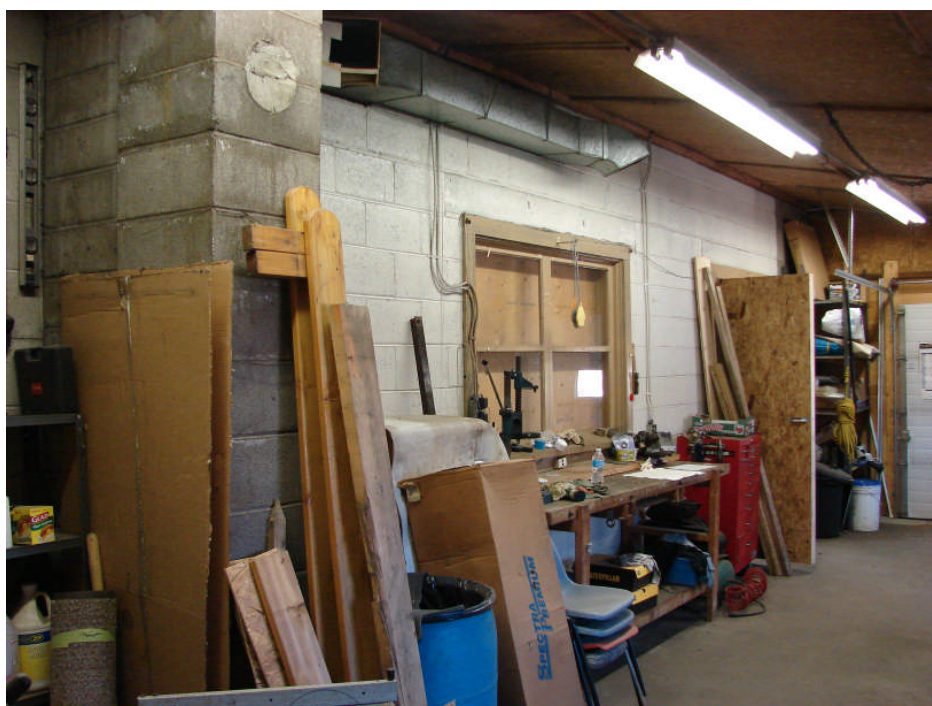
**Photograph 53:** Garage Building – unpainted concrete slab-on-grade central areas cracks, typical.

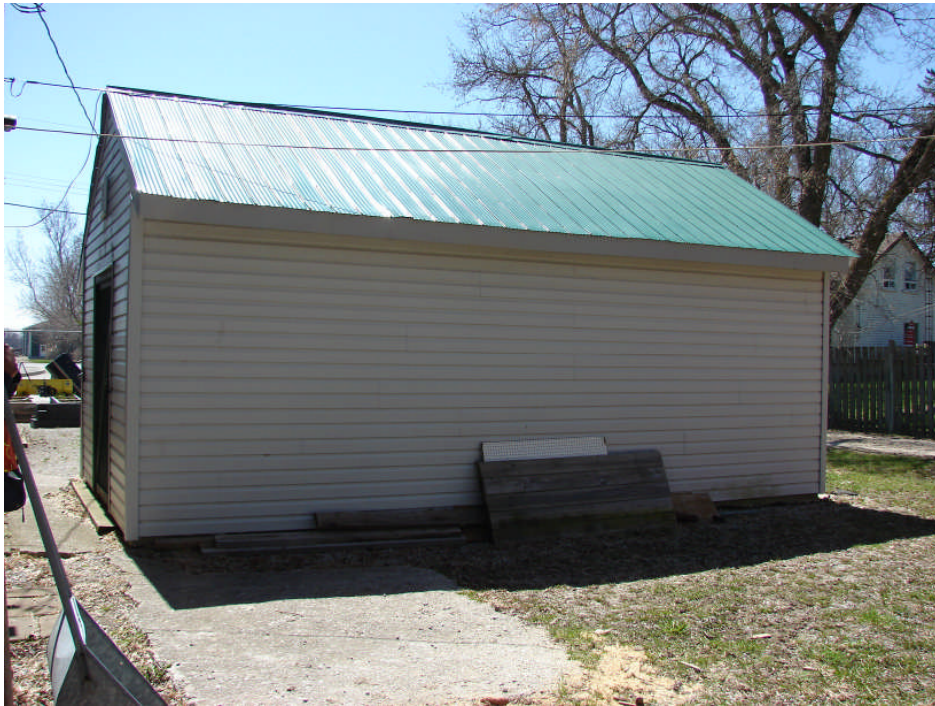
**Photograph 8:** Other Structures Storage Building - roof ridge missing end cap at east end, typical.
