KIRKFIELD

CAUSEWAY

BUTTS, ROSS & ASSOCIATES LTD.
CONSULTING CIVIL ENGINEERS
1489D MERIVALE RD.
OTTAWA 5, CANADA
224-1414

**REPORT
OF A
SITE INVESTIGATION
KIRKFIELD CAUSEWAY**

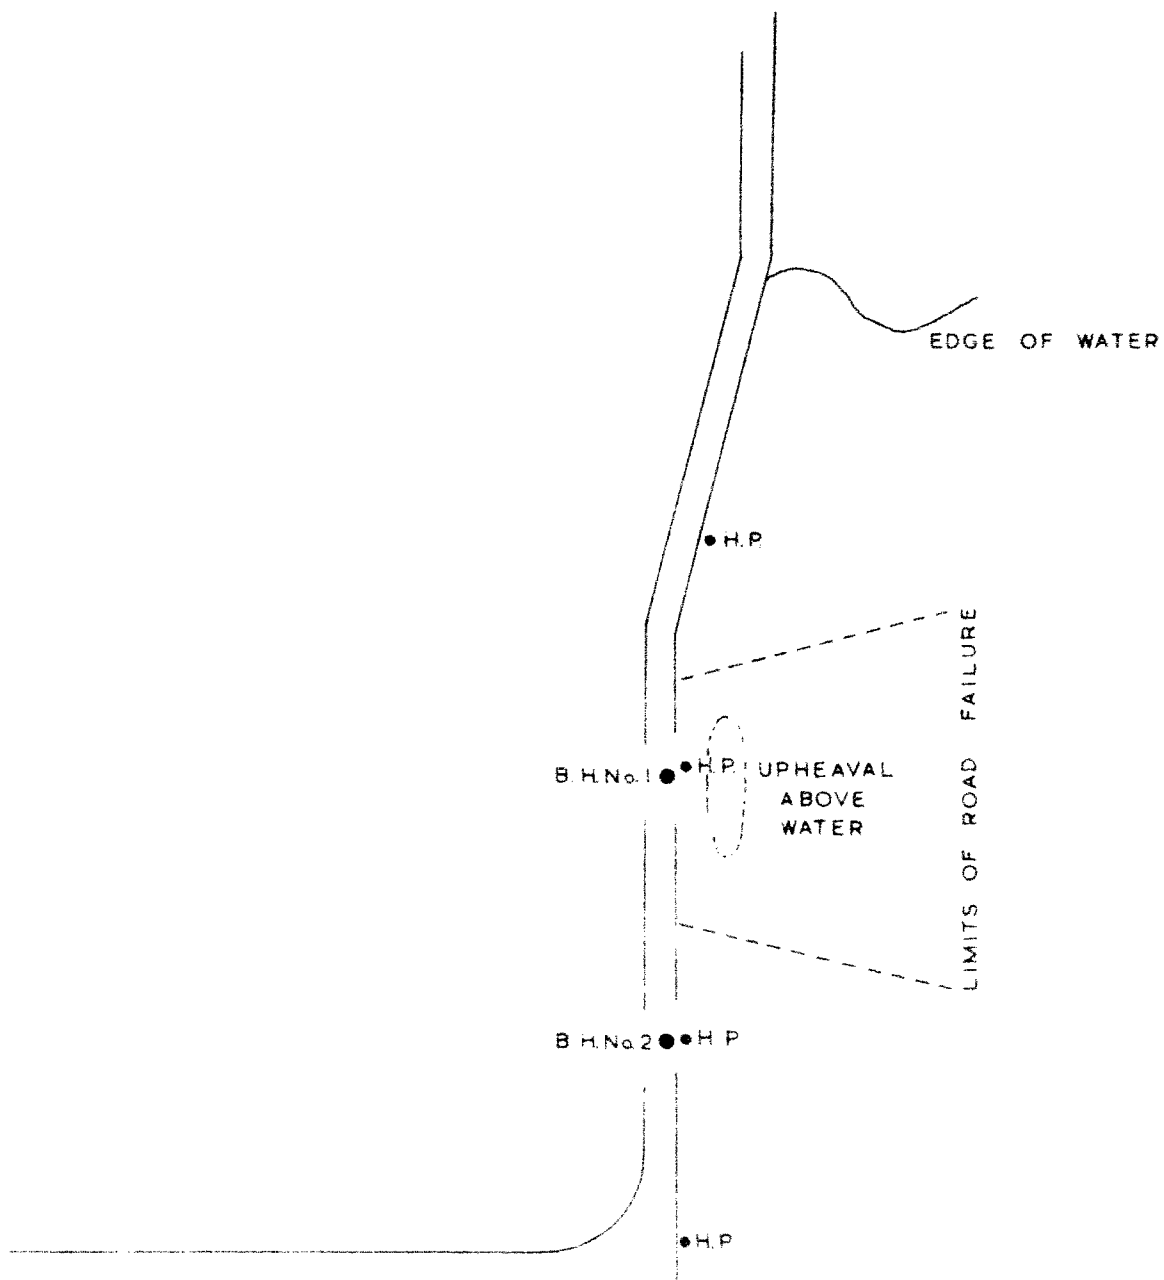
Plate No.

Two boreholes were completed in this manner. One borehole was located in the centre of the failure area and the other 290' to the east on the unaffected roadway.
