Technical Memorandum

Subject: Permanent Remediation of Cut Slope Instabilities on Highway 89 near 5th Line, Essa Township.
W.O. 2012-11010
GEOCRES No. 31D-537

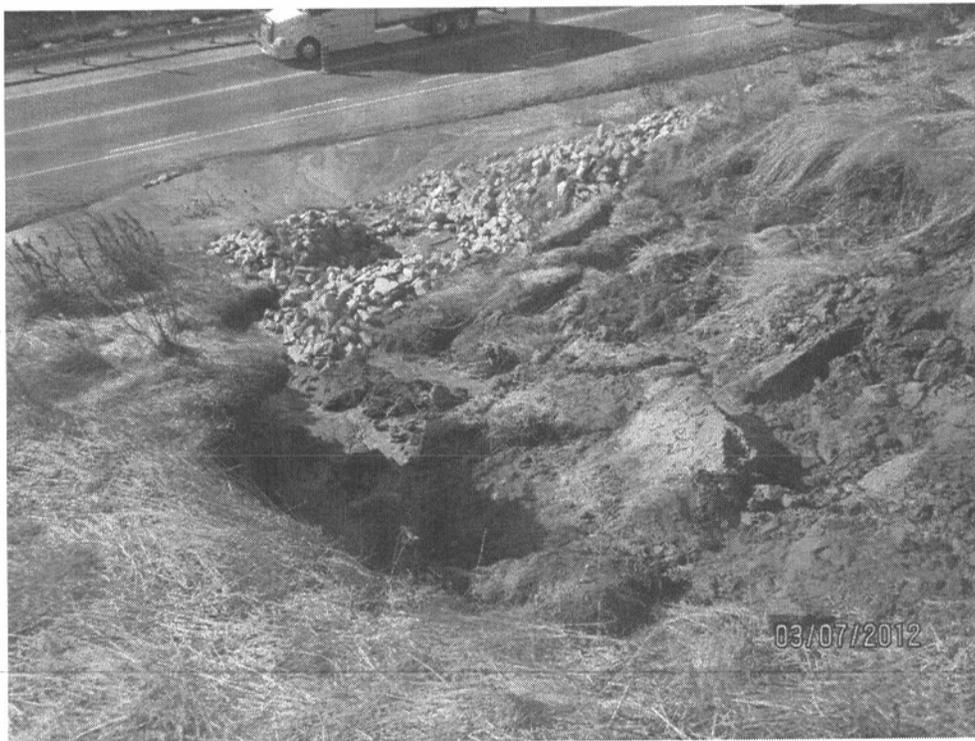
perspective. The slope instability was observed to be approximately 75 m east of the intersection of Highway 89 and 5th line, which coincides with the middle of the portion where riprap is present. The location of instability is approximately shown with dotted lines in Figure 1. Figures 2 to 4 show some views from the slope instability. Sand bags had been placed to control the run-off from the slope by the contractor after the incidence took place. However, they were not observed to efficiently control the run off (see Figure 5).

Figure 2: Slope Instability from the crest, towards south.

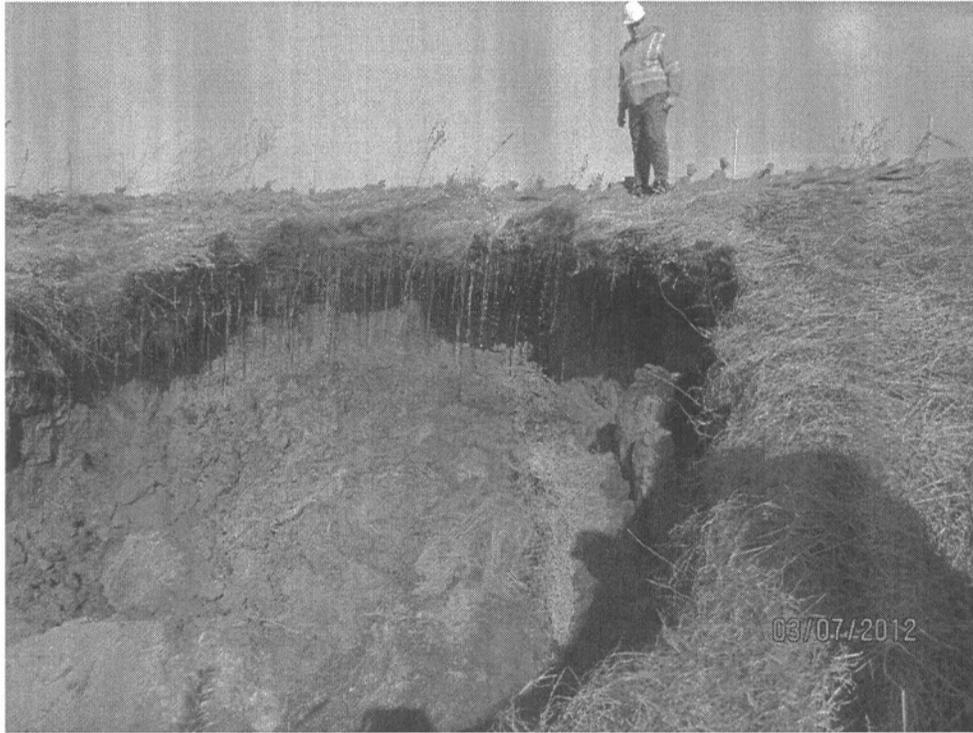
Figure 3: Slope Instability from the mid-height berm, towards north.

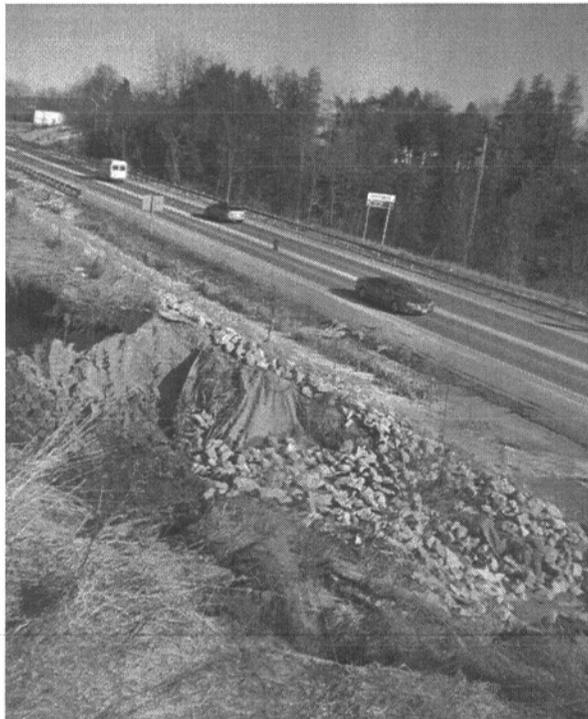
Figure 4: Slope Instability, towards south-east.

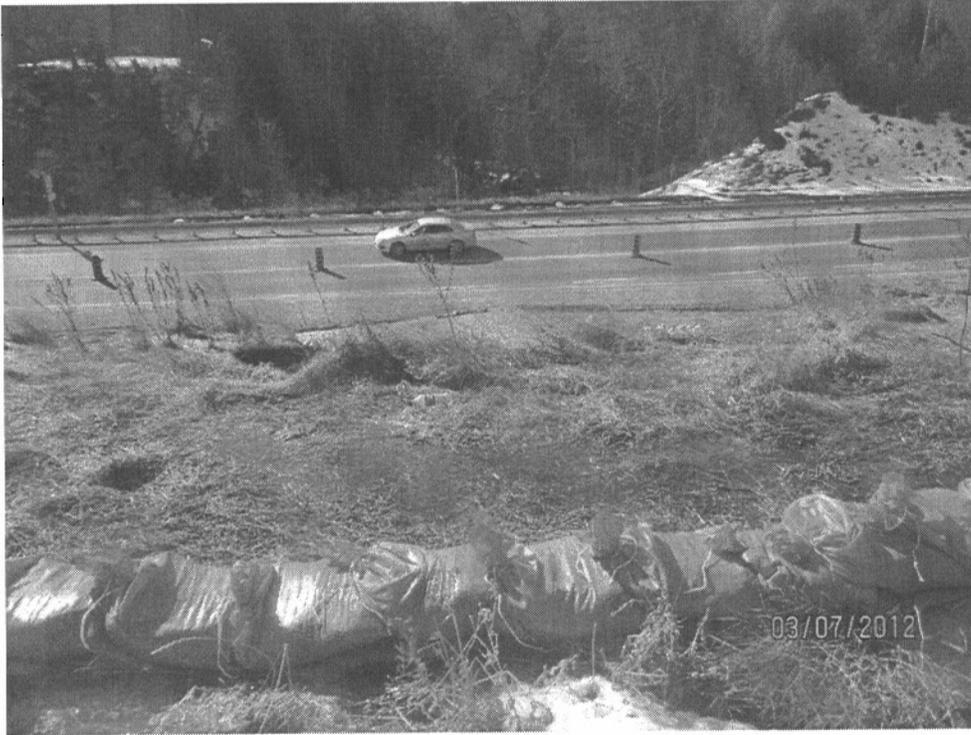
Figure 5: Sand bags placed after the instability took place.

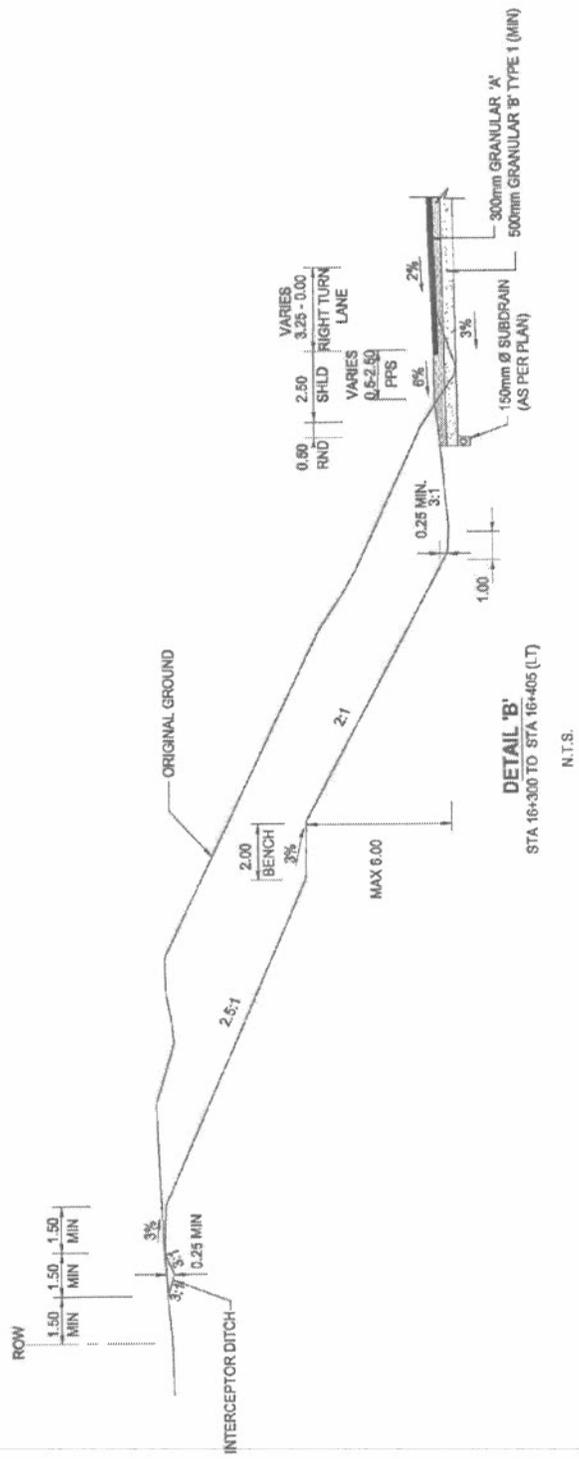
Figure 7. Design geometry of cut slope and interceptor ditch.

The foundation report recommended that the construction of an interceptor ditch on top of the upper slope is necessary in order to minimize the surface flow over the slope and control surficial erosion. Thus, construction of interceptor ditches as shown in contract drawings are recommended as the first step. The details of the interceptor ditch are provided in contract package. The minimum dimensions of the interceptor ditch are given in Figure 7.

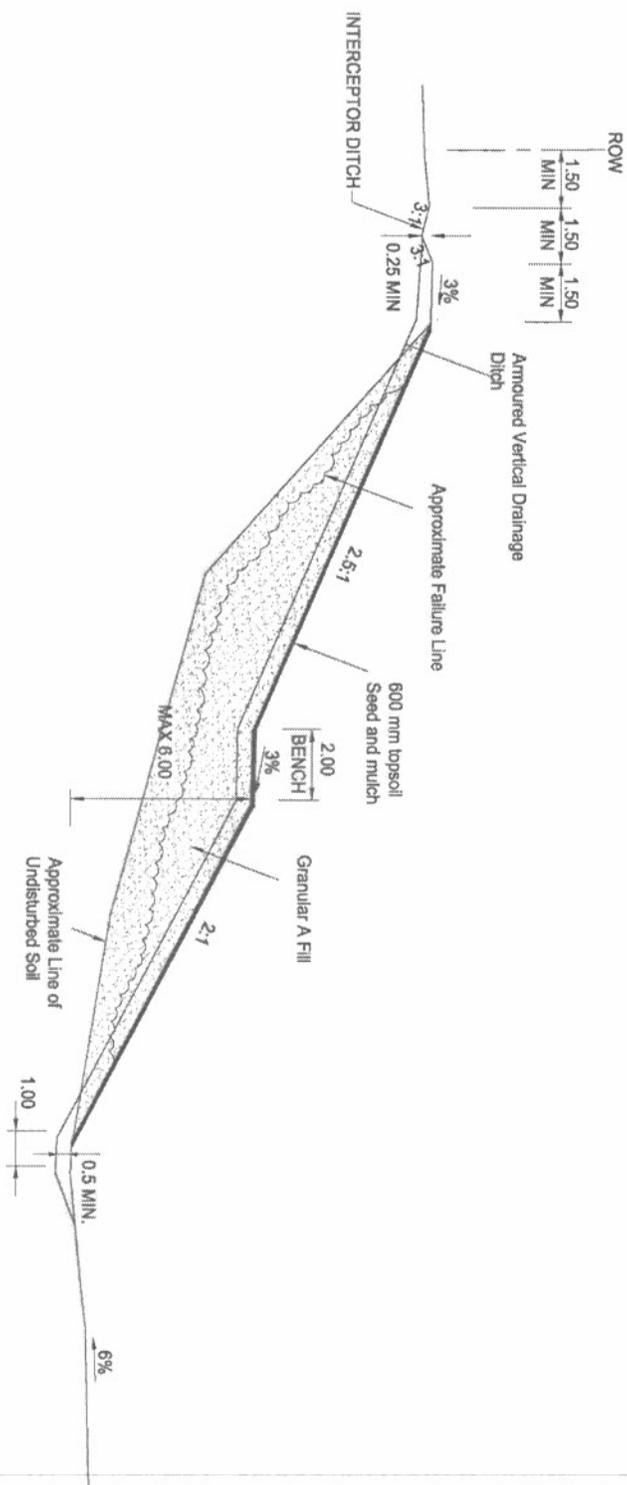
Figure 8. Repair of the failed sections.

At the instabilities, the disturbed soil shall be cleared before reinstating the slope to original design geometry. The soil shall be excavated to a minimum of 1m beyond the horizontal limits of failure and to a minimum of 500mm below the vertical extent of failure. Hypothetical lines that represent the line of failure and the line of clearing are depicted in Figure 8. The slope shall be rebuilt using granular A fill material in steps or lifts not exceeding 500mm and compacted after each step or lift with an appropriate sized static roller (see OPSS 1004: Material Specification for Aggregates – Miscellaneous). Reconstruction shall proceed from bottom to top and granular material shall extend to base of overlying topsoil. Geotextiles-riprap cover shall not be reinstated at repaired sections. The reinstated sections shall be covered with a minimum 600 mm topsoil with appropriate seeding and mulching/protection. The East-West extent of the repair sections shall include the areas, where sloughing and erosion exist (which may be only one massive location unless others have occurred since the noted site visit) .Please refer to Figure 9 for illustration.

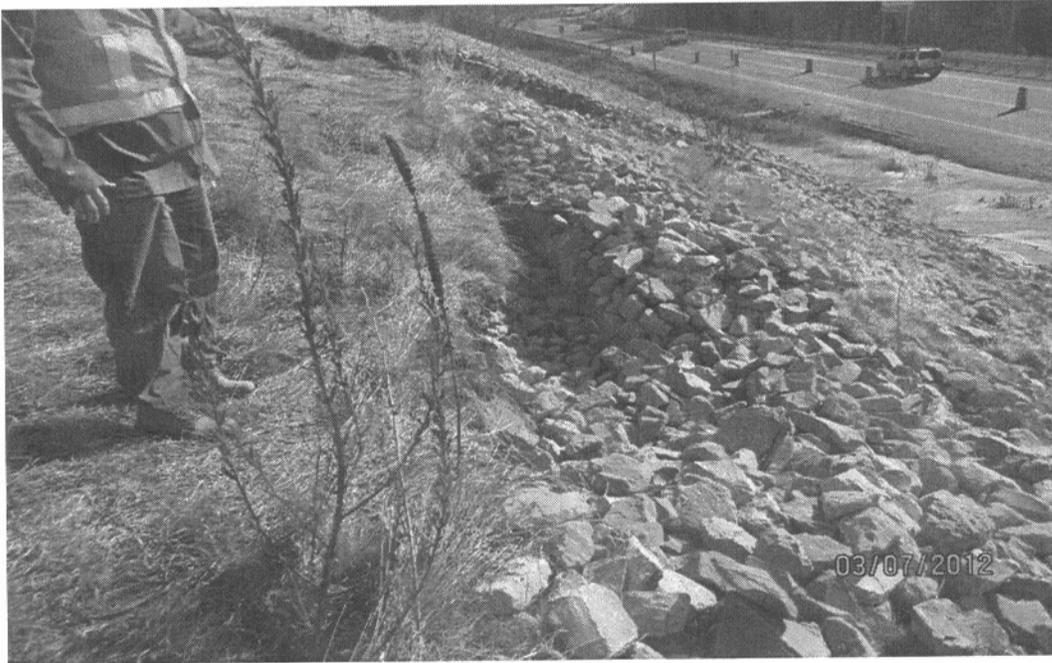
Figure 9. Depression zones west of the failed area.

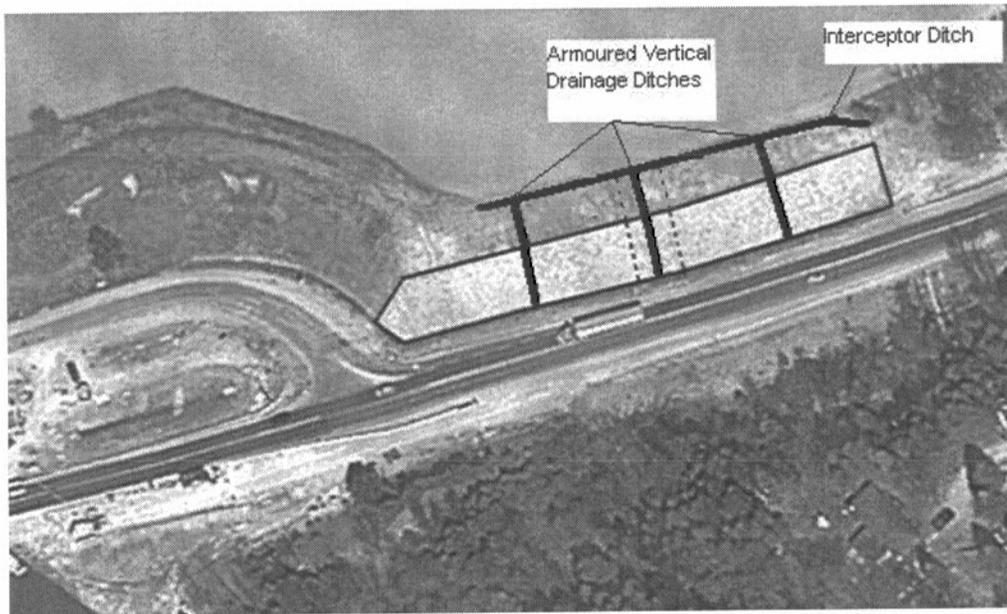
Figure 10. Locations of armoured vertical drainage ditches.

Figure 10. Intermittent replacement of geotextiles-riprap with granular toe berm.

After reinstating the slope to original geometry as shown in Figure 8, vertical armoured ditches shall be constructed at three locations as shown in Figure 10 by re-excavation of trenches. The depth of the ditch shall be minimum 1m from the slope design surface and a minimum of 2m wide. The trenches shall be filled with Rip-Rap R-10 grading aggregate fill. The existing drainage ditch at the toe of the cut slope shall also be armoured with Rip-Rap R-10 grading aggregates (minimum thickness 300mm). All Rip-Rap R-10 grading aggregates shall be placed using rock protection construction method from the bottom up (i.e. machine place and random manner and without geotextile separator). Compaction is not required. Refer to the following Ontario Provincial Standard Specifications for construction method and material selection:

The construction of armoured vertical ditches shall be performed at three locations in total with one at the center of the repaired area and one at 30m to the east and west of the centreline. The geotextiles underlying the riprap is considered to be clogged and resulting in a raise in ground water table. However, the removal of the entire geotextile-riprap zone is considered impractical. Thus, geotextile shall be removed at the locations of the armoured vertical ditches. This operation shall proceed as follows:

- Excavate drainage ditches removing geotextiles/riprap
- Backfill with R-10 aggregate
- Connect vertical drains to toe drain
- Connect vertical drains to interceptor ditch last through channels in order to avoid flooding from runoff during construction
