# Memorandum Report

**Subject:** Assessment and Recommendations for Planning Further Design for Remedial Measures for Embankment Instabilities  
At Culvert just south of W-S Ramp from Bayfield Street to Hwy 400 SB, Barrie  
W.O. 2012-11008  
GEOCREs No. 31D-539

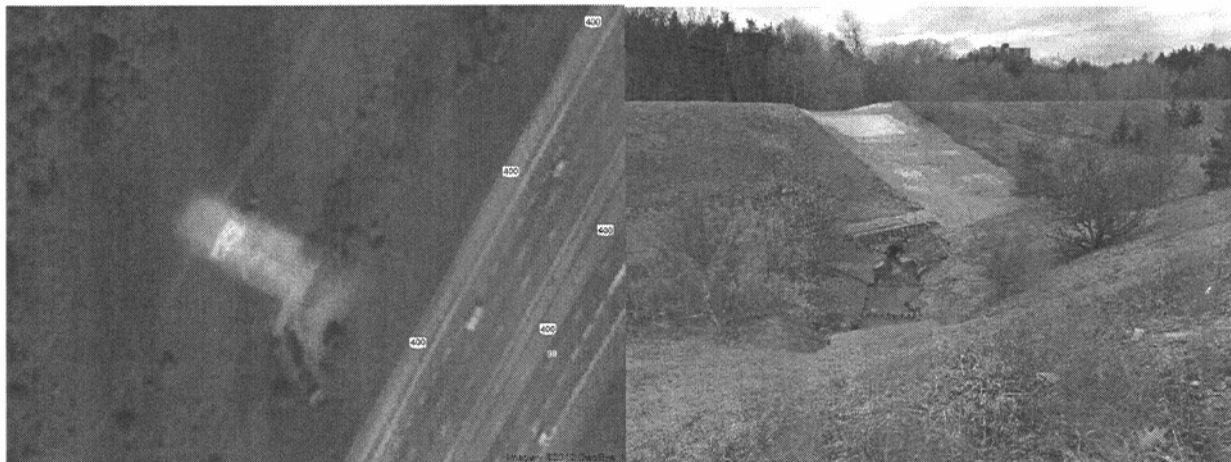
**Figure 2a and 2b: Satellite Image and Photo of Slope Instability Area**

- The sediment around the sides and top of culvert has been eroded away; this indicates that water is flowing around the sides of the culvert during flood periods. The immediate backfill to the culvert is composed of boulders. The boulders are round and vary in sizes from 0.50m to 1.0m in diameter.

- There is an embankment slump due to undercutting above the culvert starting a midslope.
- The erosion around the culvert backfill extends about 2m above the culvert obvert and 2m on each side.

- There is a 300mm diameter corrugated steel pipe outletting into the slope above the Hwy 400 culvert inlet. The culvert outlets from the Hwy 400 median sewer. A section of this pipe has been broken by the slope slump leaving the functioning drain outlet buried within the embankment slope.

Based on the site inspection, instabilities at this site are primarily caused by erosion of the backfill around the inlet of the Hwy 400 culvert. The erosion has led to undermining of the embankment above the culvert and subsequently to shearing of the CSP that drains from the Hwy 400 median sewer onto the slope. Alternatively, the CSP break may have predated and contributed to the slump by outletting into the slope and eroding the backfill.

- closing a portion of the SB shoulder lane (note: this is an extremely tight area for traffic)
- excavating the gabions, boulders and whatever backfill remains around the outside say 5m of the culvert and back to stable material
- cutting off the distressed portion of the culvert and replacing that portion with a box culvert addition
- finding and reconstructing the end of the CSP drain that extends from the Hwy median sewer and then outletting it to the base of the embankment ditch instead of onto the slope
- reconstructing the slope and backfill to the culvert per usual MTO standards
- constructing a head wall to the culvert or alternatively an impermeable clay seal around the culvert inlet to channel water through the culvert and prevent erosion of the culvert backfill and the embankment
- armouring the inlet area with rock fill or gabion mat

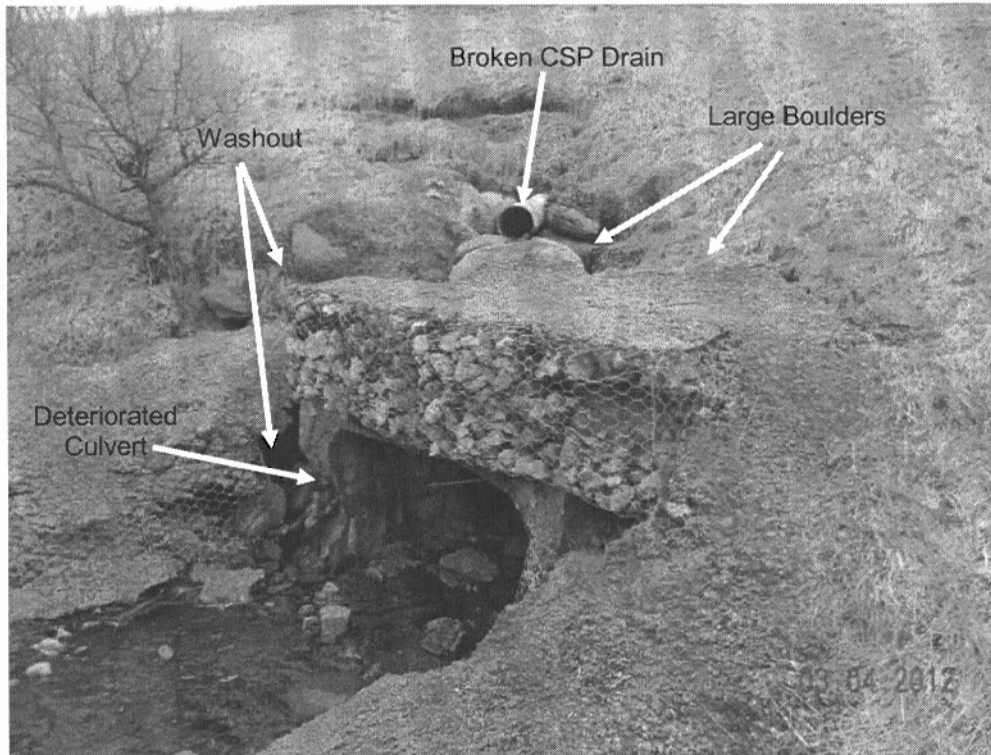
**Figure 3: Culvert Inlet under Hwy 400**

- There is a concrete spillway on the east side of the berm above the berm culvert outlet – probably part of a storm management system.
- The Hwy 400 culvert is an approximately 1.0m high and 2.0m wide CIP concrete box culvert. The inlet has deteriorated concrete and exposed reinforcing steel. There are 1m x 2m x 1m gabion baskets, covered with asphalt, placed along the sides of the culvert and on the top of the culvert.

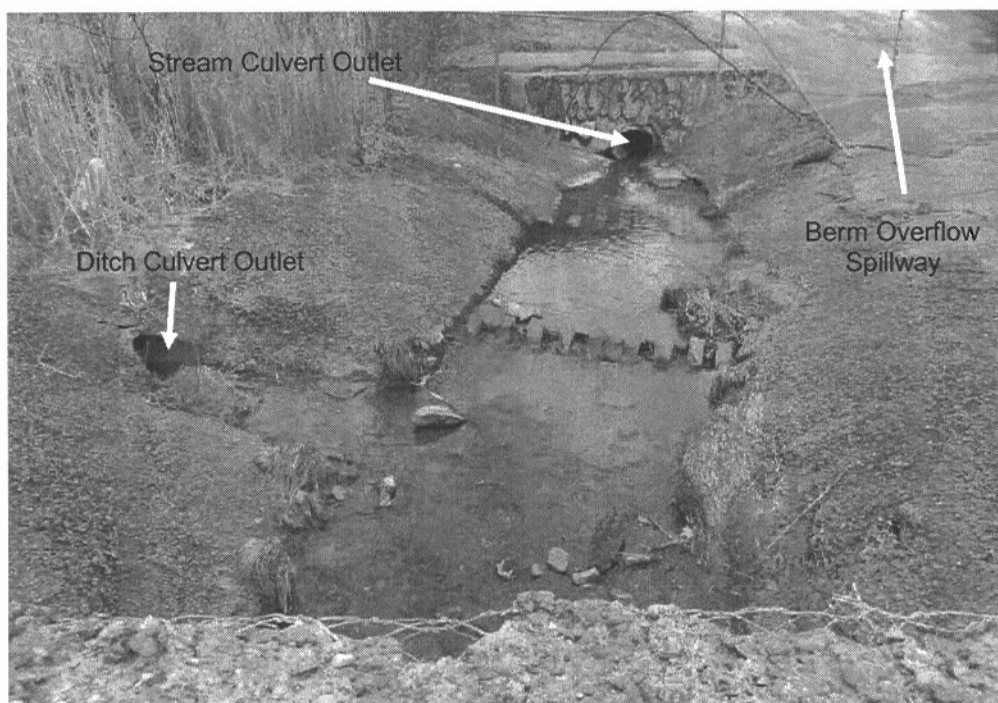
**Figure 4: Upstream of Hwy 400 Culvert**

- The stream flows from the NE, through a culvert under a berm parallel to and to the west of Hwy 401, then through a culvert under Hwy 400. A small culvert from the west side ditch discharges into the stream between the inlet and outlet culverts. Also, a CSP drain outlets onto the side slope of Hwy 401 above the Hwy 401 culvert inlet.
