D.H.O. FOUNDATION INVESTIGATION  
(W.P. 244-60) -- W.J. 60-7-32.

# FOUNDATION REPORT

Hwy. 500 at Pusey and Grace Lake Junction,  
Township of Cardiff, District 11.

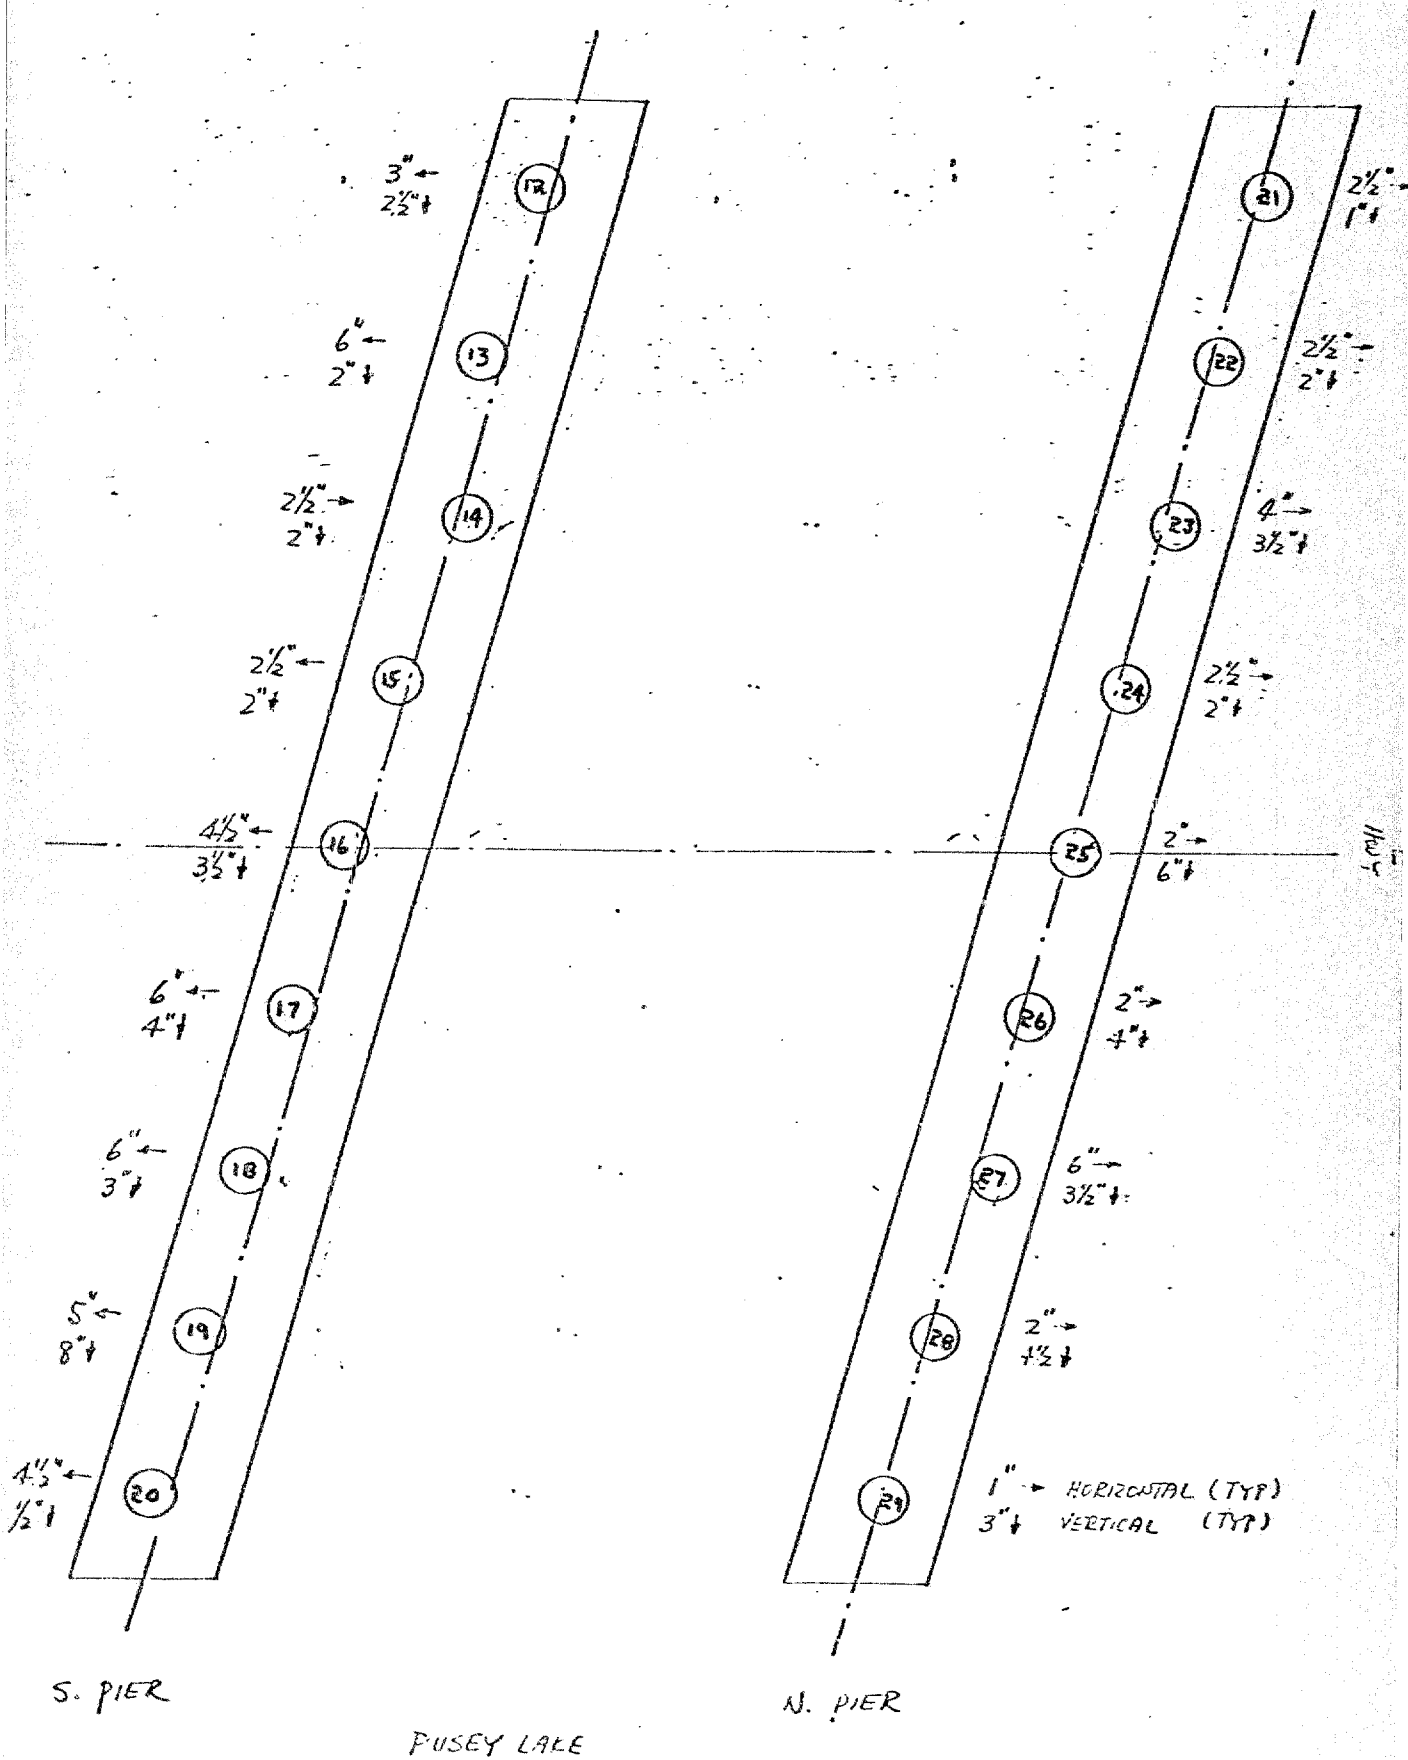
# Measured Pile Movements Contract 78-08

- i) The pile butts of the south pier bent had moved laterally towards the south abutment and settled vertically. Likewise, the north pier piles had moved towards the north abutment and settled. The magnitude of movements are shown on the attached diagram. Tension cracks in the soil surrounding the pier piles indicated the piles had moved laterally towards the abutments.
- ii) The author could not inspect the abutment piles since the pile caps had already been poured and the south abutment wall was in the process of being poured.

- v) All pier piles commenced movement only during the driving of the abutment batter piles. No relative movement occurred after driving the abutment piles.
- vi) No movement of the abutment piles had occurred during driving the adjacent piles except for pile No. 6 which settled 7 inches during the driving of pile No. 7.
- vii) Slight movement of the south pier piles was observed during the driving of the north abutment batter piles.

Since no unusual movement or problems of the abutment piles were reported by the construction field staff, we feel these piles will behave as designed. In order to verify the load-movement behaviour of the displaced pier piles, it is recommended to carry out a full scale load testing program on selected pier piles.

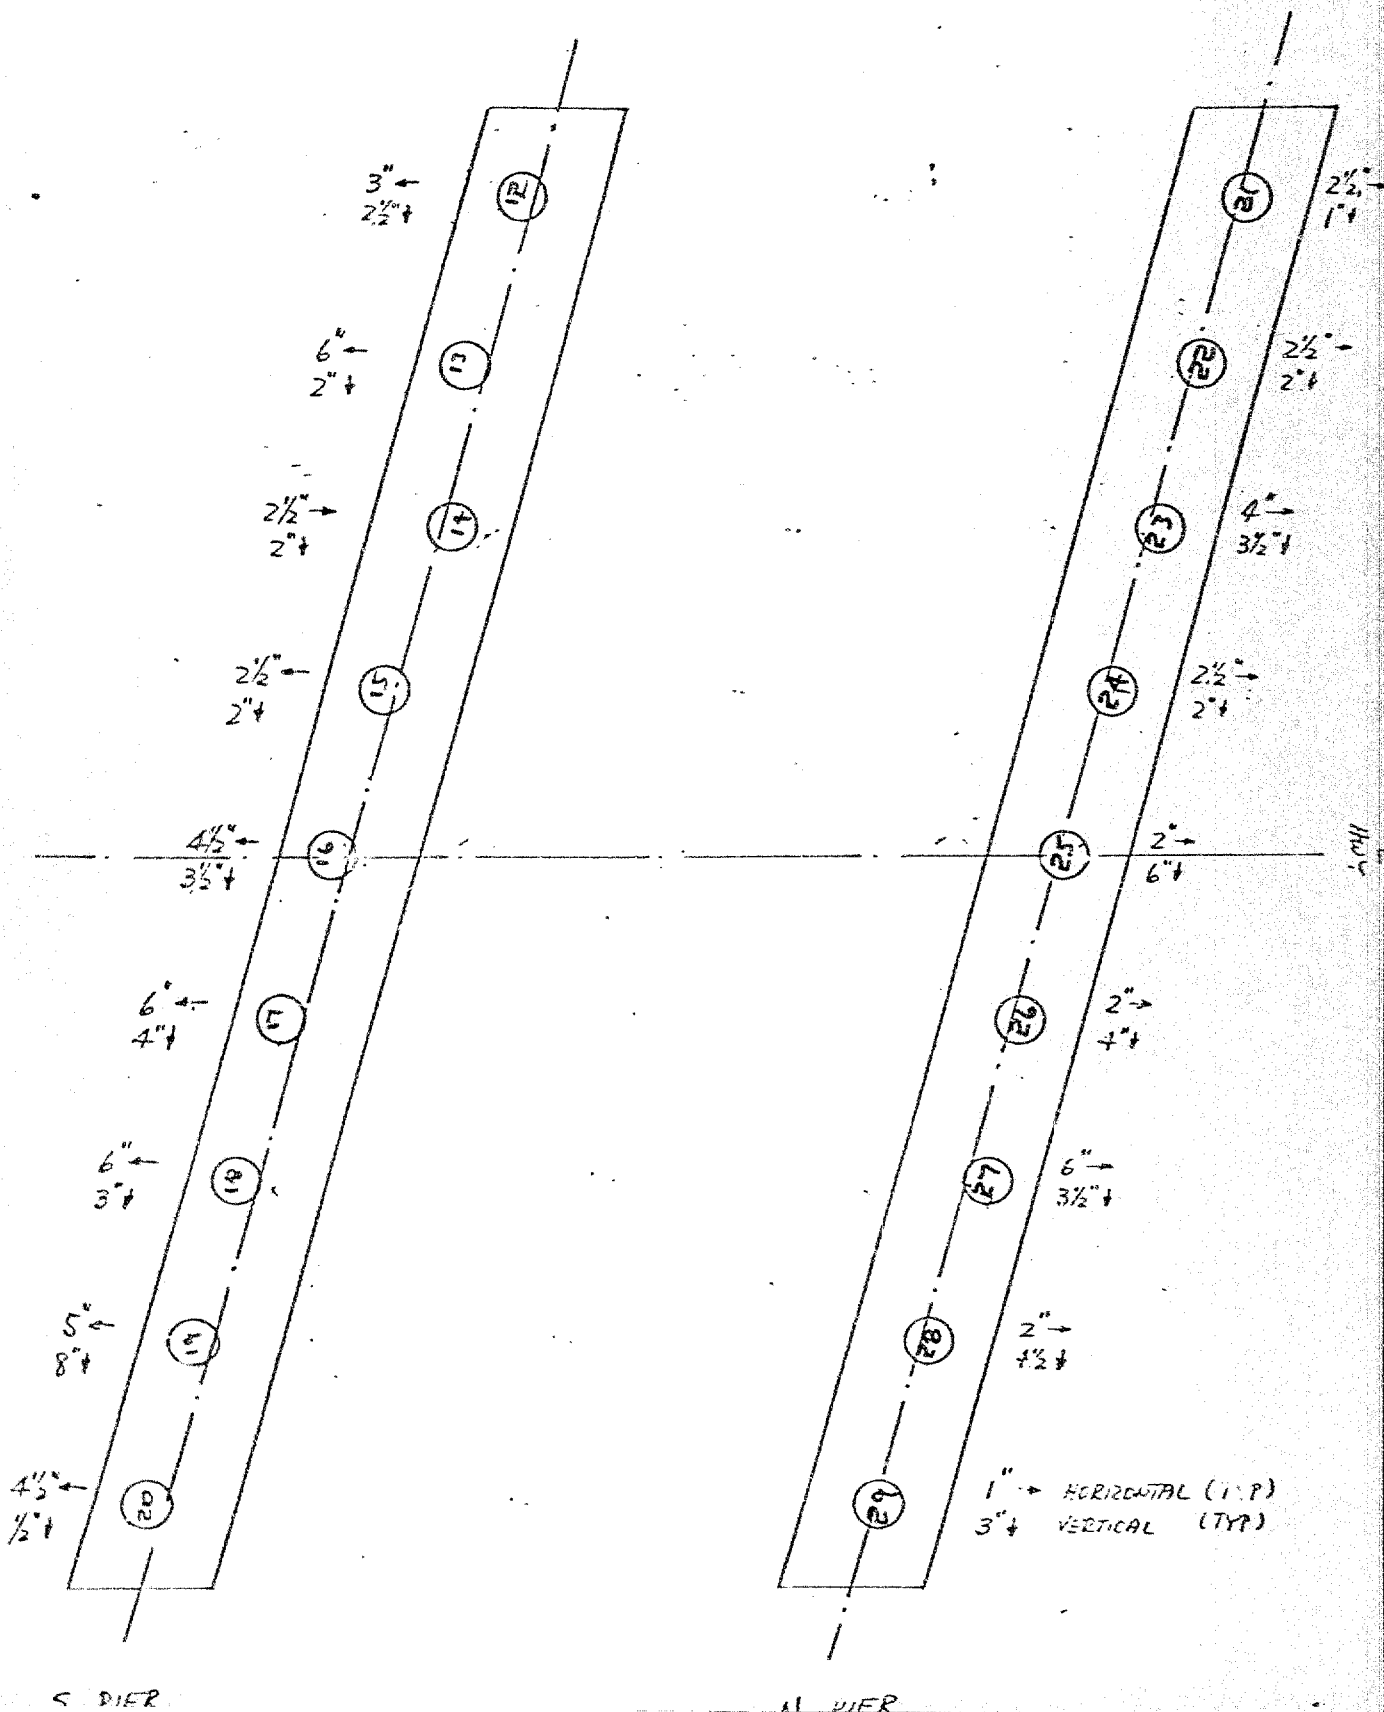
# Measured File Movements Contract 78-C8

The construction of the 3 span structure at the above mentioned site is proceeding with work performed by Gaffney Construction under the supervision of M.T.C. Regional Construction personnel. During driving of the abutment batter piles into the loose to compact sandy silt underlying the site, movement of the previously driven north and south pier piles was observed. The magnitude of these movements ranged to a maximum of 6 inches laterally and 3 inches vertically. No further movement of these pier piles were observed upon completion of pile driving operations. Considering the magnitude of lateral and vertical movement and the sensitivity of the structure to differential settlement, concern was expressed whether the piles would settle excessively under the design load. The Soil Mechanics Section was made aware of this problem on 78 08 16 and on 78 08 21 it was recommended to carry out a full scale load testing program on selected pier piles in order to verify the pier pile performance under actual load.

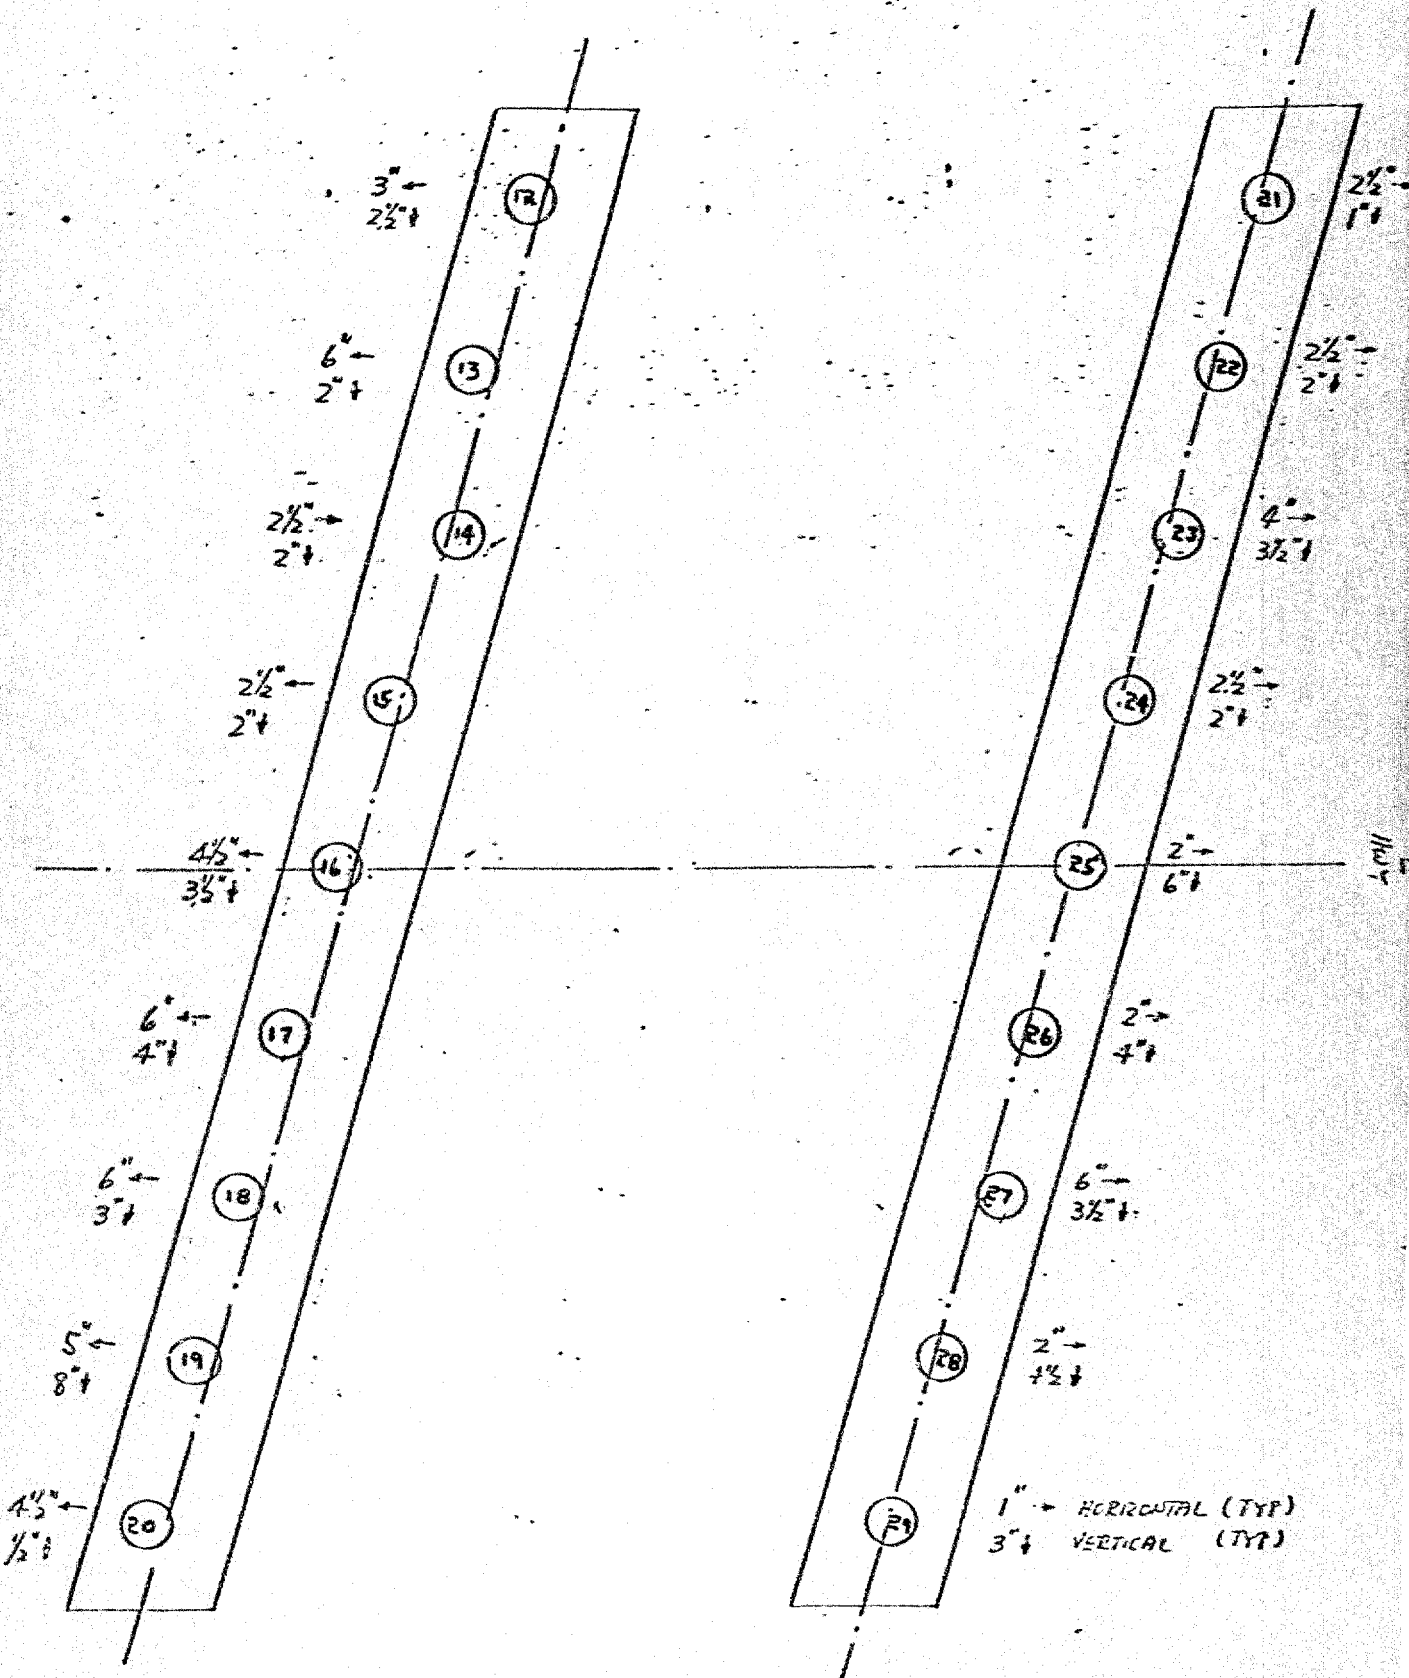
# Measured Dike Movements Contract 78-C8

- i) The pile butts of the south pier bent had moved laterally towards the south abutment and settled vertically. Likewise, the north pier piles had moved towards the north abutment and settled. The magnitude of movements are shown on the attached diagram. Tension cracks in the soil surrounding the pier piles indicated the piles had moved laterally towards the abutments.
- ii) The author could not inspect the abutment piles since the pile caps had already been poured and the south abutment wall was in the process of being poured.

- v) All pier piles commenced movement only during the driving of the abutment batter piles. No relative movement occurred after driving the abutment piles.
- vi) No movement of the abutment piles had occurred during driving the adjacent piles except for pile No. 6 which settled 7 inches during the driving of pile No. 7.
- vii) Slight movement of the south pier piles was observed during the driving of the north abutment batter piles.

Since no unusual movement or problems of the abutment piles were reported by the construction field staff, we feel these piles will behave as designed. In order to verify the load-movement behaviour of the displaced pier piles, it is recommended to carry out a full scale load testing program on selected pier piles.

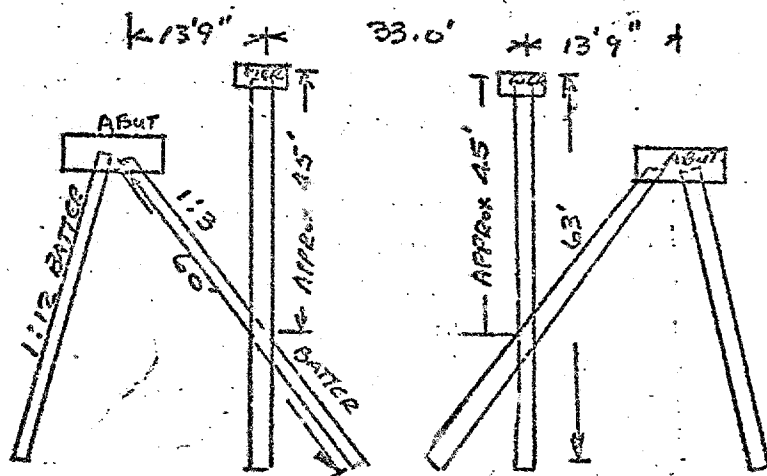
Donn Const'n. then commenced driving the piles in the south abutment. While driving the 1:3 batter piles in this abutment movement was noticed in the south pier cap piles. Movement was also recorded in the north pier cap piles when the 1:3 batter piles were being driven in the north abutment footing. The reason for this movement was that these batter piles was crossing between the pier piles which was 3' 9" apart. This crossing occurred at approximately 45' (feet) down on the pier piles.  
- SEE SKETCH BELOW -

PIER PILES ARE 3'9" APART.

The piles in these pier caps moved approximately 1" to 6" horizontal and  $\frac{1}{2}$ " to 8" vertical.

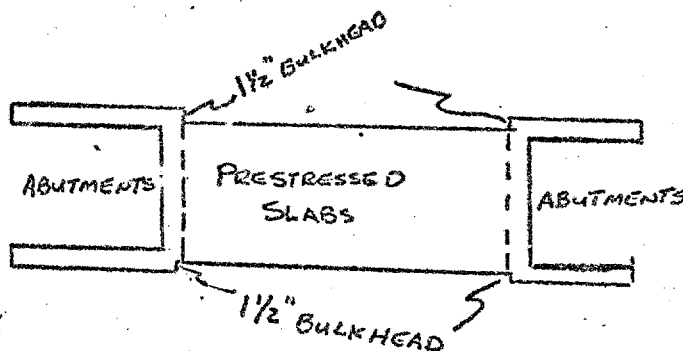
SEE SKETCH BELOW

When these beams arrived on the contract, every beam was approximately  $\frac{1}{4}$ " to  $\frac{3}{8}$ " narrower than the 4.0' as shown on the contract drawings. A bulkhead of approximately  $1\frac{1}{2}$ " had to be built on the outside of the barrier walls at the expansion joints on each side of the structure to compensate for this.
