CONTRACT 68-123

H.W.Y. #516 (FAILURE)

MEMORANDUM

Failure of Hwy. 516 at Utterson Lake
Contract 68-123 -- W.J. 69-F-69

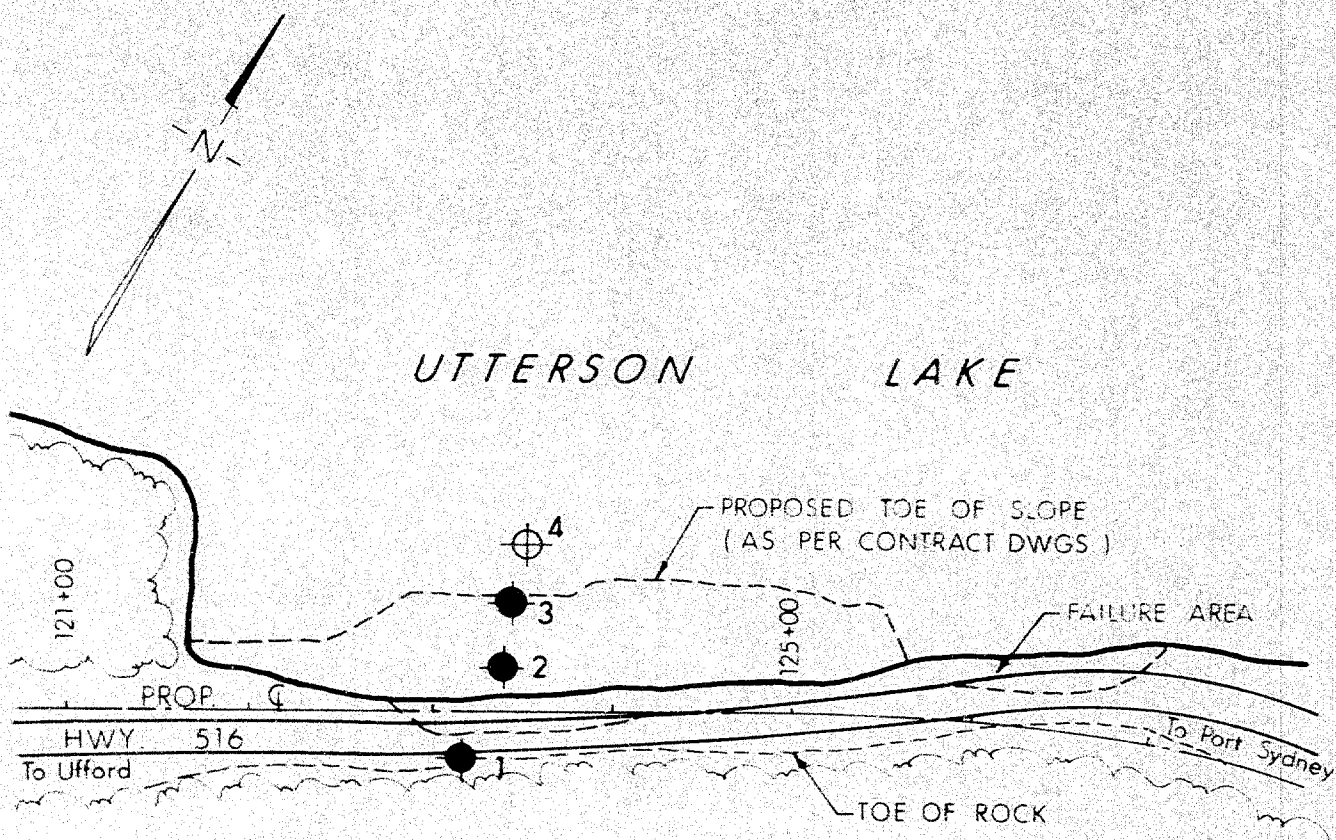
PLAN
SCALE 1" = 100'

Subsoil was found to consist of from 7 to 15 feet of very soft to soft clayey silt followed by 20 to about 40 feet of loose to very dense silt followed by granite bedrock. The thicknesses of the subsoil layers increase with increasing distance into the lake from the edge. Along the boundary of the failed zone a rock ledge was observed to extend from the east end of the zone to about Station 123+15. At this point B.H. #1 revealed that the rock was about 10 ft. deep, indicating that the projecting ledge was sloping steeply downwards from a point just east of Station 123+15.

Failures have occurred by displacement of the soft clayey silt subsoil referred to on the foregoing page. Shock waves from blasting, and the impact loads of large quantities of blasted rock have been the cause of the failures. This type of failure is likely to reoccur in the future until all blasting work is completed, or until all of the soft material is displaced.

With regard to the future construction and subsequent performance of the section of highway involved, it is our opinion that a satisfactory road can be built along the line as originally designed, though of course it would be preferable to move the line as far south into the rock as is possible. In any event, all future fills which overlie the soft material should be built initially several feet higher than the final grade. The object here is to ensure that the embankment portion will be subjected to greater loads during construction than after construction, in which case, it can be assumed that a reasonable safety factor will have been achieved. The method of placing fill, therefore, should be designed so as to achieve this objective.

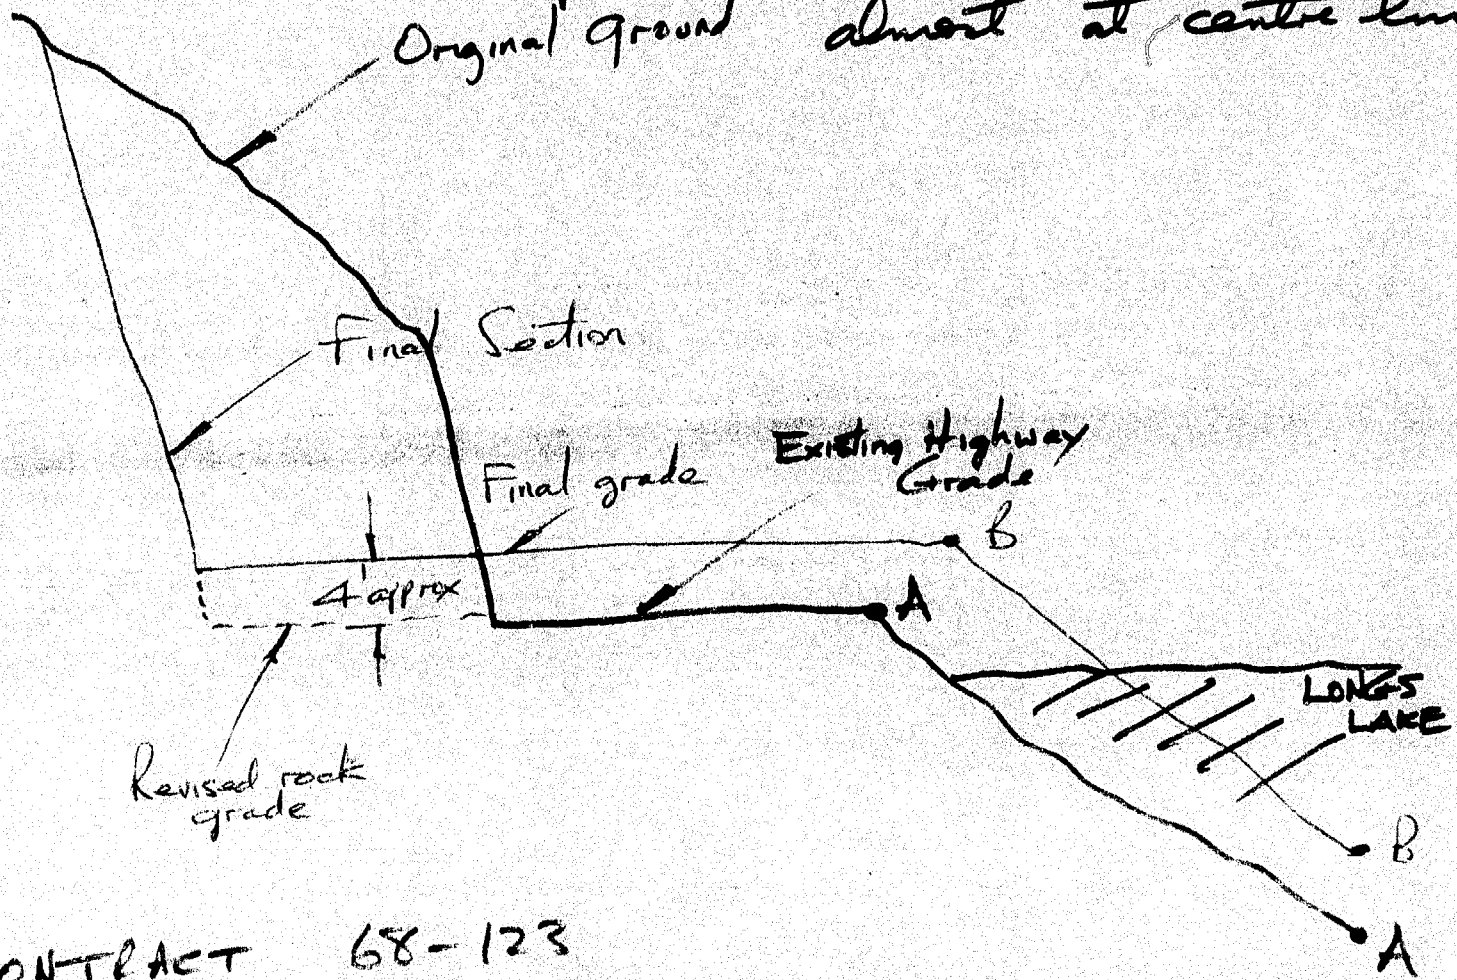
CONTRACT 68-123
SIDE HILL CUT AT
LONGS LAKE

- a) I have discussed with Tony Stermac the possibility of a future failure of fill material along rock face A-A. Mr. Stermac's opinion is that this is impossible to predict, and his advice is that we proceed in accordance with our plans and keep a watch on the situation. I agree with his recommendation.
- b) We have requested the Contractor to blast several short sections of the cut rather than take out all of the rock in one or two blasts. Our reasons are twofold, namely:
 - (i) One or two large blasts could, we feel, result in a large amount of rock kicking into, and being lost in, Long's Lake, beyond the proposed fill slope B-B.
 - (ii) We are not at all certain that mucking could be completed in 48 hours. Detouring would be complex, and

NOTE At the "worst" location the line A-A produced intersects the new grade almost at centre line.

1. Rock grade for the length of side hill cut from approximately station 124+50 to 127+50, will be lowered by some 4' so that final rock grade will be at the elevation of the existing highway. This will give us a more uniform roadbed and will make available rock which is badly needed for widening on the lake side.
2. Should still more rock be required for widening, we will establish a rock borrow item.
3. We will investigate the possibility of lowering profile grade through this section of the project, however, if that is not feasible, we will build up from the existing highway elevation with borrow.
