59-F-254C  
W.P. 221-59  
Hwy. # 60  
SMOKE RIVER

### PROPOSED CROSSING OF SMOKE RIVER

HWY No 60 — PECK TOWNSHIP

FOUNDATION INVESTIGATION  
PROPOSED CROSSING OF SMOKE RIVER  
HIGHWAY 60 -- PECK TOWNSHIP

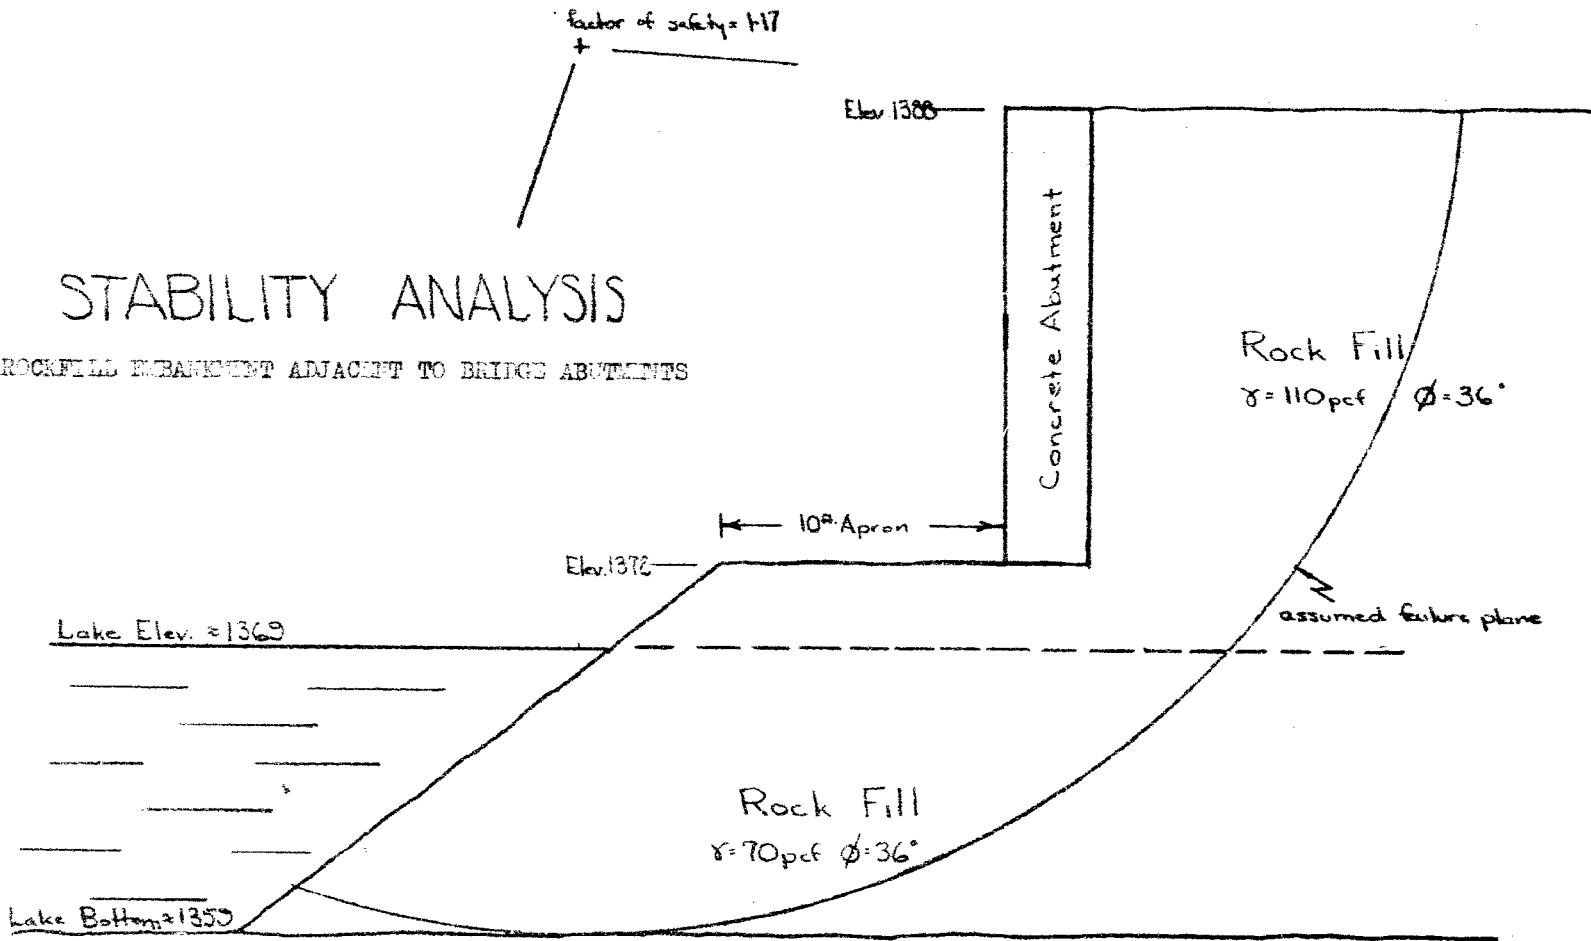
# STABILITY ANALYSIS

An analysis has been made to determine the stability of the abutments and their foundations when acted upon by the thrust of 16 feet of rockfill of the causeway approach to the bridge. This study was made in order to determine how much filling was required in front of the abutments. The results of the analysis, shown in drawing 6, indicate that the factor of safety against slope failure is approximately 1.17 when the fill extends 10 feet in front of the abutments. In these computations, the angle of internal friction of the fill was assumed equal to its angle of repose or about 36 degrees; the most critical circle was not determined.

This preliminary computation indicates that a considerable apron of rock fill will be required before the slope can be considered to be stable. Consequently it would seem that spill-through type abutments would be more suitable for this structure. With this arrangement horizontal pressures from the approach fill are not a matter of concern.

ROCKFILL EMBANKMENT ADJACENT TO BRIDGE ABUTMENTS

factor of safety = 1.17

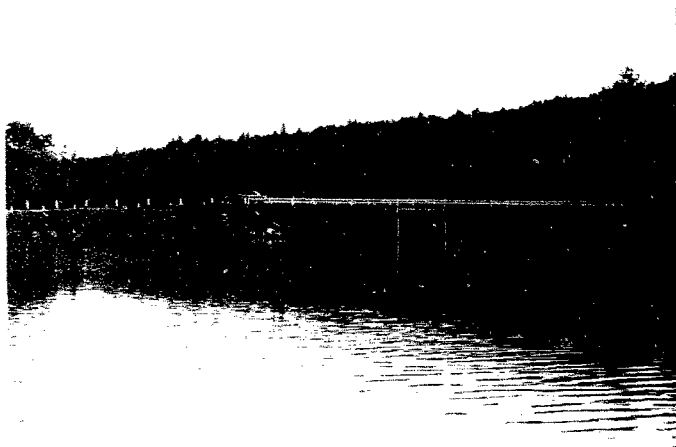
Existing Timber Bridge - Looking East

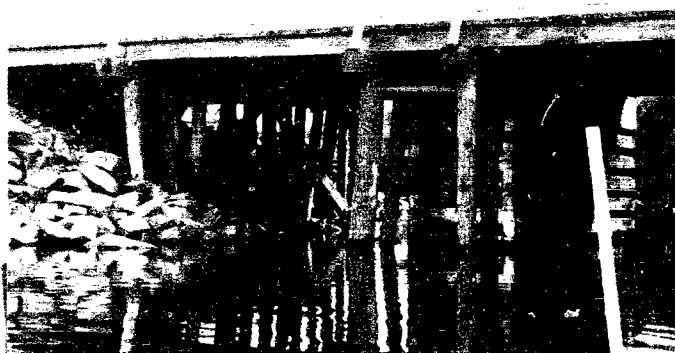
North West Corner of Existing Timber Bridge

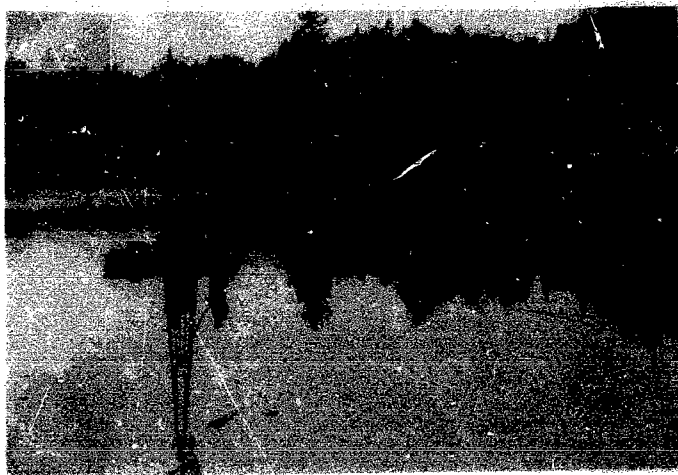
View Looking North along Line B  
Drill on Hole No. 4

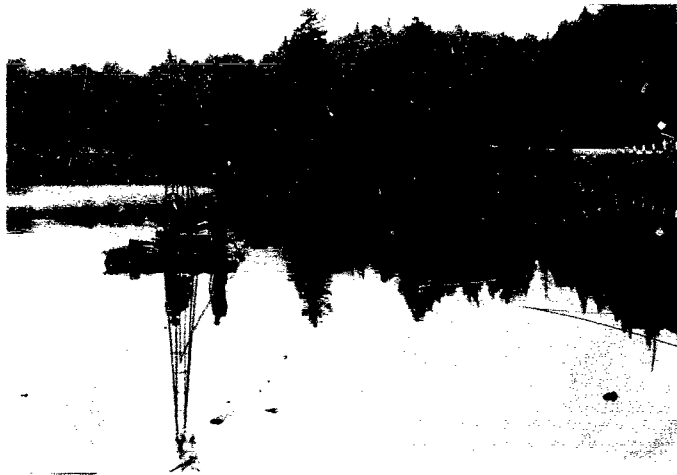
View Looking North along Line B  
Drill on Hole No. 4
