FOUNDATION INVESTIGATION REPORT

Structural Plate Pipe - Jenkins Creek
Sta. 164+98, Hwy. 520
District 11, Huntsville
W.P. 193-65-00

JENKINS CREEK BRIDGE
Site 44-70, Hwy. 520
Dist. 11

Re: Jenkins Creek Bridge - Hwy. 520
0.7 Miles West of Sec. Hwy. 510
Site 44-70 -- W.P. 193-65

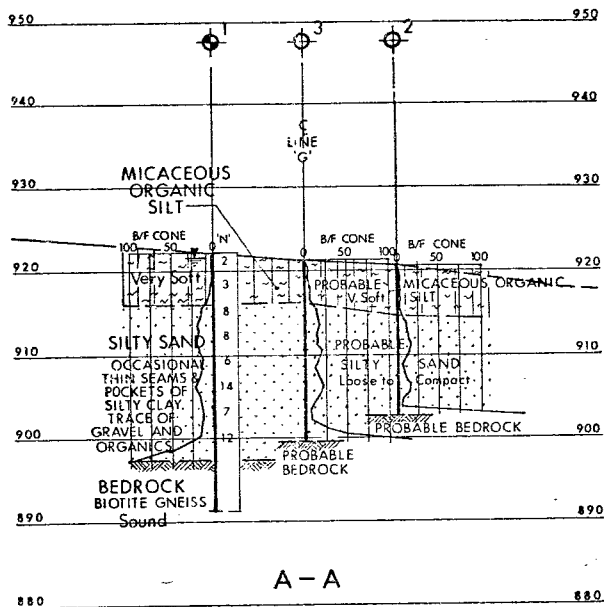
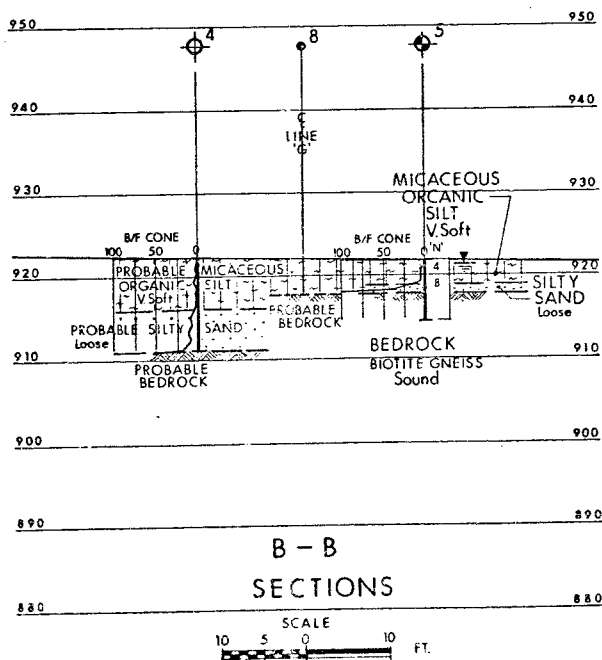
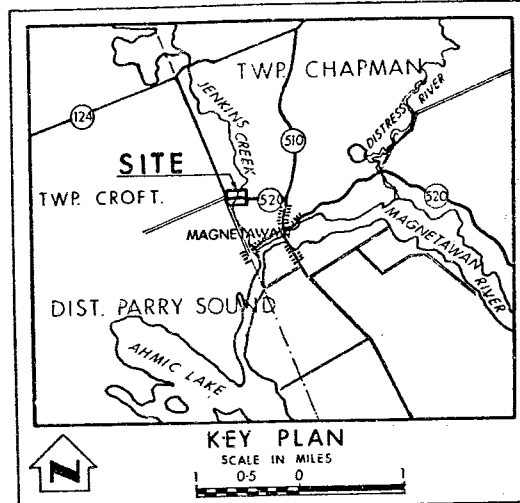
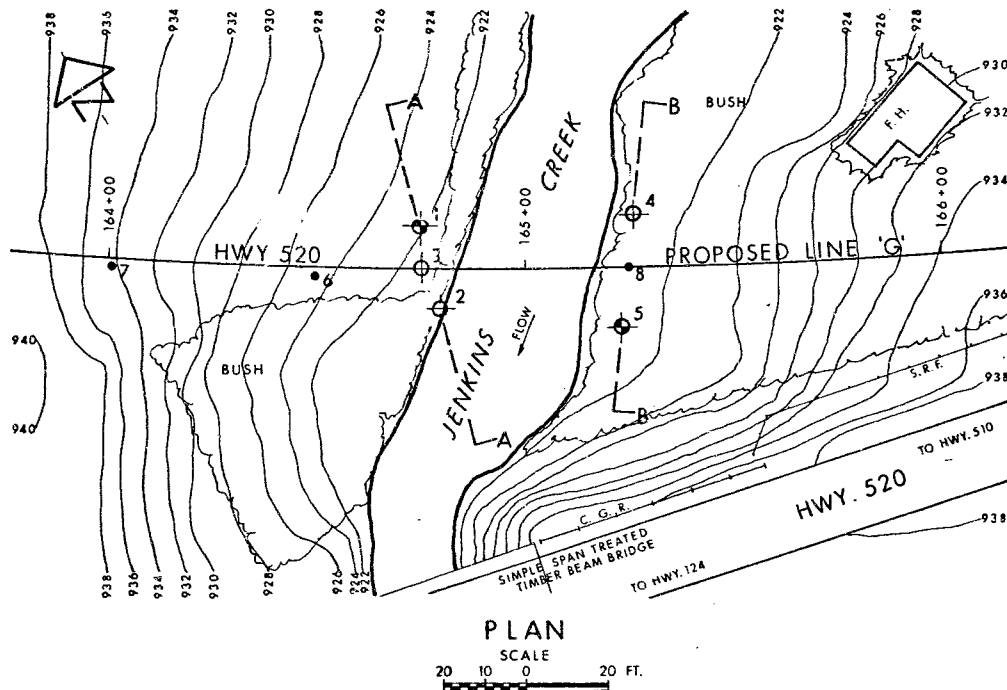
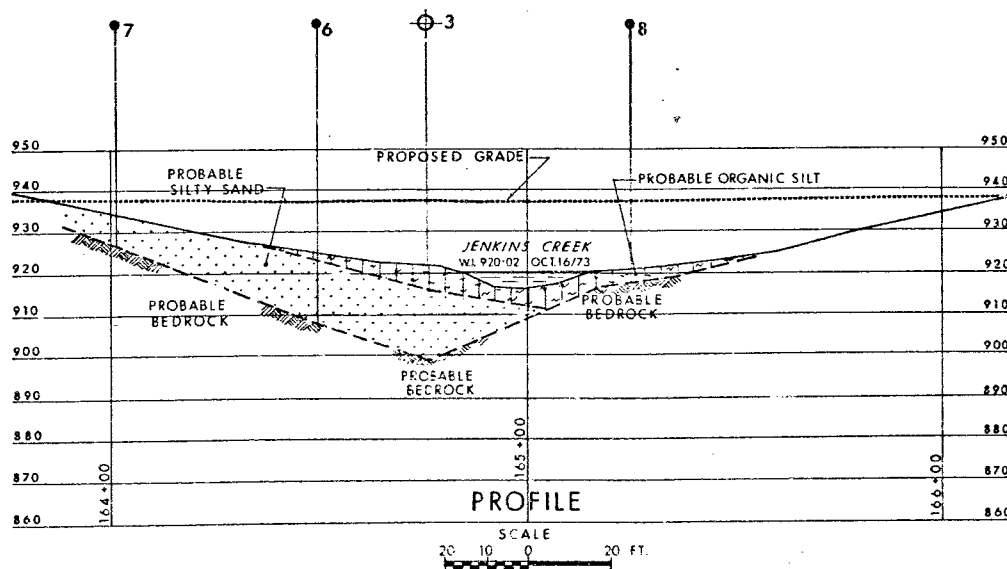
BORE HOLE LOCATIONS & SOIL STRATA

The boundaries between soil strata have been established only at Bore Hole locations. Between Bore Holes the boundaries are assumed from geological evidence.
