Re: Hwy 35, vicinity of Boshkung Lake
Cont. 70-229
District 52, Huntsville

Subject: Wp 164-90-01 Hwy 35 Settlement Area
Vicinity Boshkung Lake, Township of Stanhope,
District 52, Huntsville
=====

RE: Settlement, Highway 35, Vicinity of Boshkung Lake
Stations 200+00 to 211+00, Contract 70-229
District #11, Huntsville

SETTLEMENT HWY 35 - VICINITY OF BOSHKUNG LAKE

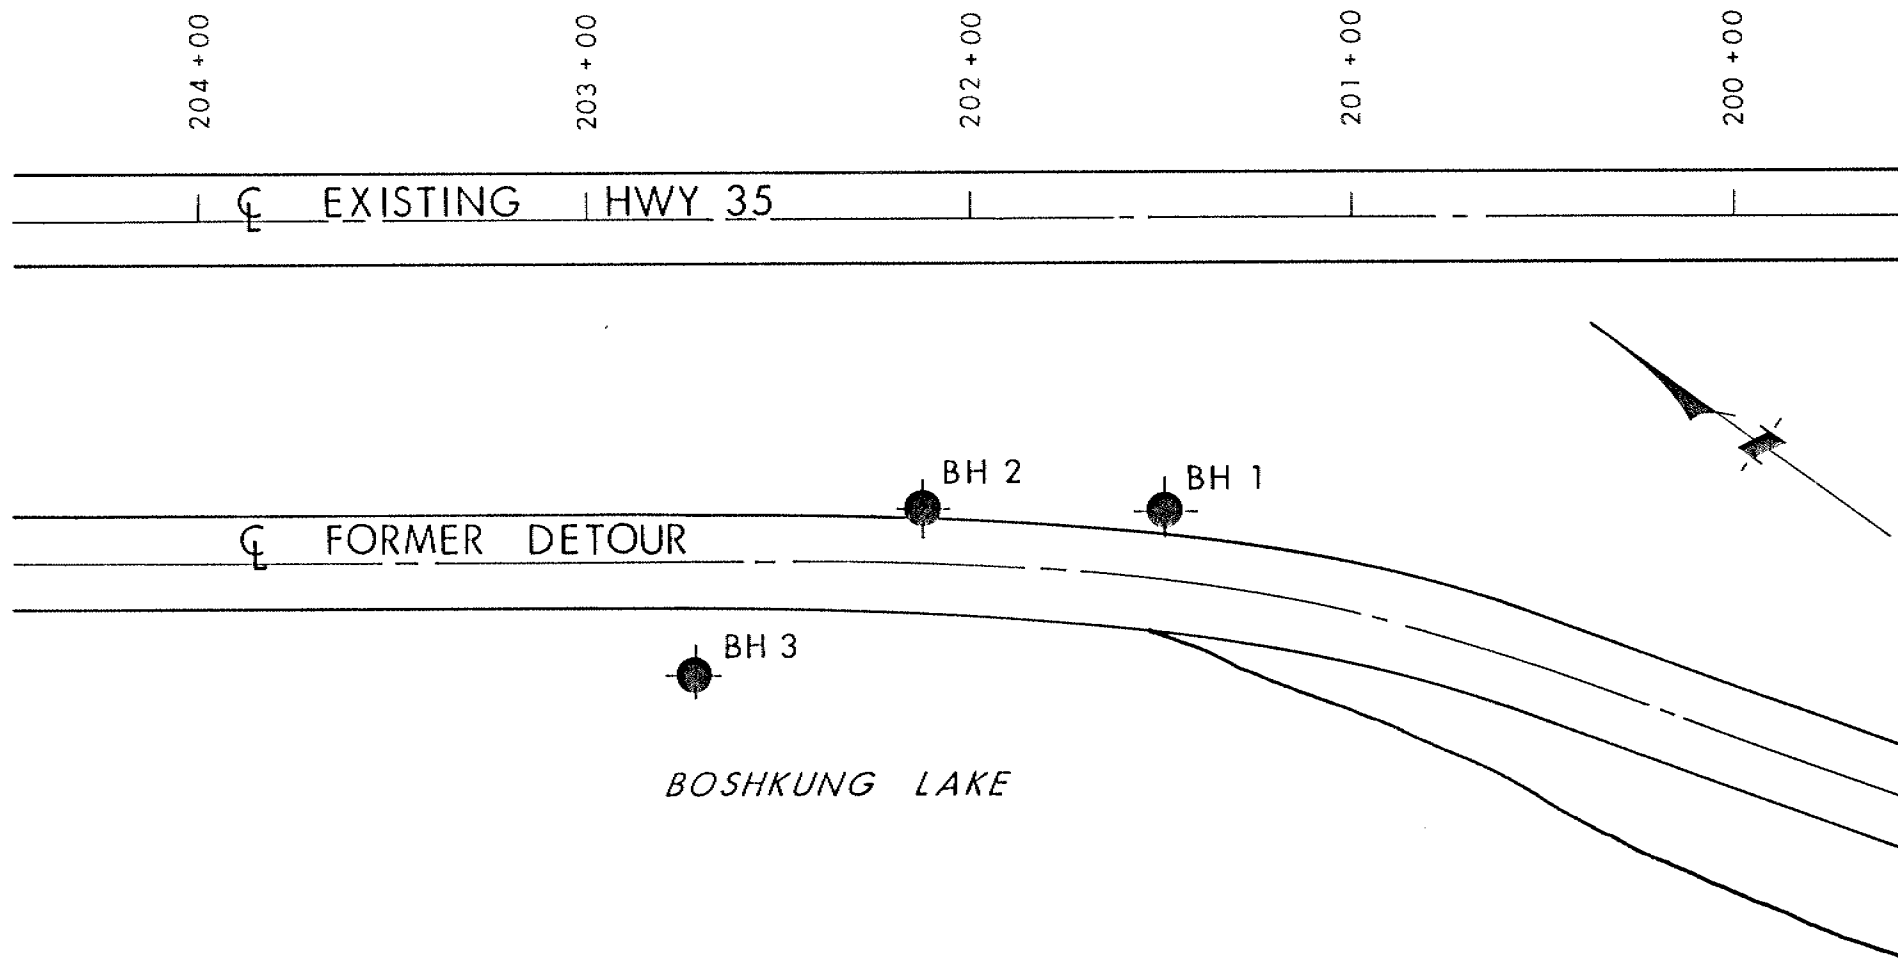
Geocres No 31E - 104
 Cont 70 - 229
 Dist 11
 Figure No 1

For a more detailed description of the subsurface and groundwater conditions encountered, reference should be made to the Record of Borehole Log Sheets contained in the Appendix of this report (Boreholes 1, 2 and 3). The plan locations of the borings are shown on Figure 1.

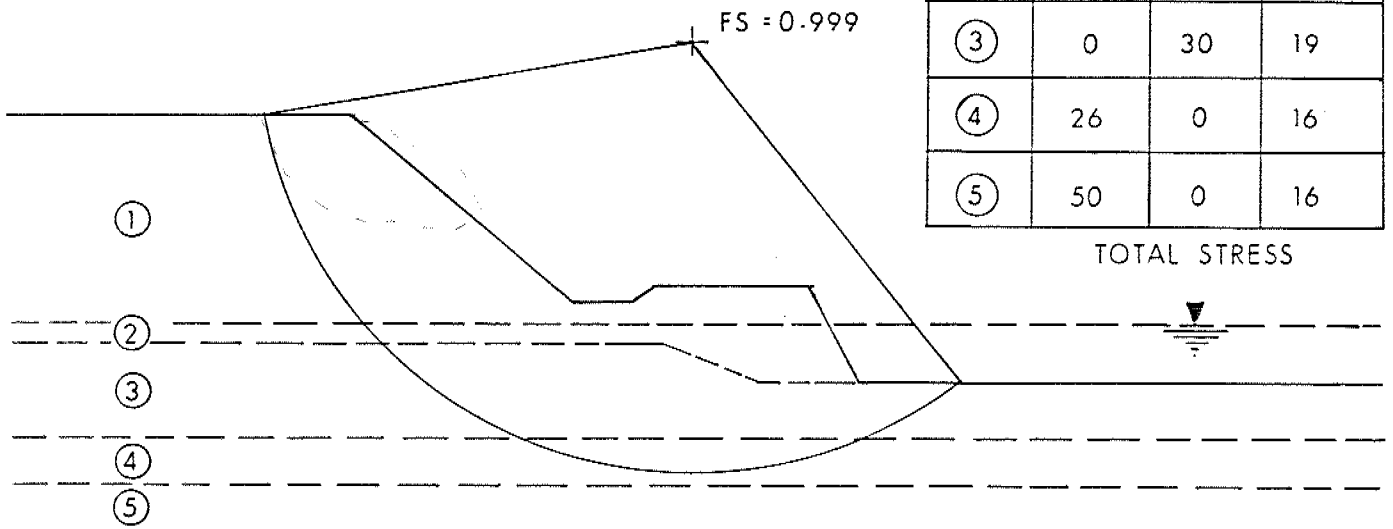
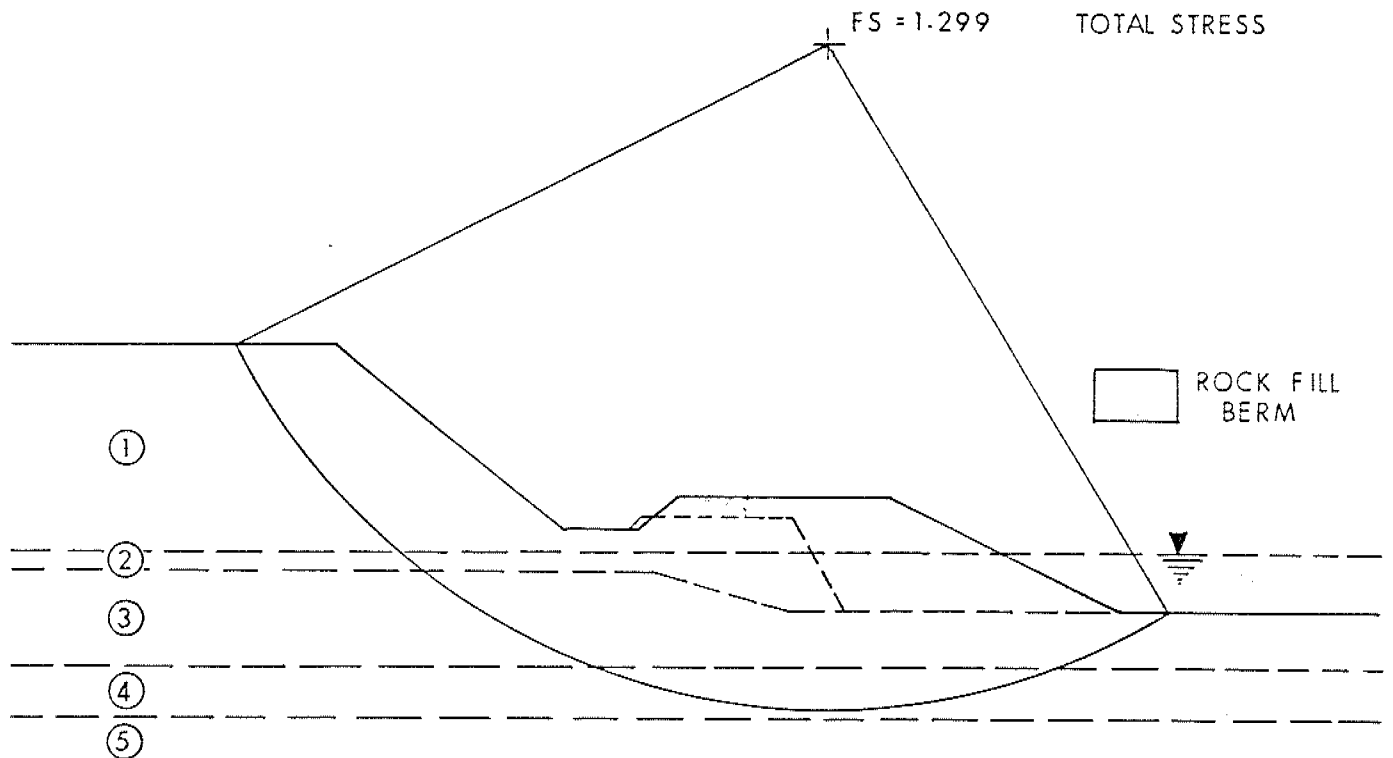
Stability analyses in terms of total stresses have been carried out for the existing cross section with and without various berm designs. Details of the assumptions and results of the stability analyses are provided in Figure 2. Based on these, it is recommended that the following berm (refer to figure 3) be constructed as indicated below.
