# memorandum

GEOCRES  
No: 31F-172

RE: Douglas Creek Culvert  
6.4 km West of Former Hwy. 17  
W.O. 88-46016, Site 29-155  
Hwy. 60, District 9, Ottawa

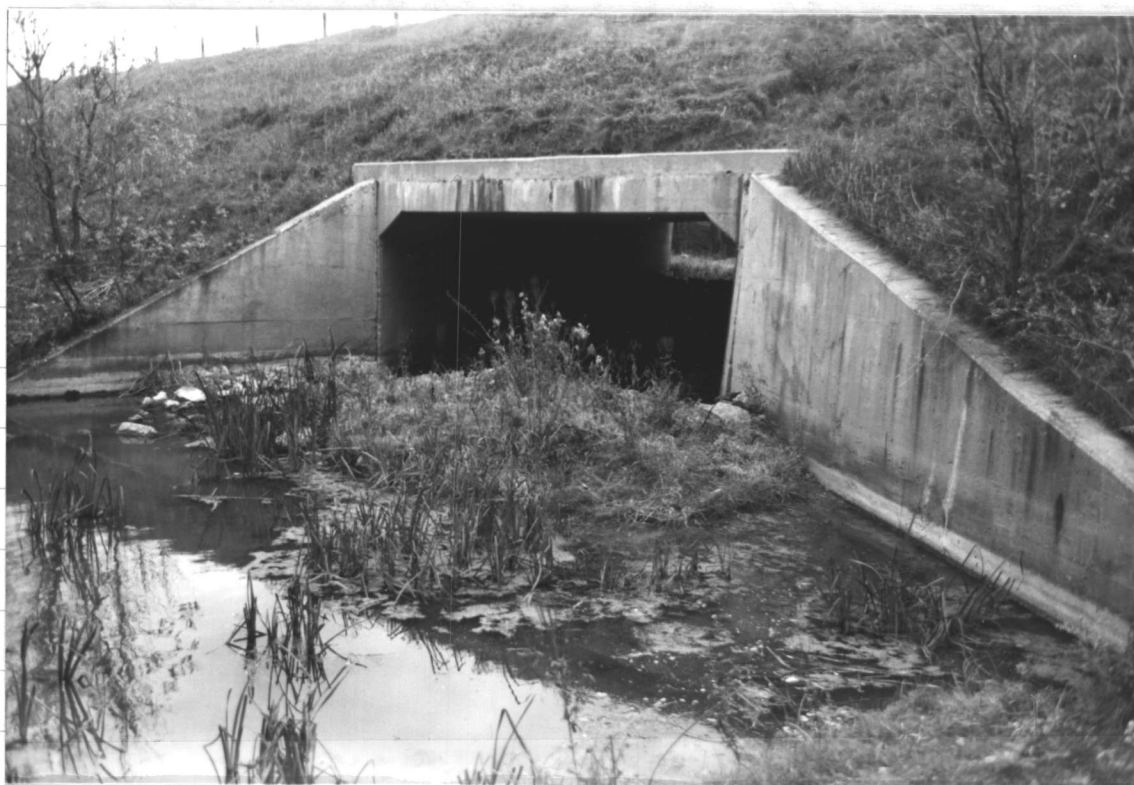
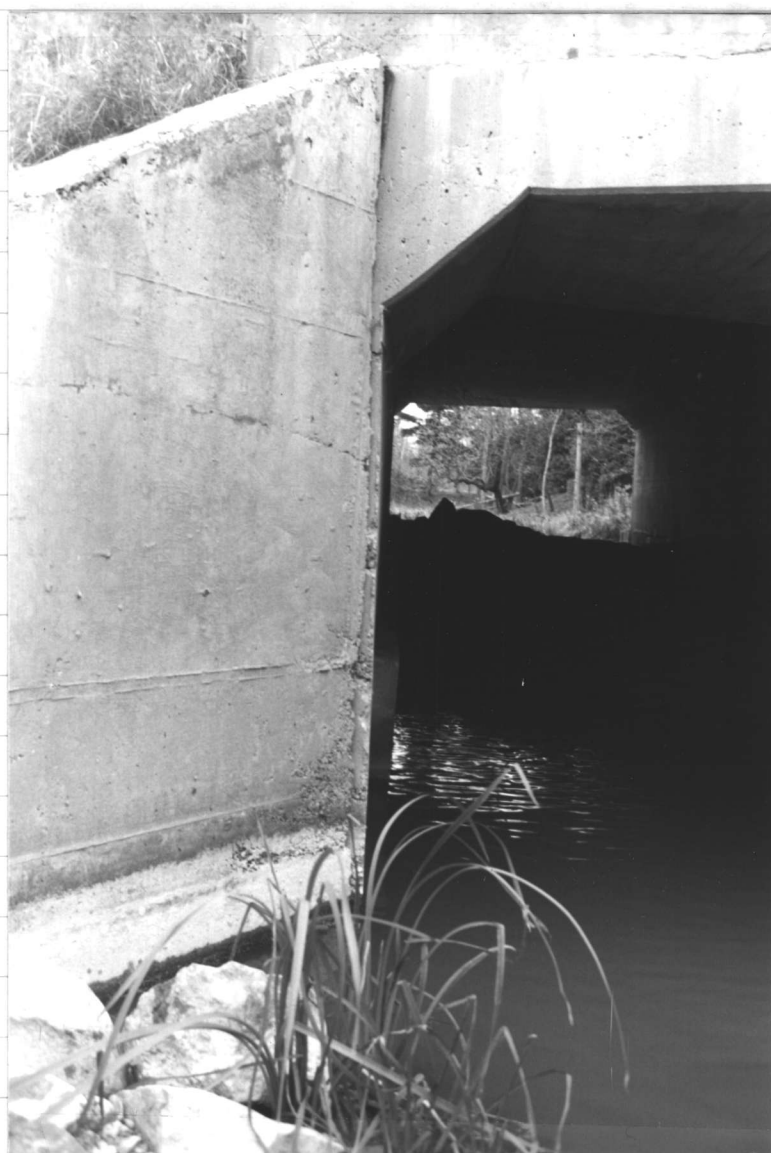
SITE 29-155  
DOUGLAS CREEK CULVERT  
HIGHWAY 60

An inspection of the culvert implemented by this Section on December 1, 1988, confirmed your observations of considerable translation and rotation of the south corner of the east culvert wall. Observation revealed the absence of weep holes along this section. Weep holes, of course are designed to provide channels for the release of hydrostatic pressure. Undermining of culvert footings were noticeable along various sections of both culvert walls. However, it was difficult to ascertain the presence of undermining in the south corner of the east culvert where the significant displacements have occurred because of the elevation of the Douglas Creek waters at that location. The possible coexistence of undermining and water at the footing base can result in not only excessive horizontal force exerted by the water and a potential "jacking" effect produced by the formation of ice, but the resisting forces could also be substantially reduced as a result of the absence of contact between the concrete footing and the bedrock founding material. Furthermore, voids between the footing and founding material can provide routes for potential corrosive attack on the dowels which produces further reduction of lateral resistance.
