## FOUNDATION INVESTIGATION REPORT

Proposed D.H.O. Patrol Yard,  
Hwy. #62, Lot 27, Twp. of Herschel,  
County of Hastings, District #10.  
W.J. 63-F-126 -- W.P. (Nil)

#63-F-126  
HWY #62  
MAYNOOTH  
PATROL YARD

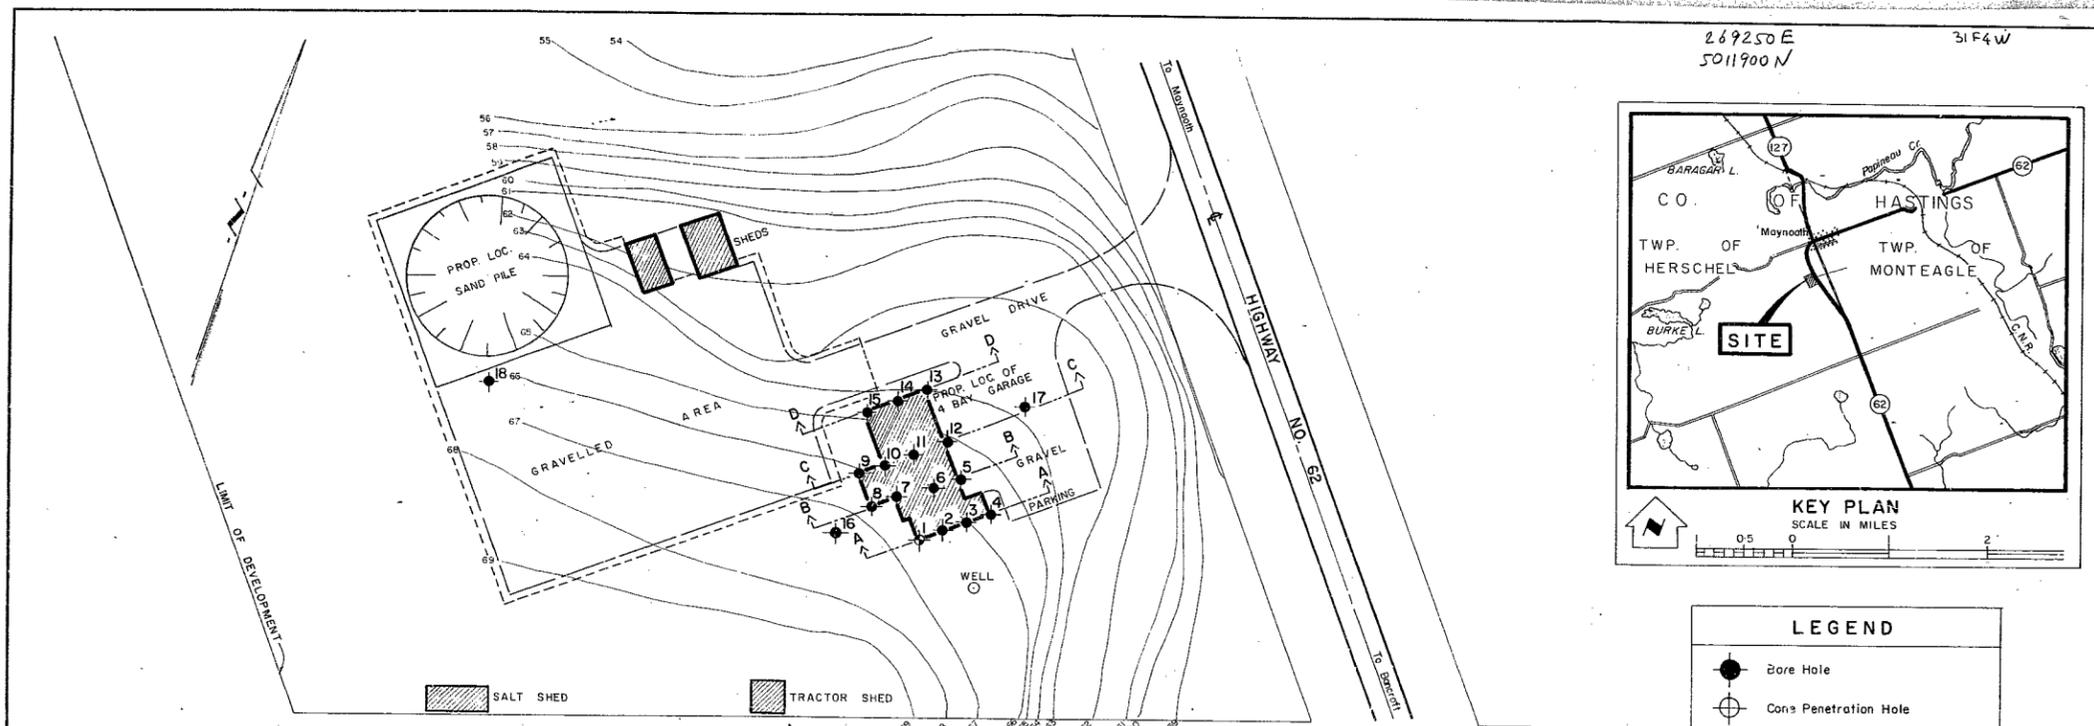
The elevations, as well as the locations of the boreholes, are shown on Dwg. No. 63-F-126A, attached to this report.

The stratigraphy of the soil throughout the site, was found to be quite uniform. The upper 12" to 18" consists of black, organic topsoil, followed by compact silty sand, underlain by very dense silty sand and gravel with frequent boulders.

In the area outlined by a dotted line on Dwg. #63-F-126A, subexcavation will be required to remove the organic material. For estimating purposes an average depth of 36" may be assumed. The backfill should consist of 18" granular material over earth backfill. A portion of the gravelly materials overlying the topsoil could be salvaged for this purpose. Otherwise, borrow is available in the immediate vicinity.
