SUBSOIL INVESTIGATION - D.H.O

W.J. 61-F-88.

Re: -- ROAD FILL MOVEMENTS --
Sta. 386+40 to Sta. 392+00,
Hwy. #17, Near Cobden, Dist. #9.

61-F-88
Hwy # 17
ROAD FILL
MOVEMENTS
NEAR COBDEN

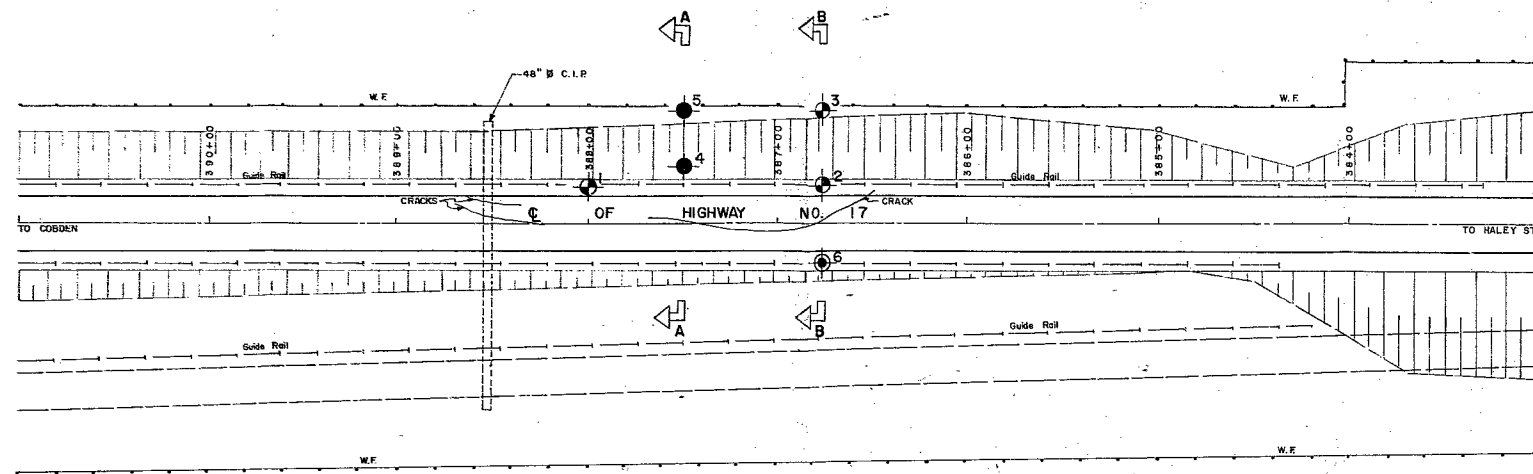
PLAN
SCALE: 1 in. = 40 ft.

The field investigation was carried out in two stages - i.e. - in August 1960 and a year later, in August 1961. During the first field investigation, boreholes 1, 2 and 3 were completed, and during the second investigation, two additional boreholes No's 4 & 5 were carried out. The borehole locations are shown on Drawing No. 61-F-88A.

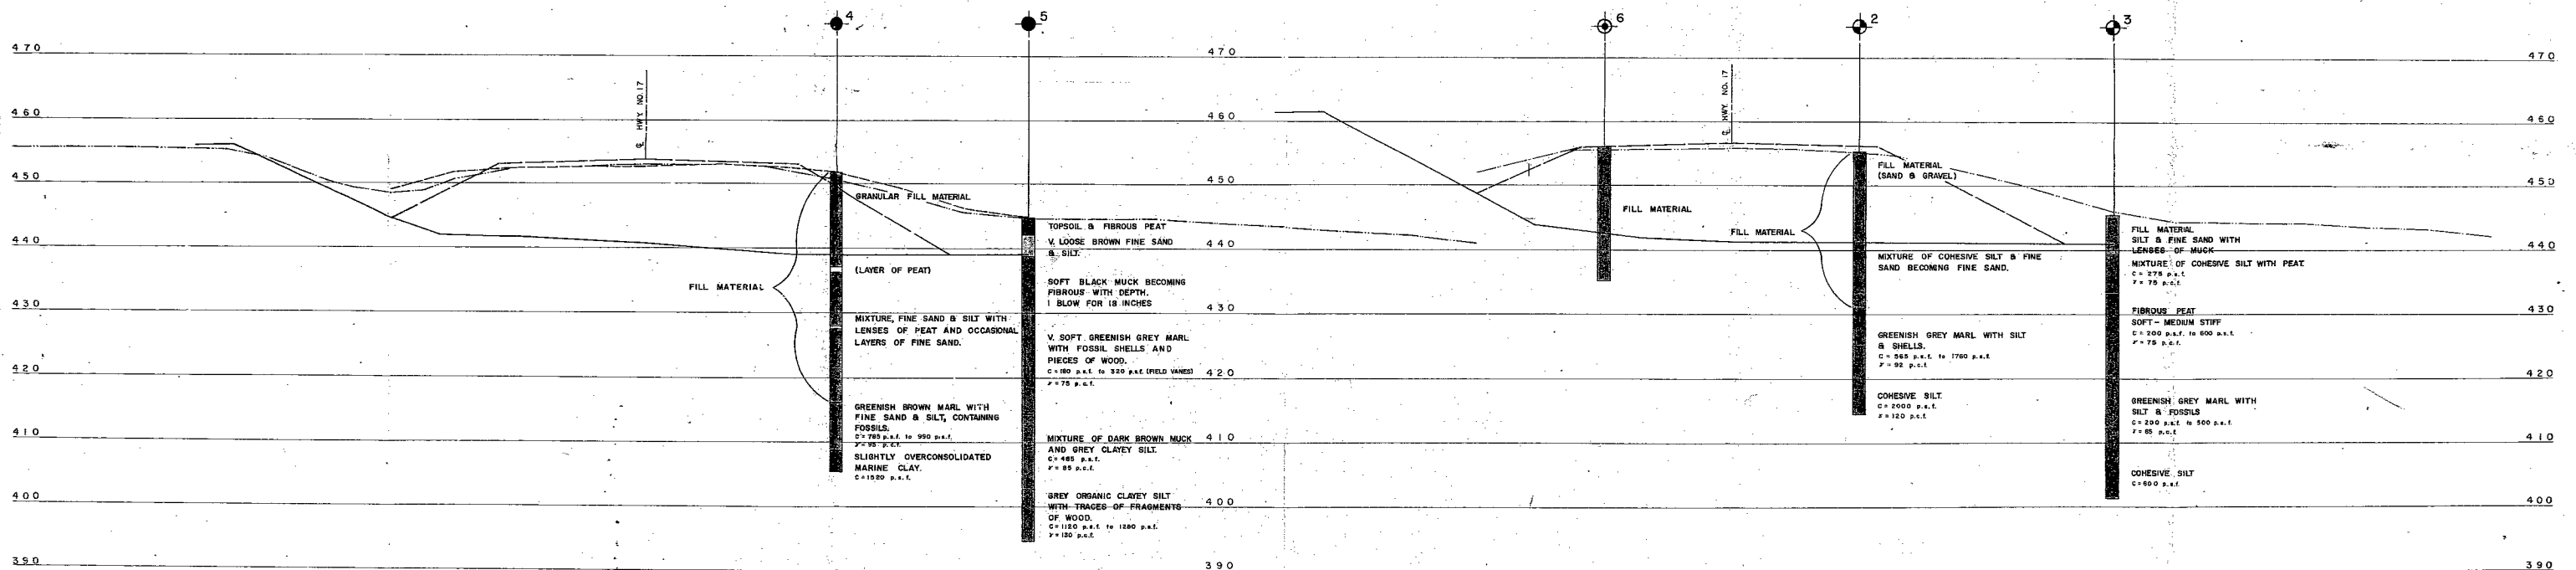
The cross sections at which the four out of five boreholes were drilled, are presented on Drawing No. 61-F-88A. The presented stratigraphy shows the variable depth to which the original subsoil was either excavated or displaced and replaced by fill material. Underlying the fill material is a layer of very soft silt with a high content of calcium carbonate in the form of small shells (marl).

In places, this layer was found to be disturbed, as evidenced by the presence of mucky material which was originally overlying the marl. Being very soft, the material has a low shear strength and is highly compressible.

Bulk density and undrained shear strength measurements in the marl material under the 26-ft. high fill, carried out during the 1960 field investigation, produced values of 92 lb./cu.ft. and 565 lb./sq.ft., respectively. During the 1961 field investigation those values, under the 36-ft. high fill, were 95 lb./cu.ft. and 785 lb./sq.ft., respectively, while at the location of B.H.'s. 3 & 5 where the fill was not as high, lower values were determined in 1960 and 1961, respectively. All this indicates that the material has consolidated under the superimposed fill load and, consequently, its bulk density and undrained shear strength have increased.

On the basis of the above given information, data and the established subsoil stratification, as presented on Drawing No. 61-F-88A, the conclusion has been reached that the described movements were mostly due to rather rapid consolidation of the soft underlying marl layer, resulting in differential settlements of the fill. Due partly to the ground topography, and partly to the uneven displacement of the soft layer, the movements have occurred on the northern half of the road. It is believed that the lateral movements are the result of some lateral consolidation of the soft layer due to the above reasons, rather than the result of a circular or shear block failure.

On the basis of the afore-mentioned conclusion, no radical remedial measure can be recommended, but to pad the settled portion with granular material, thus bringing the road to the required design grade and maintain the road surface. Any surcharging that would increase the rate of consolidation of the soft layer and thus shorten the time to equilibrium, could easily result in a shear failure and therefore, has to be discarded.
