foundation investigation and design report

Culvert Replacement

FOUNDATION INVESTIGATION REPORT

Culvert Replacement
Hwy. 132, W.P. 58-80-01
District 10, Bancroft

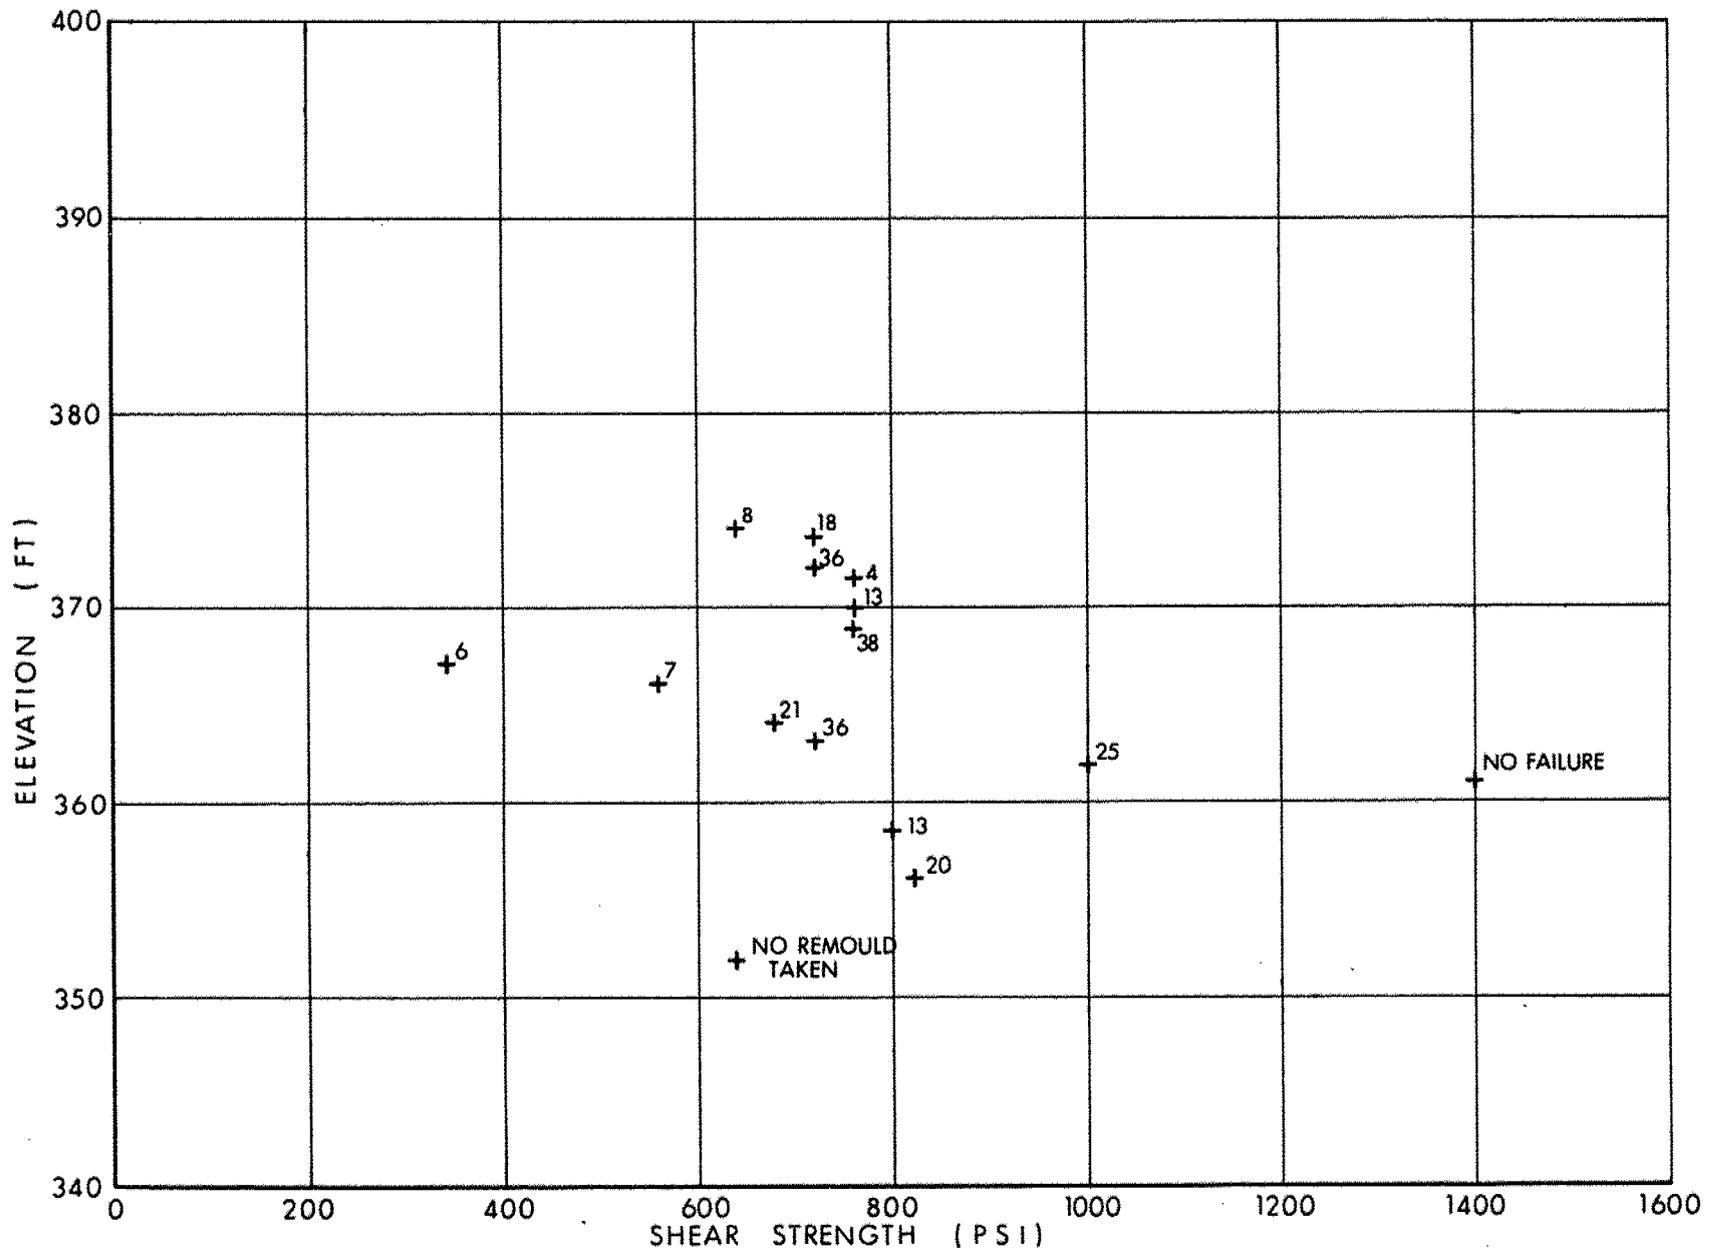
FIG. 1 - SHEAR STRENGTH VS DEPTH

Parent subsurface conditions consist of a surficial deposit of firm to sensitive grey clay about 25 feet thick. Insitu vane testings gave shear strengths ranging from 320 to 1000 P.S.F., generally in the order of 650 to 800 P.S.F., and sensitivities as high as 38 in this cohesive deposit. The results of the vane shear strength testing are shown on Figure 1. This deposit contains a trace of sand, silt and some organic inclusions and from past experience may be described as a clay of medium to high plasticity, CI to CH zone on the Atterberg Limit chart. This material is known to be only slightly overconsolidated and very highly compressible. Laboratory consolidation testing is presently being carried out.

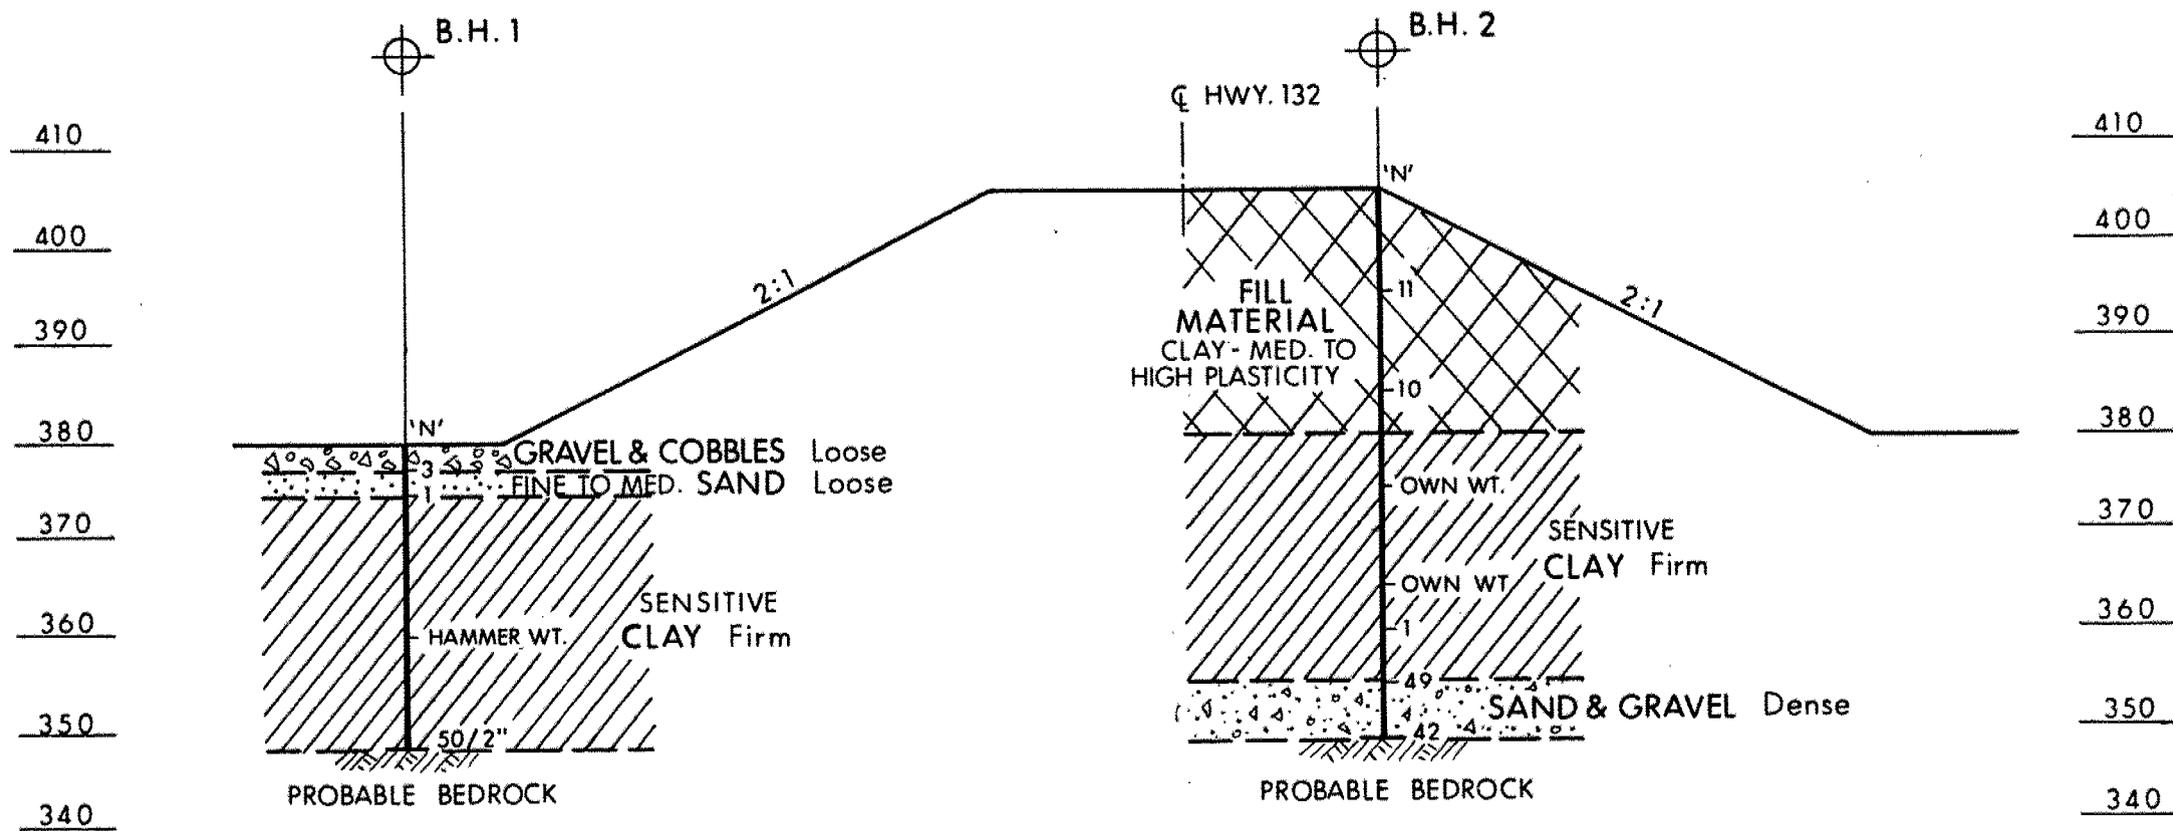
DWG. NO 588001-A

The boundaries between the various subsoil types are shown on the stratigraphical cross-section on Drawing 588001-A which has been inferred from the borehole information. The location and elevation of the boreholes are shown on Drawing 588001-A as well.

CROSS-SECTION HWY. 132
SUBSURFACE STRATIGRAPHY

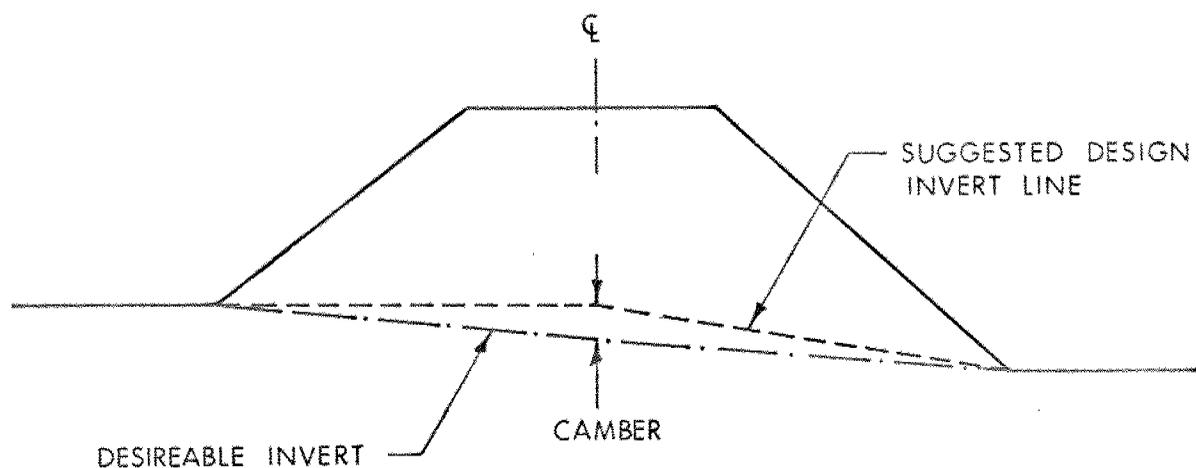
HWY. 132 CROSS-SECTION
SHOWING CAMBER REQUIREMENTS
(NOTE: DISTORTED SCALE)

The consolidation test data was used to estimate settlement under the centre of a 25 foot high earth embankment. The Purdue Method of Stress Distribution was employed to calculate induced pressures due to the embankment loading. Two sets of computations were carried out, one using the consolidation test data from the sample obtained directly under the embankment, the other using the consolidation test data obtained outside the existing area. The computations indicate that due to the original embankment loading the underlying clay would consolidate about 16 inches at the centre of the embankment and that since the embankment has been constructed, 70% of the anticipated consolidation has occurred. It is therefore concluded that an additional 5 to 6 inches of consolidation of the clay material will occur in future years.

In view of the foregoing, a camber of 0.5 feet (6 inches should be applied to the replacement culvert under the centerline of the embankment). See sketch above.

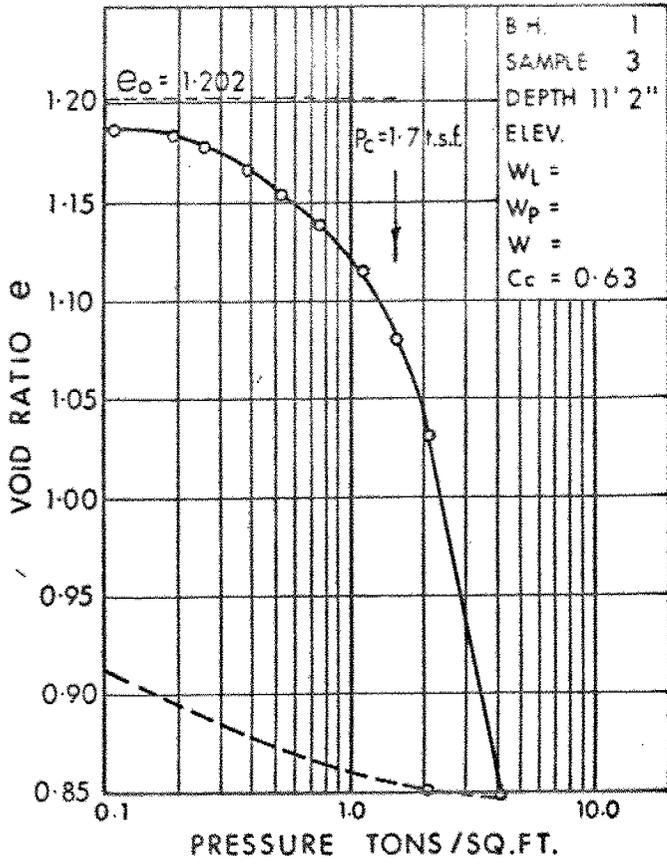
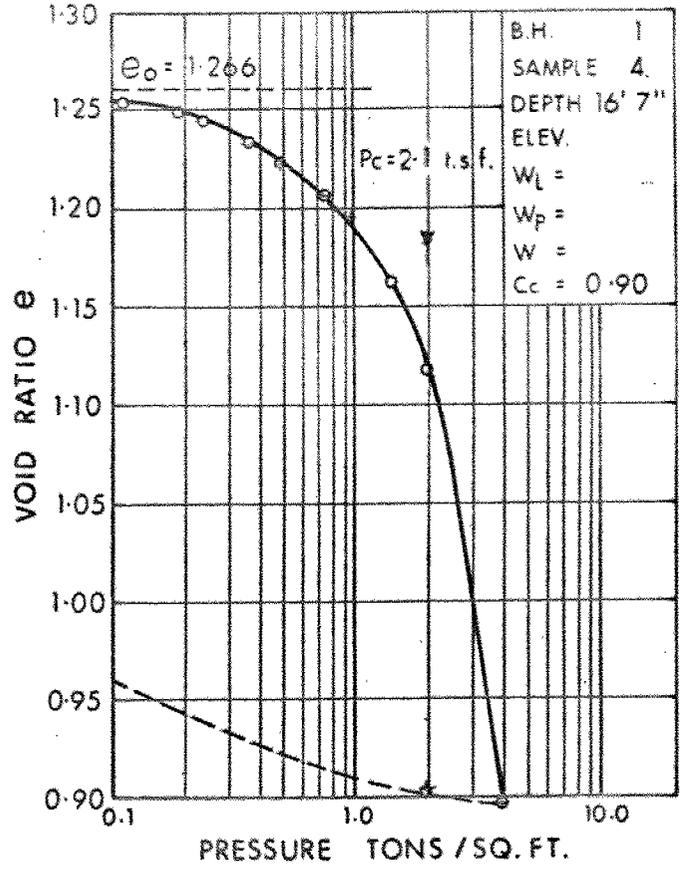
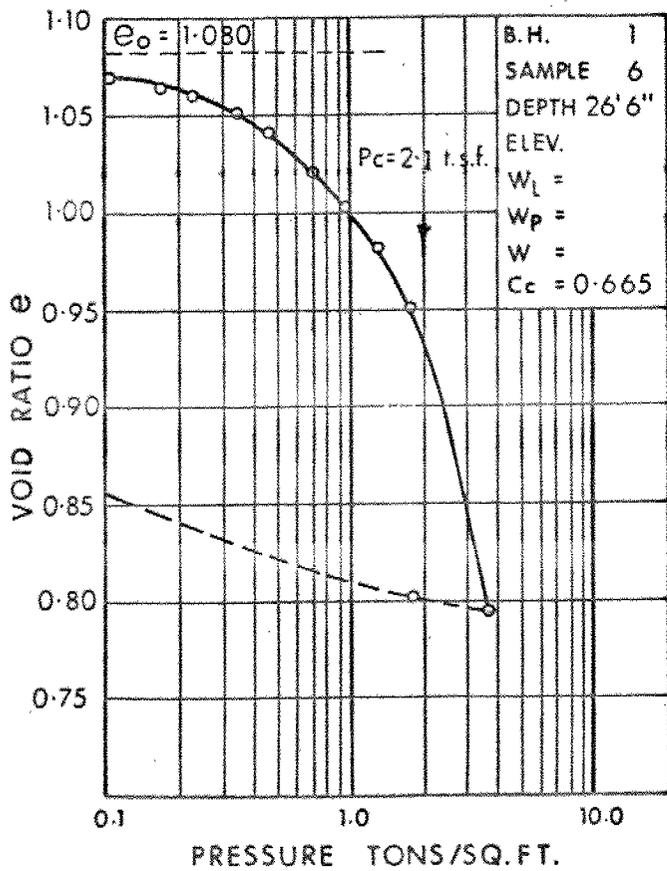
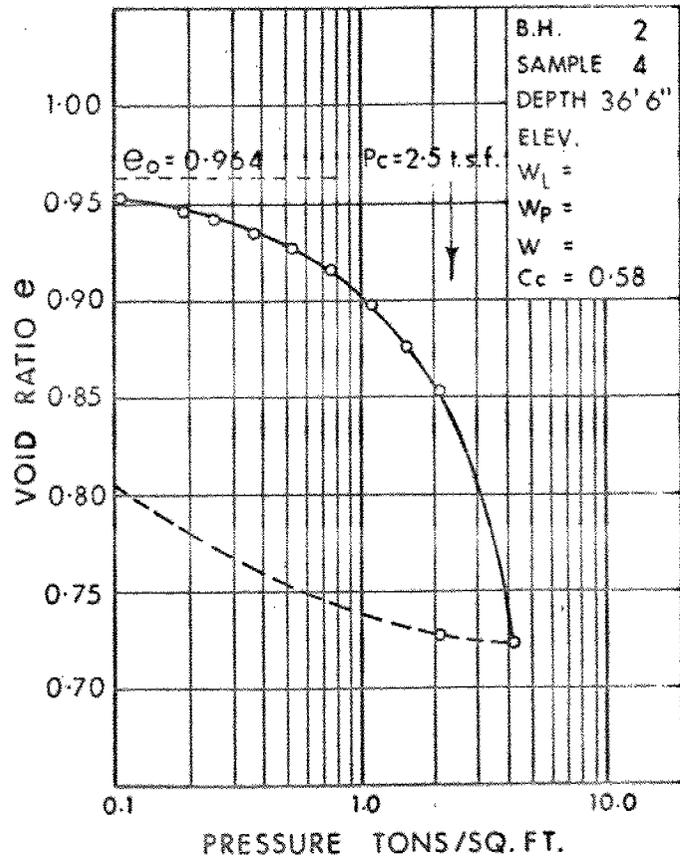
FIG. 1

Four consolidation tests were carried out on relatively undisturbed samples obtained from the extensive clay deposit at the site. One test was carried out on a sample obtained beneath the highway embankment; the other tests were performed on samples obtained outside the embankment limits. The test results are shown on the attached Figure 1, and summarized briefly in the following table:

The consolidation results indicate that the stratum is highly compressible and will consolidate under imposed loads greater than the overburden pressure.
