W.P. No. 81-83-01

HWY. No. 41

Re : Culvert Review
Township of Denbigh
W.P.81-83-01, Site N/A
Hwy. 41, District 10, Bancroft

RE: Culvert Review, Work Project 81-83-01, Highway 41 Vicinity Station 17+240, MTO Plate 438-41/18-0, Township of Denbigh

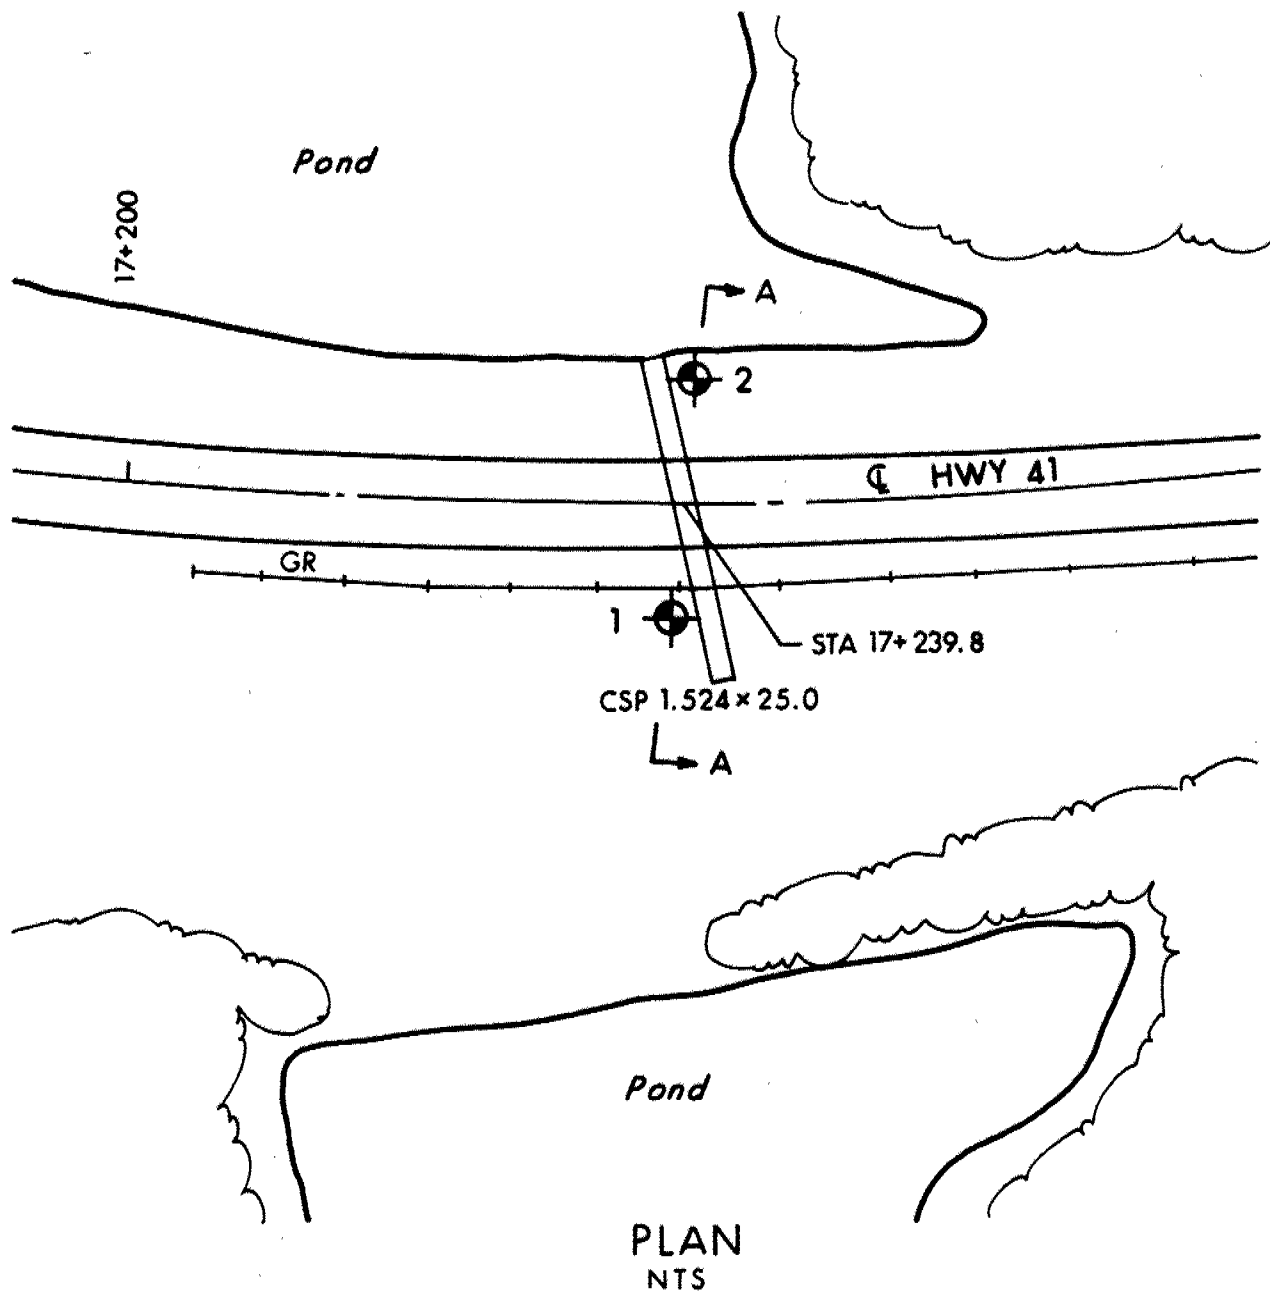
FIG 1

The field work was conducted between 91 08 13 and 91 08 15 and consisted of two (2) sampled boreholes taken down to 6.7 m and 9.4 m depths. Dynamic cone penetration tests were carried out in each of the holes to assess the strength of the subsoil. The locations of the holes are shown in Figure 1.

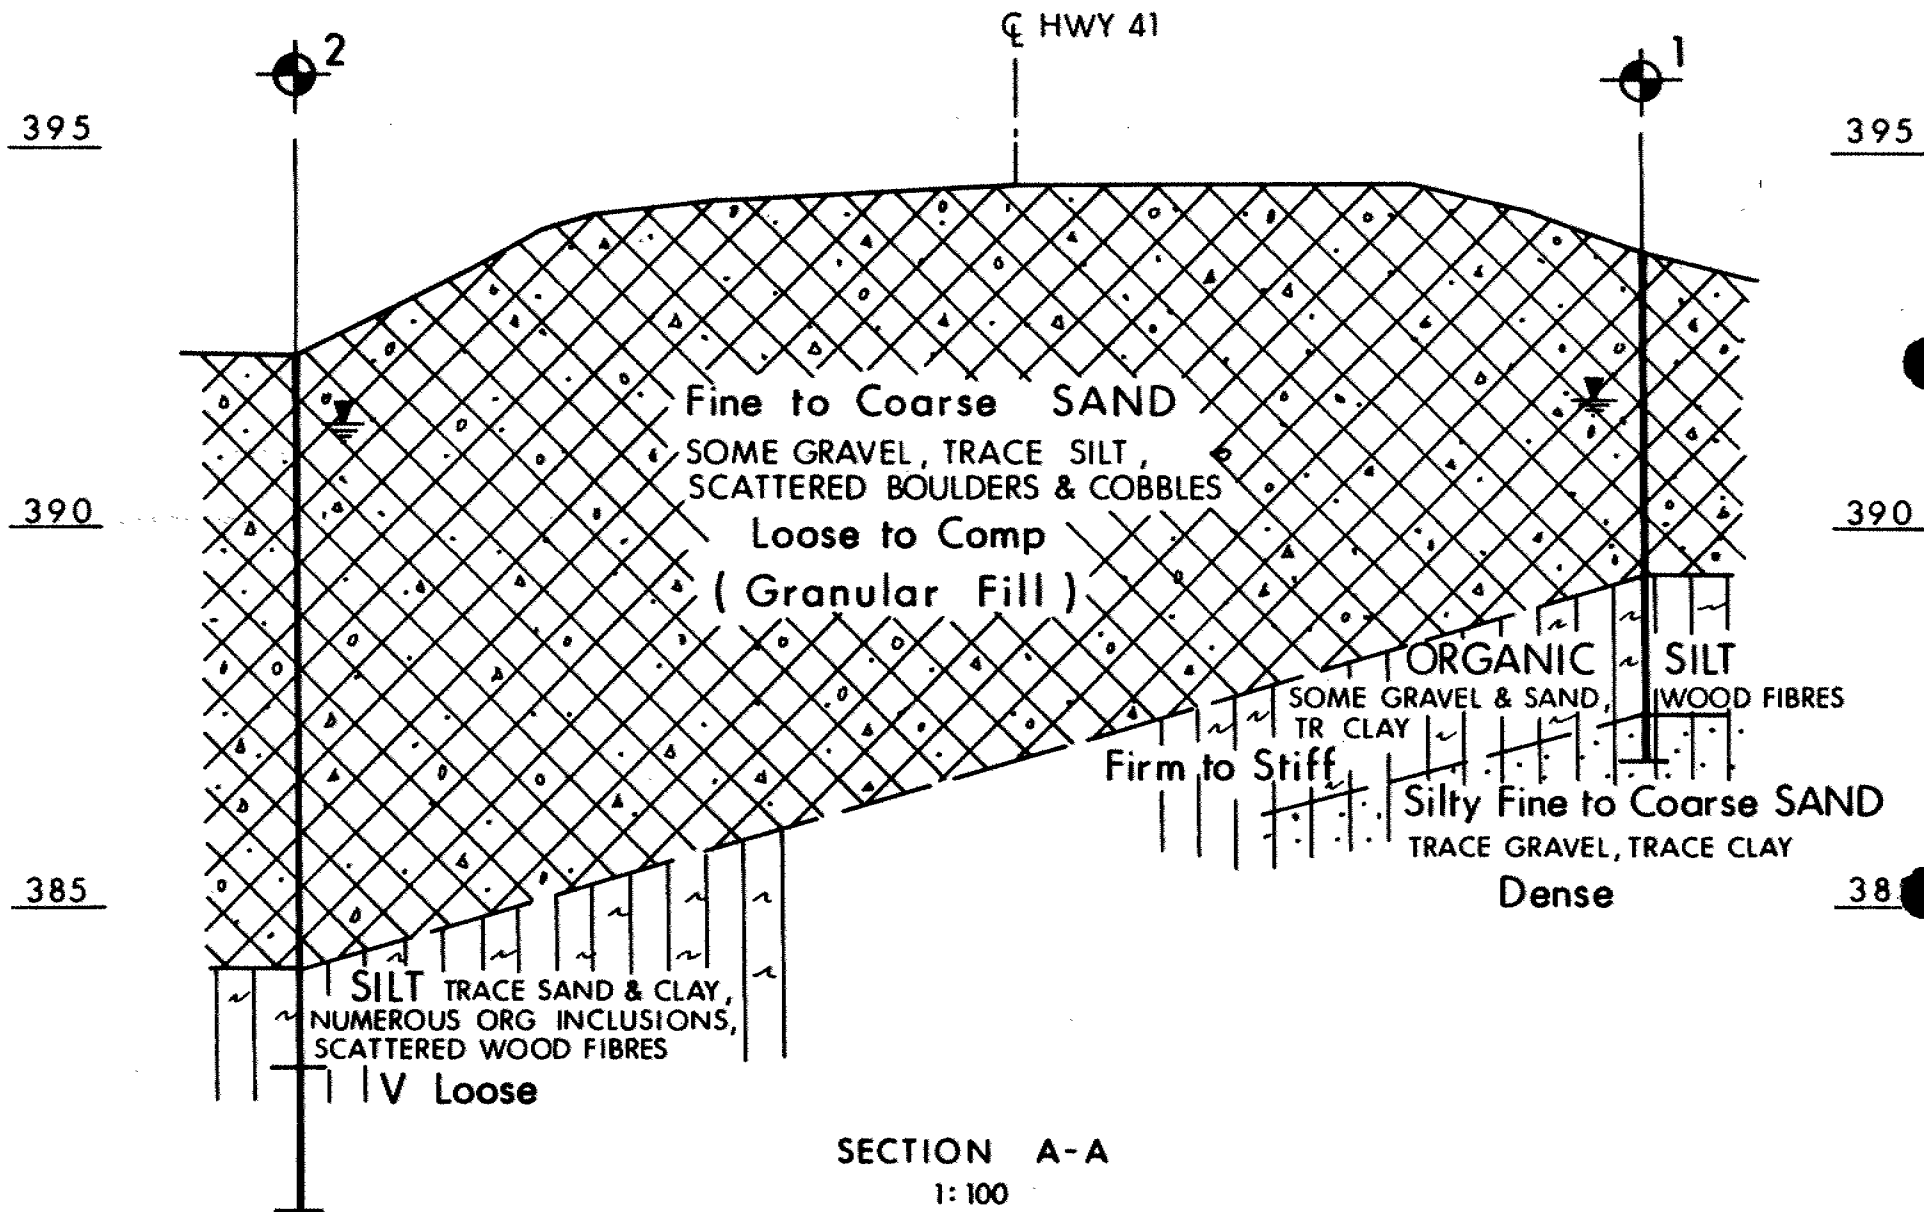
FIG 2

Reference is made to Figure 2 for the stratigraphical profile at the culvert location and the Record of Borehole sheets for subsurface details and laboratory test results. The subsurface stratigraphy typically comprised a 4.3 m to 8.1 m of granular fill overlying a thin layer (about 1 to 2 m) of organic material. Underlying the organic layer was the native sand/silt deposit. The overburden was not penetrated at the maximum depth of 9.4 m in the two boreholes advanced.

Based on the investigation results, a thin layer of compressible organic silt was encountered in the boreholes advanced. The material was either mixed with the granular fill above or the native non-cohesive material below. The extent and thickness of this compressible layer underneath the existing culvert is unknown and cannot easily be determined as they depend on the method adopted during construction of the highway and the direction of the filling process. However, it is in the order of 1 to 2 m thick based on the limited information available. In view that the weak soils were contacted at more than 6 m below the culvert at the distressed area (BH 2) and the mixed nature of the material, it is not envisaged that they were the main cause of the pavement settlement. The continuous loss of fine grained materials through the crack in the pipe below the problem area may be the cause of the settlements. The crack is located at the crown of the pipe appears to be due to construction damage.

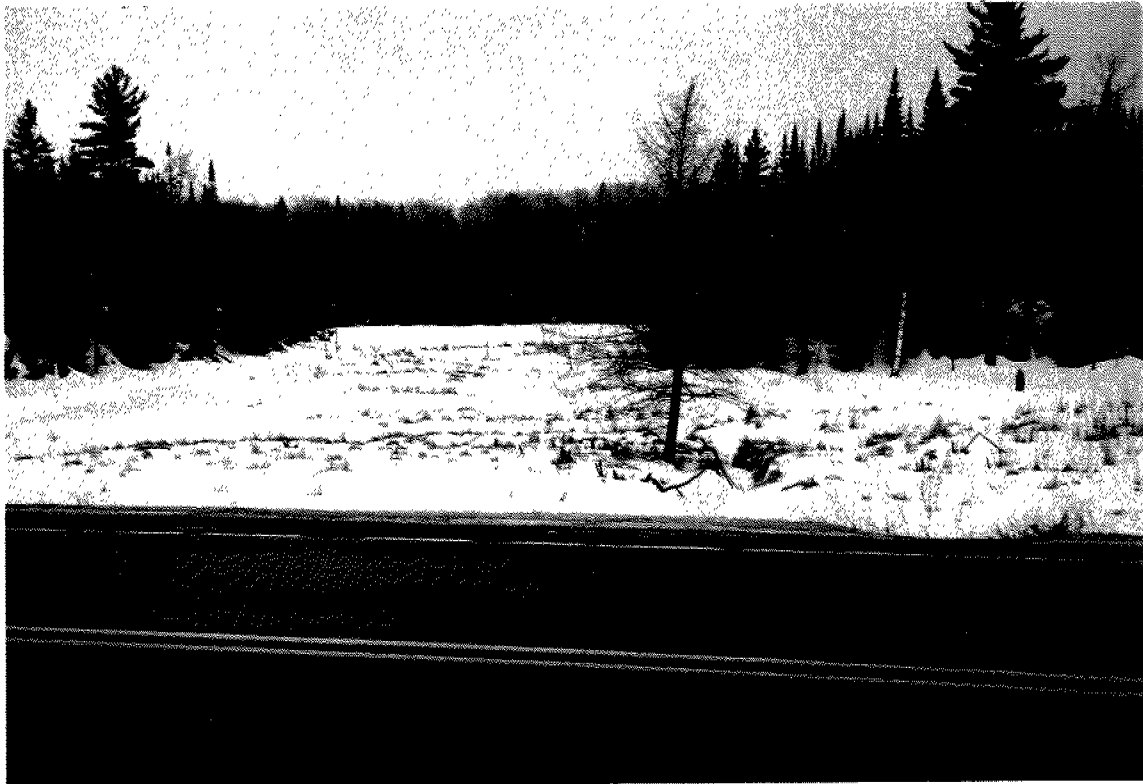
The existing 1.22 metre Corrugated Steel Pipe (CSP) provides for movement of the surface water from the catchment area west of Highway 41 (Photo 1) to the east (Photo 5). The flow gradient is basically flat with the culvert acting as an equalizer from the west to east during the spring run-off season or during heavy rainfalls.

District Maintenance information indicates that water ponding in the west catchment area (Photo 1) has not been a problem except when beaver activity blocked the pipe (note grate at pipe entrance/exit Photos 2 and 4).

Photo (1) Inlet (West) Area
Vic. Sta. 17+240 - TWP Of Denbigh

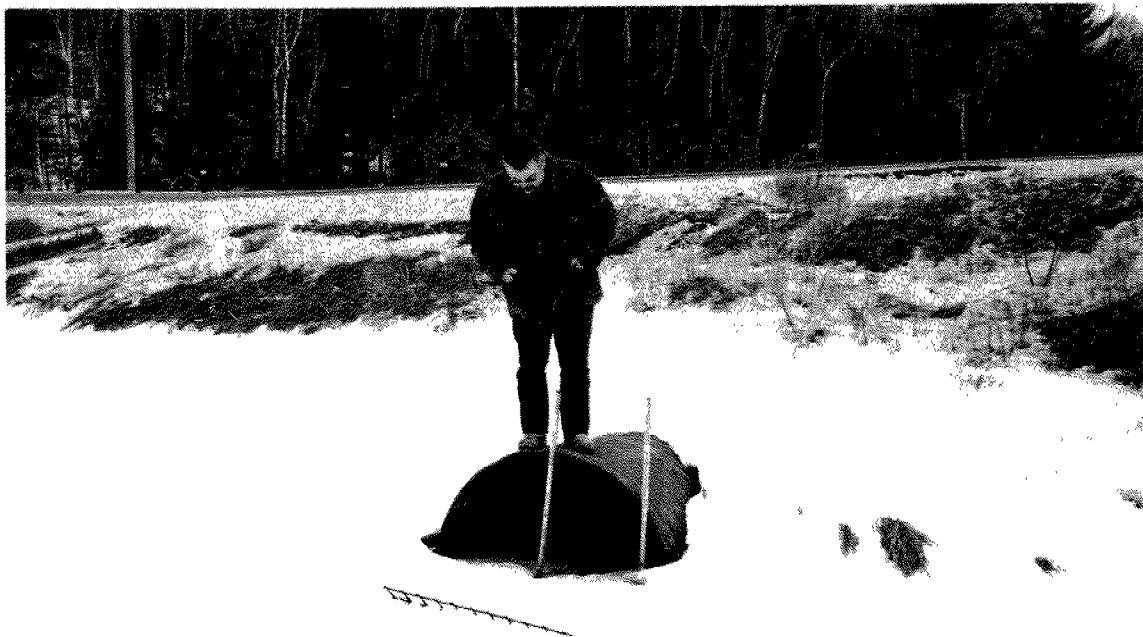
The culvert inlet, though slightly elevated, is still functioning properly (Photo 2) as is the outlet although there is some end damage which probably occurred during construction (Photo 4).

Photo (2) Inlet (West) to 1.2m CSP
Sta. 17+238 - TWP Of Denbigh

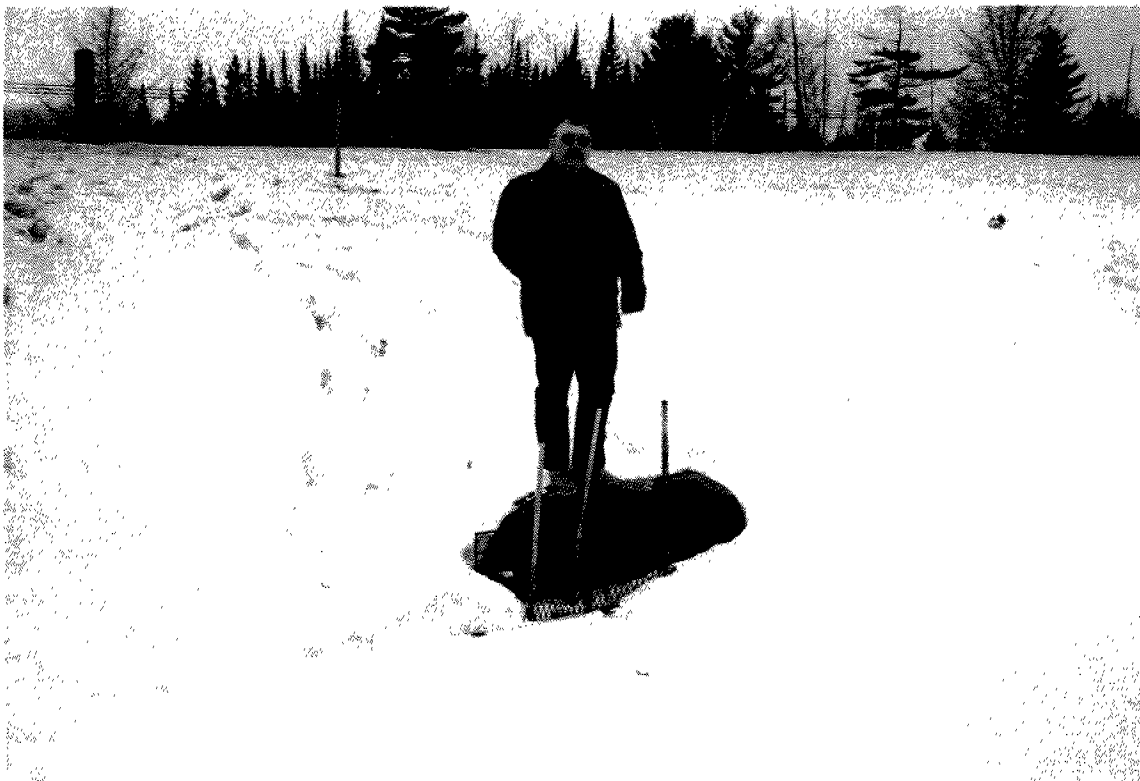
Photo (4) Outlet (East) 1.2m CSP
Sta. 17+242 - TWP Of Denbigh

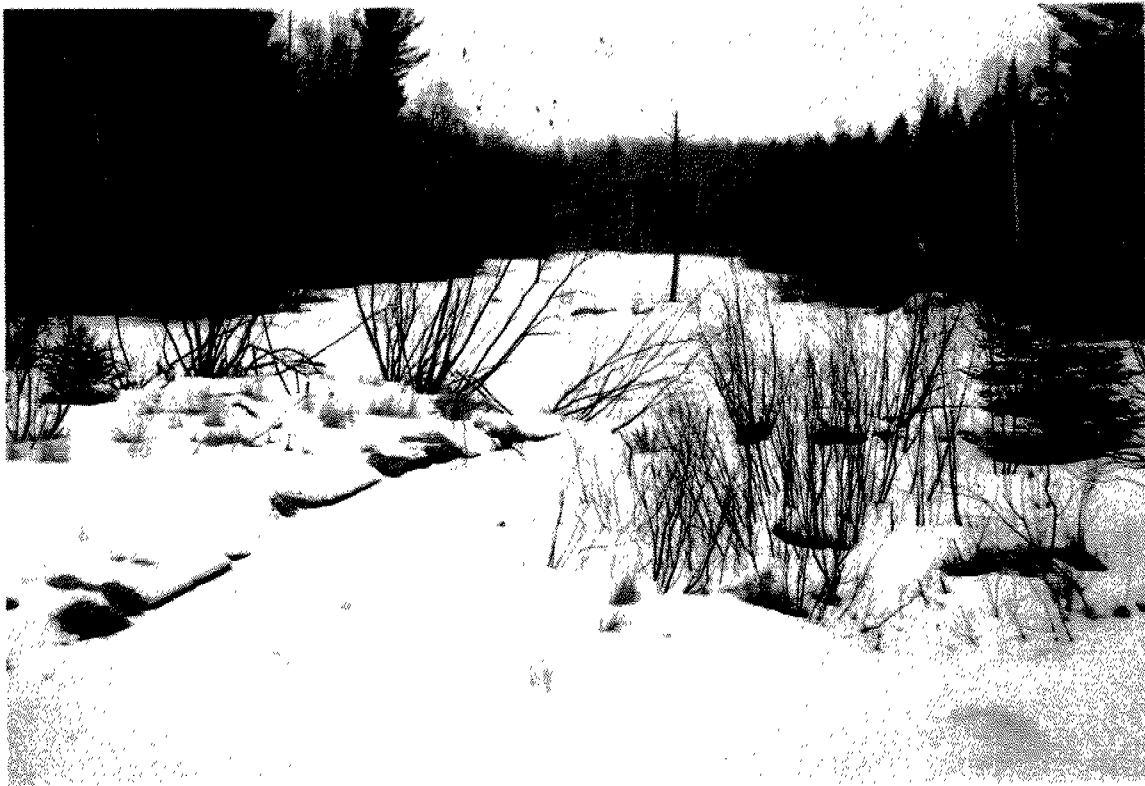
Photo (5) Outlet (East)
Vic. Sta. 17+240 - TWP Of Denbigh
