14 Bayswater Avenue

Report of a Site Investigation  
at

BAIE L'ORIGINAL, ONTARIO.

60-F-324 C

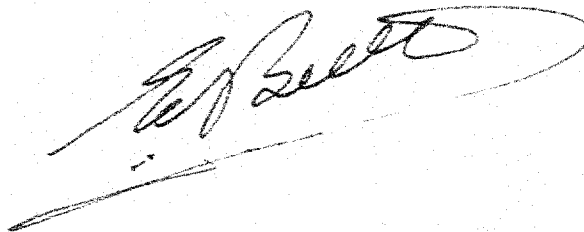
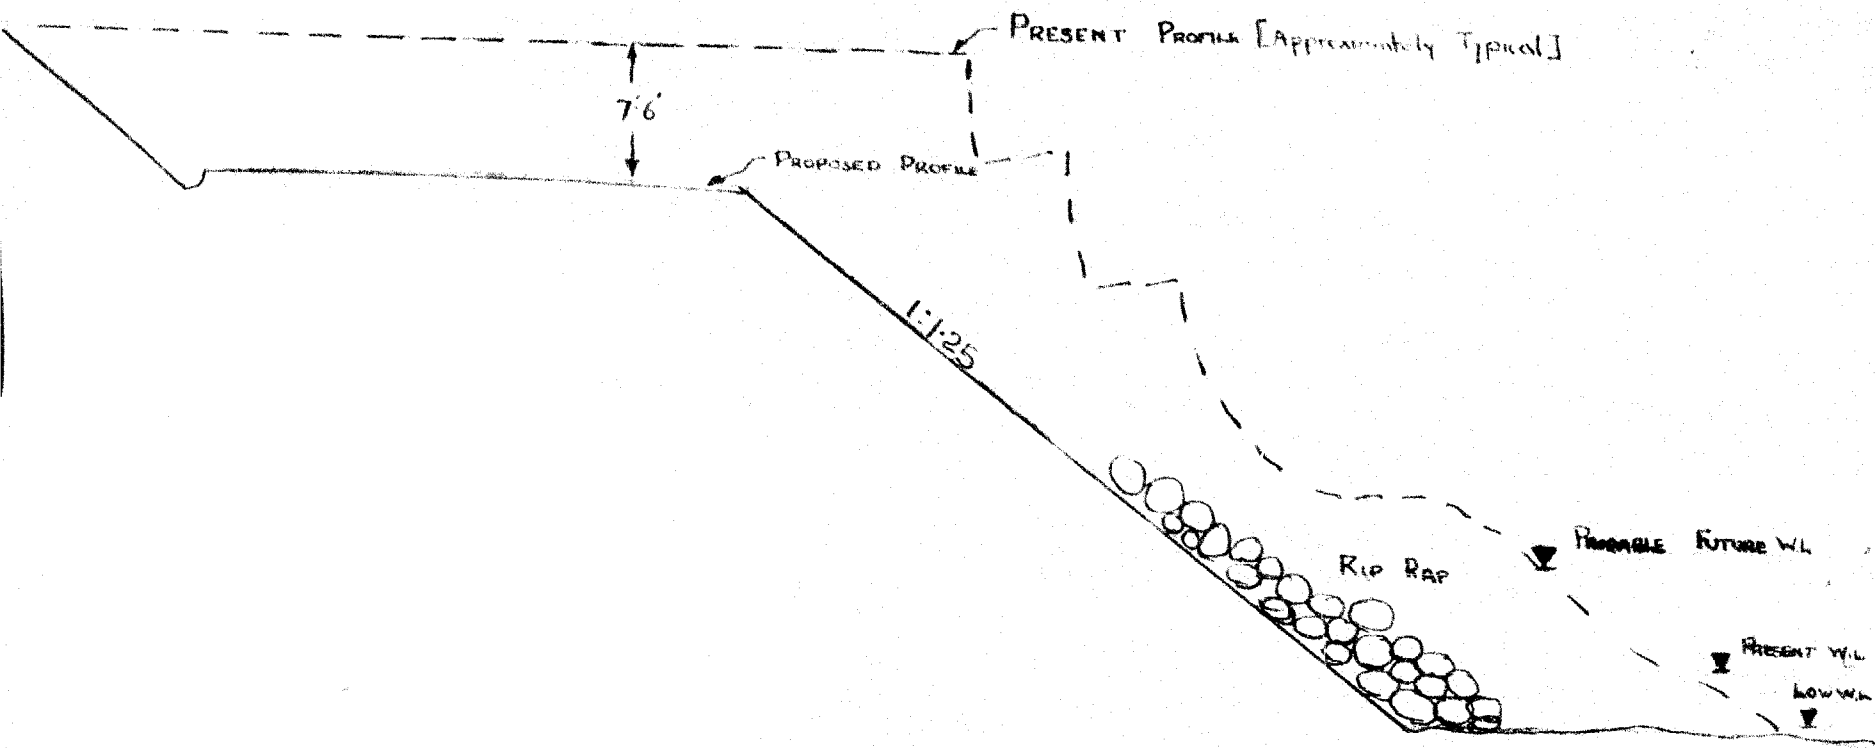
An analysis of the present bank at an assumed angle of  $1\frac{1}{2}$  to 1 was made (a) as at present (b) after the rise in water level. The writer considers that slopes steeper than  $1\frac{1}{2}$  to 1 while they can be built are unstable over the long term particularly when adjacent to water.

The factors of safety as calculated using laboratory test values of  $C=1,000$  lbs/sq.ft.,  $\phi=0$  are (c) with present water level 1.14 (b) with future water level 1.23. The effect of raising the water level in stability problems is to increase the resisting moment, but other complications arise with Leda Clay. The factor of safety of 1.2 is considered too low for design of banks in Leda clay. Further analysis was made cutting down the bank by ten feet and a factor of safety of 1.6 was secured. It is therefore considered that a 7:6" cut would be sufficient. See plate 1.

The protection from erosion is to use boulders or rip rap to break up the wave force and to support the bank.

If it is decided to cut the road down as suggested the excavated material could be pushed over the bank to give some short term protection. However it would be essential to place the rip rap before erosion of the new bank profile began.
