SPECIAL REPORT NO. 81

TITLE Failure of the Approach to the Assatika Creek Bridge

DATE OF REPORT March 23, 1959.

This report presents the test results from three Shelby tube samples and from two field vane borings at the site of a bridge abutment failure on Assatika Creek, 5 miles west of 1st Orignal, Ontario. Based on these tests the stability of the approach fill has been analysed and certain recommendations concerning reconstruction are made.

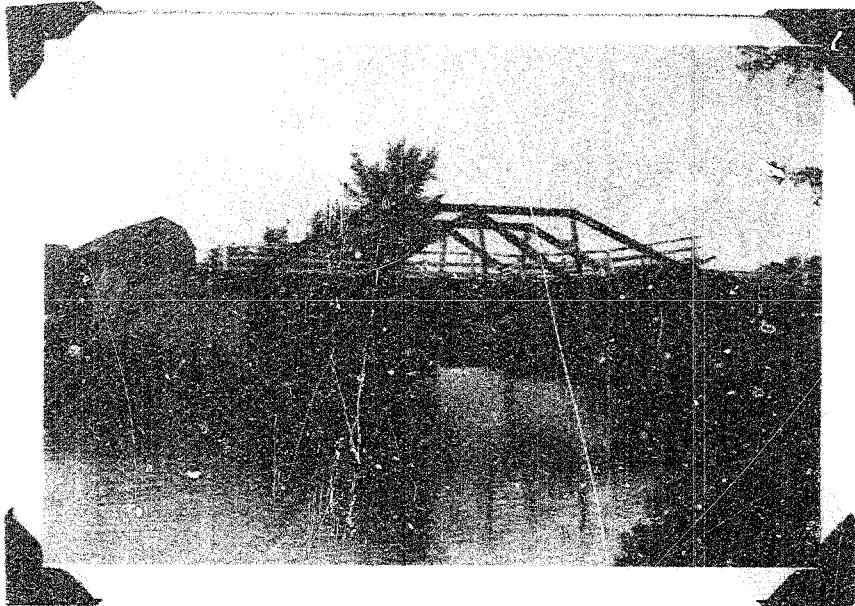
Fig. 1(a) Abutment failure

The north approach fill was then constructed. After three days of traffic, and while the west side of the north approach fill was being widened, the west side sank suddenly about 7 feet at a point about fifty feet north of the bridge abutment. The fill adjacent to the abutment sank about 3 feet. The failure lifted the old pile-bent bridge, immediately to the west of the new structure, about 3 or 4 feet. The failure cracked the west wing wall of the abutment.

Following this failure, the soil was excavated from behind the north abutment and tie rods installed between the two parallel wing walls. The approach fill was again brought up to grade but a further failure towards the old bridge occurred. This failure shifted the north abutment, indicating that the piles had been broken. After some further filling in the vicinity of the abutment, it rotated about the bridge seat and the outside ends of the wing walls settled about 6 feet.

The abutment failure is shown in Fig. 1(a). The distortion of the old bridge is shown in Fig. 1(b). Figure 2, a contour plan of the north abutment, shows the shift of

At the north end, the abutment will probably have to be removed since it has obviously been moved off its piles and may undergo a considerable amount of settlement. This could be checked, since elevations were taken on the abutment in October 1958. Assuming that a new abutment can be built on piles, there is still the question of whether to use an approach fill. If further borings were made, it would be possible to establish with some assurance whether the soft clay was removed over an appreciable area by the failure. If this is the case, a new approach fill could be considered. Otherwise, it would be advisable to carry an extended decking on pile bents from the bridge to the existing stable fill.

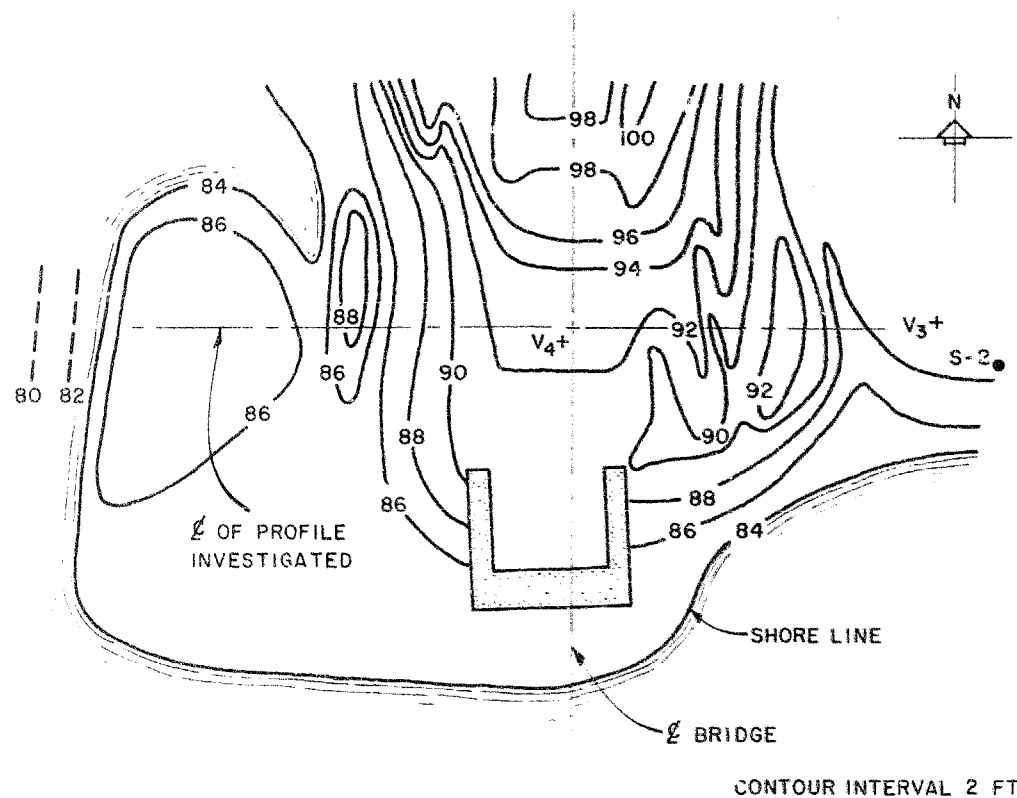
FIGURE 2 PLAN VIEW OF NORTH ABUTMENT

the abutment off-centre and the elevations of the area after failure. These failures had occurred before the site was inspected by R.C. Gauthier and J.D. Paterson, Consulting Engineers, on 10 June 1958. Early in July, the earth against the south abutment was removed as a precaution against further failure.

Two vane borings were carried out at the north approach as shown on Fig. 2, (V3 and V4). Three soil samples were obtained using a thin-walled piston-type sampler in boring S-2 as located on Fig. 2. One sampling boring and two vane borings were attempted adjacent to the south approach fill but, with the hand equipment available, it was impossible to penetrate a fairly shallow sand layer.

The section shown on Fig. 2, just north of the north abutment, was chosen for stability analysis since the first bank failure on the north side occurred at this approximate location and soil test results were available. It was thought that the analysis of a section including the abutment would be too complicated owing to assumptions regarding the restraining influence of the bridge and the piles. The cross-section under study is shown in Fig. 4. Fill dimensions are assumed to be according to design drawings, the original ground surface was selected on the basis of field observations, and the ground water table after construction was assumed to be along the original ground surface. The stability of several potential sliding arcs was analysed using average shear strength values as shown on Fig. 4 and using a fill density of 100 pounds per cubic foot and a submerged density of the natural soil of 55 pounds per cubic foot.

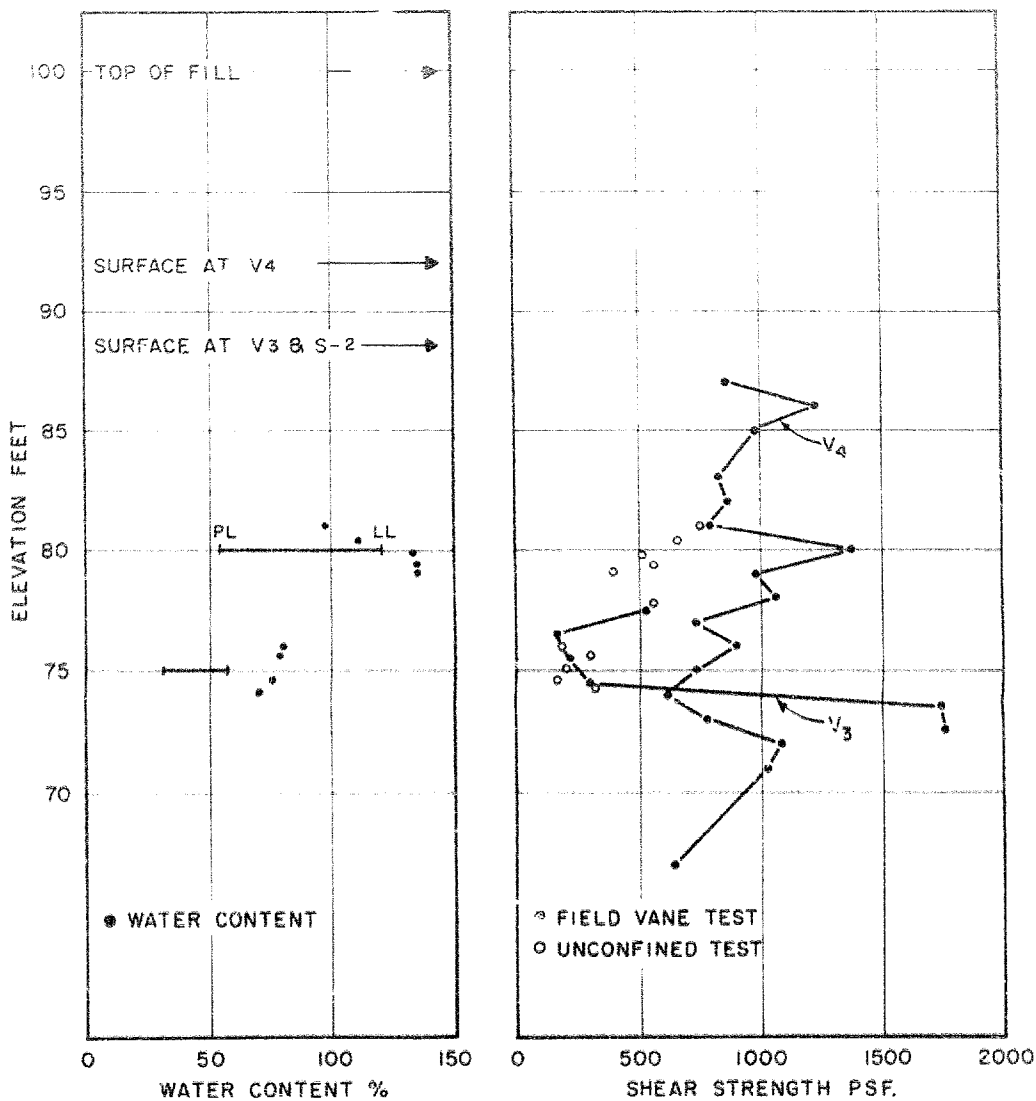
FIGURE 3
AZATIKA CREEK BRIDGE SOIL PROPERTIES
BORINGS V₃, V₄, & S-2

Results of in situ vane shear tests and of unconfined compression and classification tests on the tube samples are shown on Fig. 3. The results of vane borings V3 and V4 and of samples from boring S-2 show a fairly strong layer from the surface at elevation 68 down to elevation 81. An organic silty-clay layer occurs from elevation 81 to 77. It has a rather high water content, a high liquid limit and an undrained shear strength of 400 to 800 pcf. From elevation 77 to 74 there exists a very soft grey clay, with natural water content 70 to 90 per cent, liquid limit 98 per cent, plastic limit 32 per cent and shear strength of 150 to 300 pcf. Below elevation 74 is a hard sand layer through which sampling and vane testing could not be carried out with available equipment. All elevations are relative to the top of the

Vane test V4 was carried out through the existing fill. The results of this vane test would suggest that the very soft clay layer from elevation 74 to 77 had been removed by the failure.

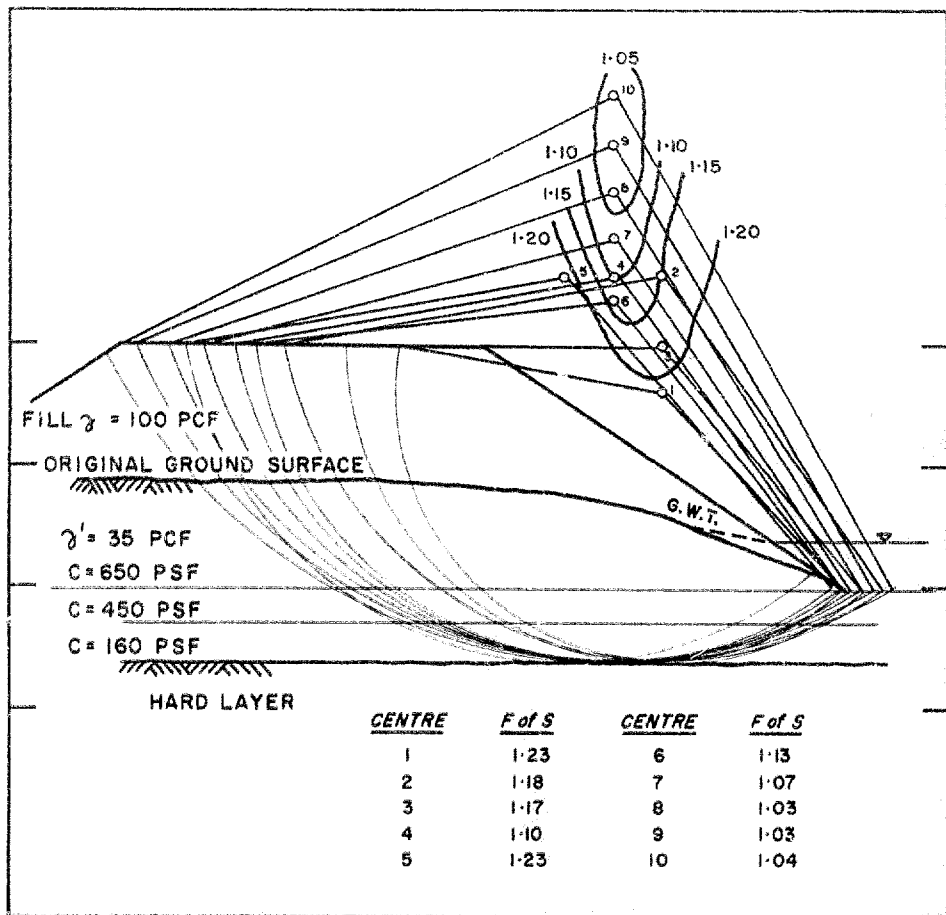
FIGURE 4
STABILITY ANALYSIS OF CIRCULAR SECTION

In the analysis, the fill material was assumed to contribute to the driving moment but its strength was not considered to contribute to the resisting moment. This is a common assumption where fresh clay fills are involved in sliding failures. A minimum factor of safety of 1.03 resulted from this analysis. Since the actual factor of safety at failure is 1, this is a satisfactory evaluation of failure conditions.

Considering the various assumptions of fill dimensions, original contours, soil densities, and average shear strengths in the natural ground, the establishment of a minimum factor of safety of 1.03 is fortuitous. Nevertheless, it confirms the usefulness of analysing "end of construction" safety using a $\phi = 0$ method of analysis in these materials.

The failure of this bridge structure was obviously due to a failure in the approach fill. To avoid failures of this type, it is desirable to carry out stage construction in which the fill is raised in level lifts and a period allowed for the soft subsoil to consolidate and increase in shear strength under each lift. In this way, the fill can be built up safely over a period of time to the final grade. Alternatively, the fill adjacent to the bridge abutment may be replaced by a series of pile bents and timber decking, thus eliminating the weight of the fill as a cause of failure.

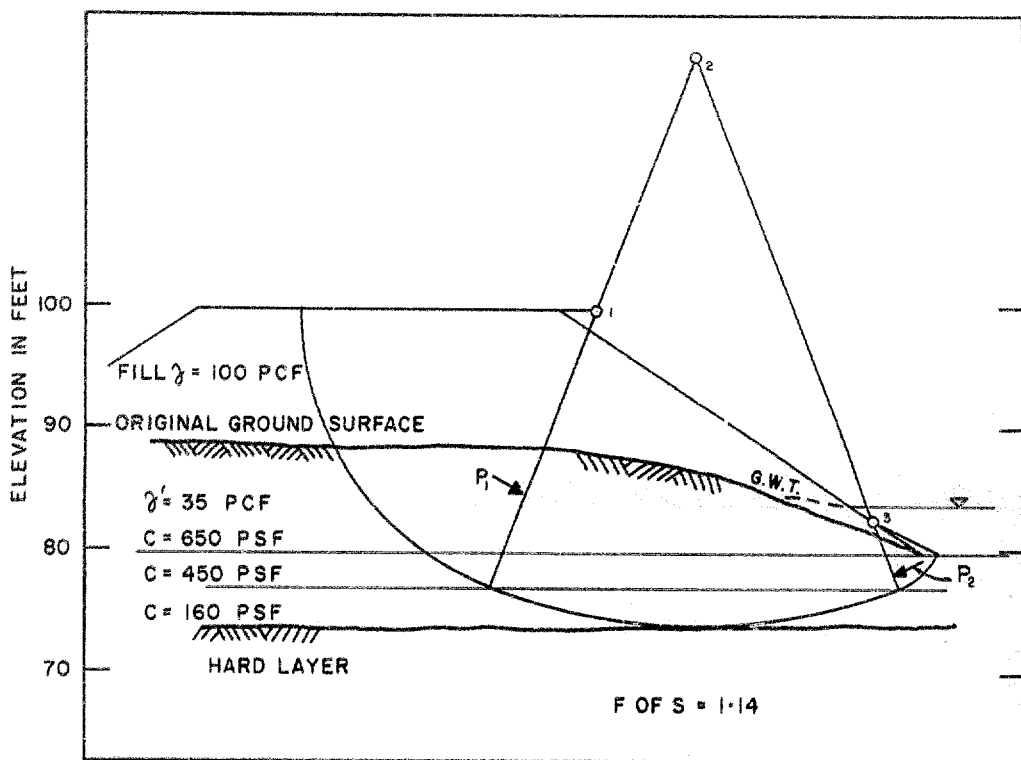
FIGURE 5
STABILITY ANALYSIS OF COMPOSITE SECTION

Because of the extremely soft layer of soil beneath the fill, a composite sliding surface, involving three circular arcs, was analysed as shown in Fig. 5. This analysis gave a factor of safety of 1.14. An infinite number of composite sliding surfaces could be analysed but it was not thought worthwhile to pursue this course.
