BRIDGE #14

Re: Cornwall Twp. Bridge #14,
Over St. Andrews Rd., Hwy. 401,
Dist. #9. -- W.P. 112-59.

February 9, 1962.
Inspection Trip

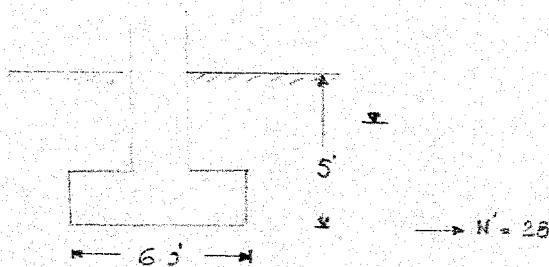
Cornwall Trp Bridge #14 @ St Andrews Rd

$$N = 15 + \frac{1}{2}(N' - 15) \\ = 15 + \frac{1}{2}(28 - 15) = 21.5$$

Say $N = 21$ $B = 6.0$
 $N_r = 20$ $D_f = 5.0$
 $N_q = 20$ $\gamma' = 50$

$$q_d = \frac{1}{2} E \gamma N_r + \gamma D_f N_q \\ = \frac{1}{2} \times 6 \times 50 \times 20 + \frac{50 \times 5 \times 20}{2000} \\ = 3.5 \text{ Tons/sq ft}$$

$$q_o = \frac{q_d}{F_s} = \frac{3.5}{3} = \text{Say } 1.2 \text{ T/sq ft}$$
